VEHICLE INSPECTION REPORT

CU64FHO

Ford Transit 350 2.2 TDCi 125ps H2 Van

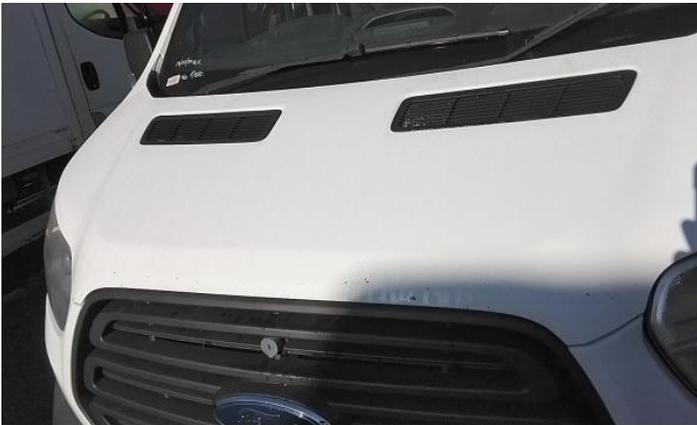
1: Bonnet
Chipped
Multiple Chips

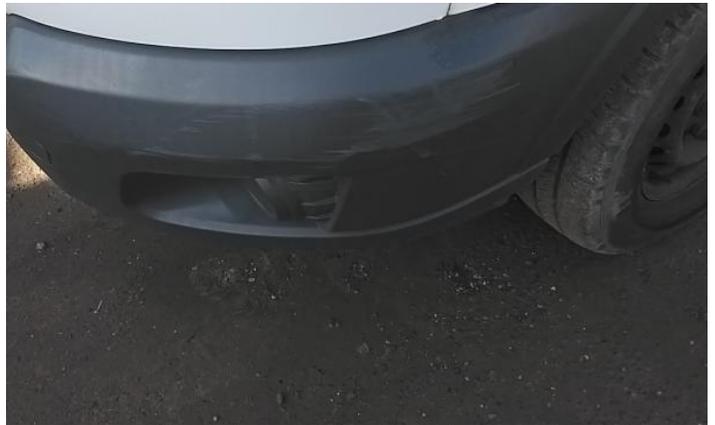
2: Bumper Front
Scratched
Over 100mm Thru Paint

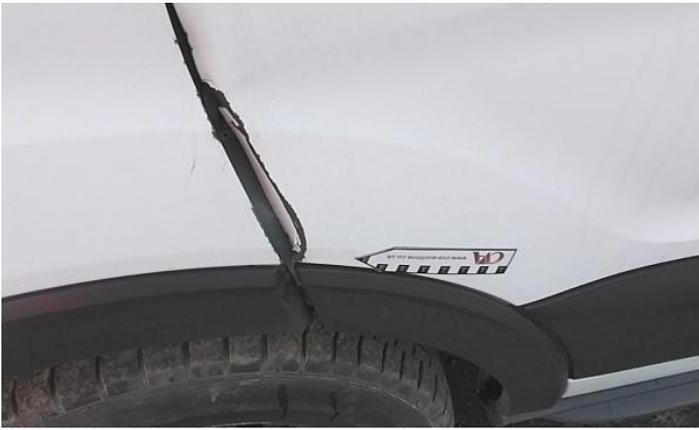
3: Door nsf
Dented
With Paint Damage

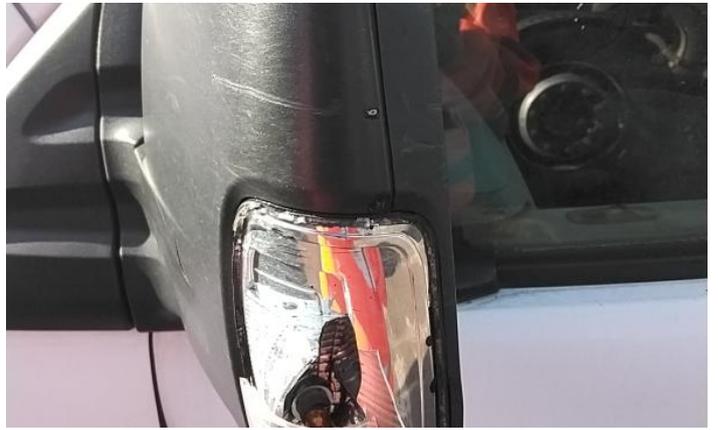
4: Door Mirror Assy nsf
Broken
Replace

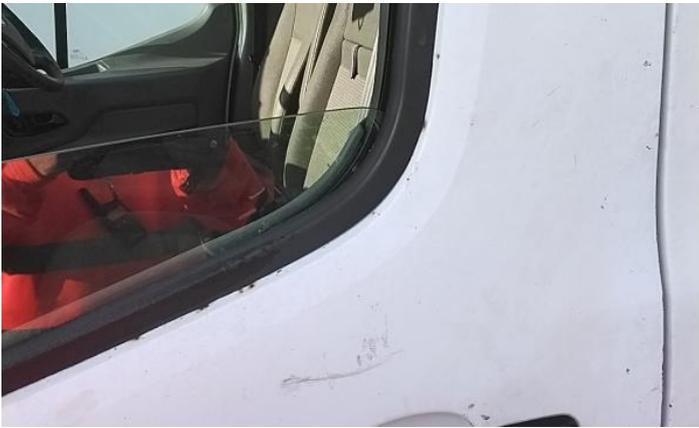
5: Door nsf
Chipped
Multiple Chips

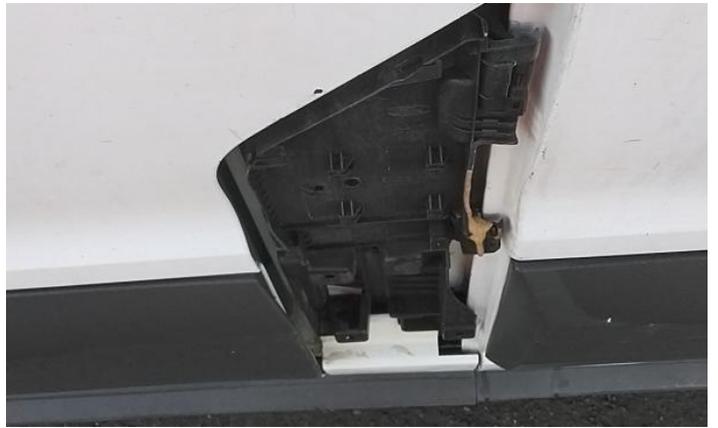
6: Fuel Flap
Missing
Replace

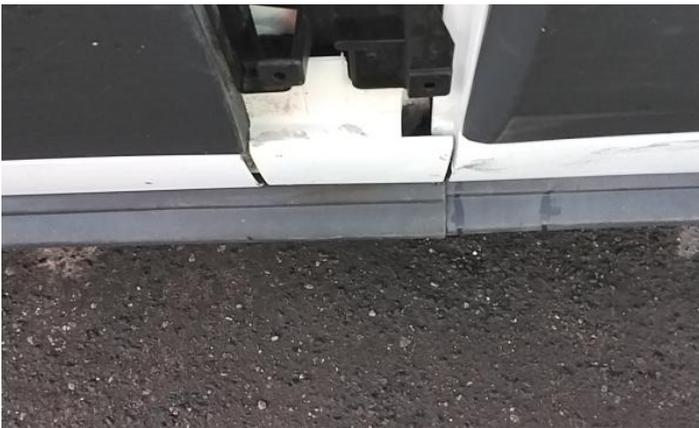
7: Door Moulding nsf
Missing
Replace

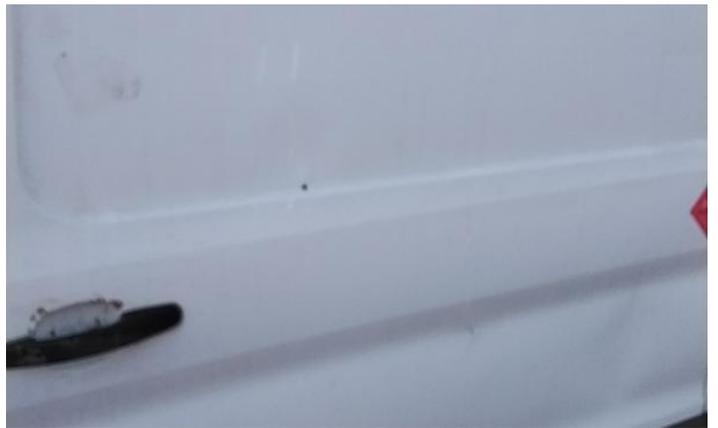
8: Qtr Panel nsr
Chipped
Multiple Chips

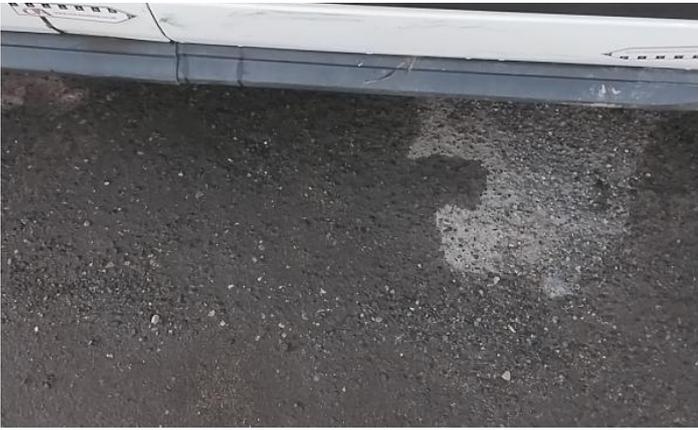
9: Qtr Panel nsr
Scratched
Over 25mm Thru Paint

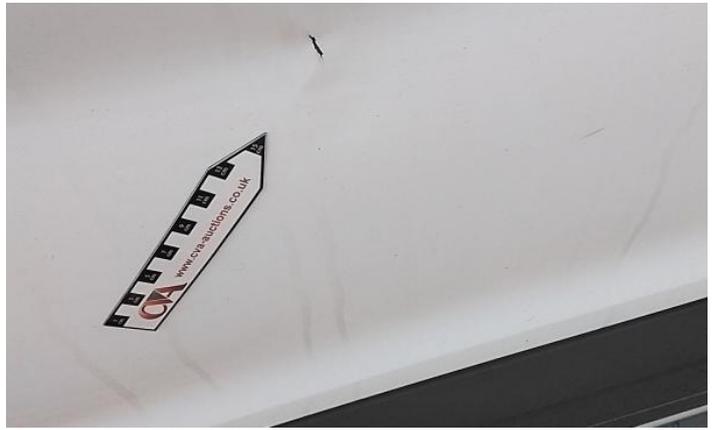
10: Qtr Panel nsr
Dented
With Paint Damage

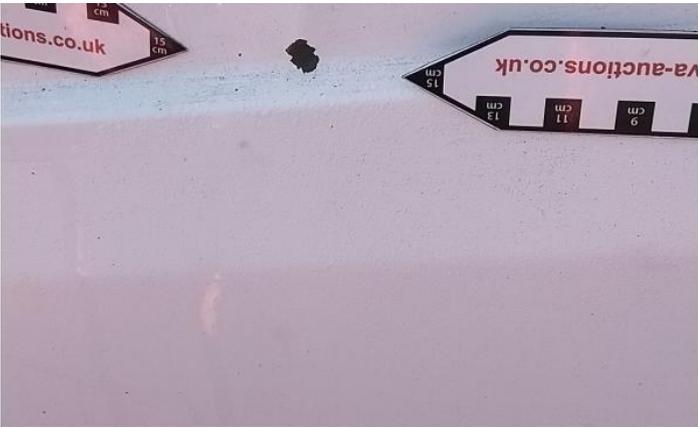
11: Qtr Panel nsr
Dented
With Paint Damage

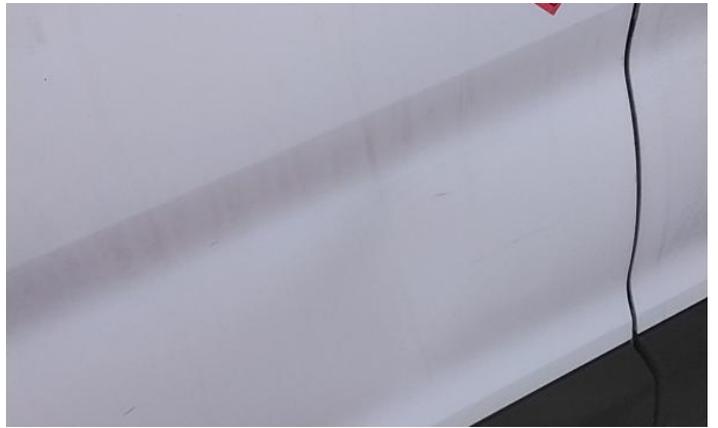
12: Qtr Panel nsr
Dented
Over 30mm

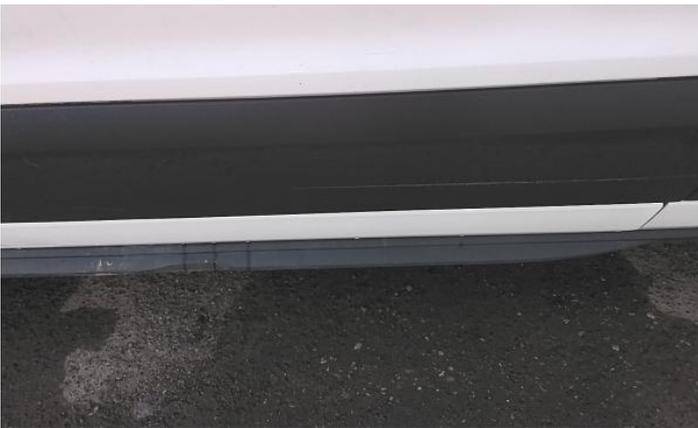
13: Qtr Panel Moulding ns
Scuffed (Unpainted)
Over 100mm

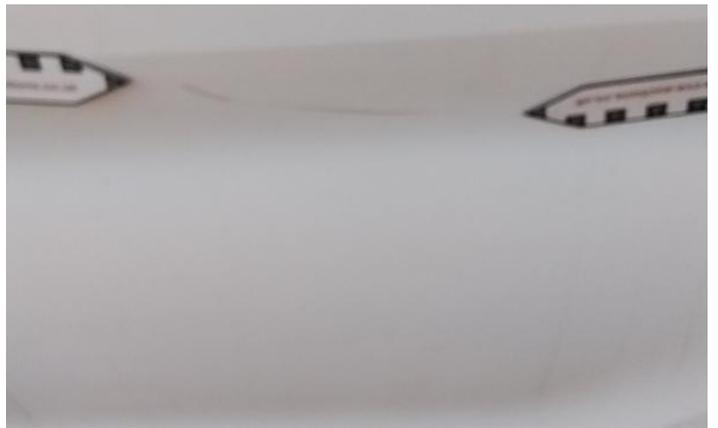
14: Qtr Panel nsr
Scratched
Over 25mm Thru Paint

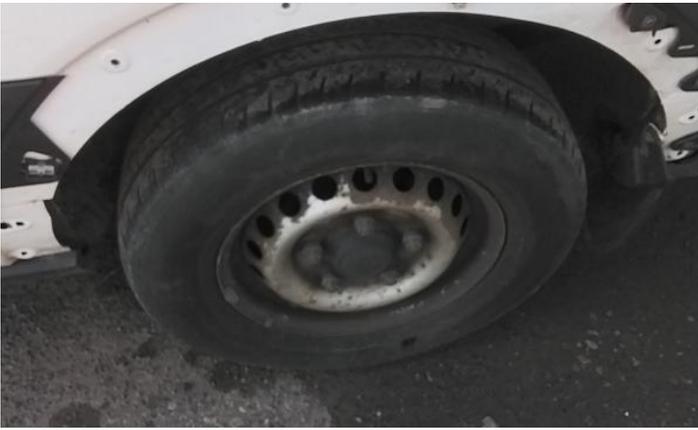
15: Qtr Panel Moulding ns
Missing
Replace

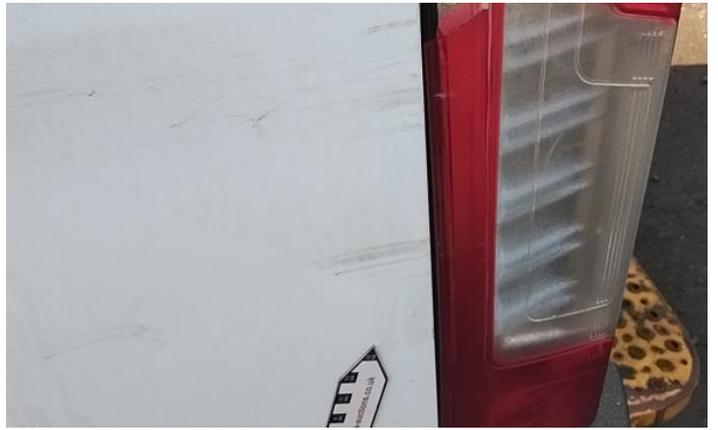
16: Qtr Panel nsr
Dented
With Paint Damage

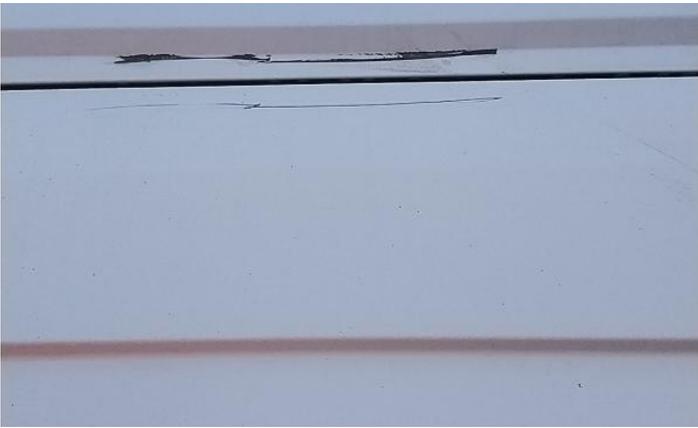
17: Qtr Panel nsr
Dented
With Paint Damage

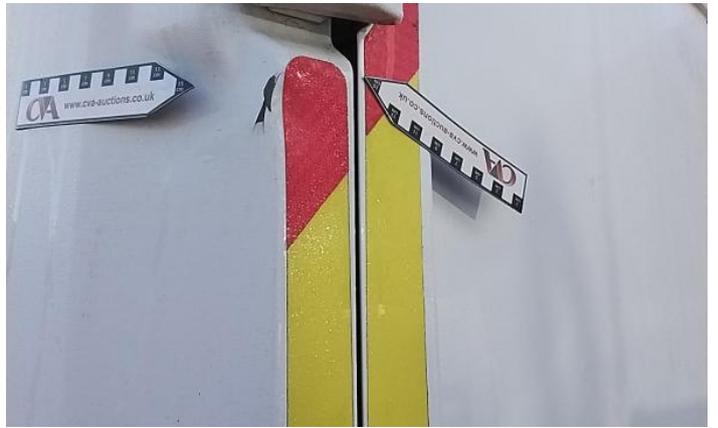
18: C Post ns
Dented
With Paint Damage

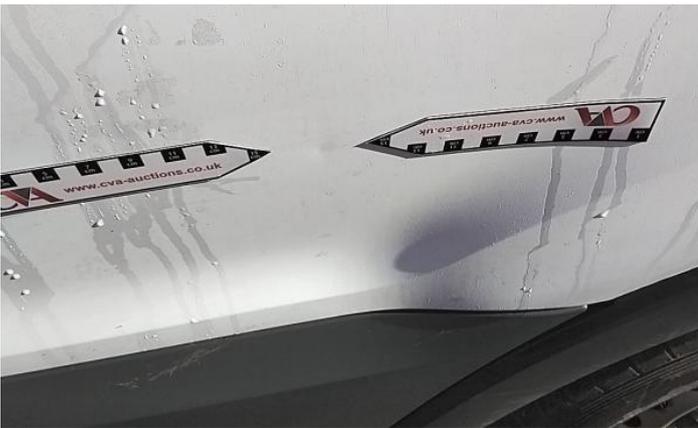
19: Qtr Panel osr
Dented
Over 30mm

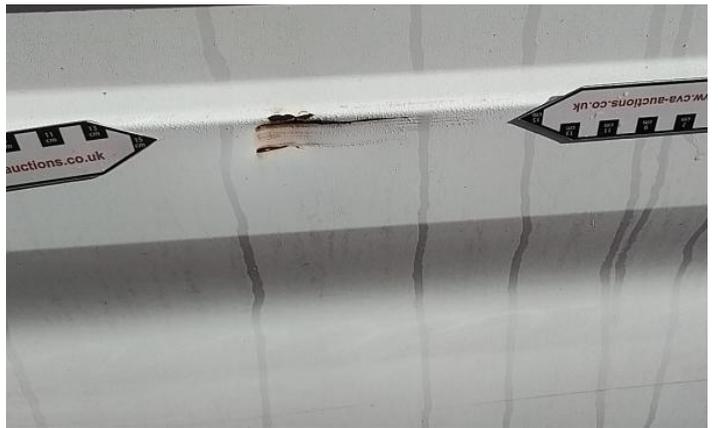
20: Qtr Panel osr
Dented
With Paint Damage

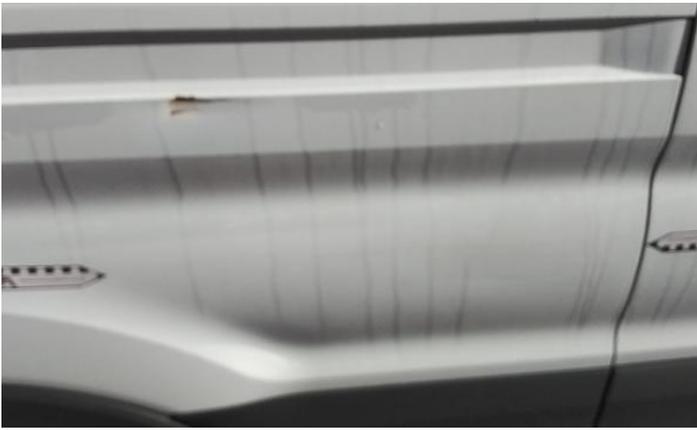
21: Qtr Panel osr
Scratched
Over 25mm Thru Paint

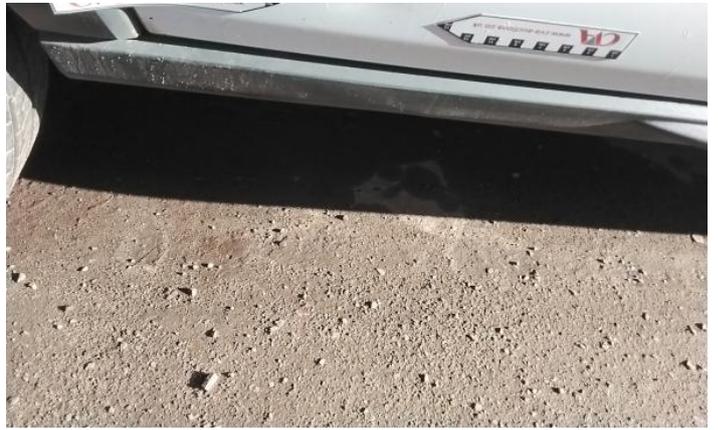
22: Qtr Panel osr
Dented
With Paint Damage

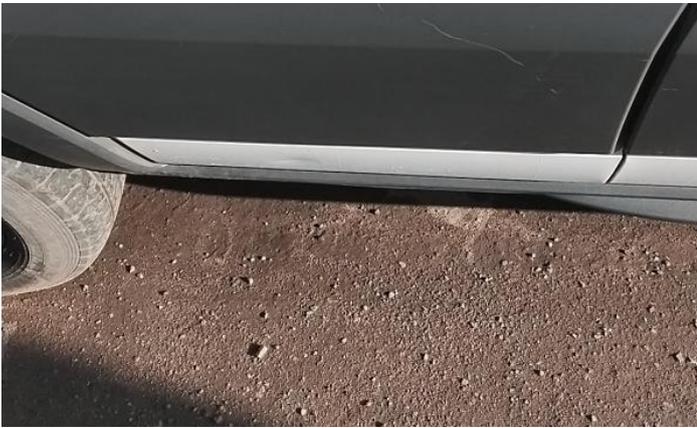
23: Qtr Panel Moulding os
Scuffed (Unpainted)
Over 100mm

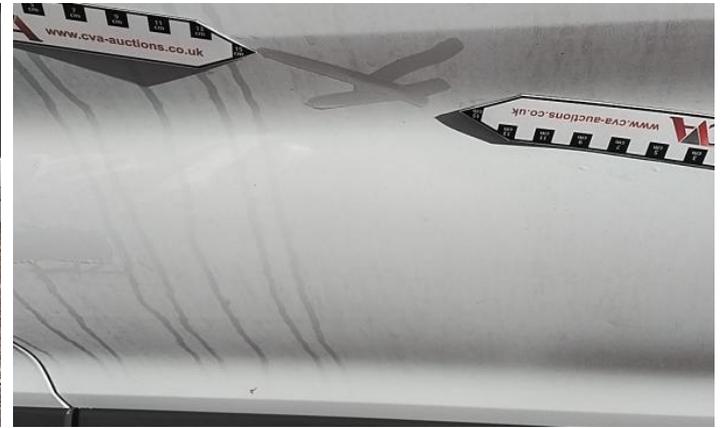
24: Qtr Panel osr
Dented
Over 30mm

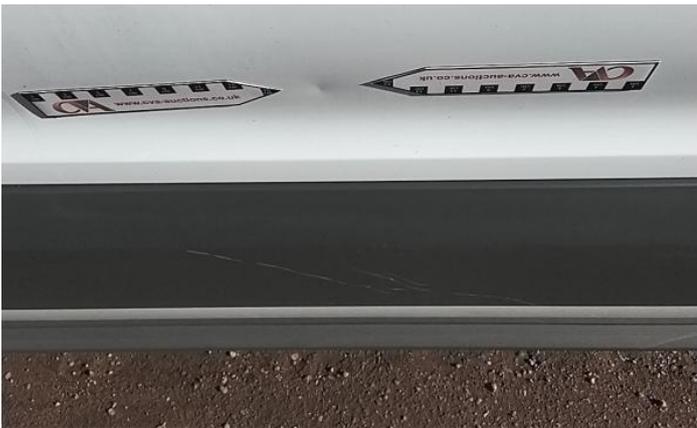
25: Qtr Panel osr
Dented
Over 30mm

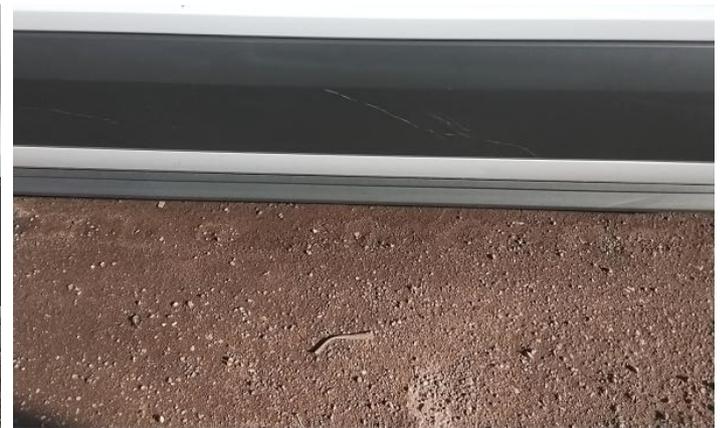
26: Qtr Panel Moulding os
Scuffed (Unpainted)
Over 100mm

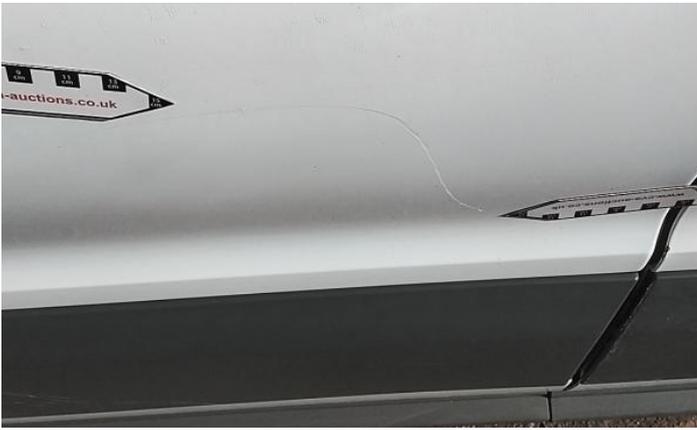
27: Qtr Panel osr
Scratched
Over 25mm Thru Paint

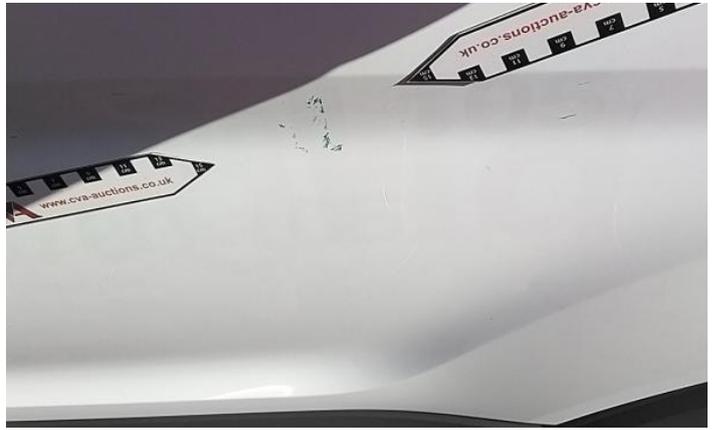
28: Door osf
Scratched
Over 25mm Thru Paint

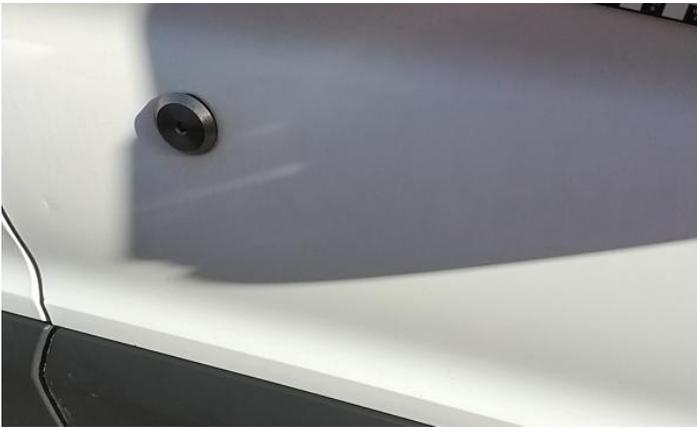
29: Door osf
Scratched
Over 25mm Thru Paint

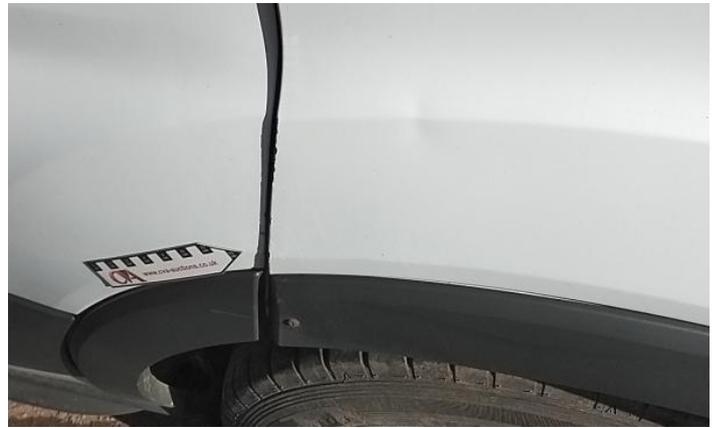
30: Wing osf
Dented
Over 30mm

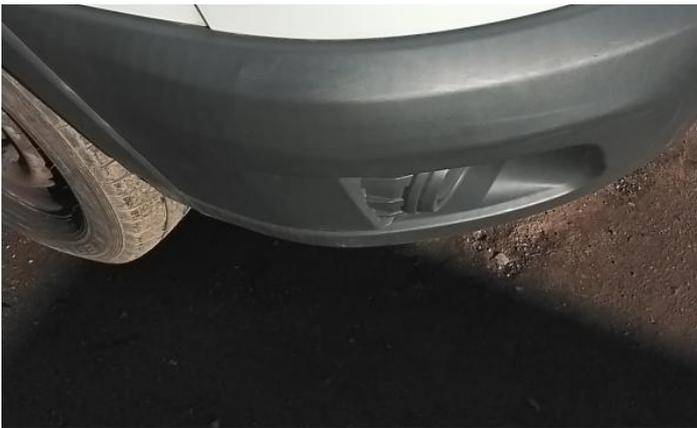
31: Bumper Front
Scratched
Over 100mm Thru Paint

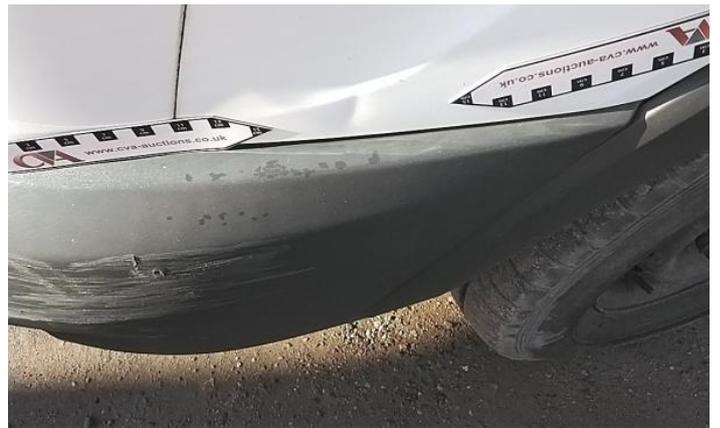
32: Wing nsf
Dented
Over 30mm

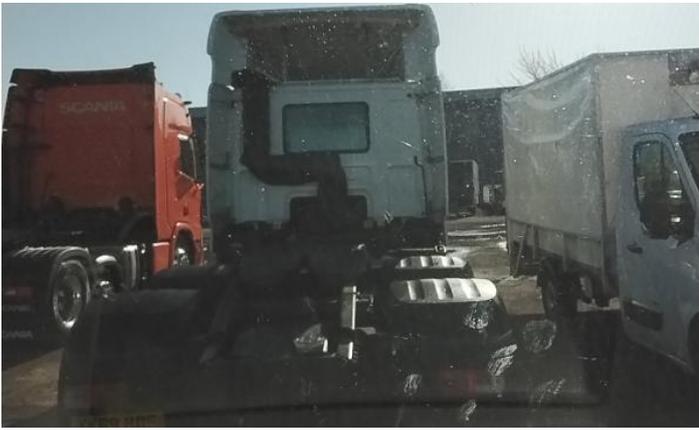
33: Screen Front
Chipped
UpTo 10mm

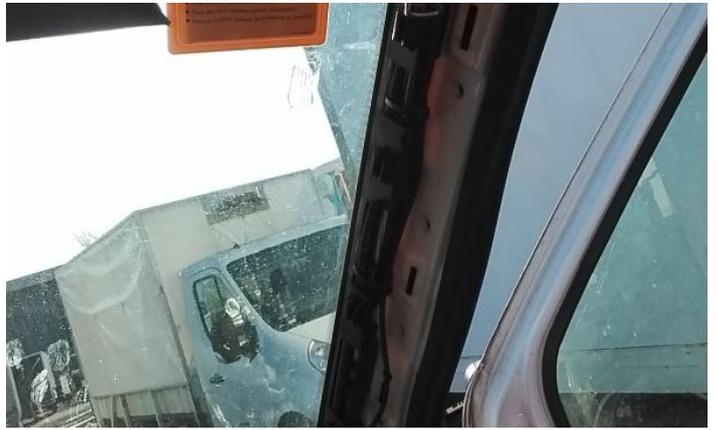
34: Fascia Panel
Missing
Replace

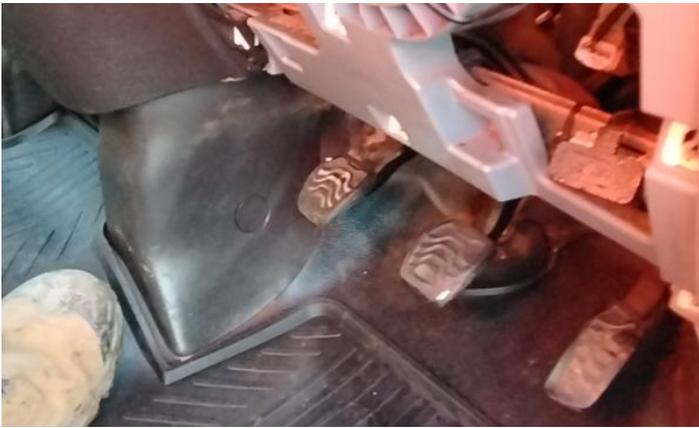
35: Fascia Panel
Missing
Replace

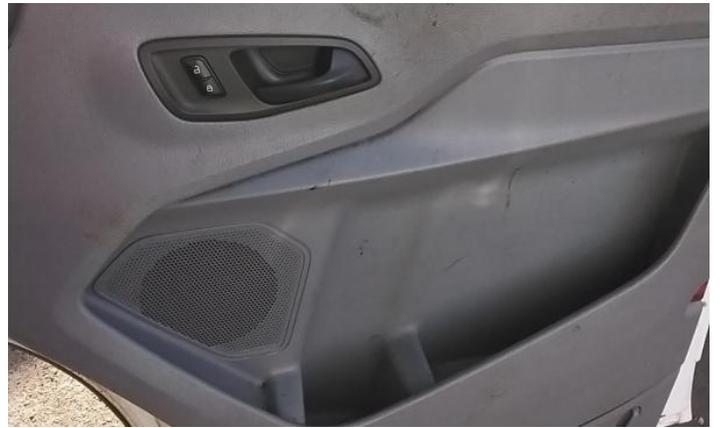
36: Door Pad osf
Soiled
Heavy

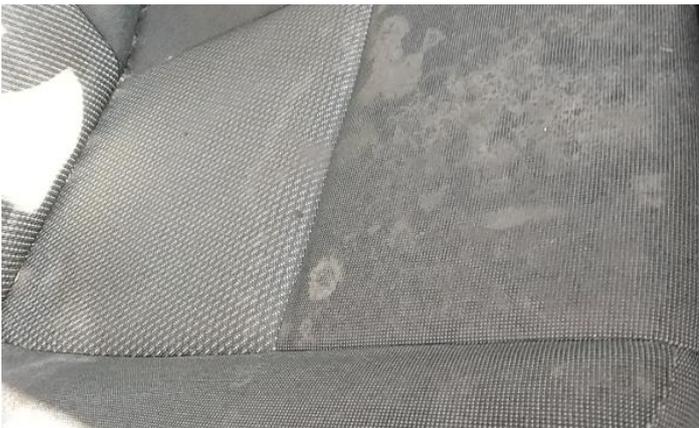
37: Seat Base Cover osf
Soiled
Heavy

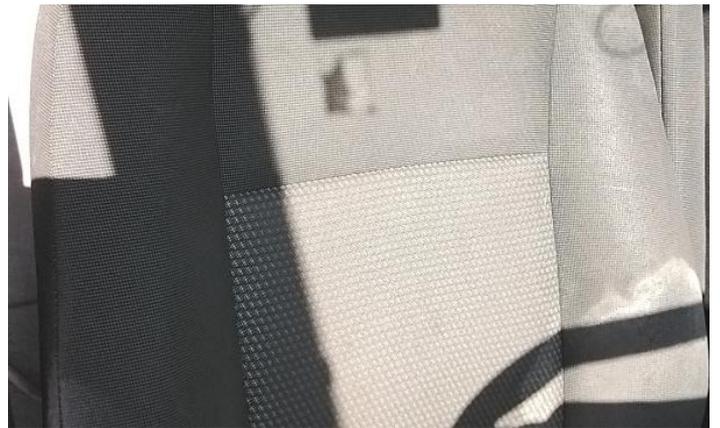
38: Seat Back Cover osf
Soiled
Heavy

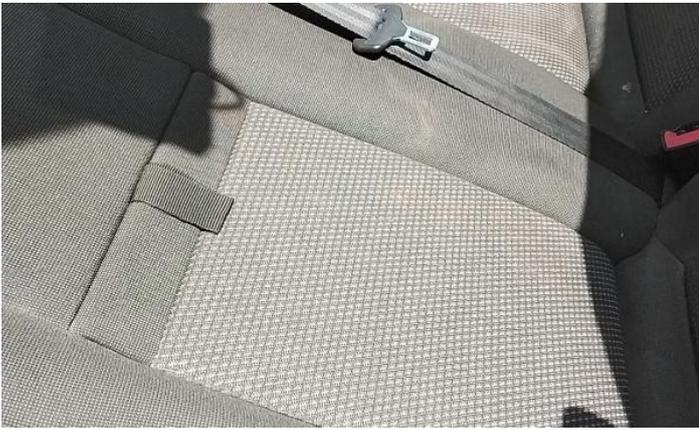
39: Seat Back Cover nsf
Soiled
Heavy

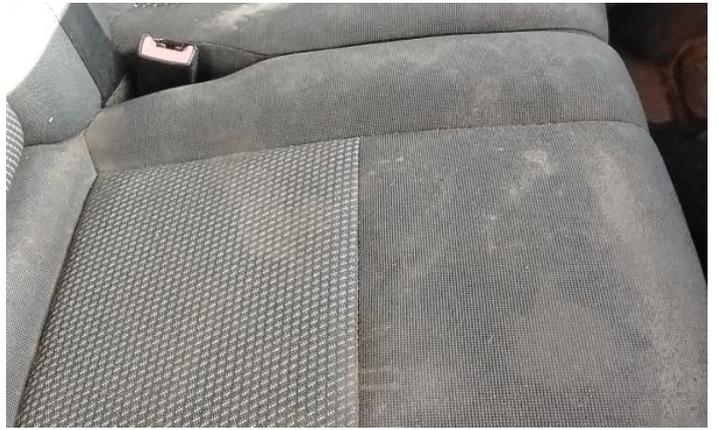
40: Seat Base Cover nsf
Soiled
Heavy

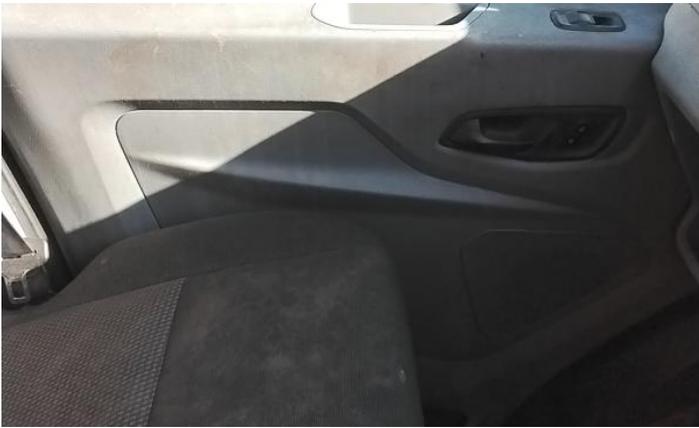
41: Door Pad nsf
Soiled
Heavy
