VEHICLE INSPECTION REPORT

CU13EHB

Ford Transit T350 TDCi 125ps

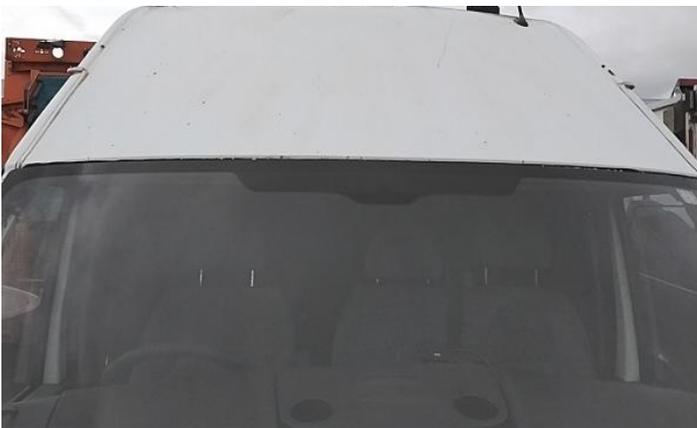
1: Roof
Chipped
Multiple Chips

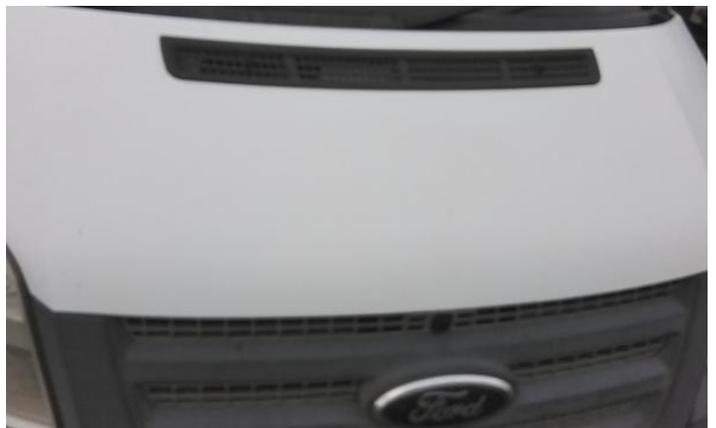
2: Bonnet
Chipped
Multiple Chips

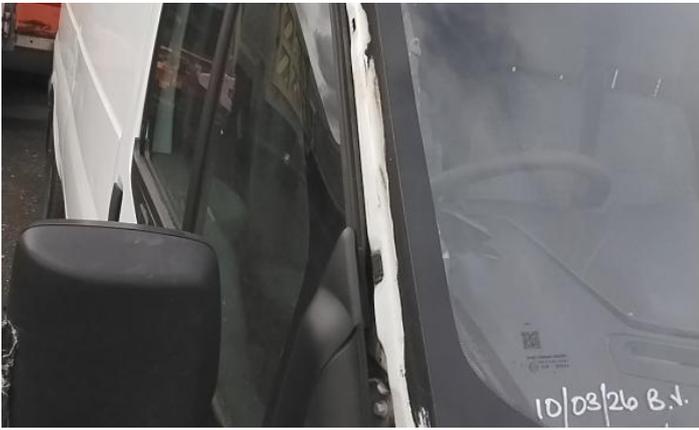
3: Panel Front
Missing
Replace

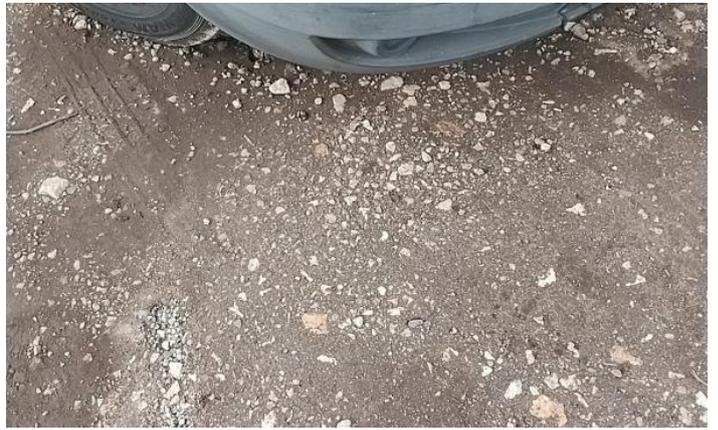
4: Bumper Front
Scratched
Over 100mm Thru Paint

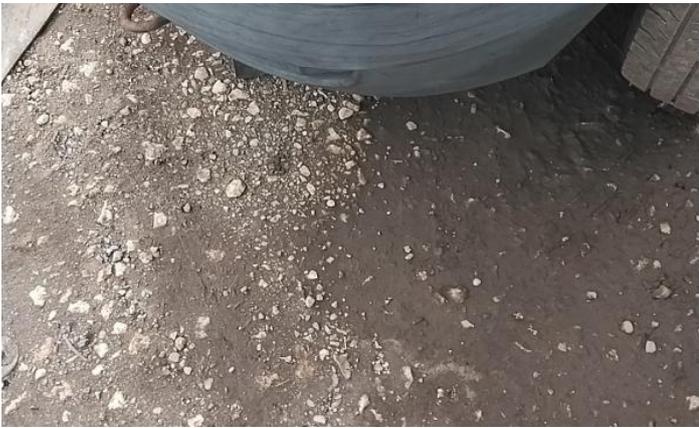
5: Bumper Front
Scratched
Over 100mm Thru Paint

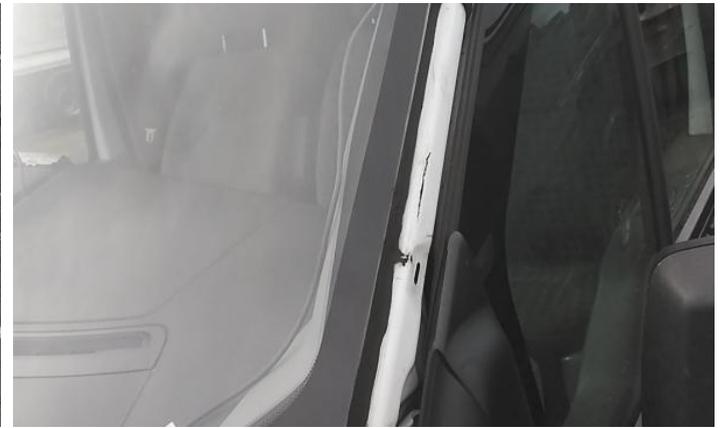
6: Panel Front
Missing
Replace

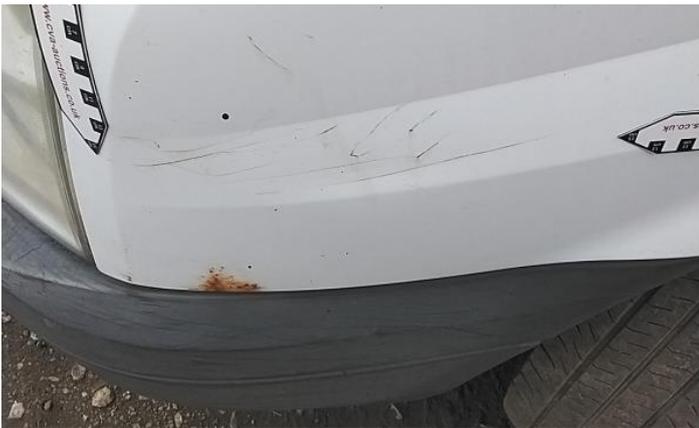
7: Wing nsf
Dented
With Paint Damage

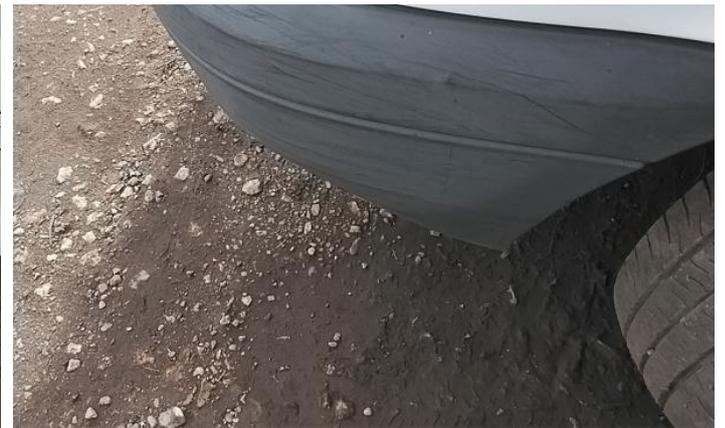
8: Wing nsf
Rusted
Over 5mm

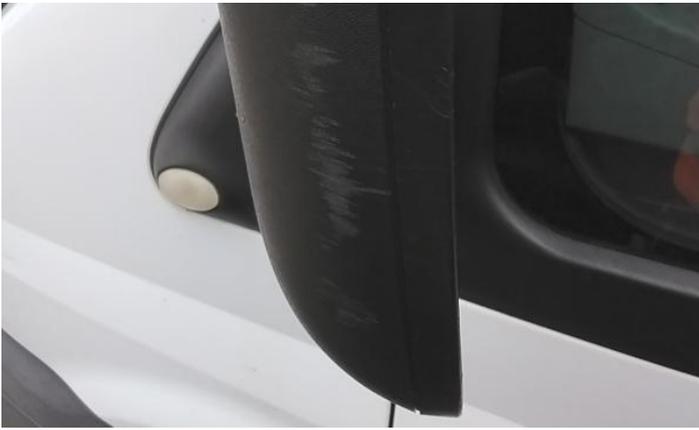
9: Door Mirror Assy nsf
Scuffed (Unpainted)
Over 100mm

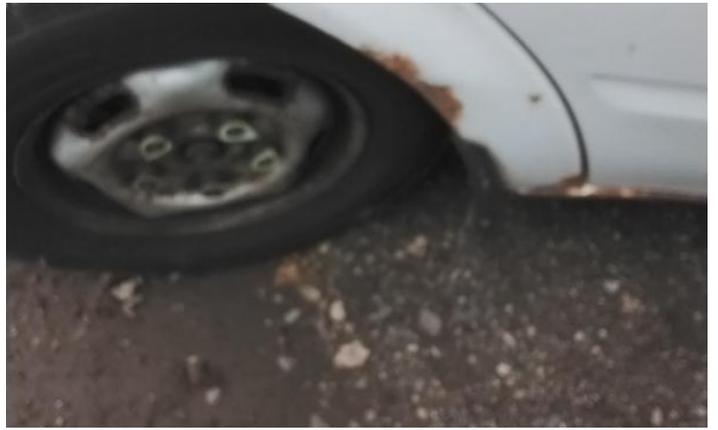
10: Wing nsf
Rusted
Over 5mm

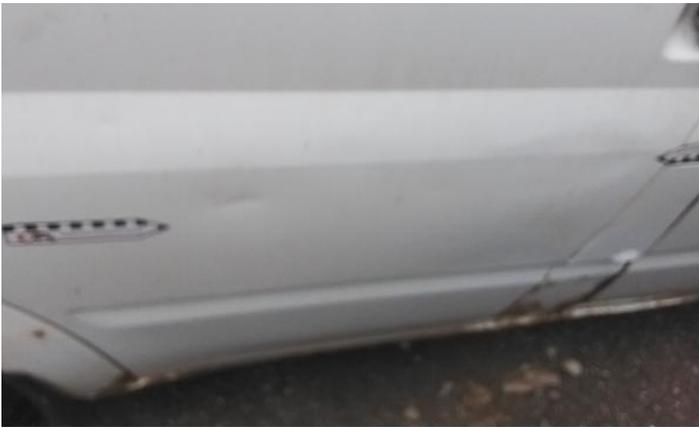
11: Door nsf
Dented
With Paint Damage

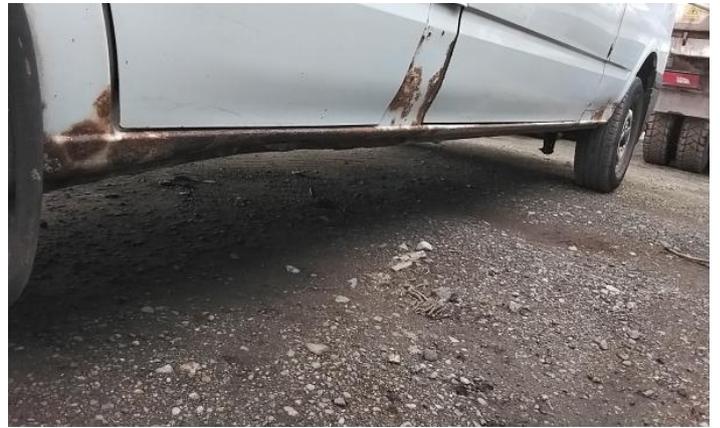
12: Sill ns
Rusted
Over 5mm

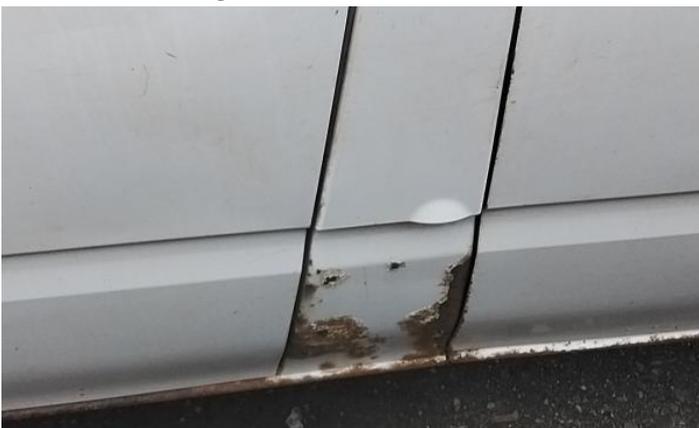
13: B Post ns
Rusted
Over 5mm

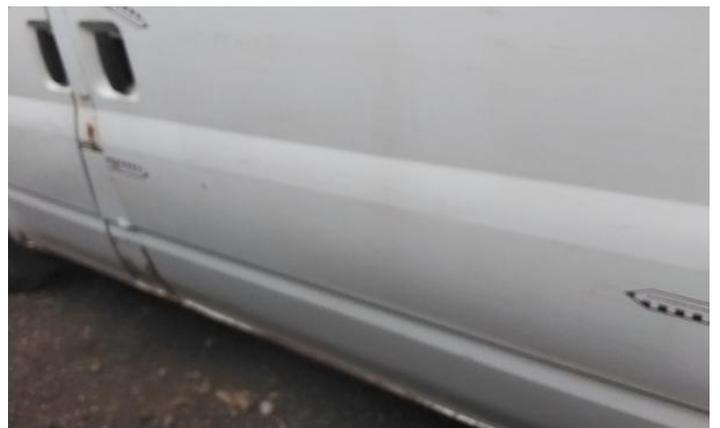
14: Qtr Panel nsr
Scratched
Over 25mm Thru Paint

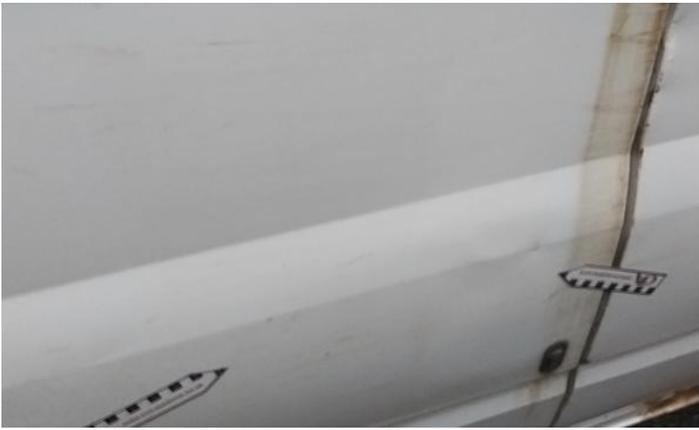
15: Qtr Panel nsr
Dented
With Paint Damage

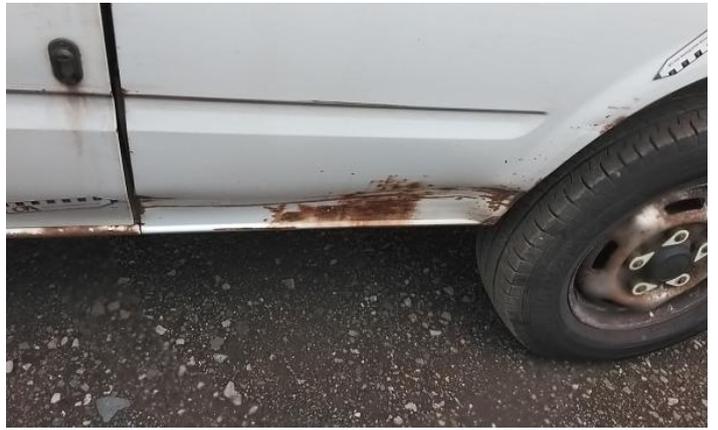
16: Qtr Panel nsr
Dented
With Paint Damage

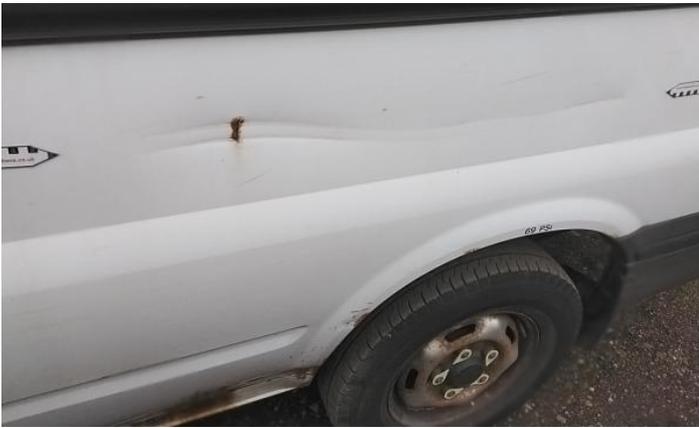
17: Qtr Panel nsr
Dented
With Paint Damage

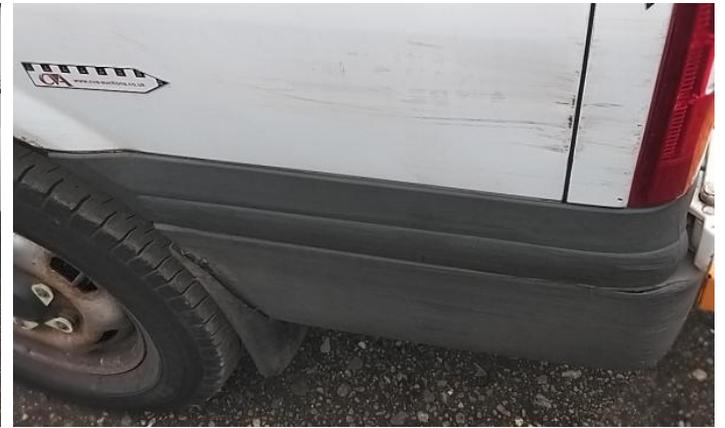
18: Qtr Panel nsr
Dented
With Paint Damage

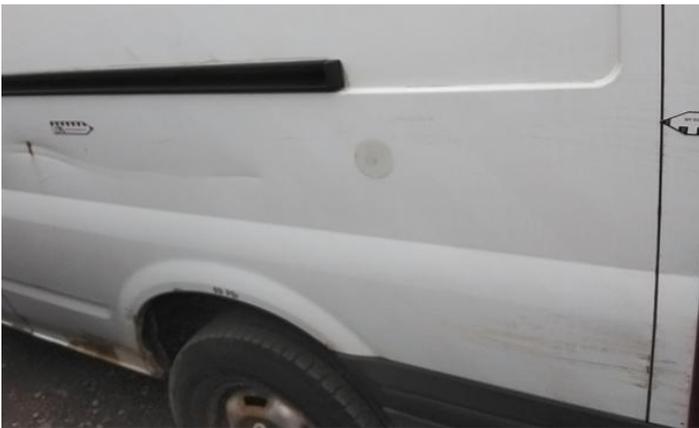
19: Qtr Panel nsr
Scratched
Over 25mm Thru Paint

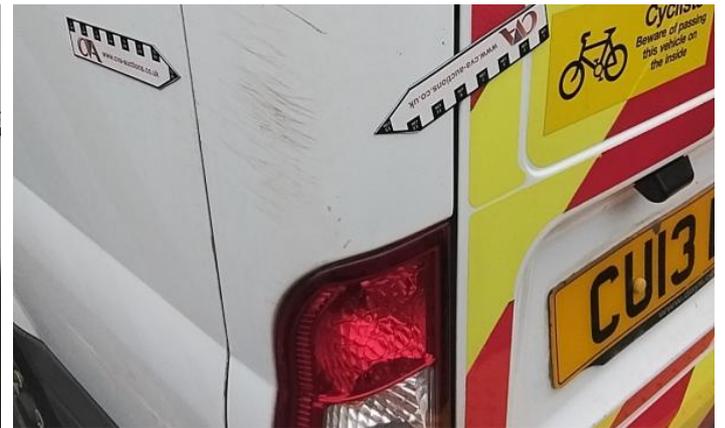
20: C Post ns
Scratched
Over 25mm Thru Paint

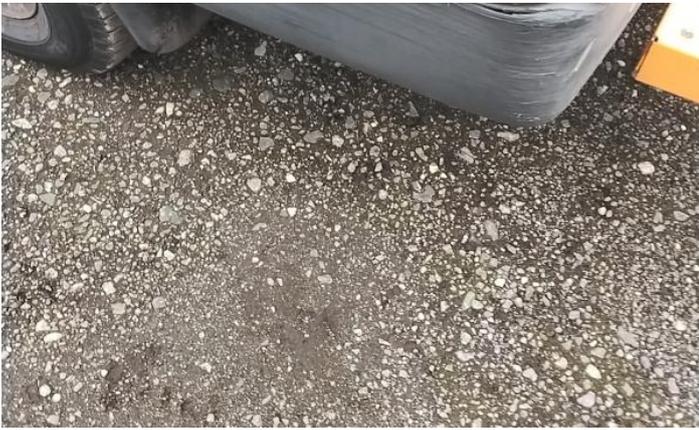
21: Qtr Panel Moulding ns
Broken
Replace

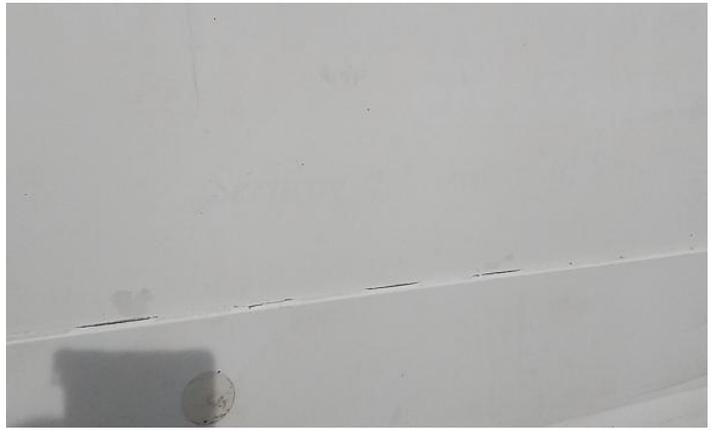
22: Qtr Panel osr
Chipped
Multiple Chips

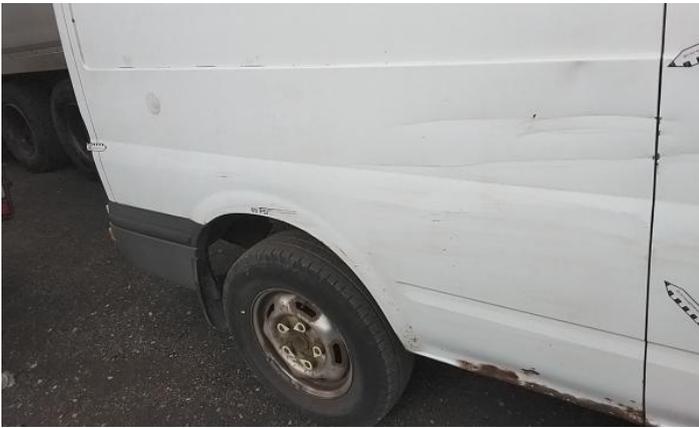
23: Qtr Panel osr
Dented
Over 30% Of Panel

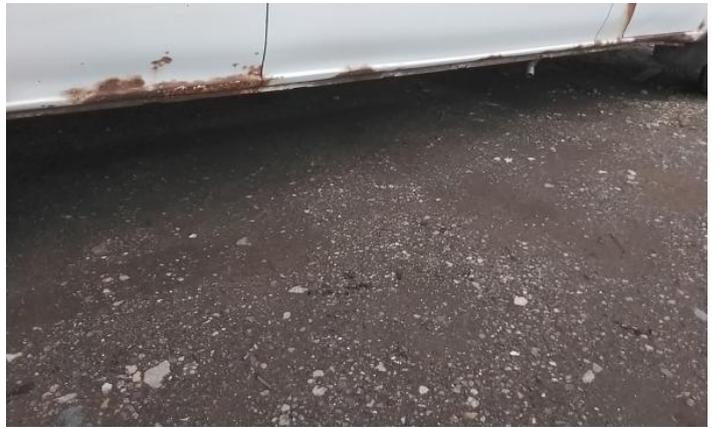
24: Sill os
Rusted
Over 5mm

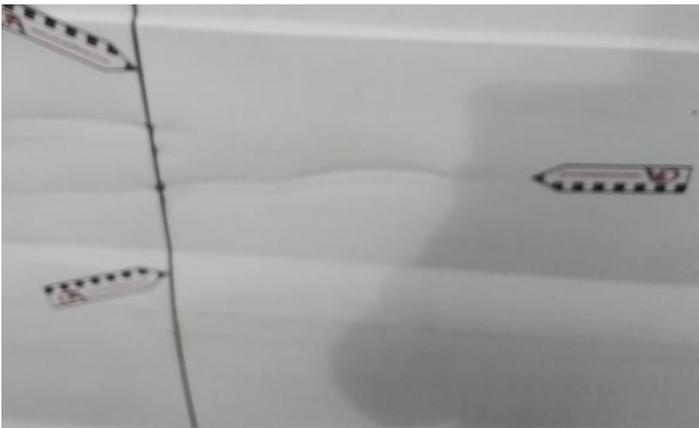
25: Qtr Panel osr
Dented
With Paint Damage

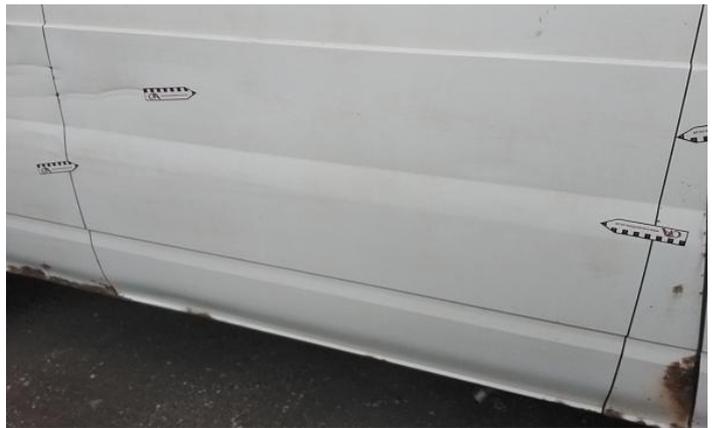
26: Qtr Panel osr
Scratched
Over 25mm Thru Paint

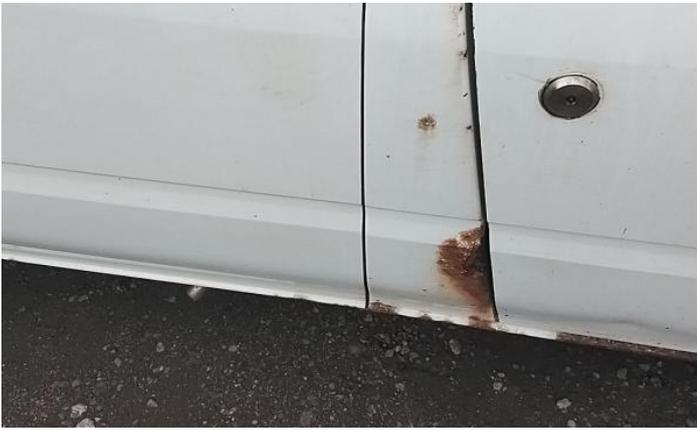
27: B Post os
Rusted
Over 5mm

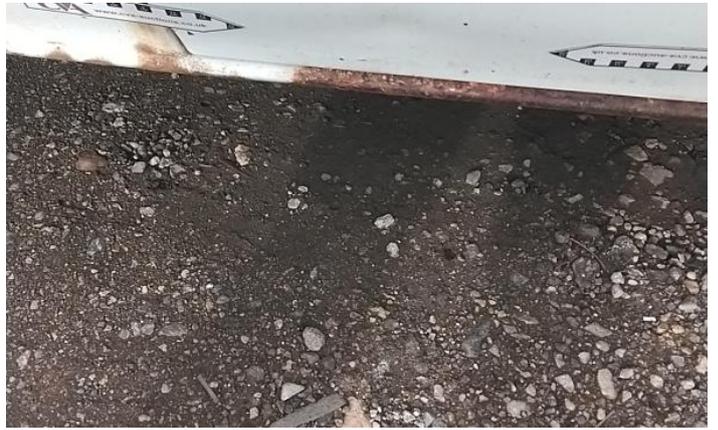
28: Door osf
Dented
Over 30mm

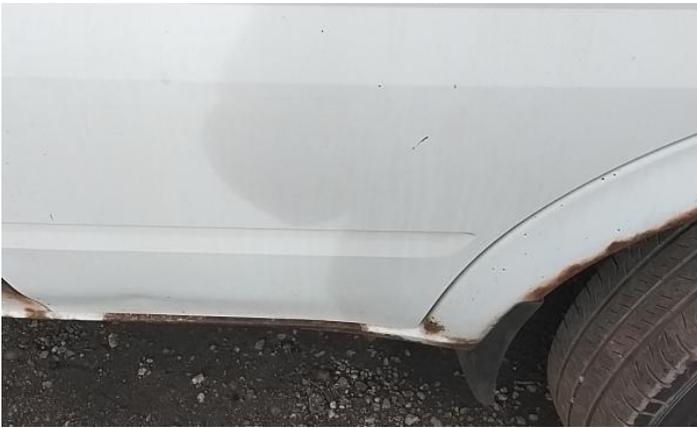
29: Door osf
Chipped
Multiple Chips

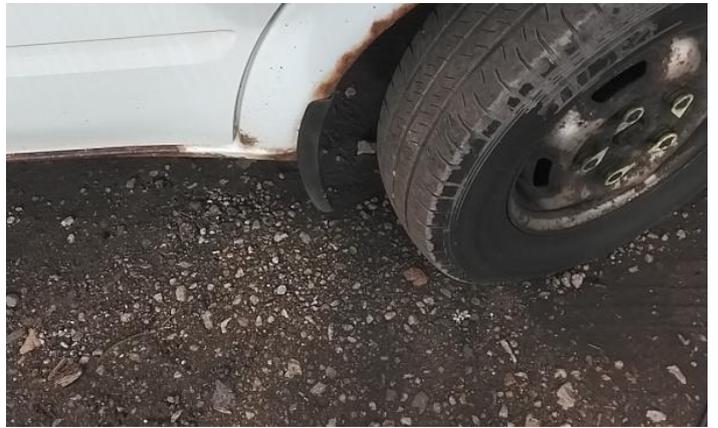
30: Wing osf
Rusted
Over 5mm

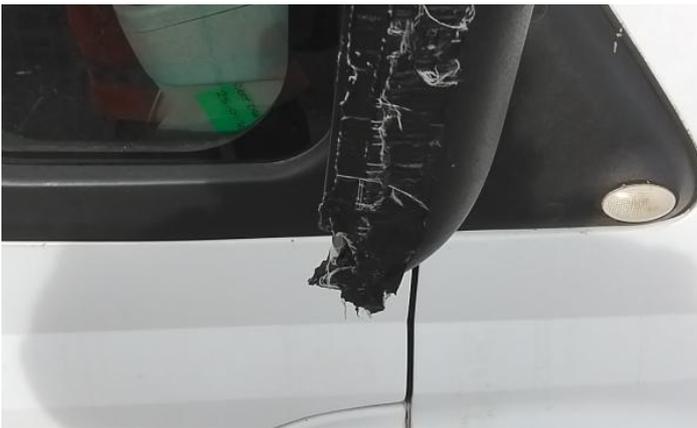
31: Door Mirror Assy osf
Broken
Replace

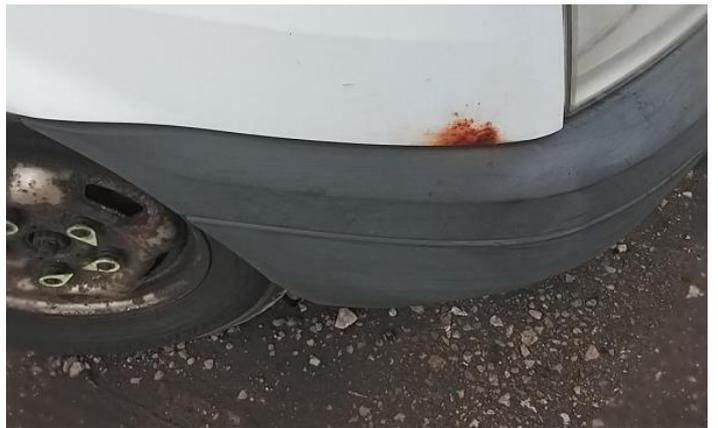
32: Wing osf
Rusted
Over 5mm

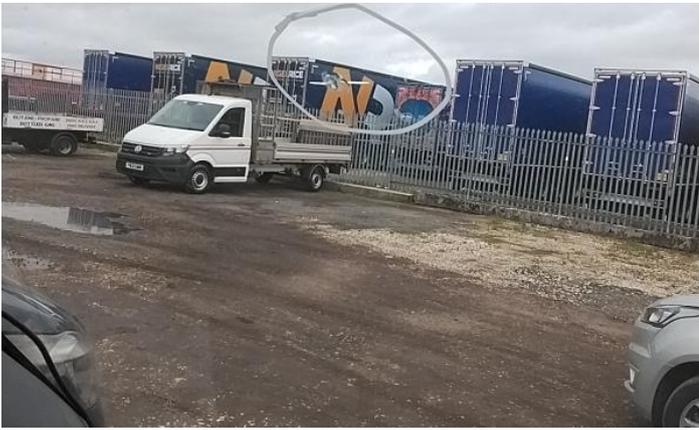
33: Screen Front
Cracked
Replace

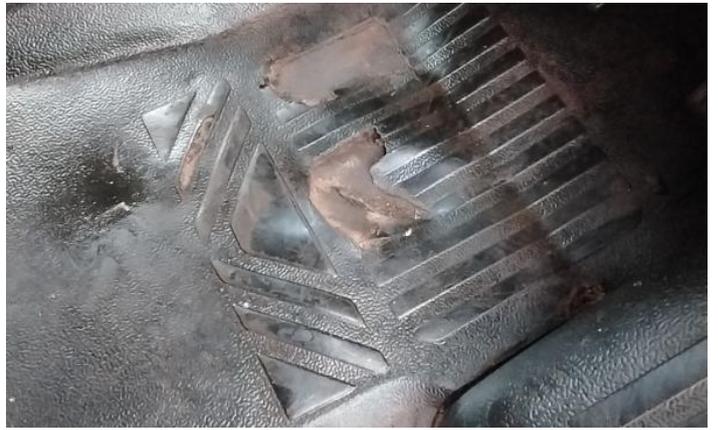
34: Carpets Front
Holed
Over 3mm

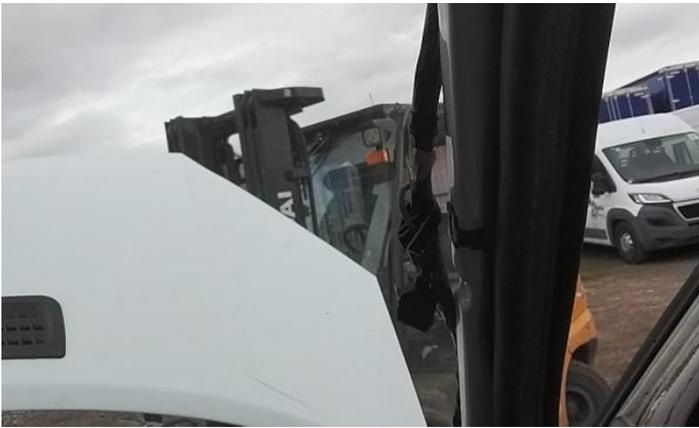
35: Fascia Panel
Missing
Replace

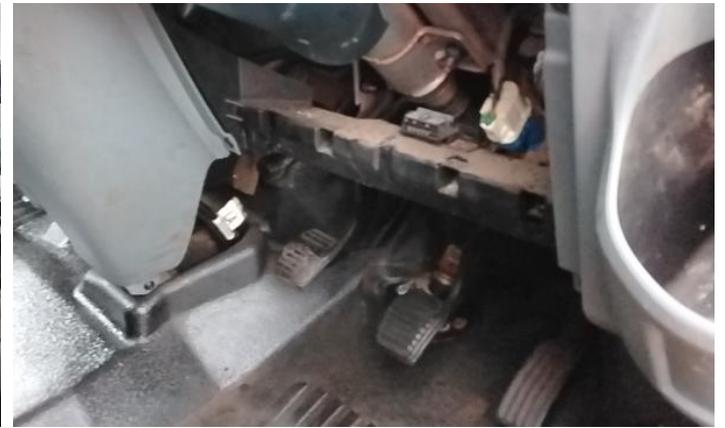
36: Fascia Panel
Missing
Replace

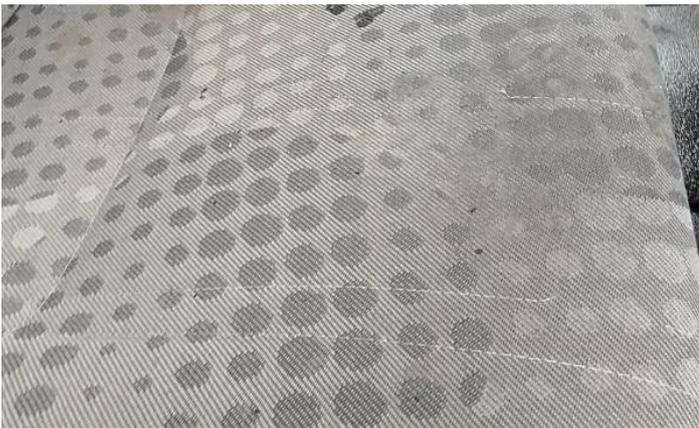
37: Seat Base Cover of
Soiled
Heavy

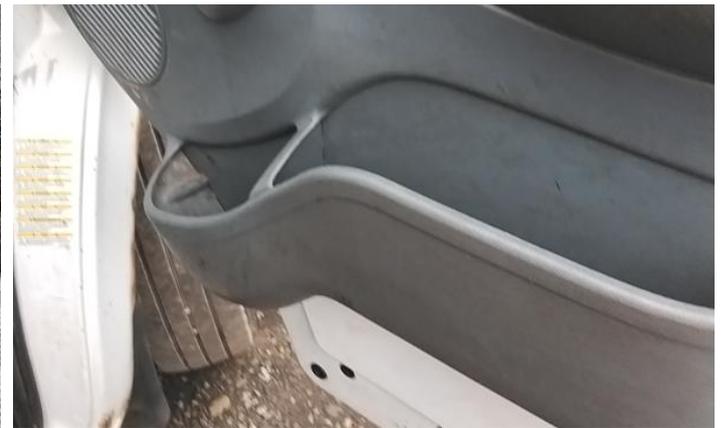
38: Door Pad of
Soiled
Heavy

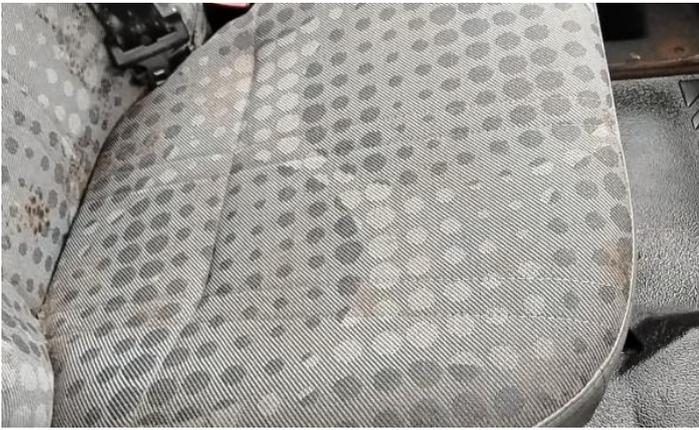
39: Seat Base Cover nsf
Soiled
Heavy

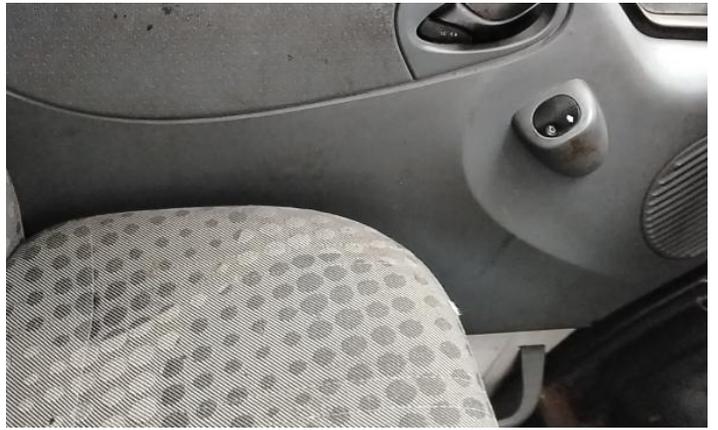
40: Door Pad nsf
Soiled
Heavy

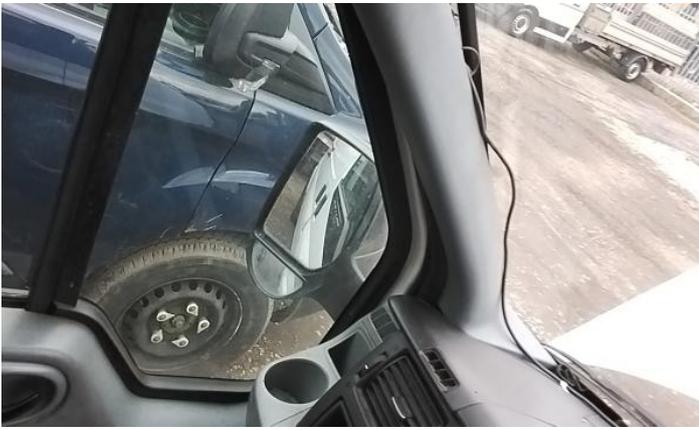
41: Fascia Panel
Broken
Replace
