VEHICLE INSPECTION REPORT

CU65EOY

Ford Transit 350 2.2 TDCi 155ps

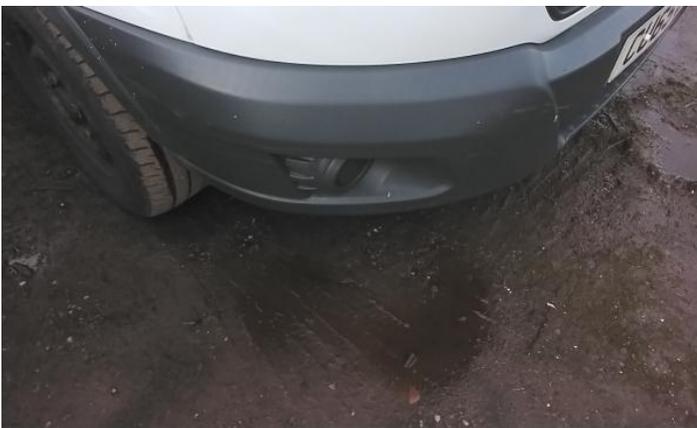
1: Bumper Front
Scratched
Over 100mm Thru Paint

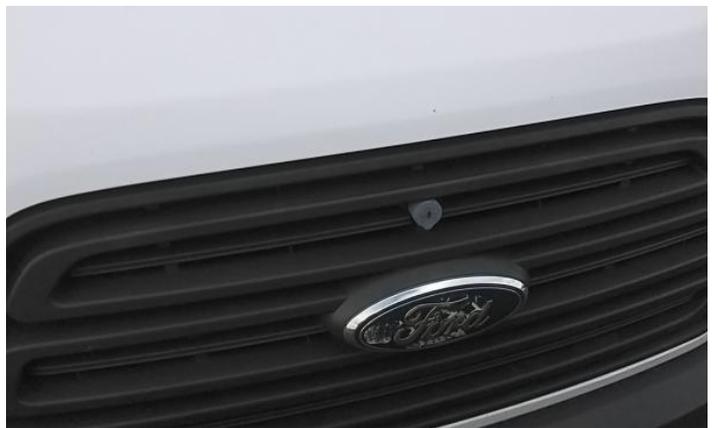
2: Bonnet
Chipped
Multiple Chips

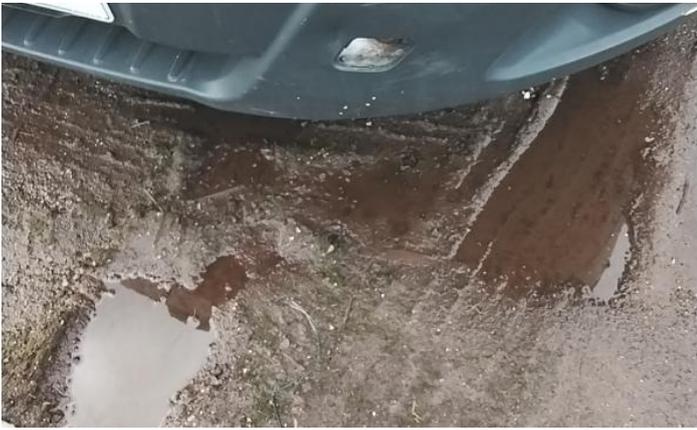
3: Bumper Front Moulding
Missing
Replace

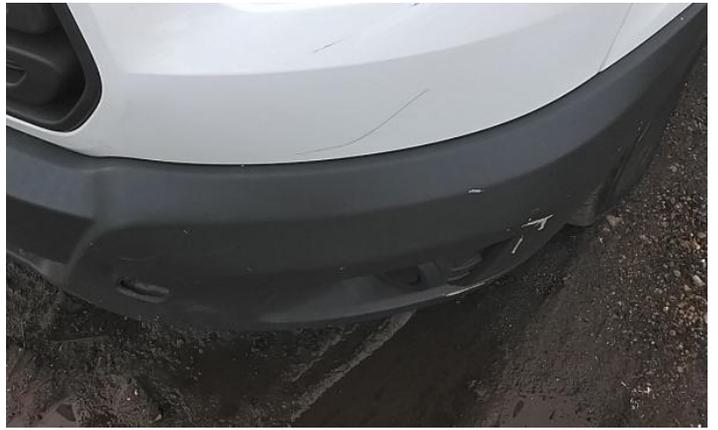
4: Panel Front
Scratched
Over 25mm Thru Paint

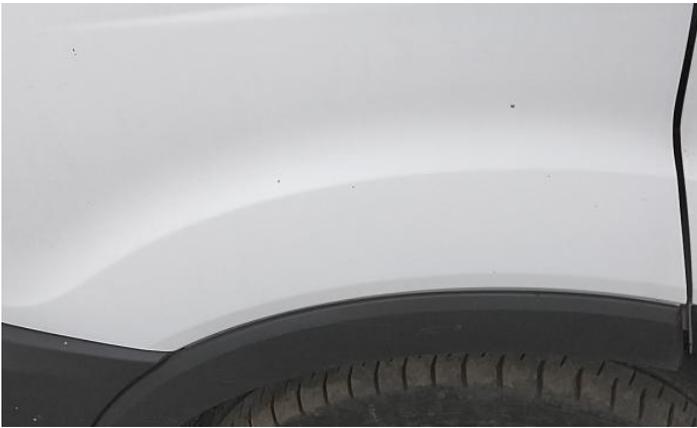
5: Wing nsf
Chipped
Multiple Chips

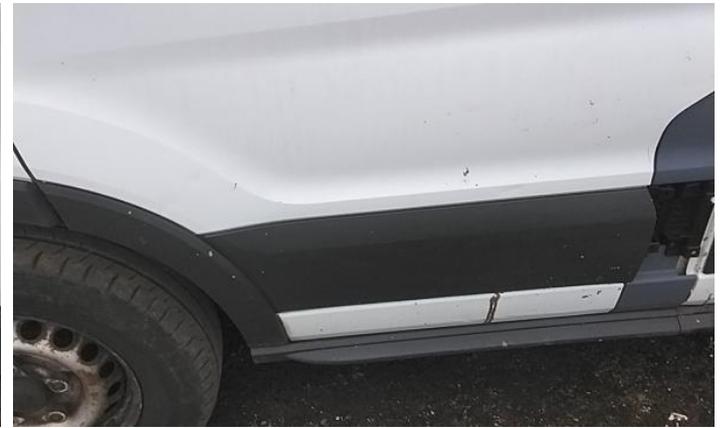
6: Door nsf
Chipped
Multiple Chips

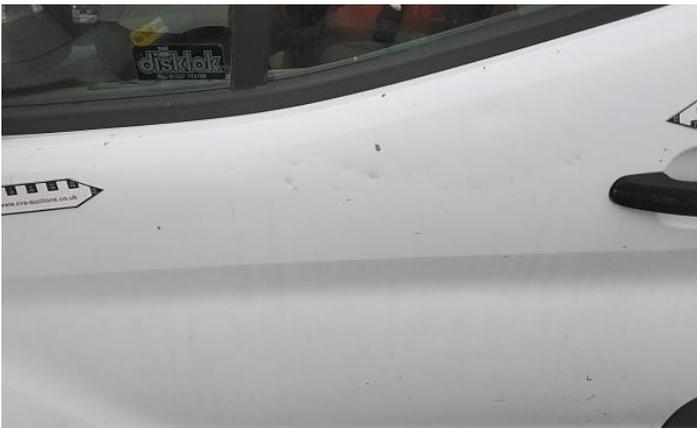
7: Door nsf
Dented
With Paint Damage

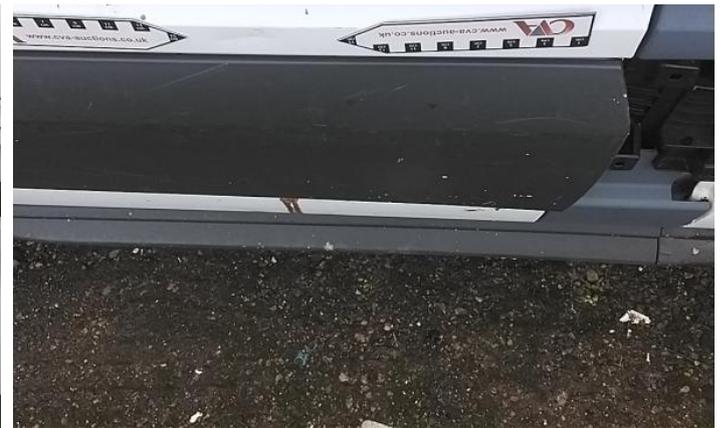
8: Door nsf
Dented
Over 30mm

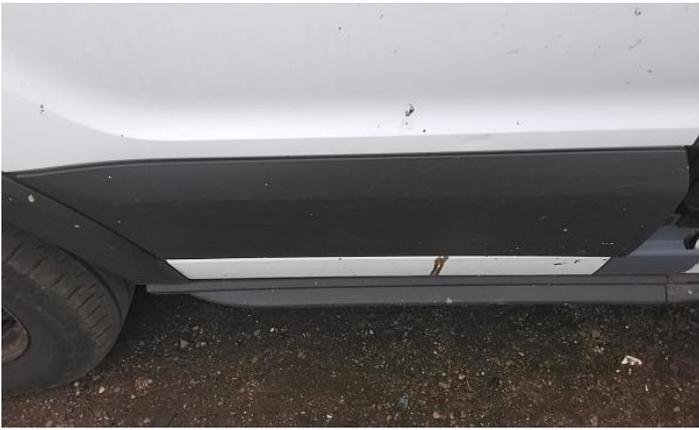
9: Door Moulding nsf
Scuffed (Unpainted)
Over 100mm

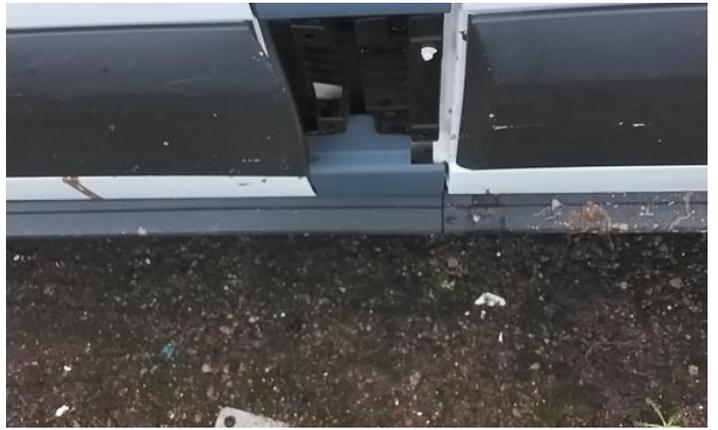
10: Door Moulding nsf
Missing
Replace

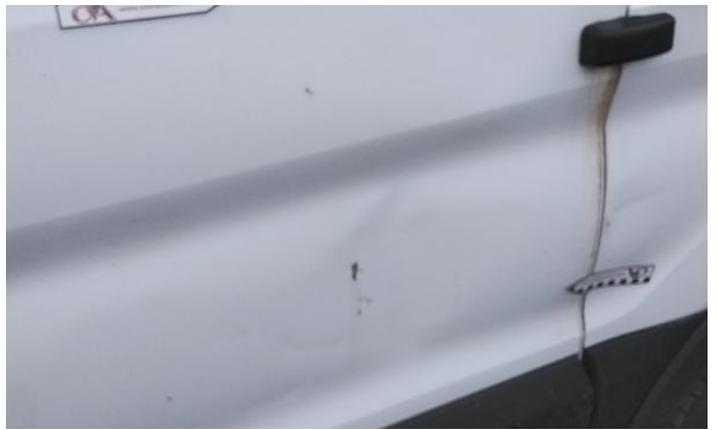
12: Qtr Panel nsr
Dented
Over 30mm

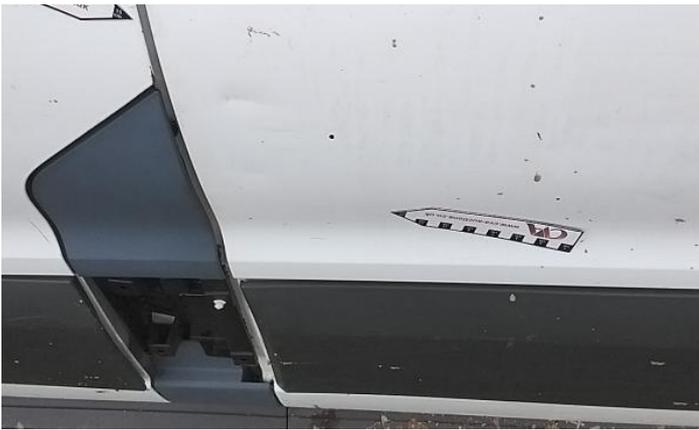
13: Qtr Panel nsr
Dented
With Paint Damage

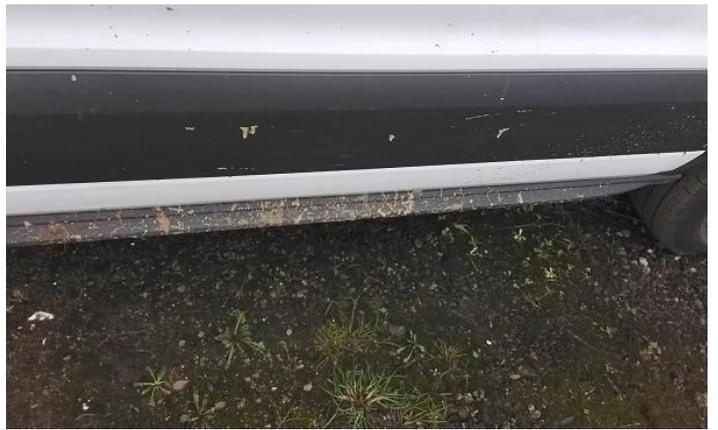
14: Qtr Panel Moulding ns
Scuffed (Unpainted)
Over 100mm

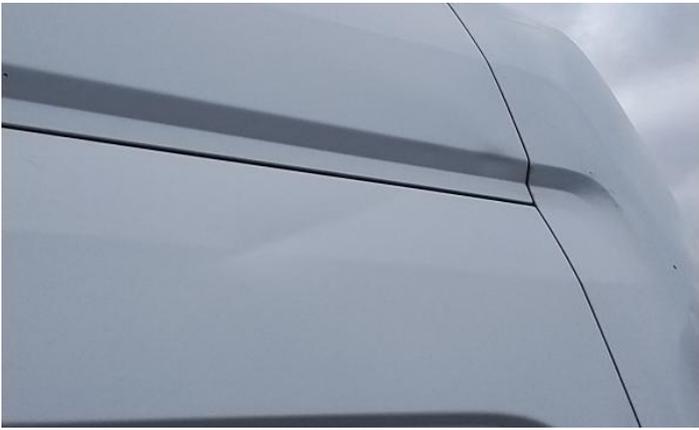
15: Qtr Panel nsr
Dented
Over 30mm

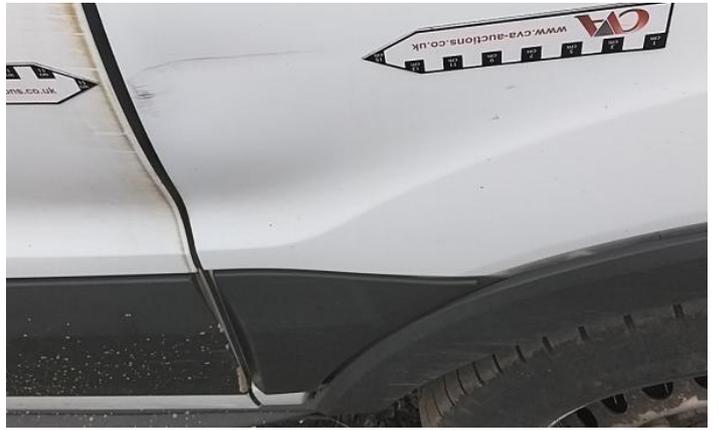
16: Qtr Panel nsr
Dented
With Paint Damage

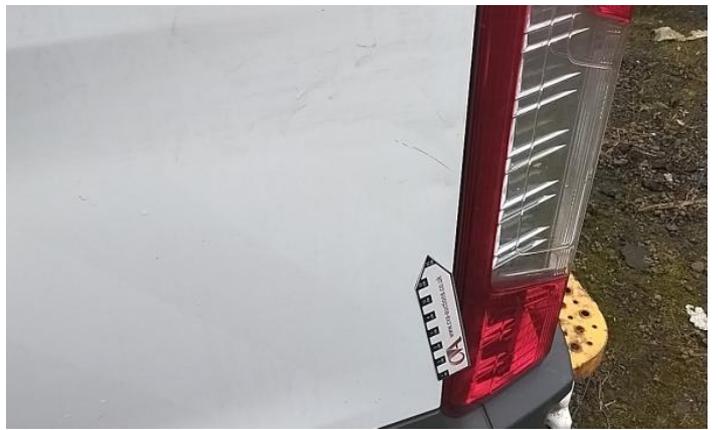
18: Qtr Panel nsr
Dented
With Paint Damage

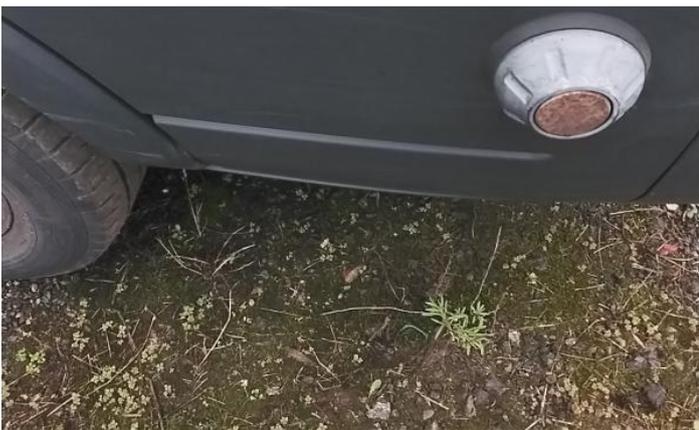
19: Qtr Panel Moulding ns
Scuffed (Unpainted)
Over 100mm

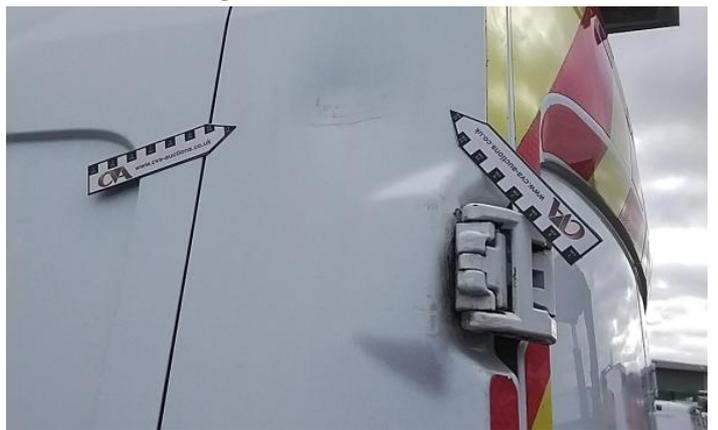
20: C Post ns
Dented
With Paint Damage

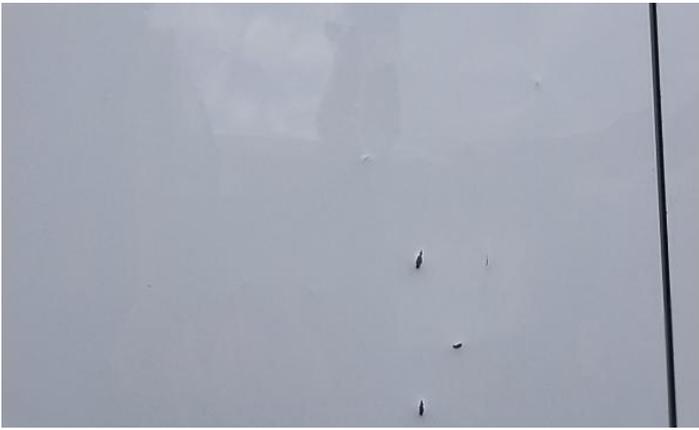
21: Door nsr
Dented
With Paint Damage

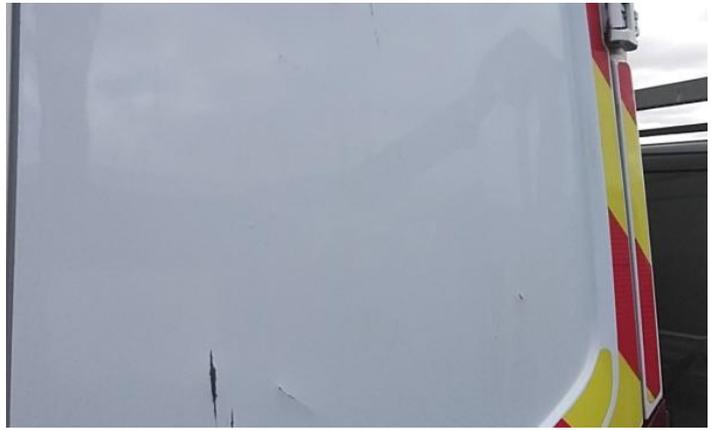
22: Door osr
Dented
Over 30% Of Panel

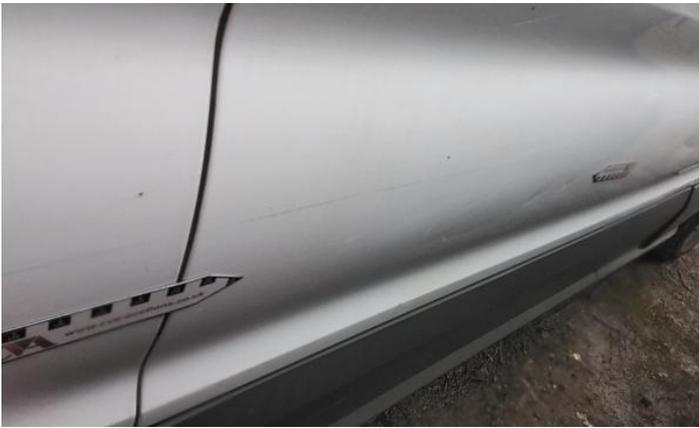
23: Qtr Panel osr
Dented
With Paint Damage

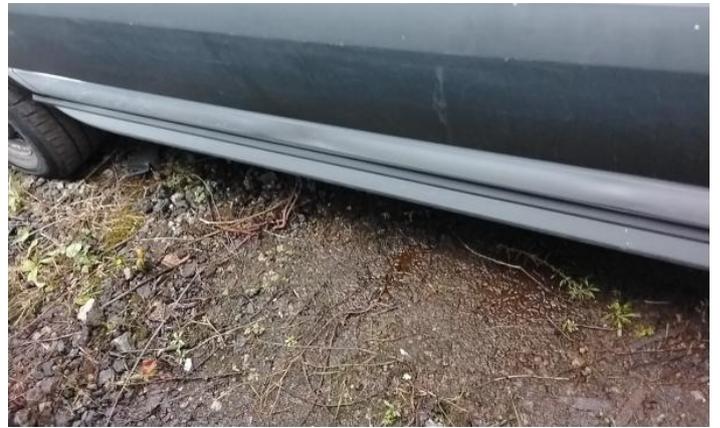
24: Qtr Panel Moulding os
Scuffed (Unpainted)
Over 100mm

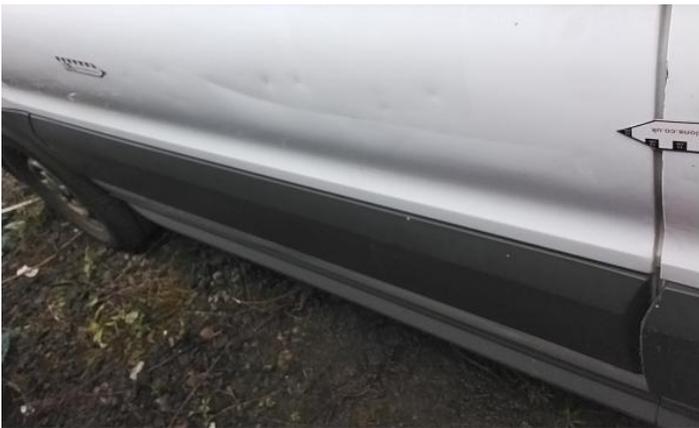
25: Qtr Panel osr
Dented
Over 30mm

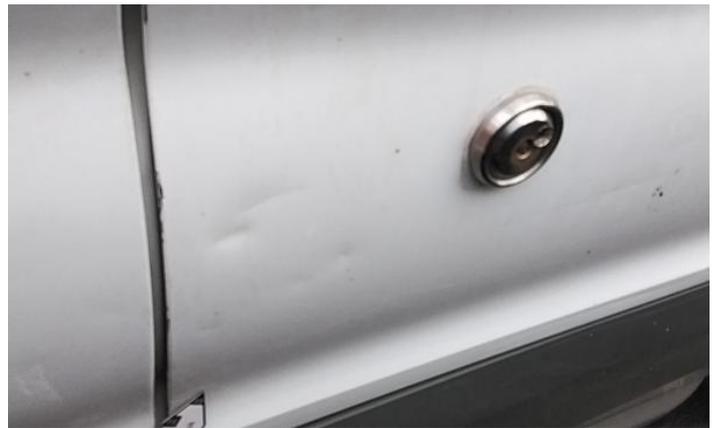
26: Door osf
Dented
Over 30mm

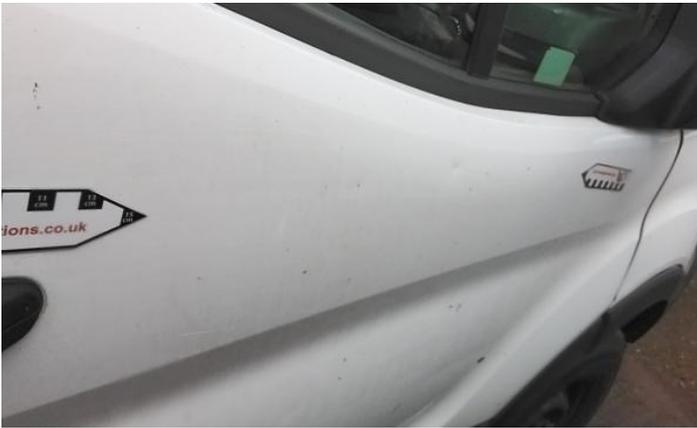
27: Door osf
Dented
Over 30mm

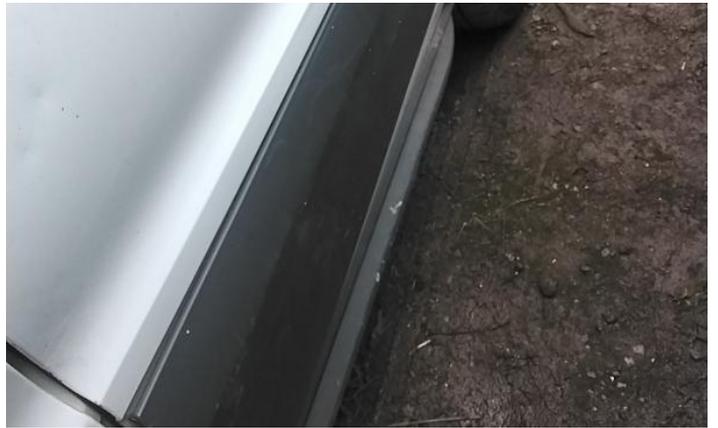
28: Door Moulding osf
Broken
Replace

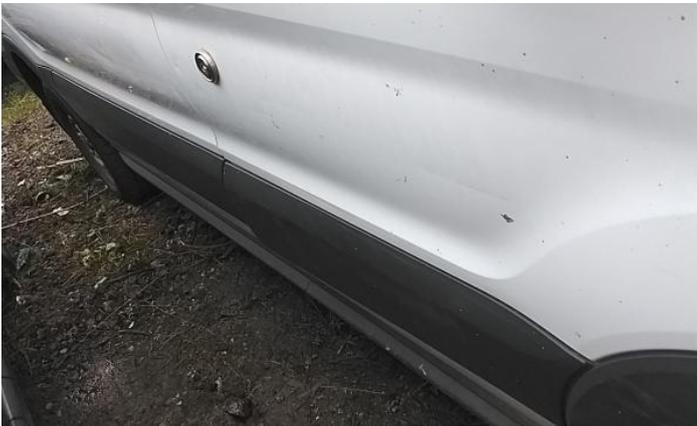
29: Door osf
Chipped
Multiple Chips

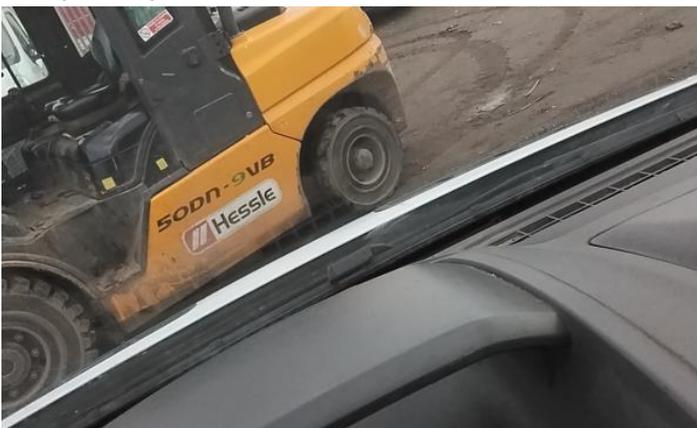
31: Screen Front
Scratched
Over 30mm

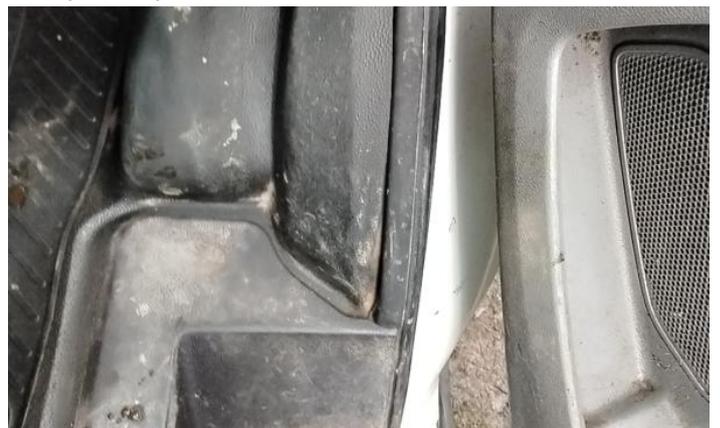
32: Carpets Front
Soiled
Heavy

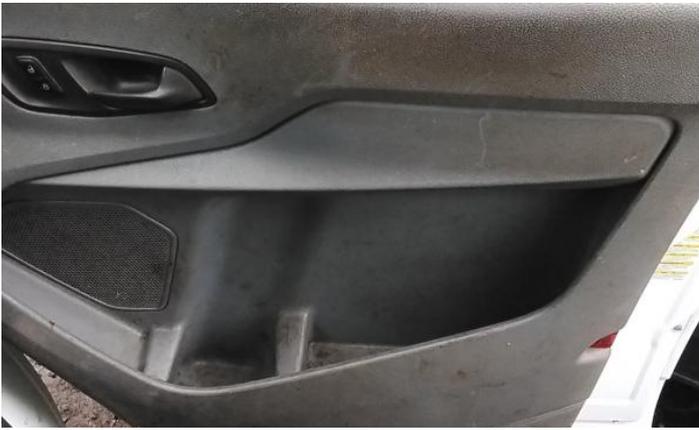
33: Door Pad osf
Soiled
Heavy

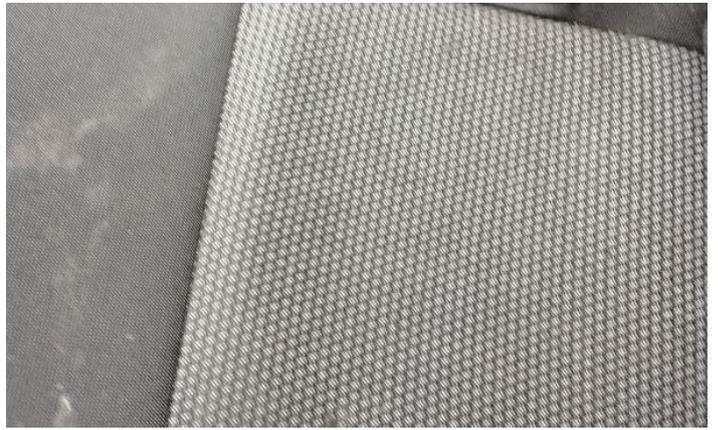
34: Seat Base Cover osf
Torn
Over 3mm

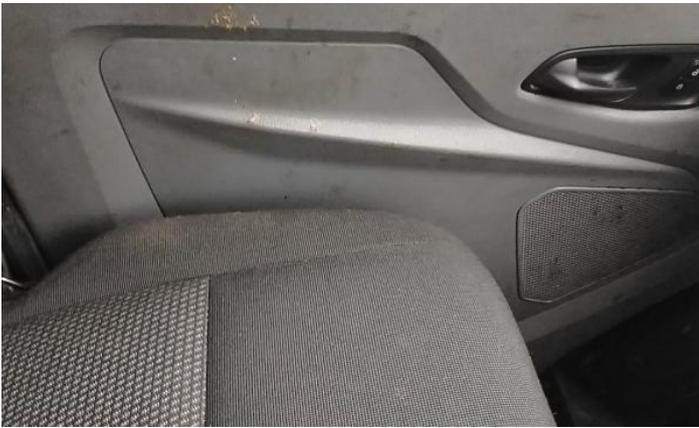
35: Door Pad nsf
Soiled
Heavy
