COMMERCIAL VEHICLE AUCTIONS LTD
THE UK'S MOST ESTABLISHED COMMERCIAL VEHICLE AUCTIONEERS

VEHICLE INSPECTION REPORT

PJ20TDZ

Mercedes-Benz Sprinter 314 CDI

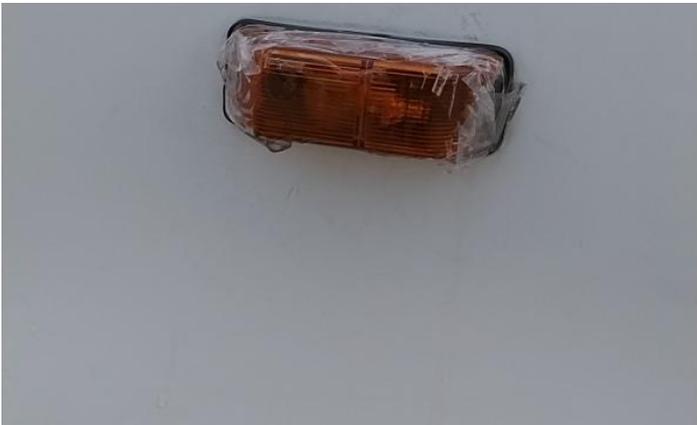
1: Flasher Side Repeater os
Broken
Replace

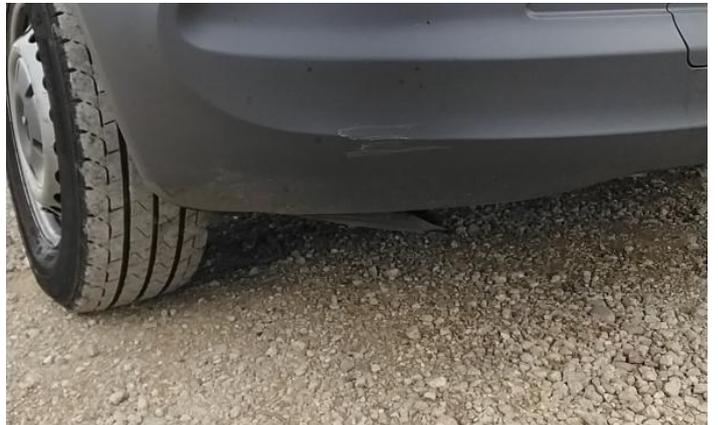
2: Bumper Front Moulding
Scuffed (Unpainted)
Over 100mm

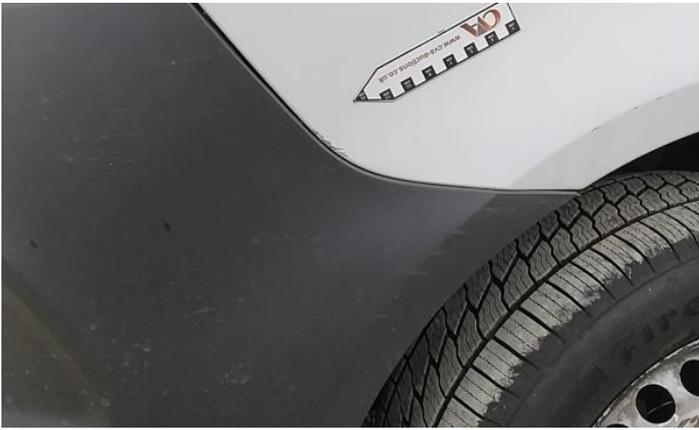
3: Wing nsf
Scratched
Over 25mm Thru Paint

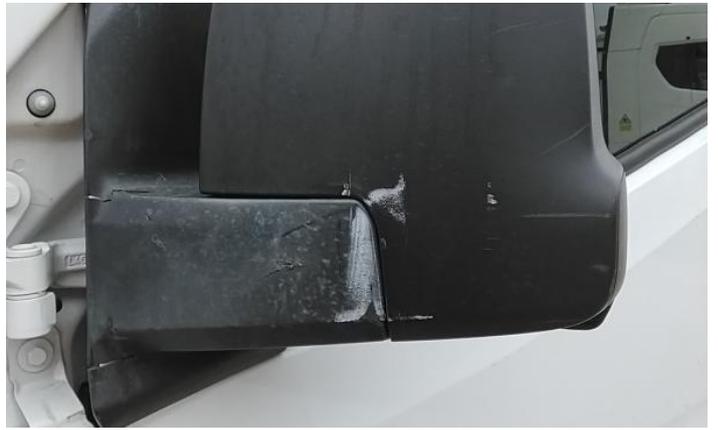
4: Door Mirror Assy nsf
Scuffed (Unpainted)
Over 100mm

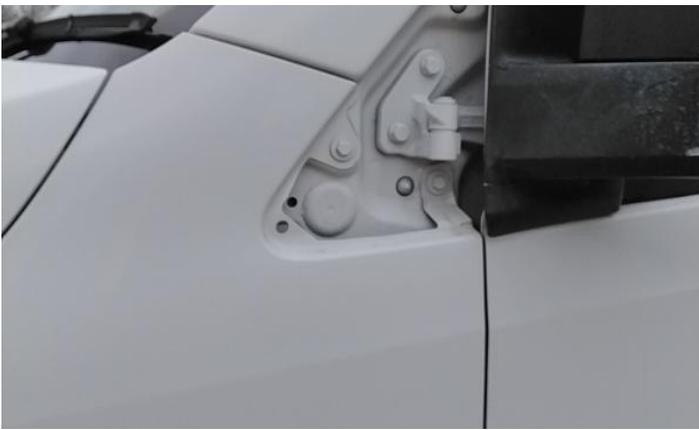
5: Moulding nsf Wing
Missing
Replace

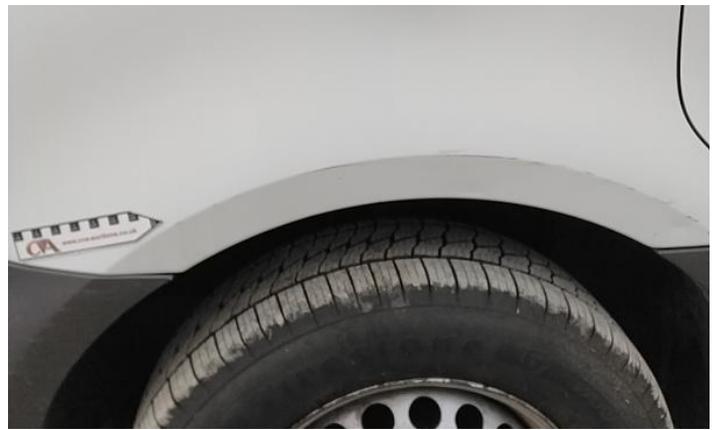
6: Wing nsf
Scratched
Over 25mm Thru Paint

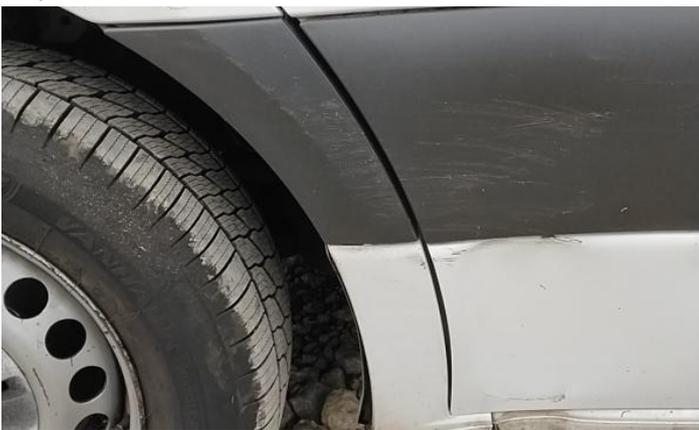
7: Wing Front Arch Extension ns
Scuffed (Unpainted)
Over 100mm

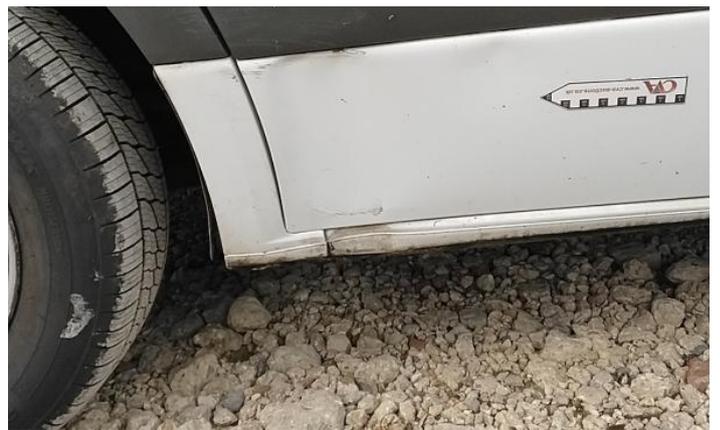
8: Door nsf
Dented
With Paint Damage

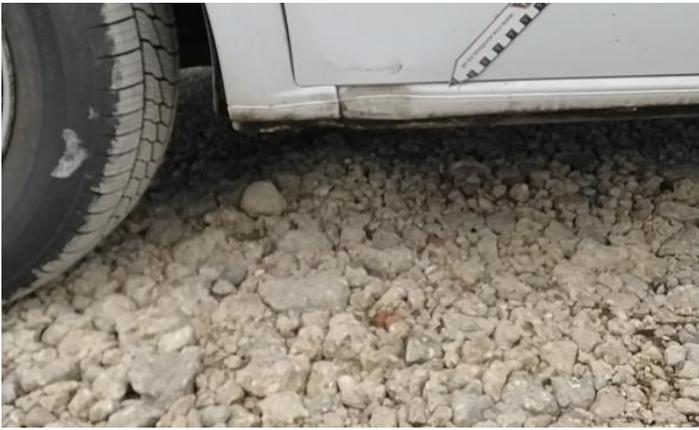
9: Sill ns
Dented
Between 10mm + 30mm

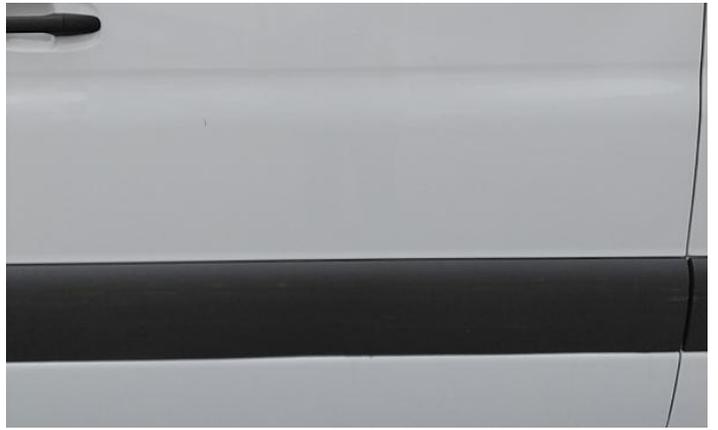
10: Door Moulding nsr
Scuffed (Unpainted)
Over 100mm

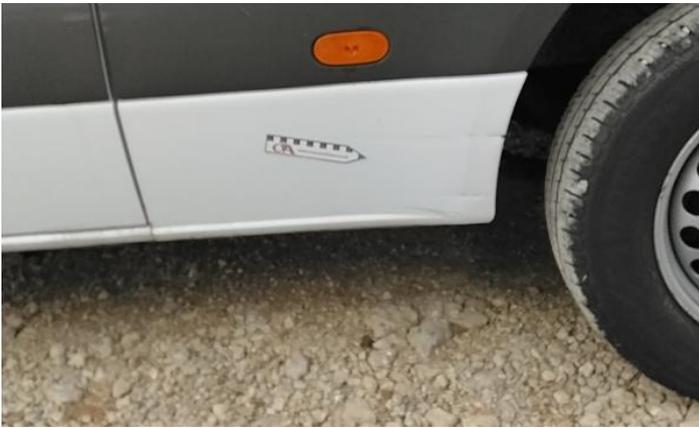
11: Qtr Panel nsr
Dented
With Paint Damage

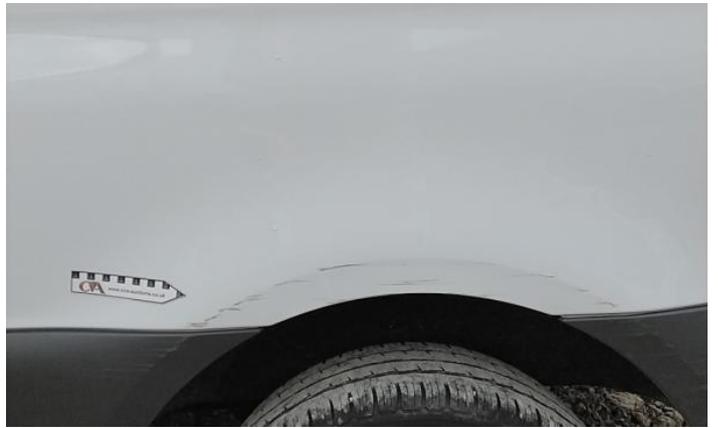
12: Qtr Panel nsr
Scratched
Over 25mm Thru Paint

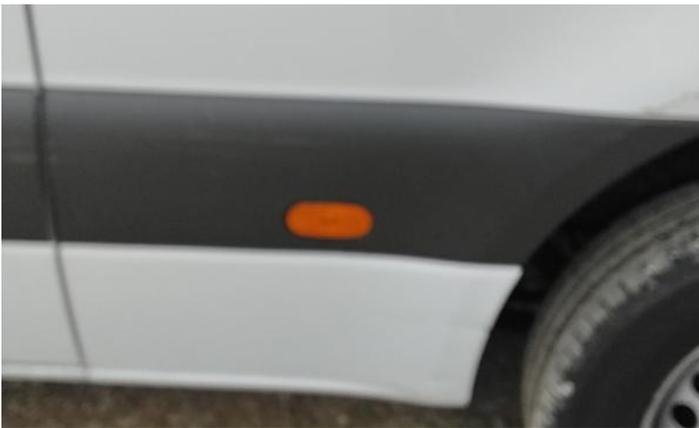
13: Qtr Panel Moulding ns
Scuffed (Unpainted)
Over 100mm

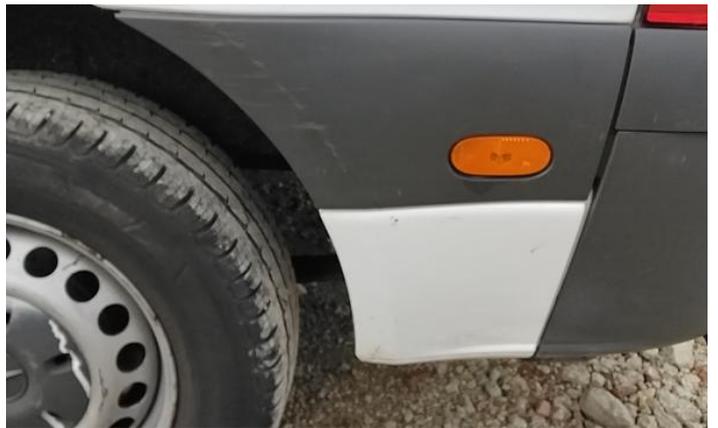
14: Qtr Panel Moulding ns
Scuffed (Unpainted)
UpTo 100mm

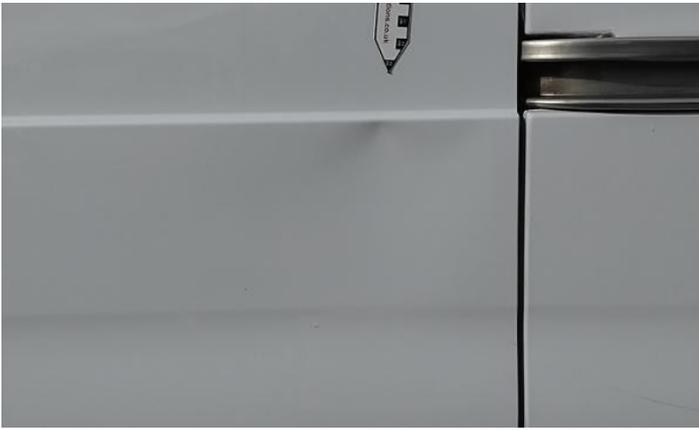
15: Door nsr
Dented
Between 10mm + 30mm

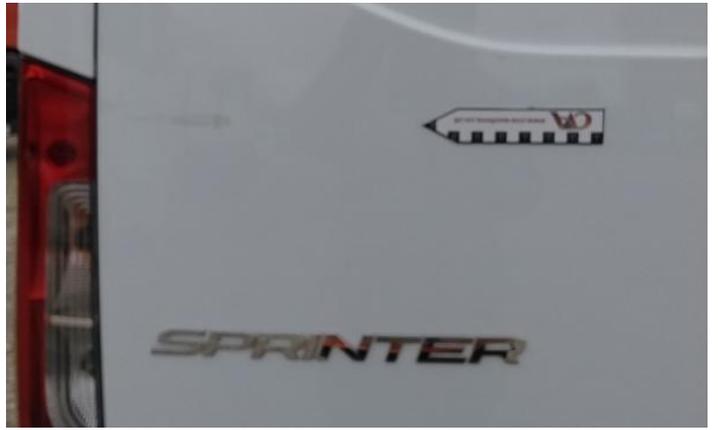
16: Door nsr
Scratched
Over 25mm Not Thru Paint

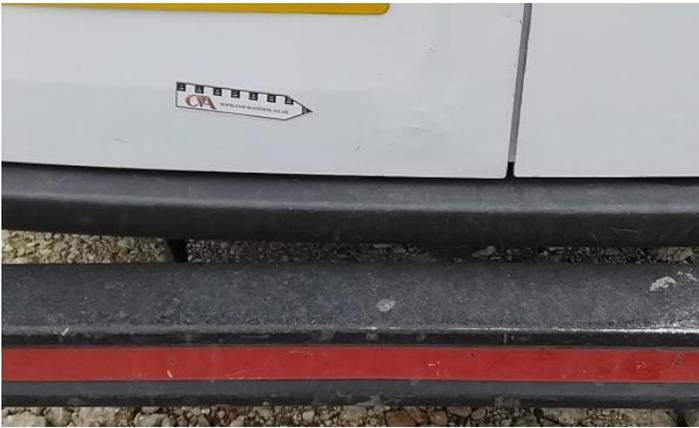
17: Door nsr
Dented
Over 30mm

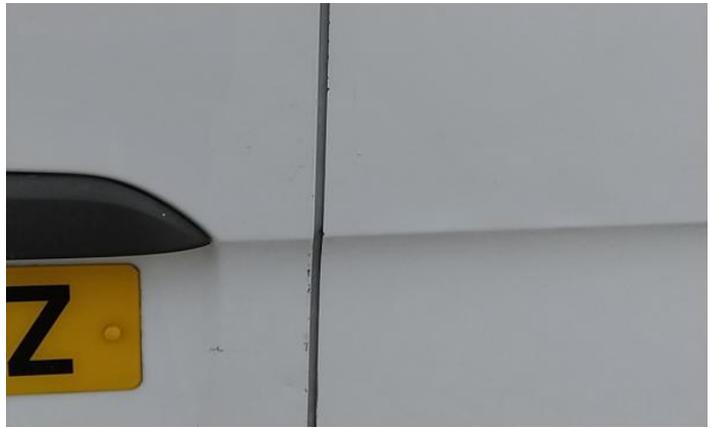
18: Door nsr
Chipped
Edge Chip

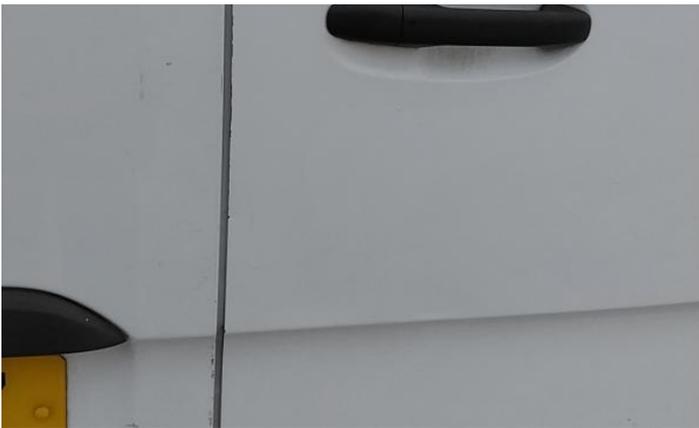
19: Door osr
Chipped
Edge Chip

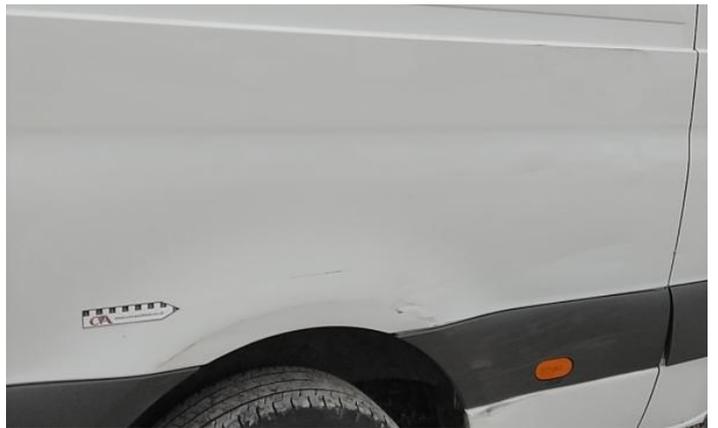
20: Qtr Panel osr
Dented
With Paint Damage

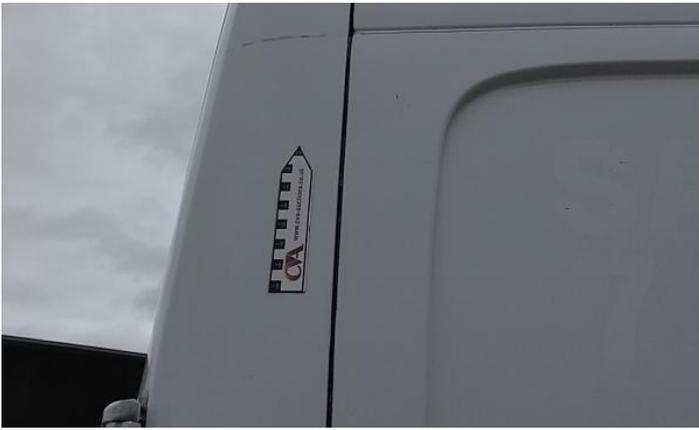
21: Qtr Panel osr
Scratched
Over 25mm Thru Paint

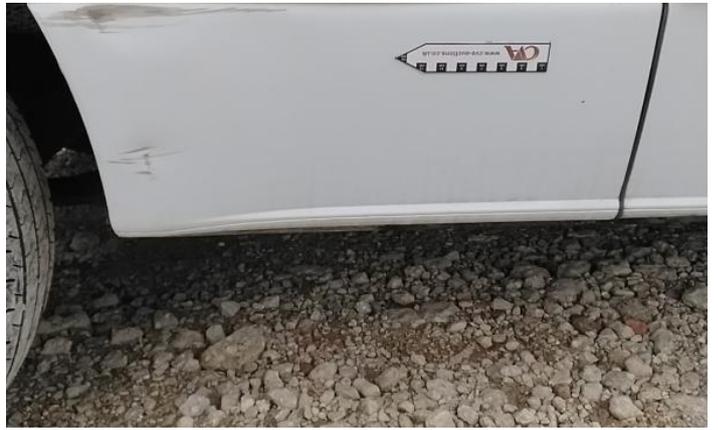
22: Qtr Panel osr
Scratched
Over 25mm Thru Paint

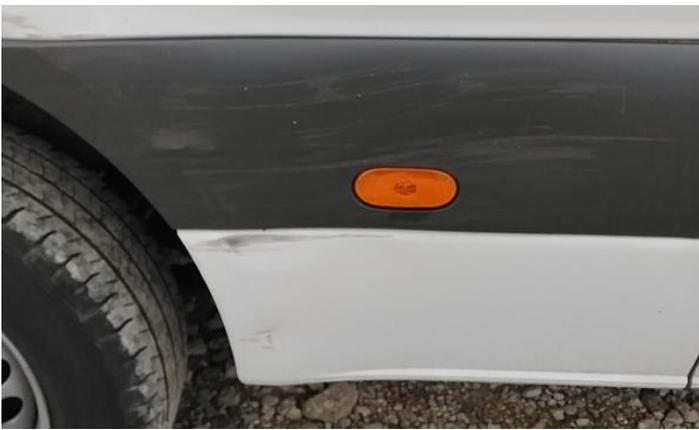
23: Qtr Panel Moulding os
Scuffed (Unpainted)
Over 100mm

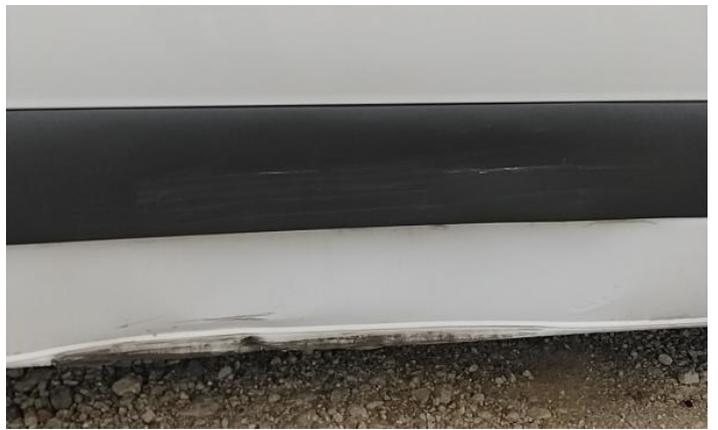
24: Qtr Panel Moulding os
Scuffed (Unpainted)
Over 100mm

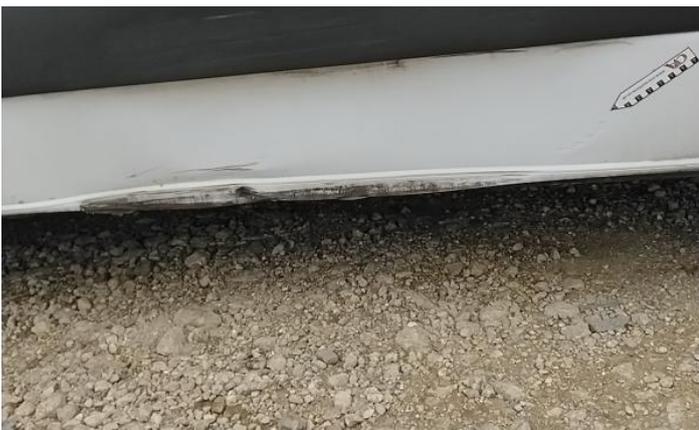
25: Sill os
Dented
With Paint Damage

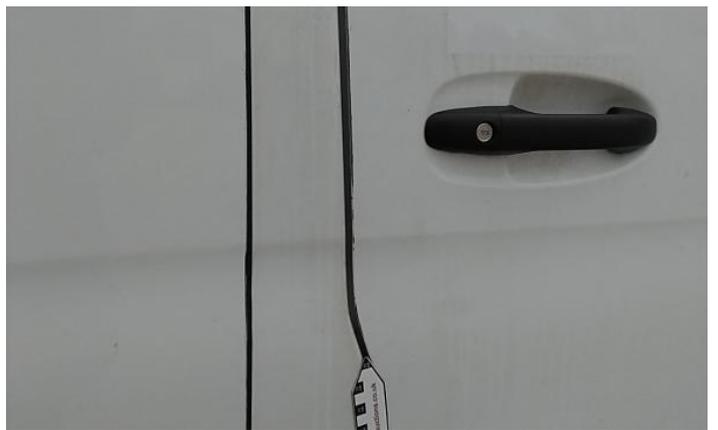
26: Door osf
Chipped
Edge Chip

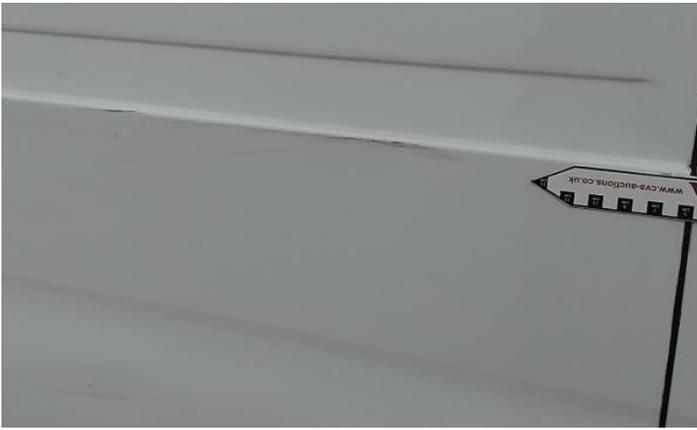
27: Qtr Panel osr
Dented
With Paint Damage

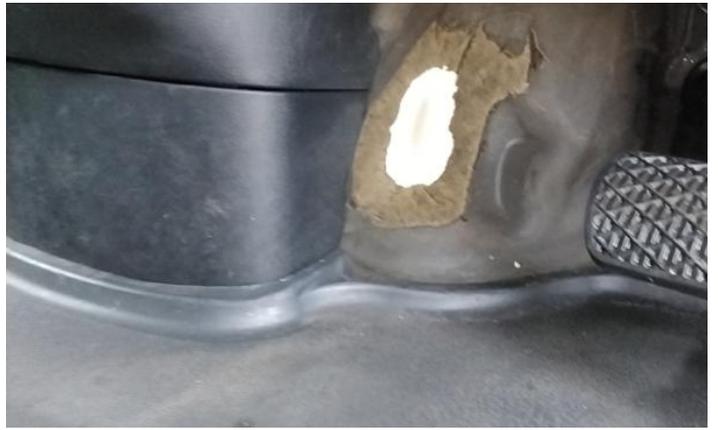
28: Carpets Front
Holed
Over 3mm

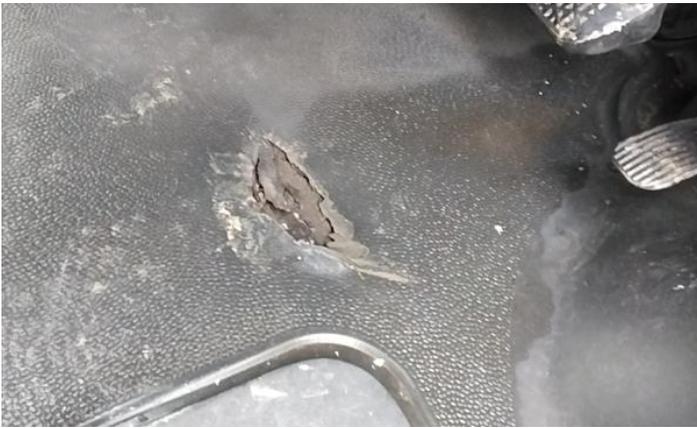
29: Carpets Front
Holed
Over 3mm

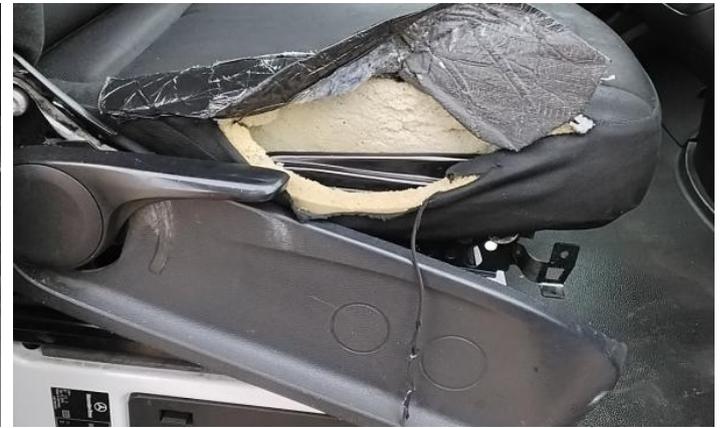
30: Seat Base Cover osf
Holed
Over 3mm
