VEHICLE INSPECTION REPORT

PJ20TCU

Mercedes-Benz Sprinter 314 CDI

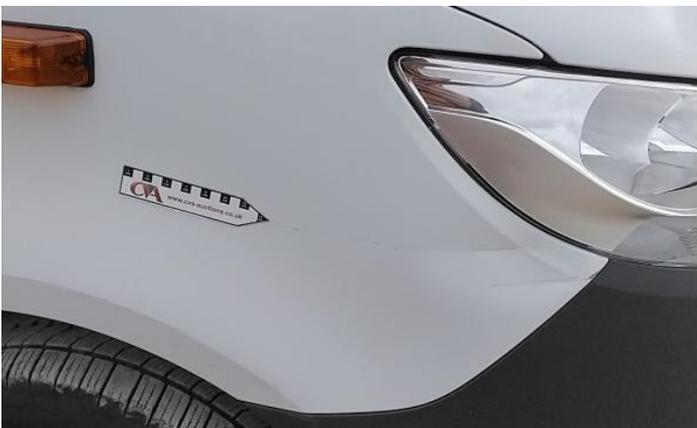
1: Wing osf
Dented
With Paint Damage

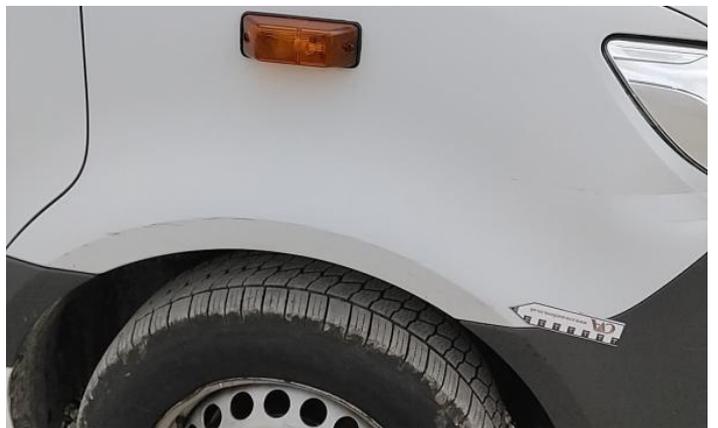
2: Wing osf
Scratched
Over 25mm Thru Paint

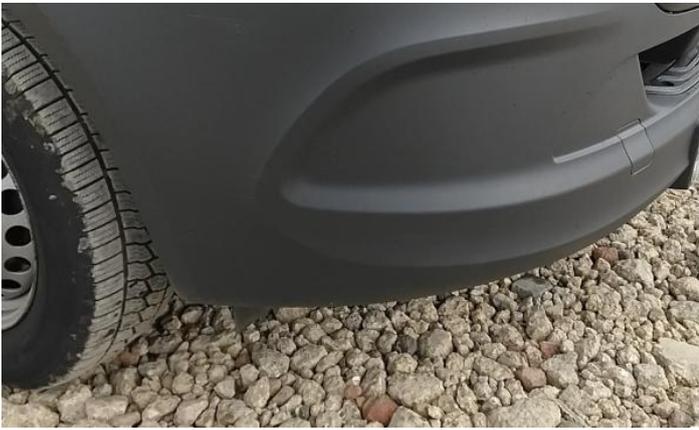
3: Bumper Front Moulding
Scuffed (Unpainted)
Over 100mm

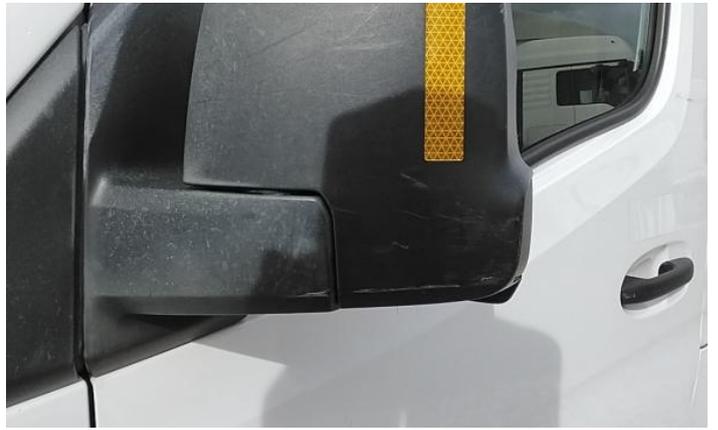
4: Door Mirror Assy nsf
Scuffed (Unpainted)
Over 100mm

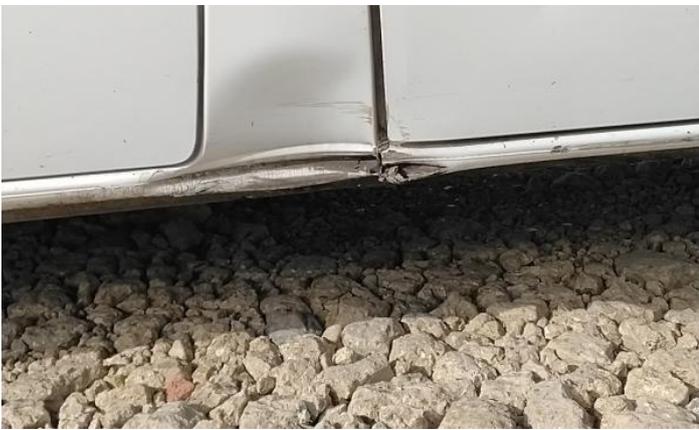
5: Sill ns
Dented
With Paint Damage

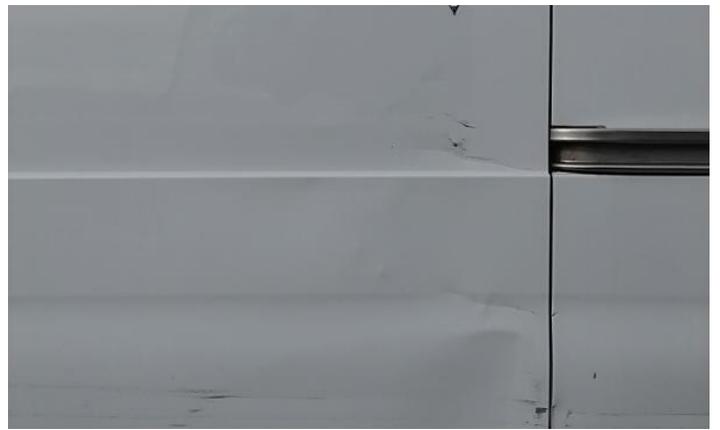
6: Door nsr
Dented
With Paint Damage

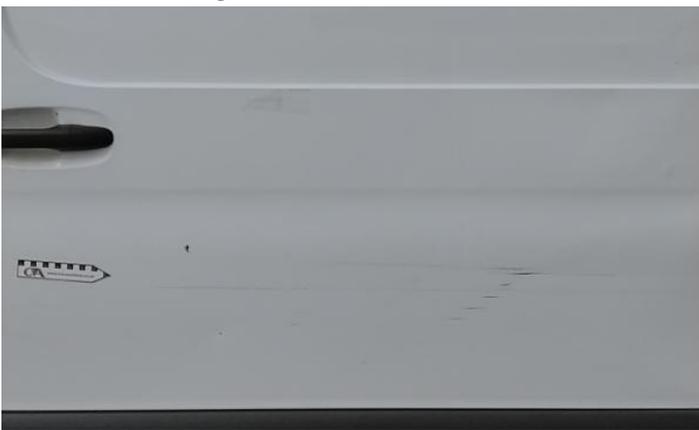
7: Door nsr
Scratched
Over 25mm Not Thru Paint

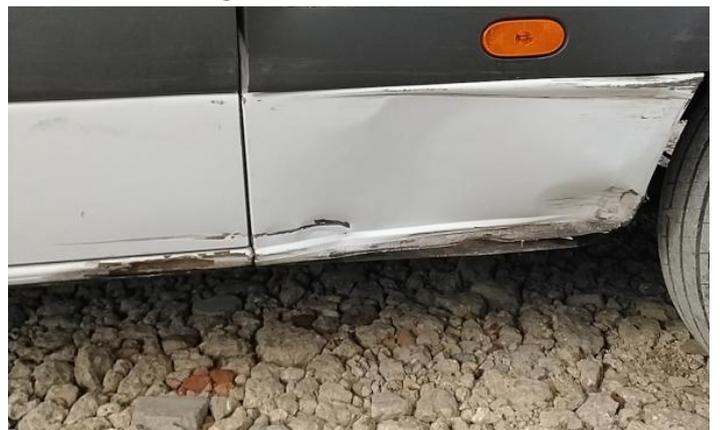
8: Sill ns
Dented
With Paint Damage

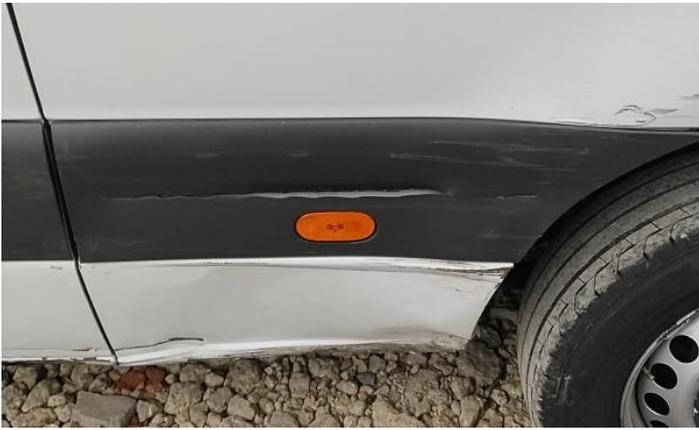
9: Qtr Panel Moulding ns
Broken
Replace

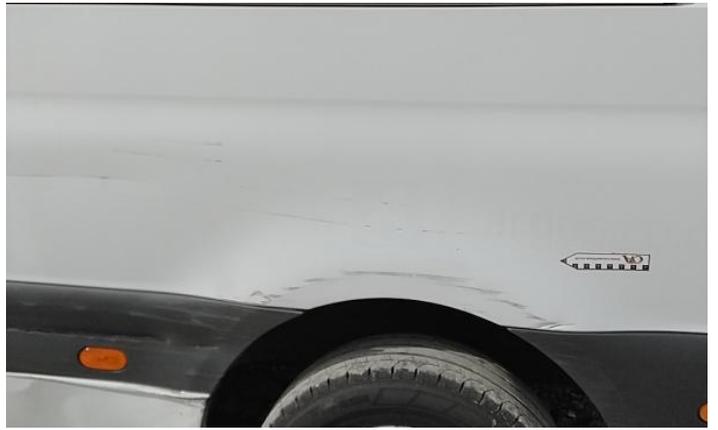
10: Qtr Panel nsr
Scratched
Over 25mm Thru Paint

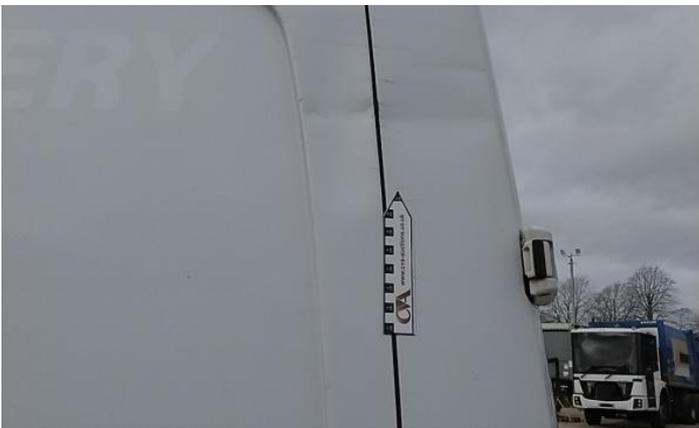
11: Qtr Panel nsr
Dented
Over 30mm

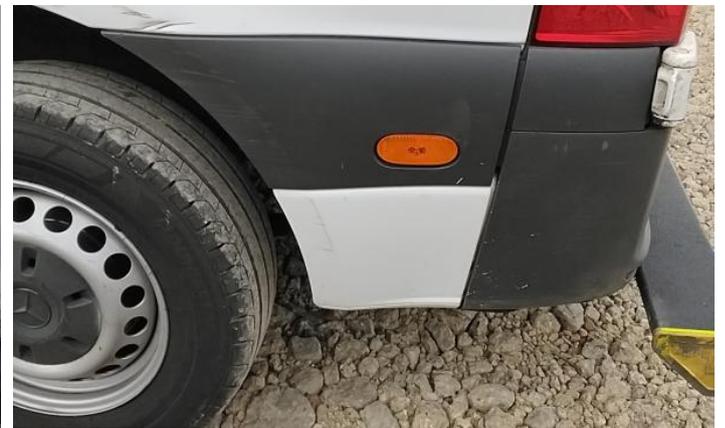
12: Qtr Panel Trim ns
Scuffed
Over 25mm

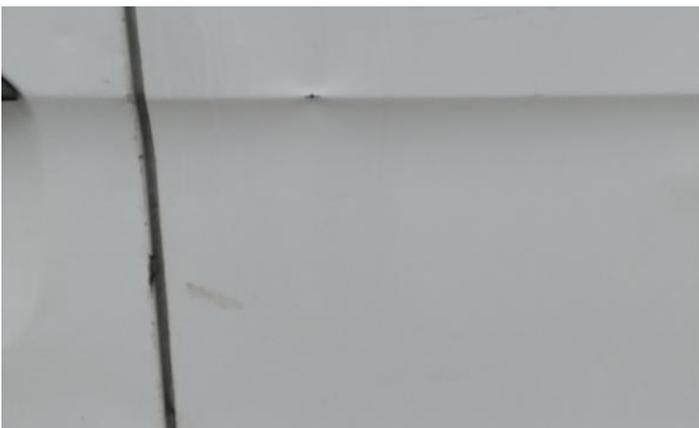
13: Door osr
Dented
With Paint Damage

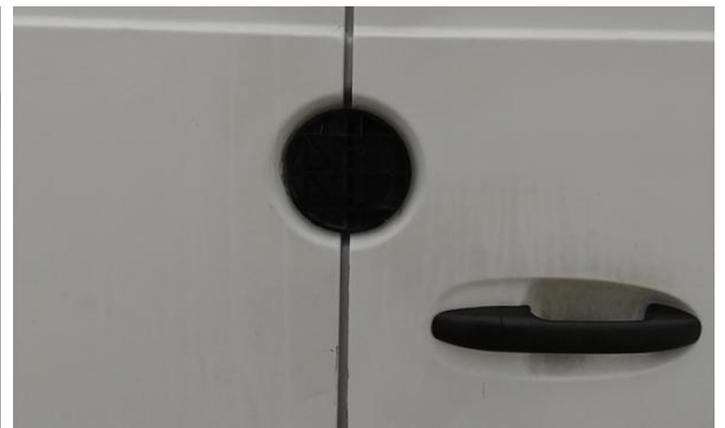
14: Badgedecal Rear
Missing
Replace

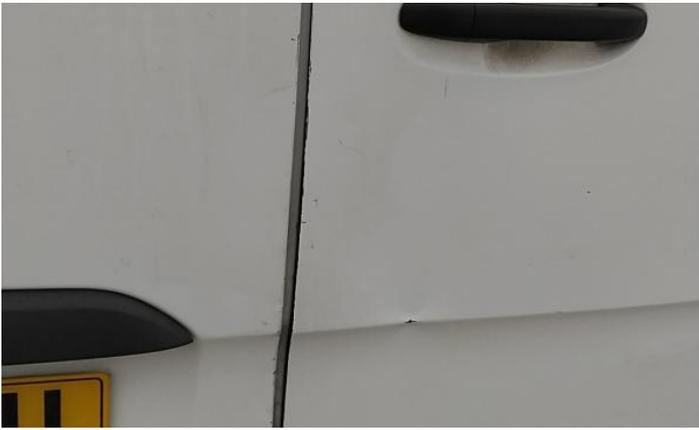
15: Door osr
Chipped
Edge Chip

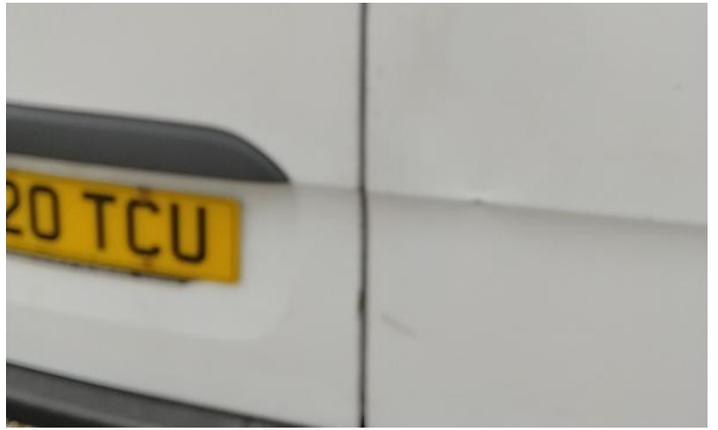
16: Door nsr
Chipped
Edge Chip

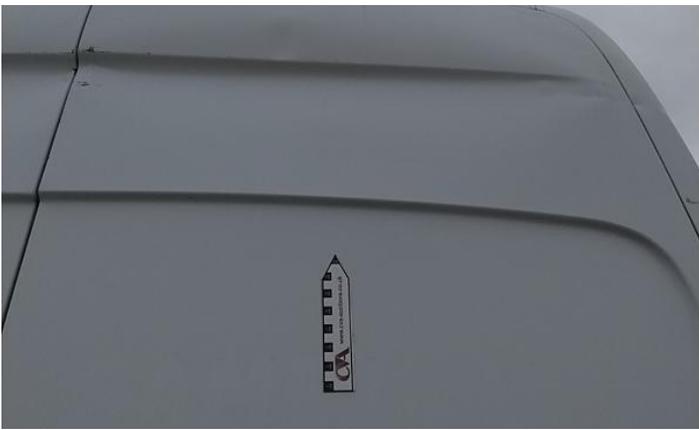
17: Door osr
Dented
Over 30mm

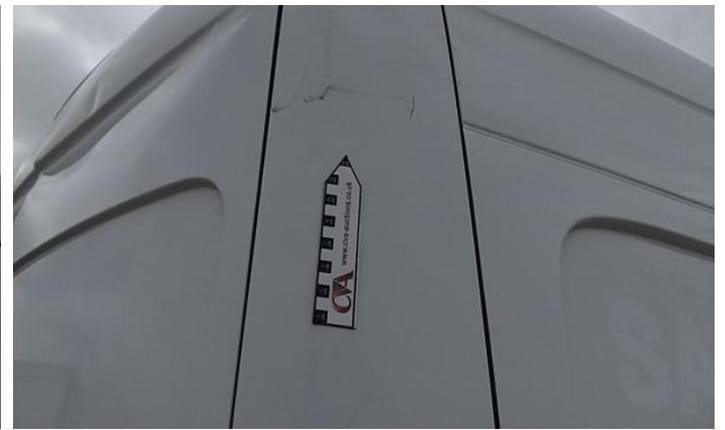
18: Qtr Panel osr
Dented
Over 30mm

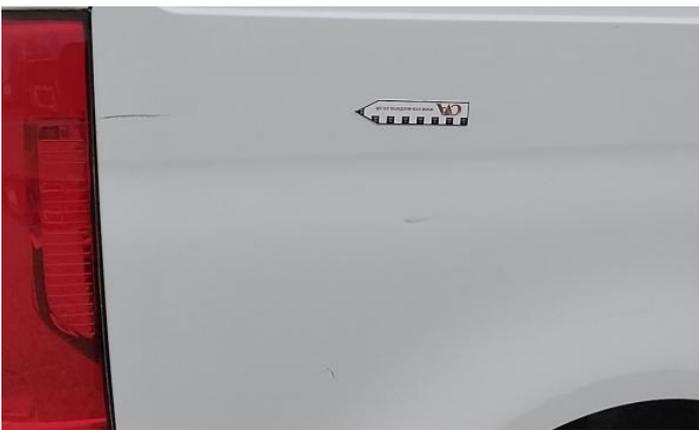
19: Qtr Panel osr
Scratched
Over 25mm Not Thru Paint

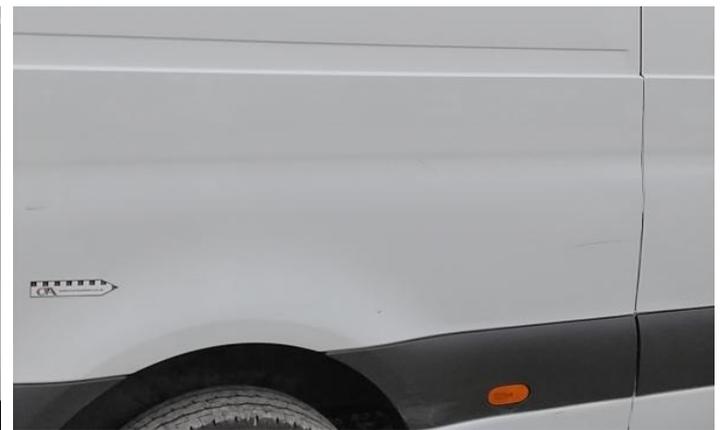
20: Qtr Panel osr
Scratched
Over 25mm Not Thru Paint

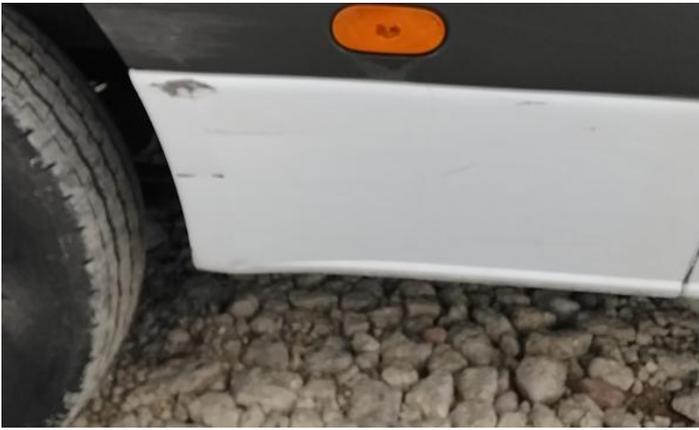
21: Qtr Panel osr
Scratched
Over 25mm Thru Paint

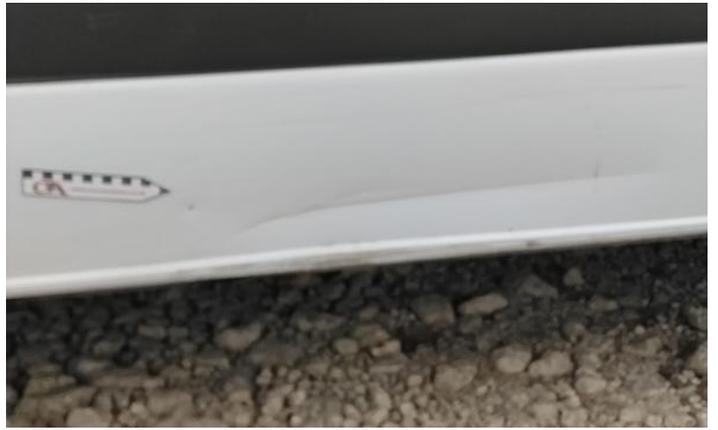
22: Qtr Panel osr
Dented
Over 30mm

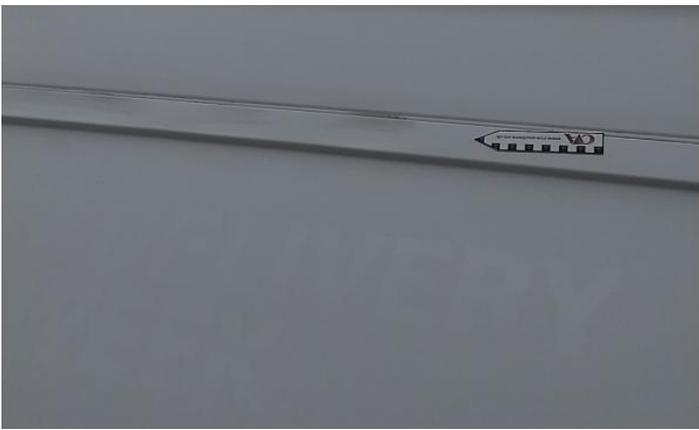
23: Qtr Panel osr
Dented
Over 30mm

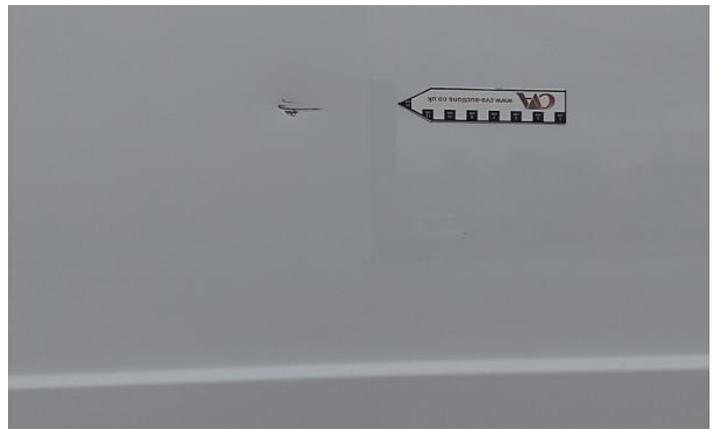
24: Qtr Panel osr
Scratched
Over 25mm Thru Paint

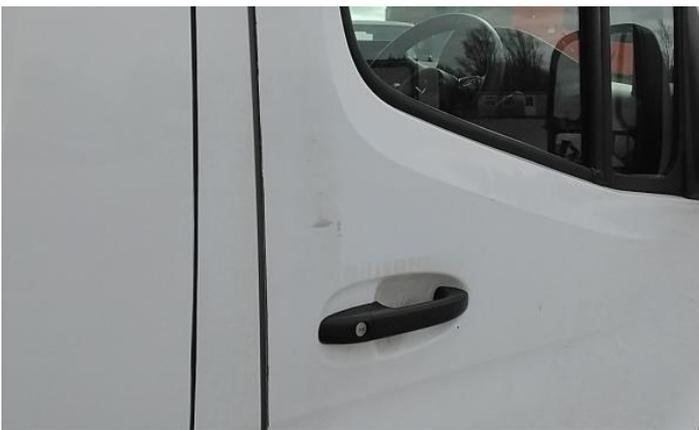
25: Door osf
Chipped
Edge Chip

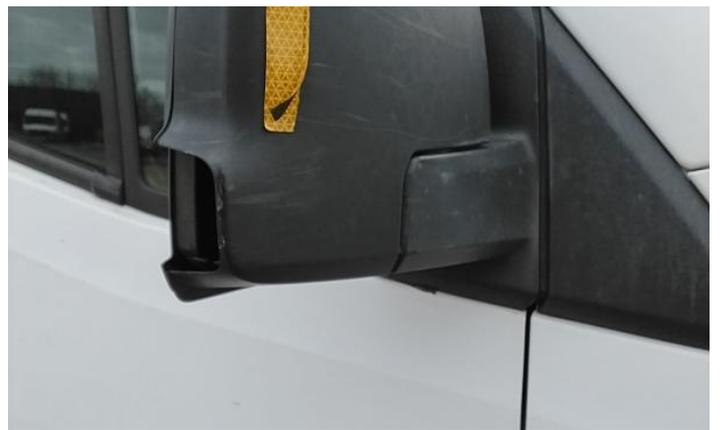
26: Door Mirror Assy osf
Scuffed (Unpainted)
Over 100mm

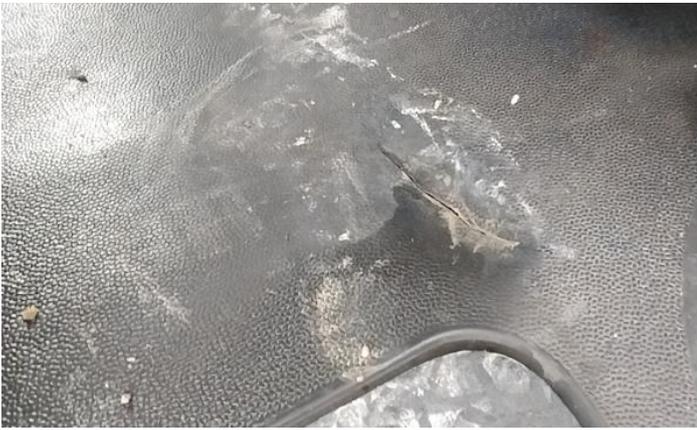
27: Carpets Front
 Holed
 Over 3mm

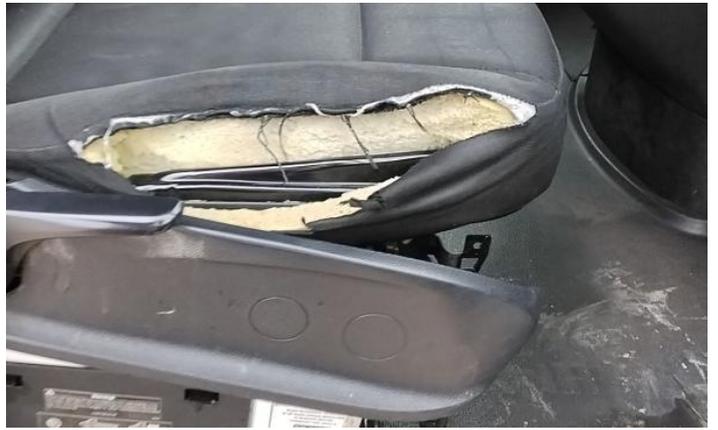
28: Seat Base Cover of
 Holed
 Over 3mm
