VEHICLE INSPECTION REPORT

YF71VHD

Mercedes-Benz Sprinter 315 CDI

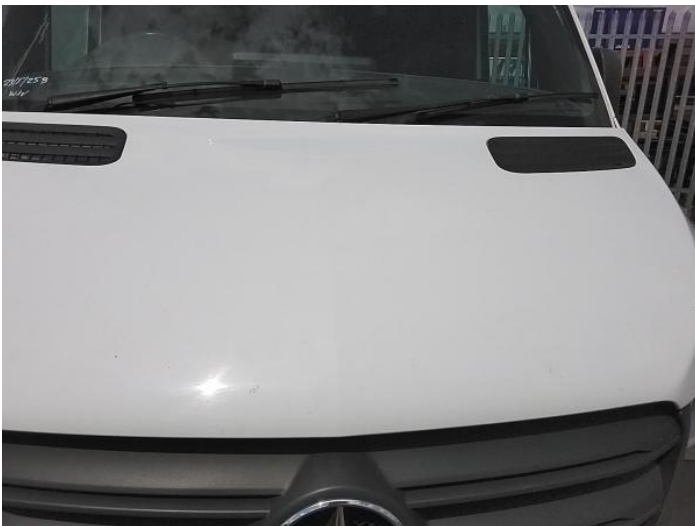
1: Bonnet
Chipped
Multiple Chips

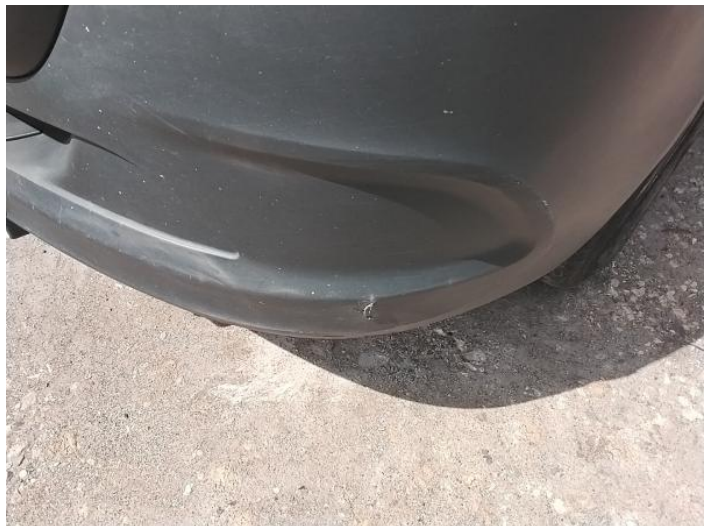
2: Bumper Front
Cracked
Over 25mm

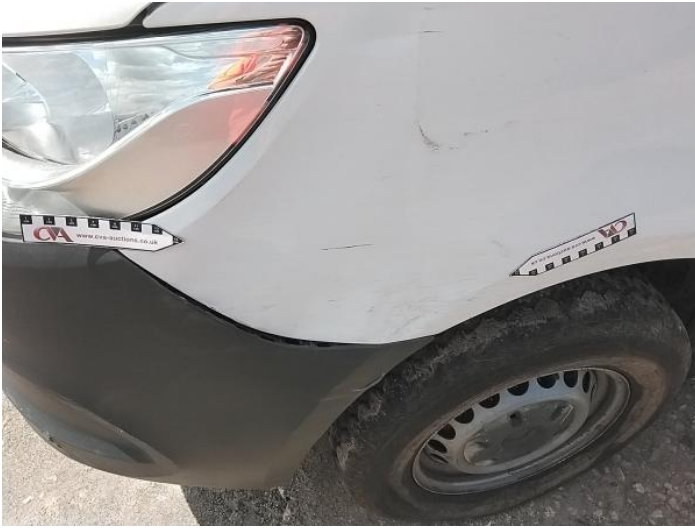
3: Wing nsf
Dented
Over 30mm

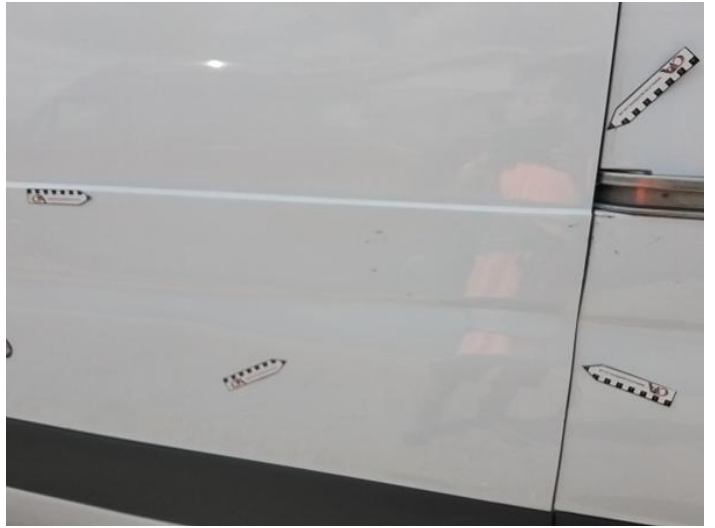
4: Qtr Panel nsr
Dented
Over 30mm

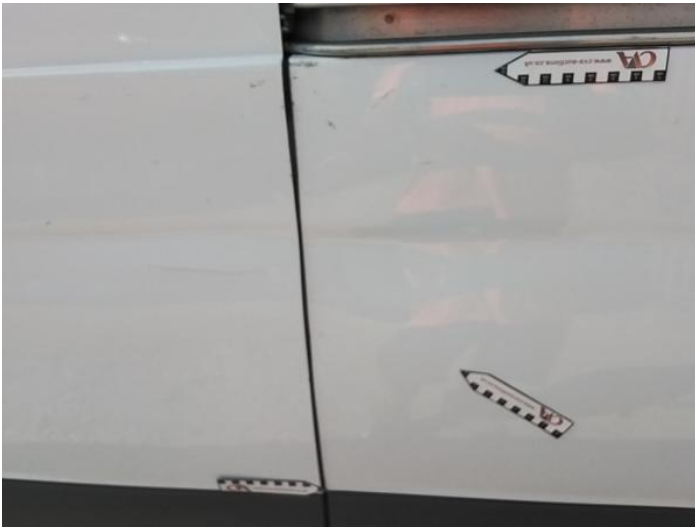
5: Qtr Panel nsr
Dented
Over 30mm

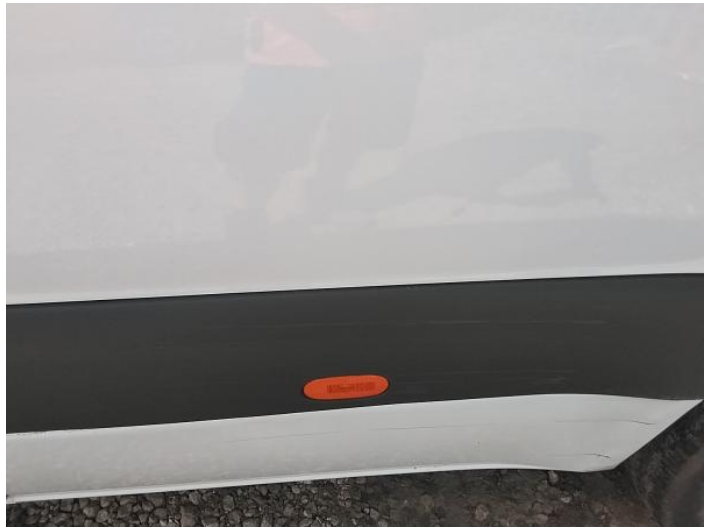
6: Qtr Panel Moulding ns
Scuffed (Unpainted)
Over 100mm

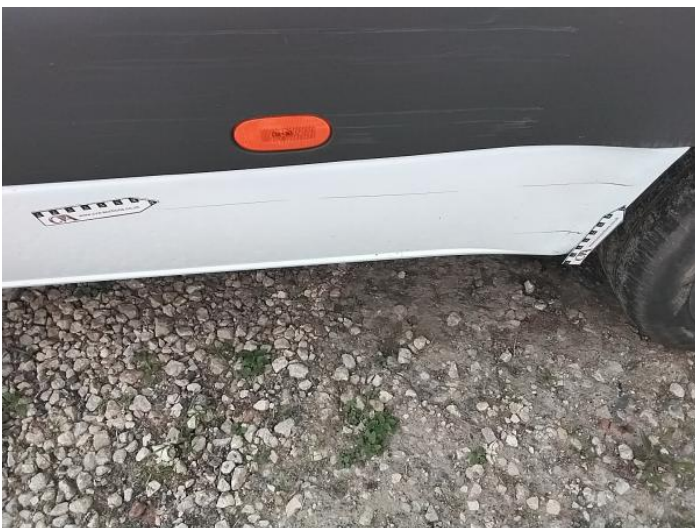
7: Qtr Panel nsr
Dented
Over 30mm

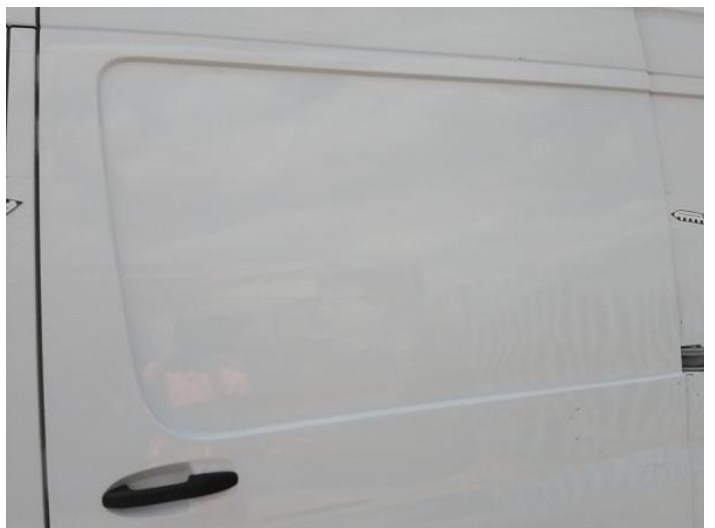
8: Qtr Panel nsr
Scratched
Over 25mm Thru Paint

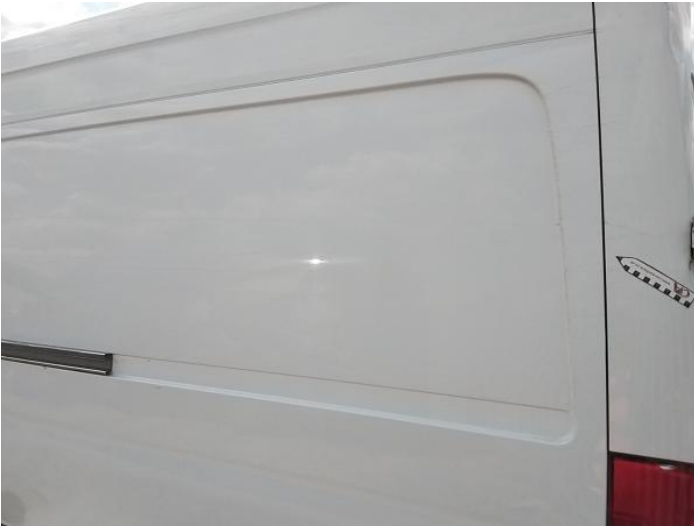
9: Qtr Panel nsr
Scratched
Over 25mm Thru Paint

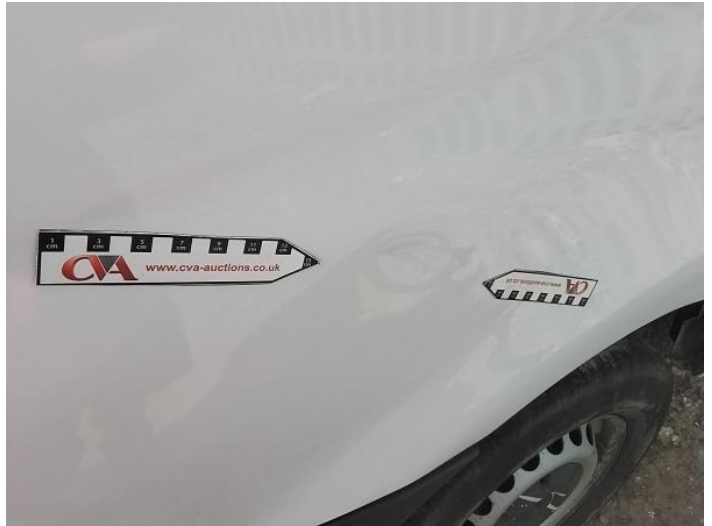
10: Qtr Panel nsr
Dented
Over 30mm

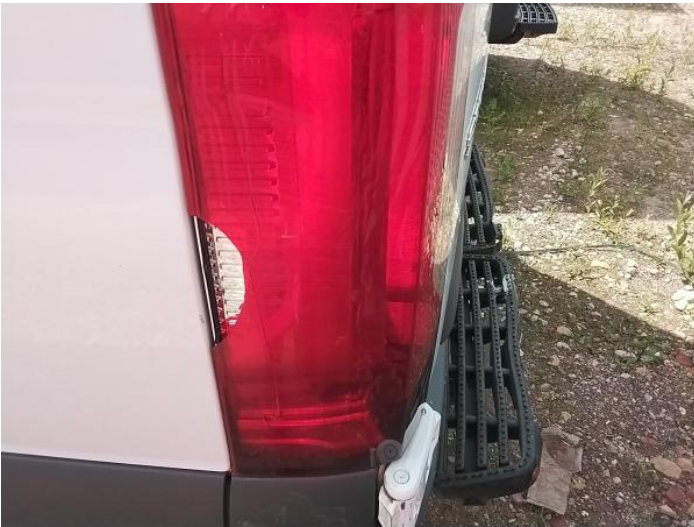
11: Lamp nsr
Broken
Replace

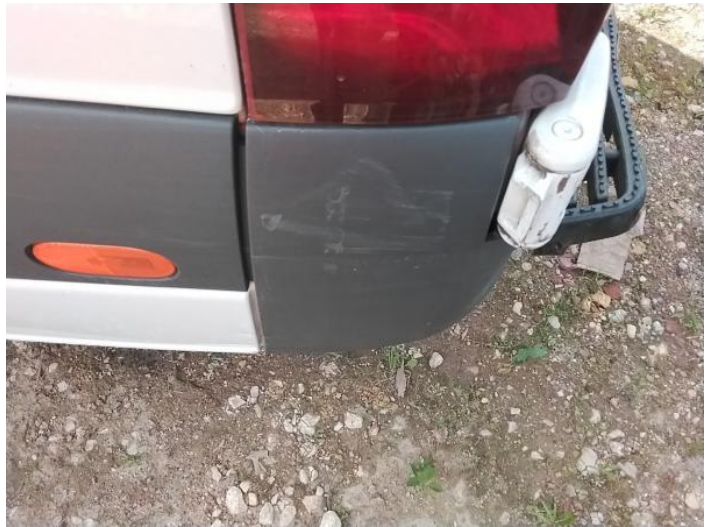
12: Bumper Rear Moulding
Scuffed (Unpainted)
Over 100mm

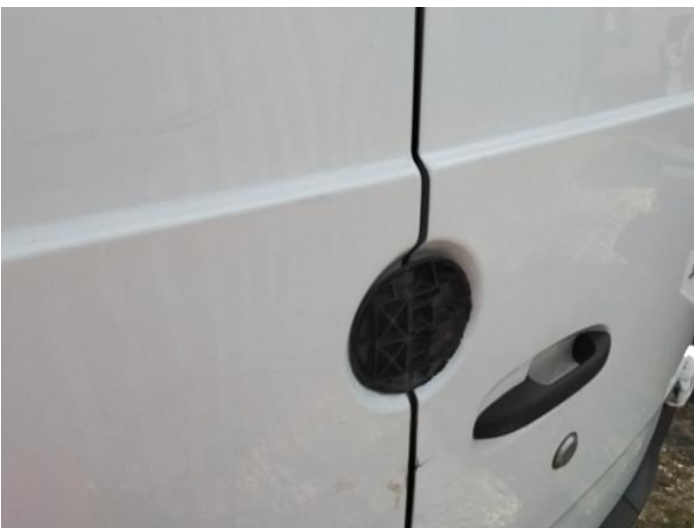
13: Badgedecal Rear
Broken
Replace

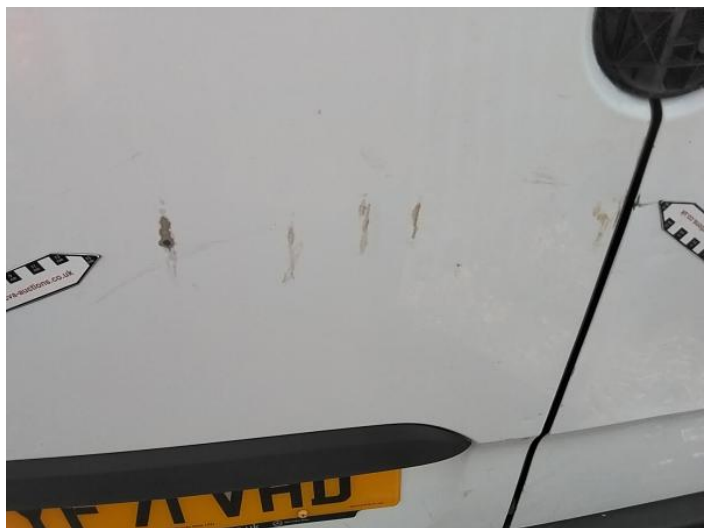
14: Door nsr
Scratched
Over 25mm Thru Paint

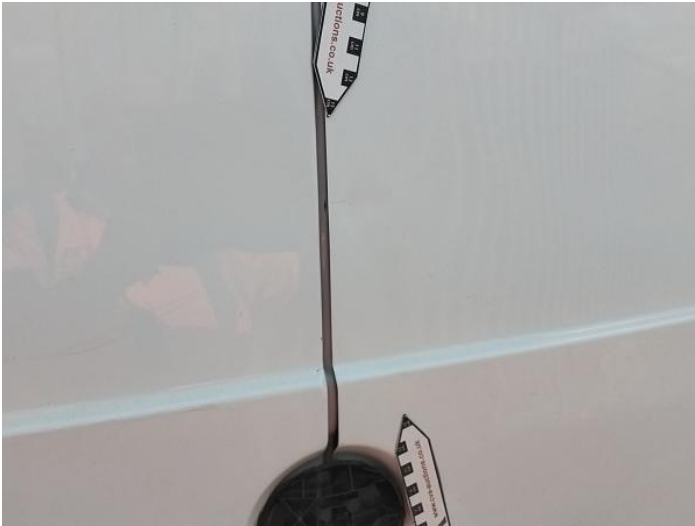
15: Door osr
Dented
Over 30mm

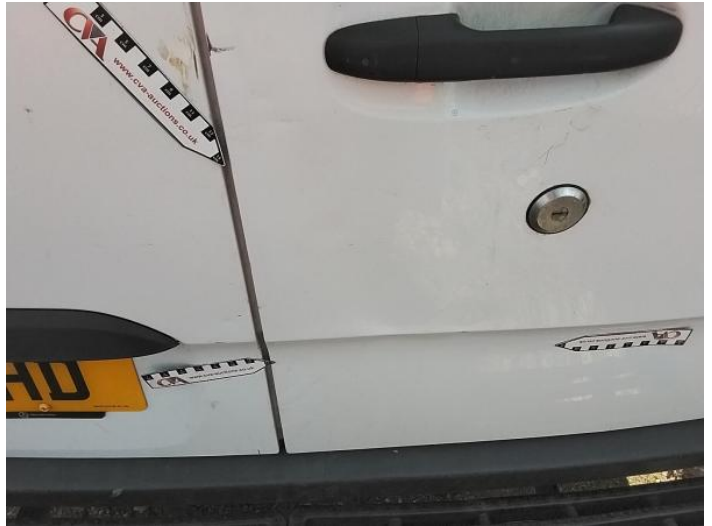
16: Door osr
Dented
Over 30mm

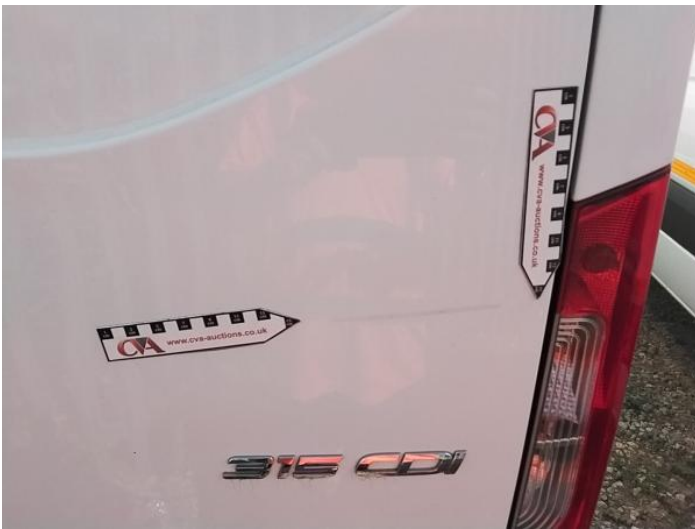
17: Door osr
Scratched
Over 25mm Not Thru Paint

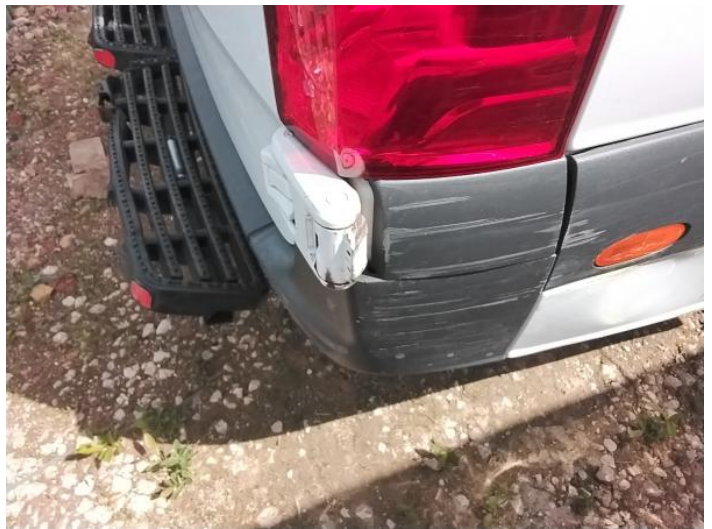
18: Bumper Rear Moulding
Scuffed (Unpainted)
Over 100mm

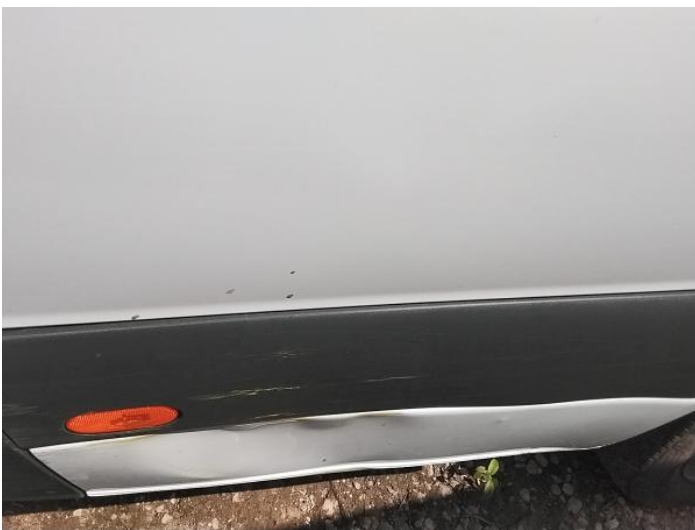
19: Qtr Panel Moulding os
Scuffed (Unpainted)
Over 100mm

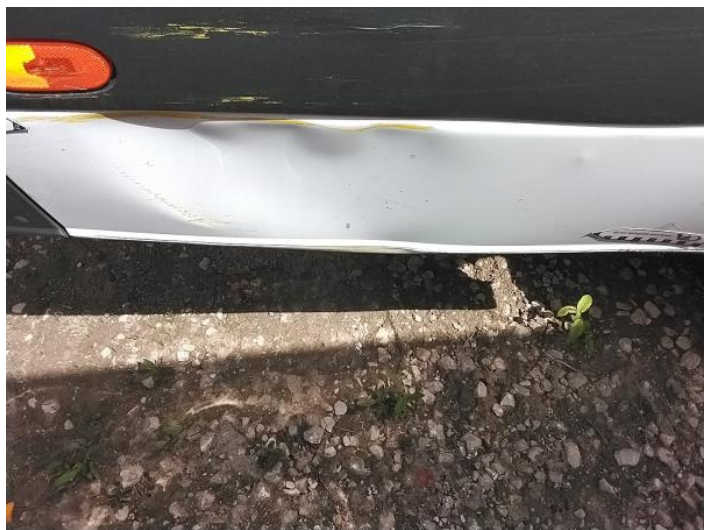
20: Qtr Panel osr
Dented
Over 30mm

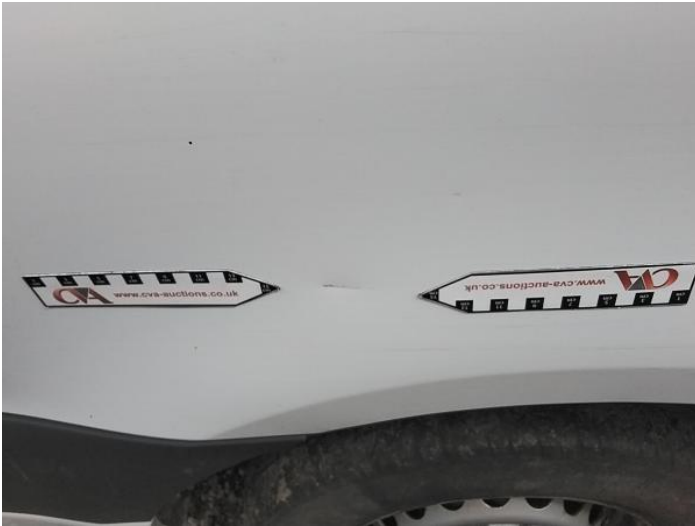
21: Qtr Panel osr
Dented
Over 30mm

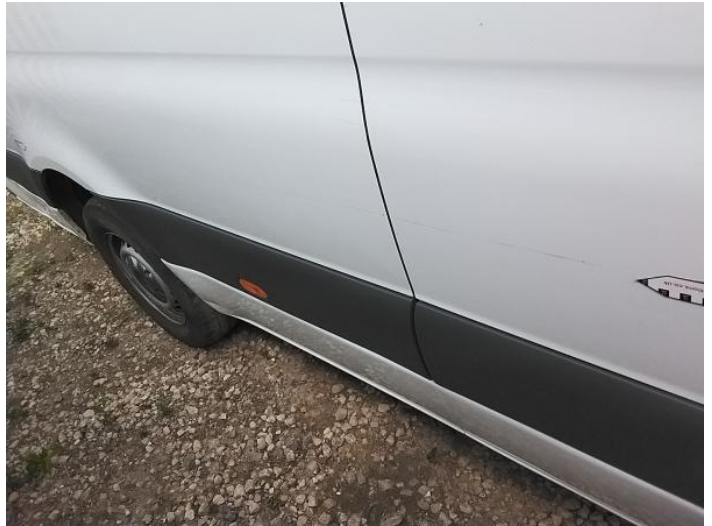
22: Qtr Panel osr
Scratched
Over 25mm Thru Paint

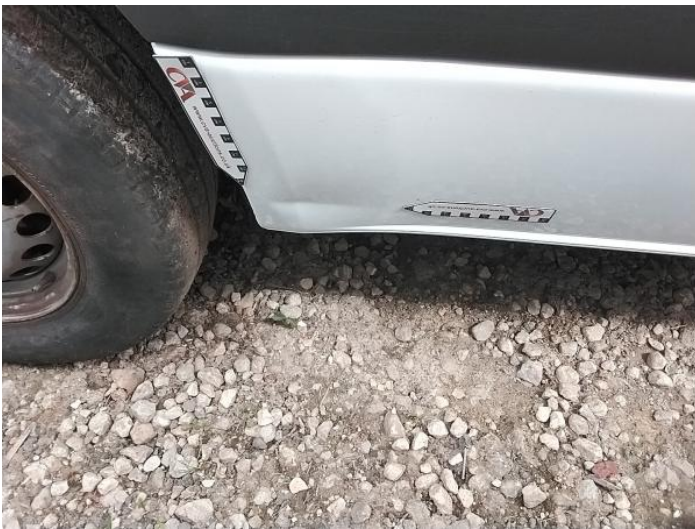
23: Qtr Panel osr
Dented
Over 30mm

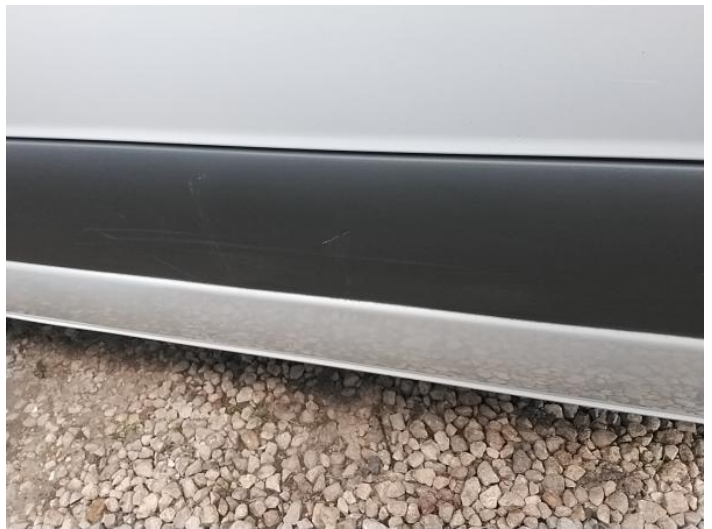
24: Qtr Panel Moulding os
Scuffed (Unpainted)
Over 100mm

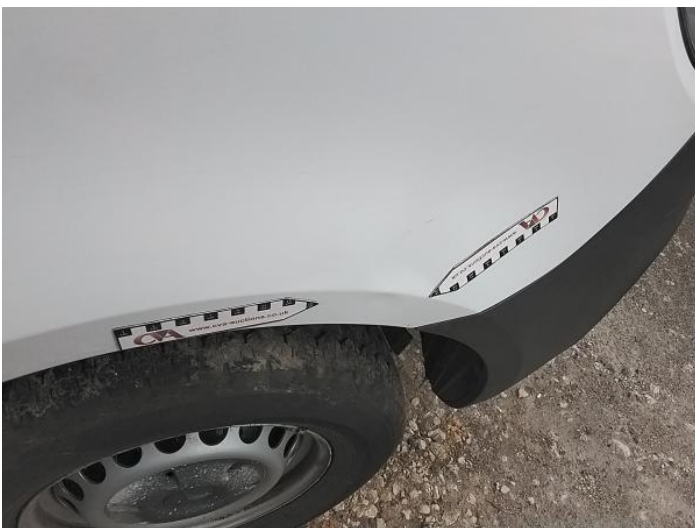
25: Wing osf
Dented
Over 30mm

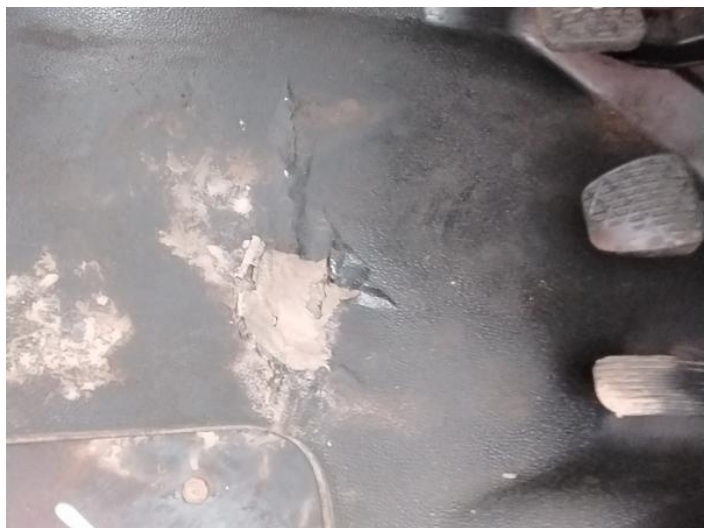
26: Carpets Front
Holed
Over 3mm

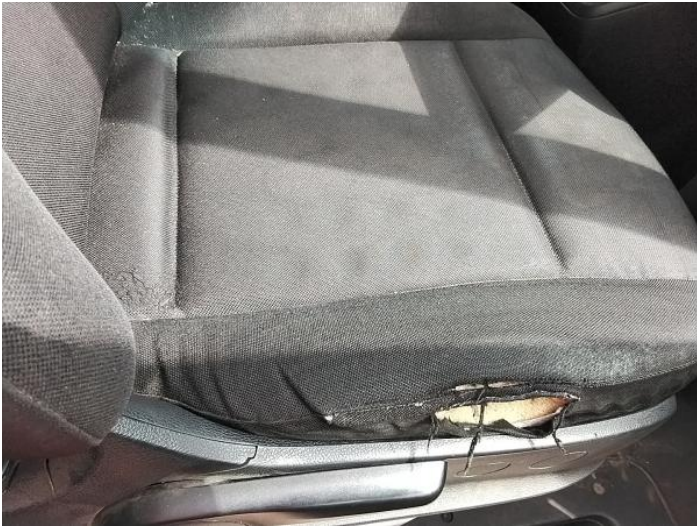
27: Seat Base Cover osf
Torn
Over 3mm

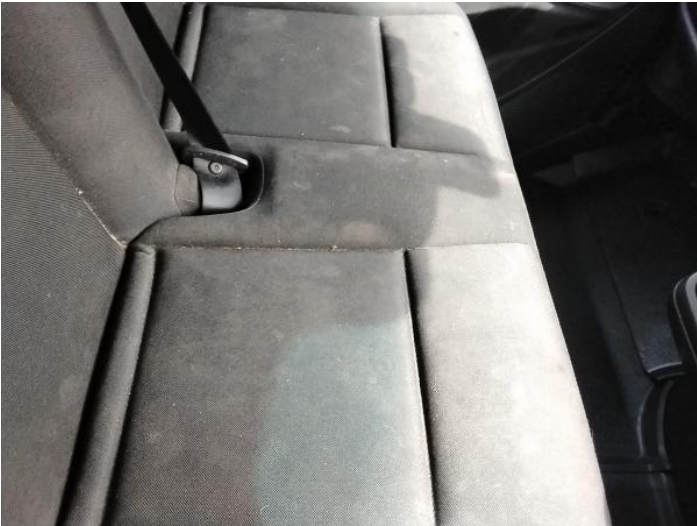
28: Seat Base Cover nsf
Soiled
Heavy

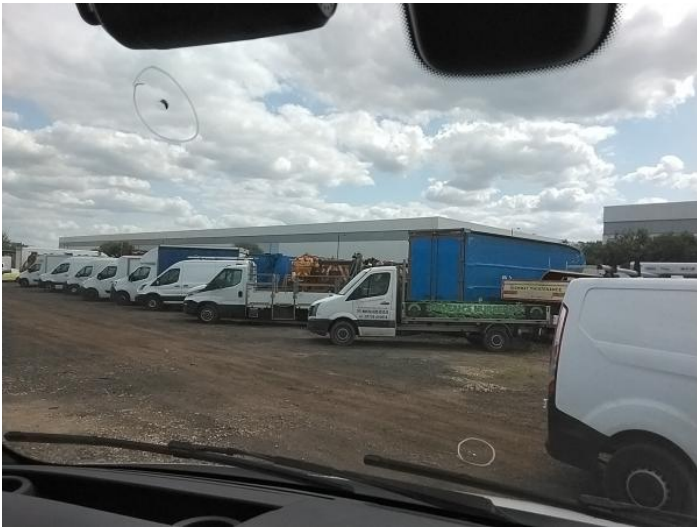
29: Screen Front
Chipped
Over 10mm

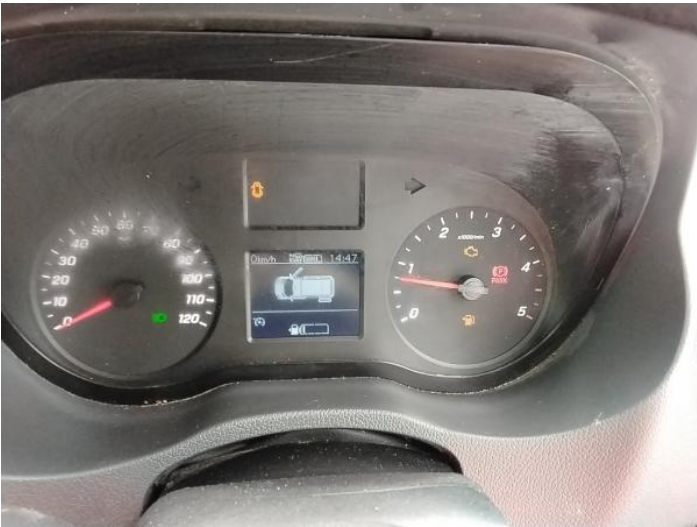
30: Dash Warning Lights
Displayed
No Action
