VEHICLE INSPECTION REPORT

YF71VHL

Mercedes-Benz Sprinter 315 CDI

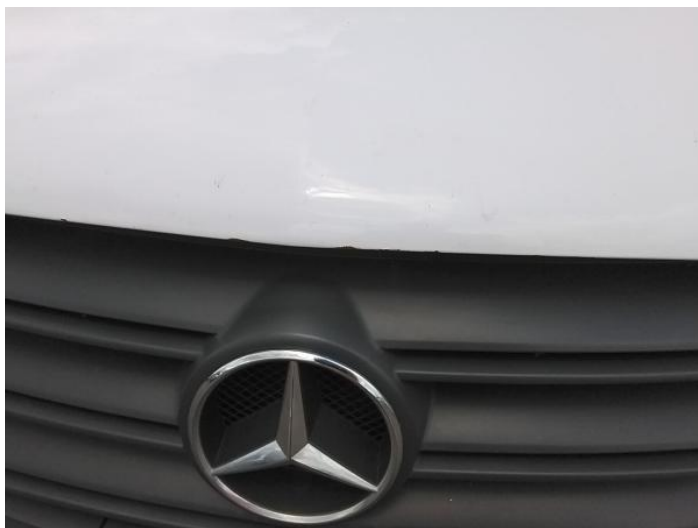
1: Bonnet
Rusted
Over 5mm

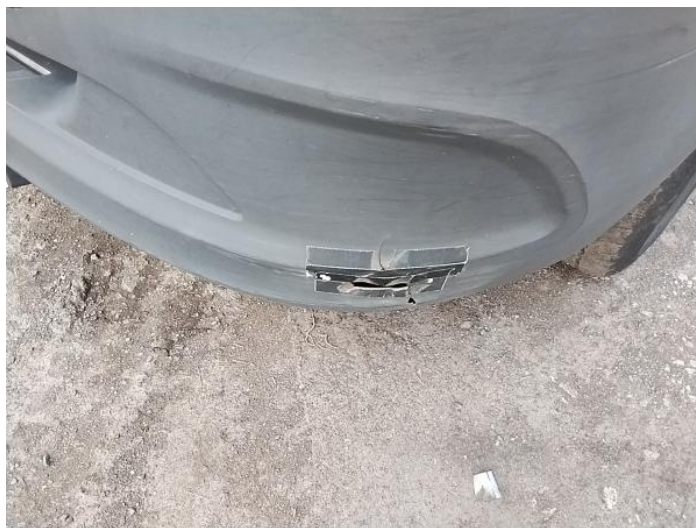
2: Bumper Front
Cracked
Over 25mm

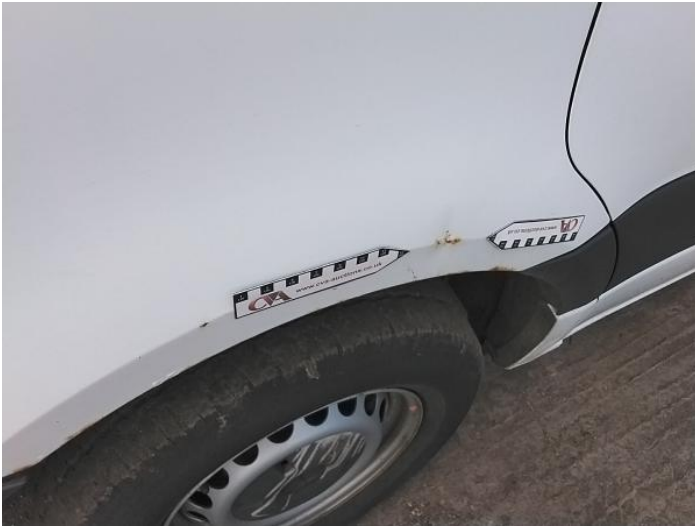
3: Wing nsf
Dented
Over 30mm

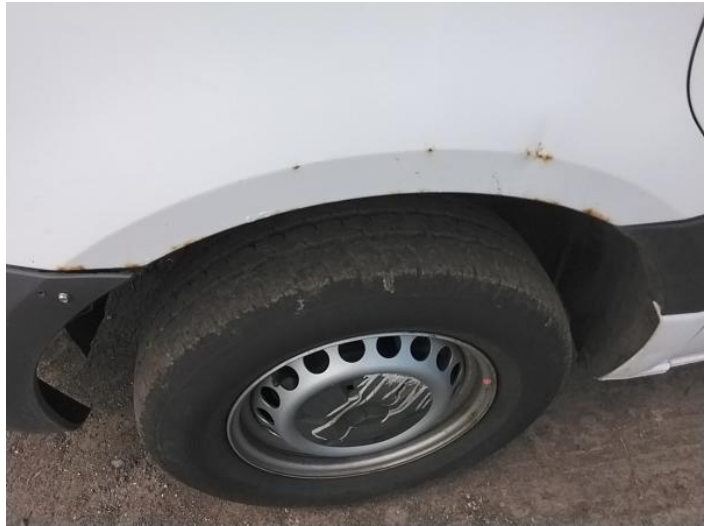
4: Wing nsf
Rusted
Over 5mm

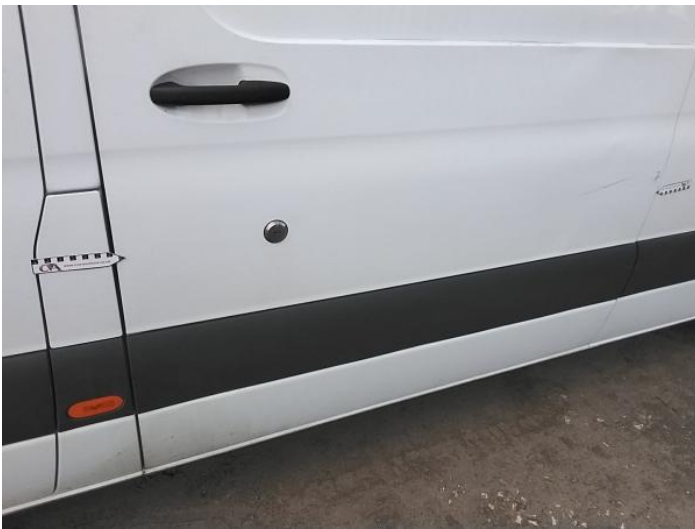
5: Qtr Panel nsr
Scratched
Over 25mm Not Thru Paint

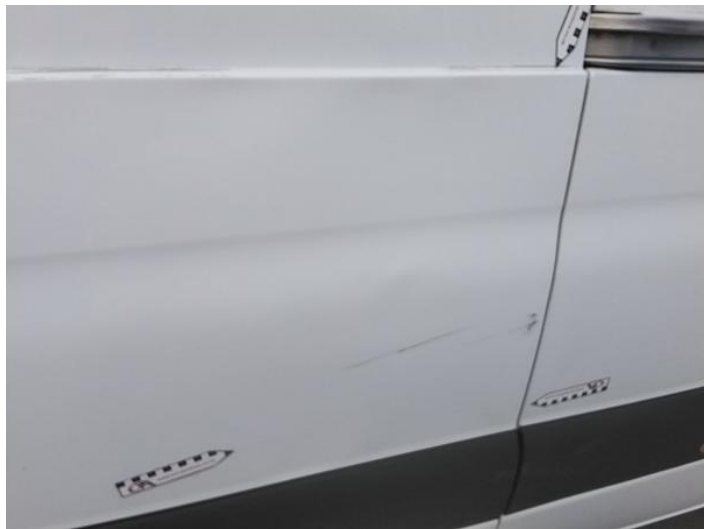
6: Qtr Panel nsr
Dented
Over 30mm

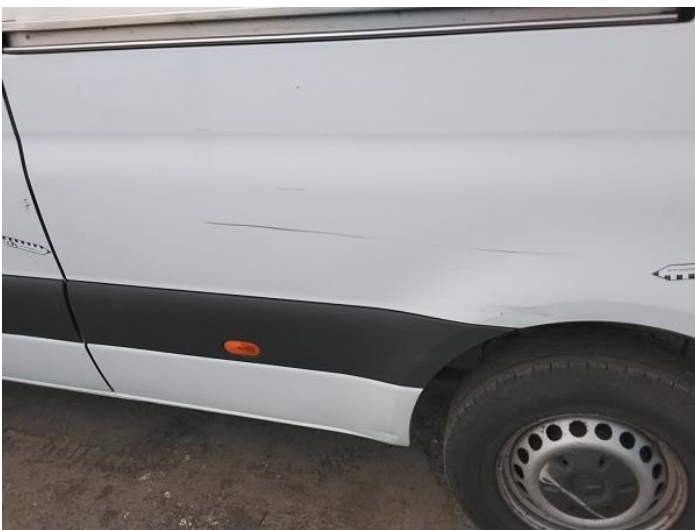
7: Qtr Panel nsr
Scratched
Over 25mm Thru Paint

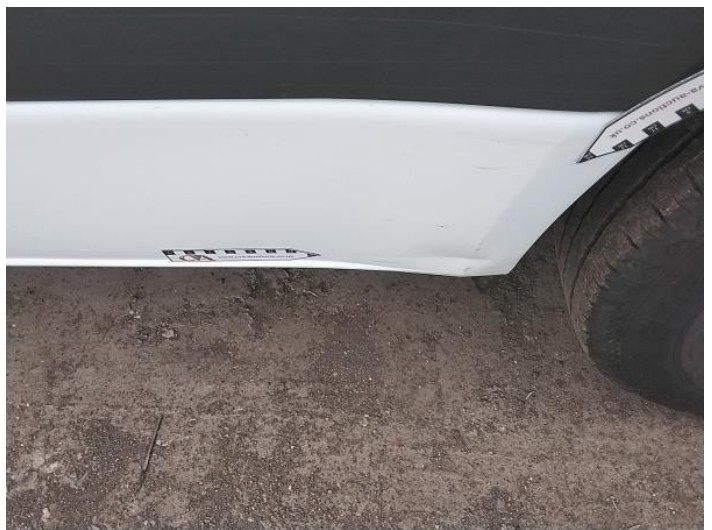
8: Qtr Panel nsr
Dented
Over 30mm

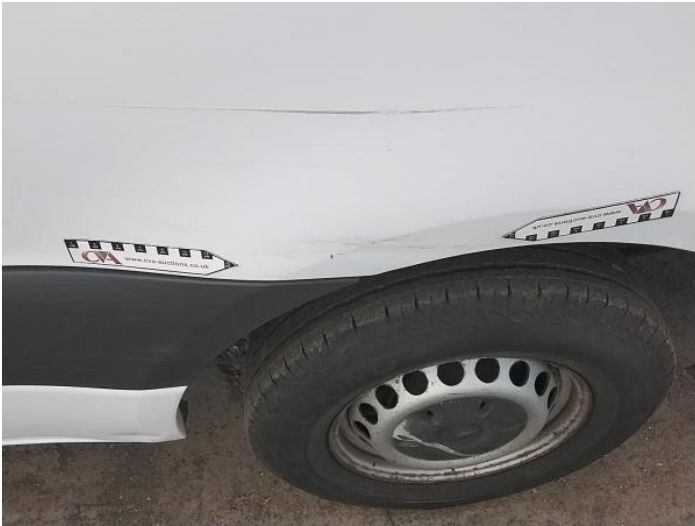
9: Qtr Panel nsr
Dented
Over 30mm

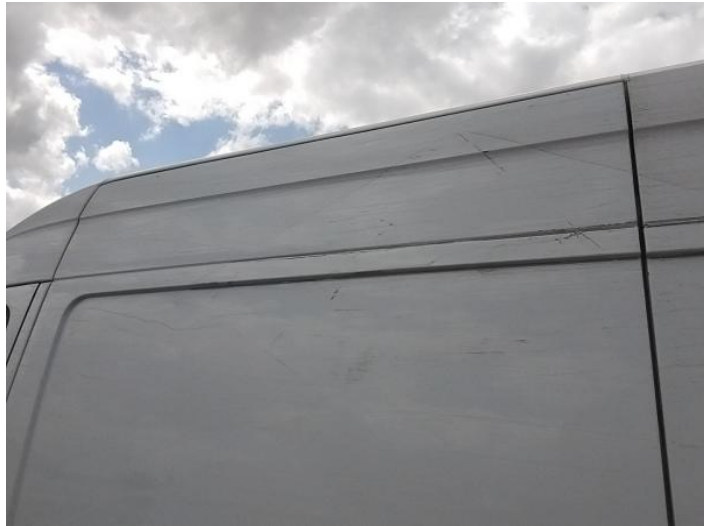
10: Qtr Panel nsr
Scratched
Over 25mm Thru Paint

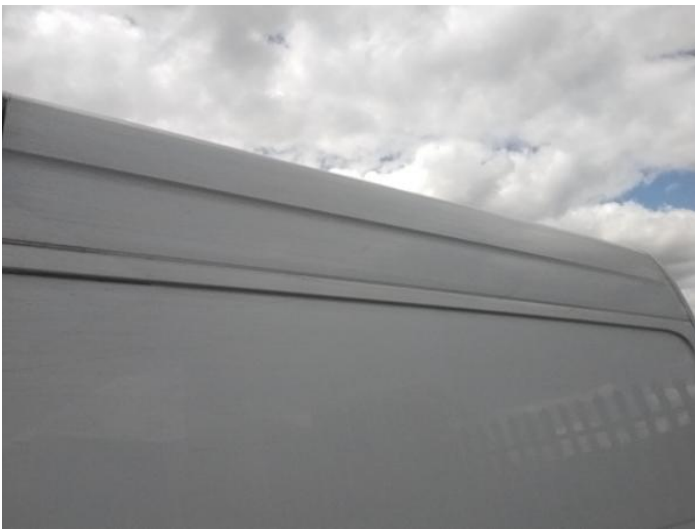
11: Qtr Panel nsr
Scratched
Over 25mm Thru Paint

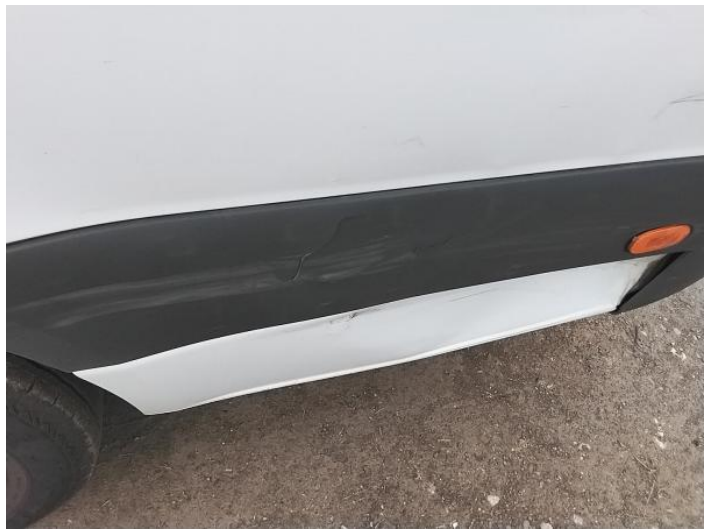
12: Qtr Panel Moulding ns
Broken
Replace

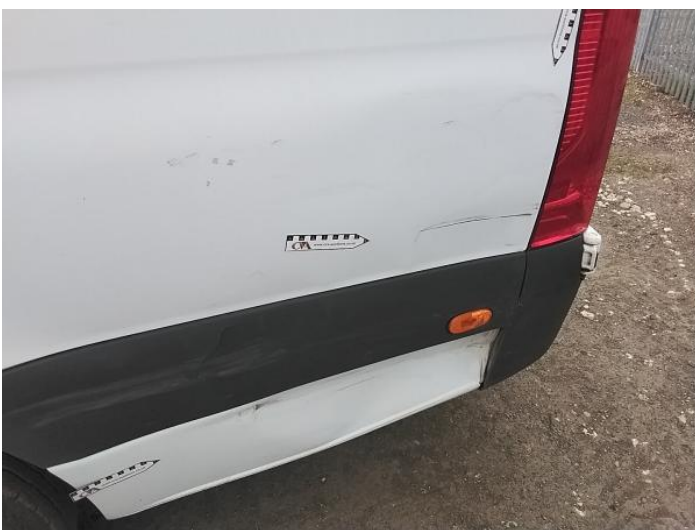
13: Qtr Panel nsr
Dented
Over 30mm

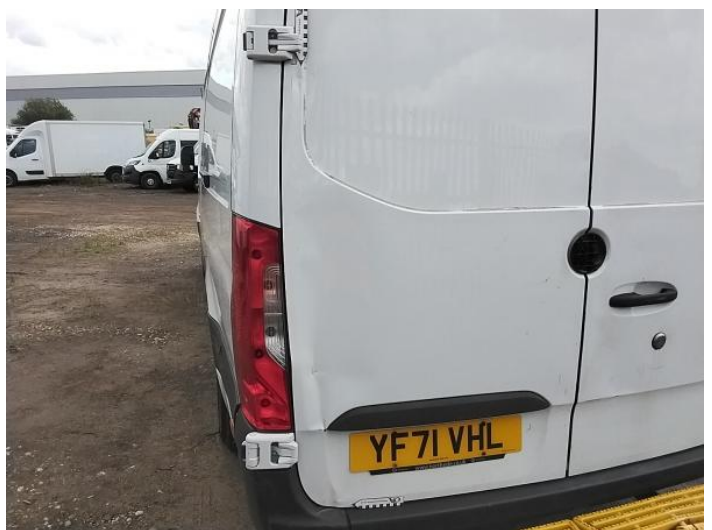
14: Door nsr
Dented
Over 30mm

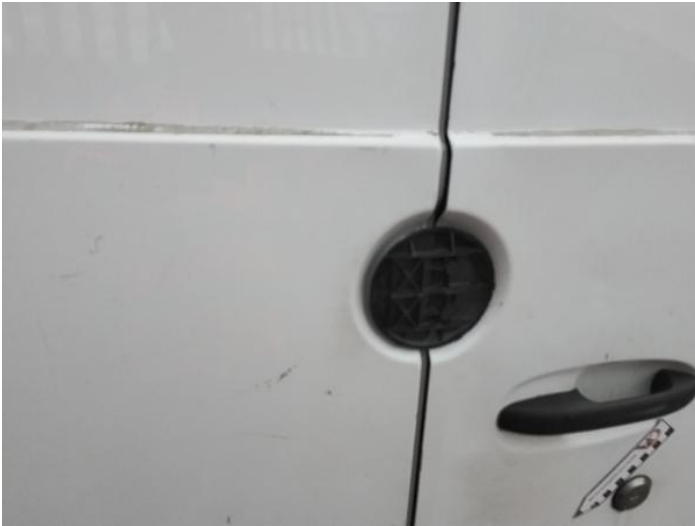
15: Badgedecal Rear
Broken
Replace

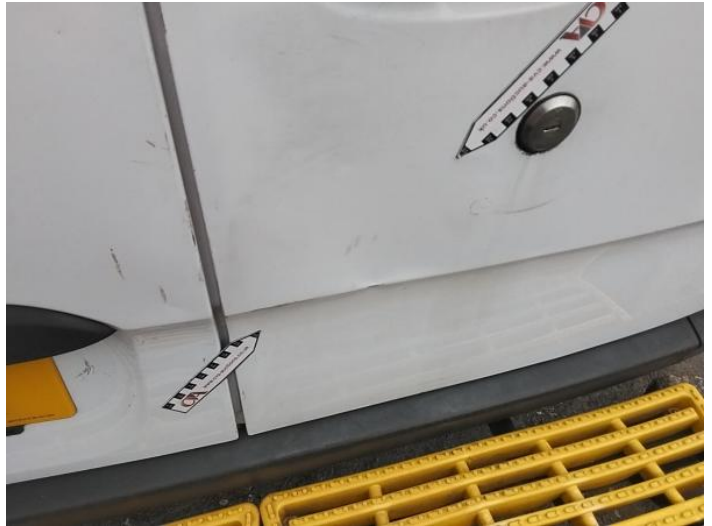
16: Door osr
Dented
Over 30mm

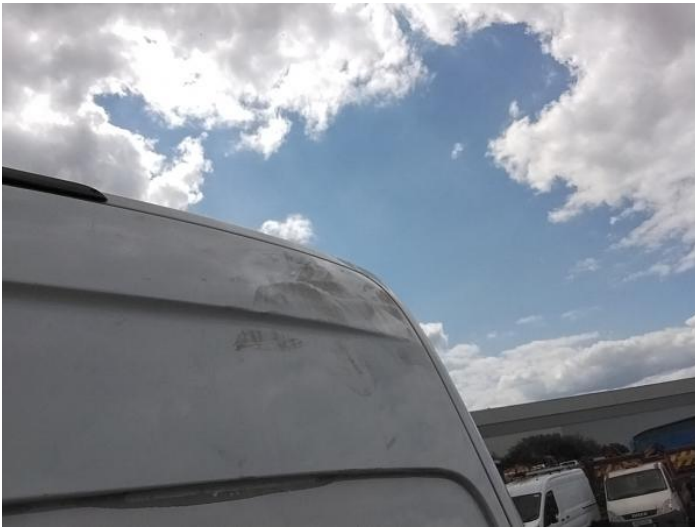
17: Door osr
Dented
Over 30mm

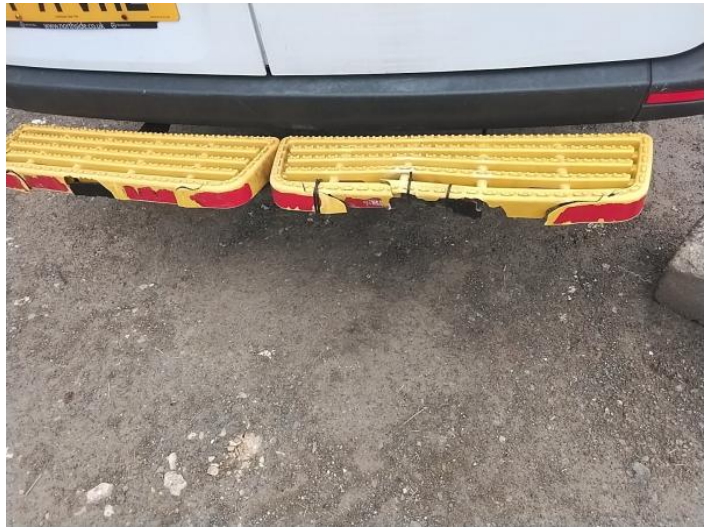
18: Bumper Rear Moulding
Broken
Replace

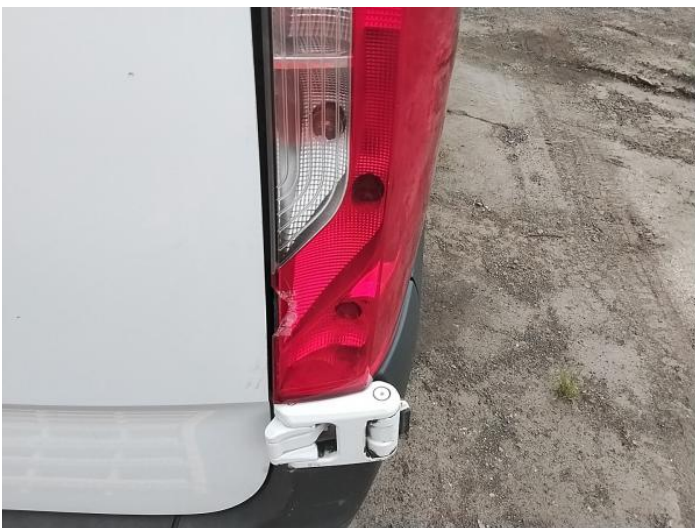
19: Lamp osr
Broken
Replace

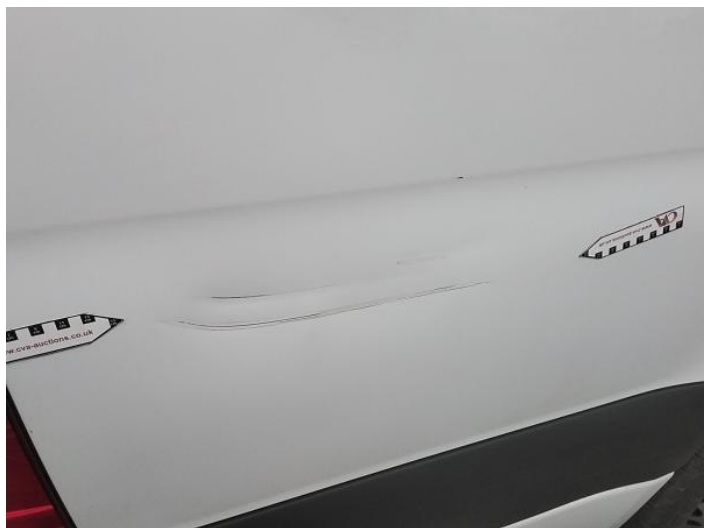
20: Qtr Panel osr
Dented
Over 30mm

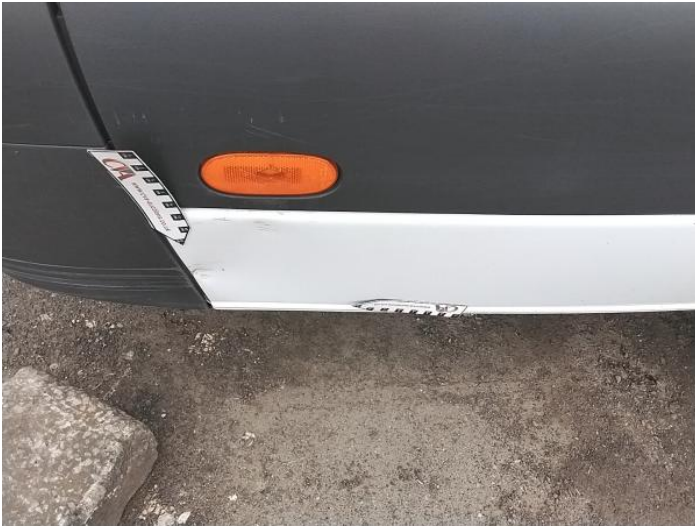
21: Qtr Panel osr
Dented
Over 30mm

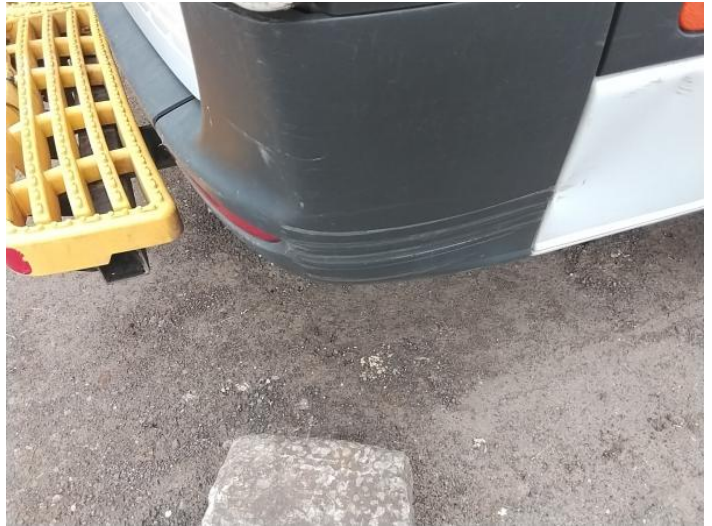
22: Bumper Rear Moulding
Scuffed (Unpainted)
Over 100mm

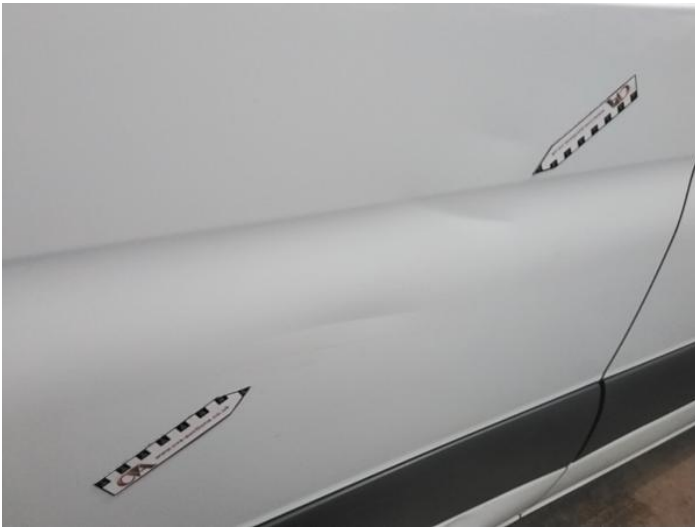
23: Qtr Panel osr
Dented
Over 30mm

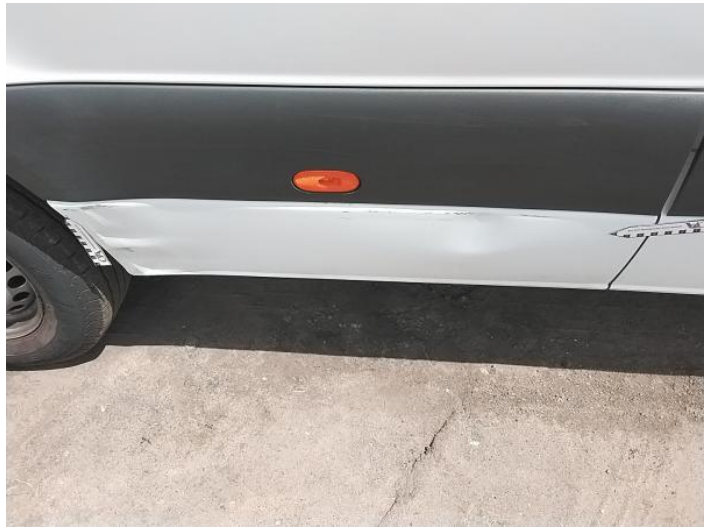
24: Qtr Panel osr
Dented
Over 30mm

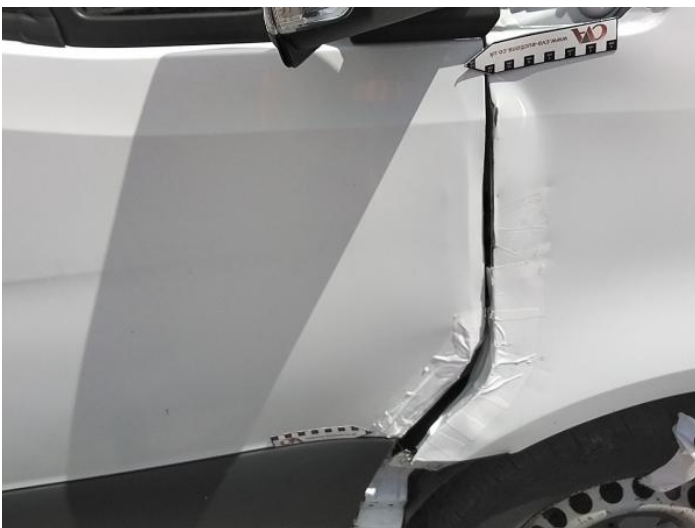
25: Door osf
Dented
Over 30mm

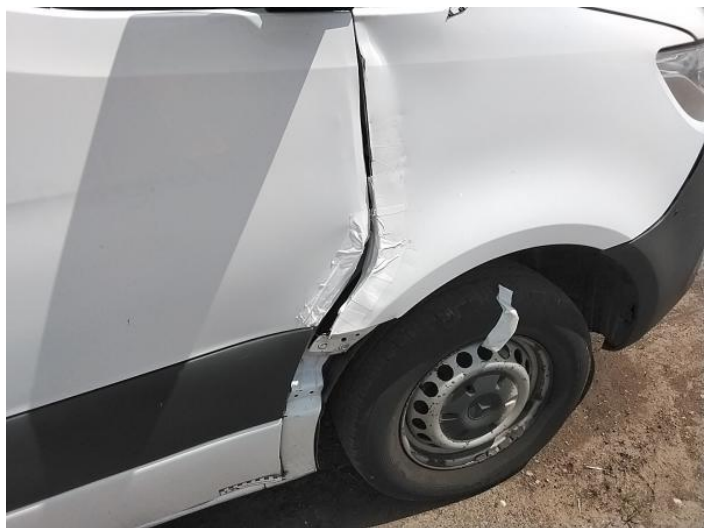
26: Wing osf
Dented
Over 30mm

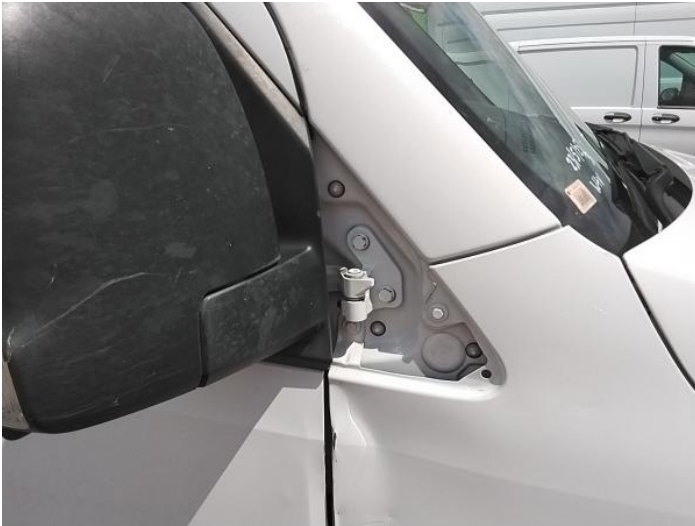
27: Door Moulding osf
Missing
Replace

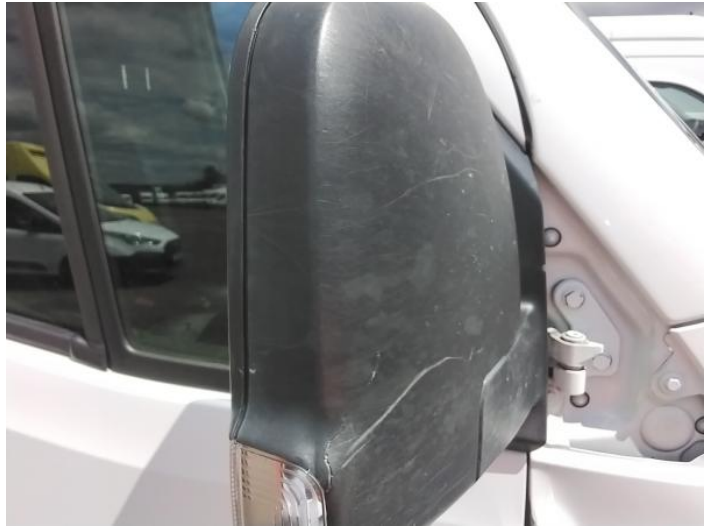
28: Door Mirror Assy osf
Broken
Replace

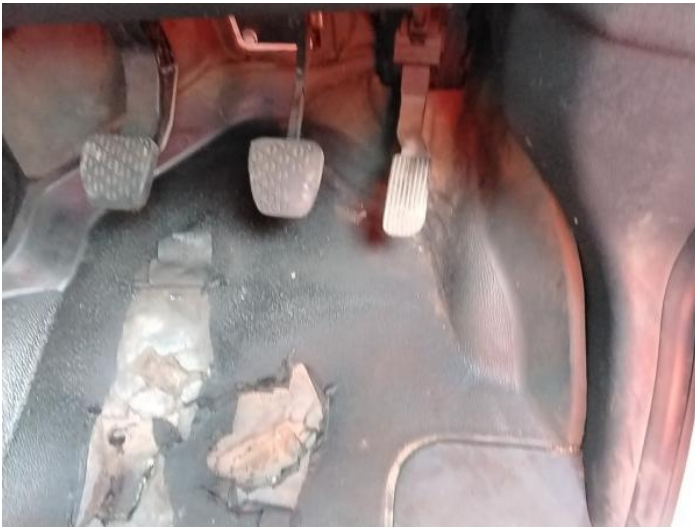
29: Carpets Front
Holed
Over 3mm

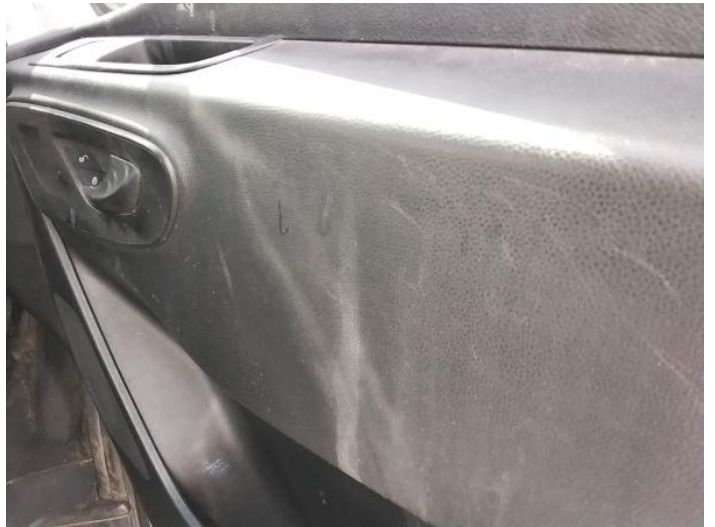
30: Door Pad osf
Soiled
Heavy

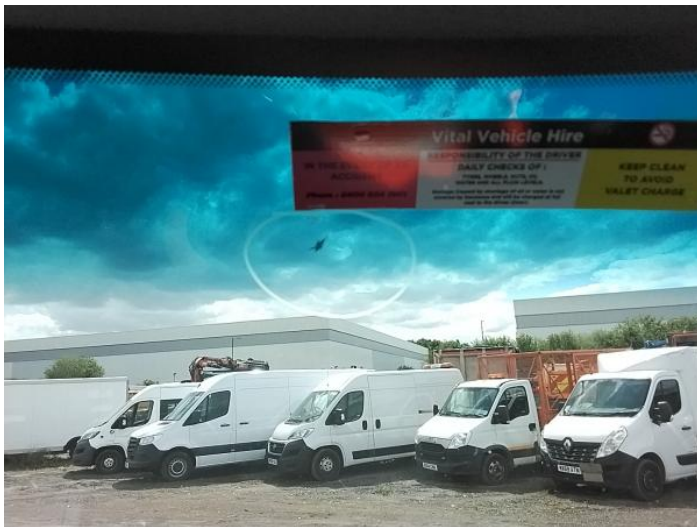
33: Screen Front
Chipped
Over 10mm

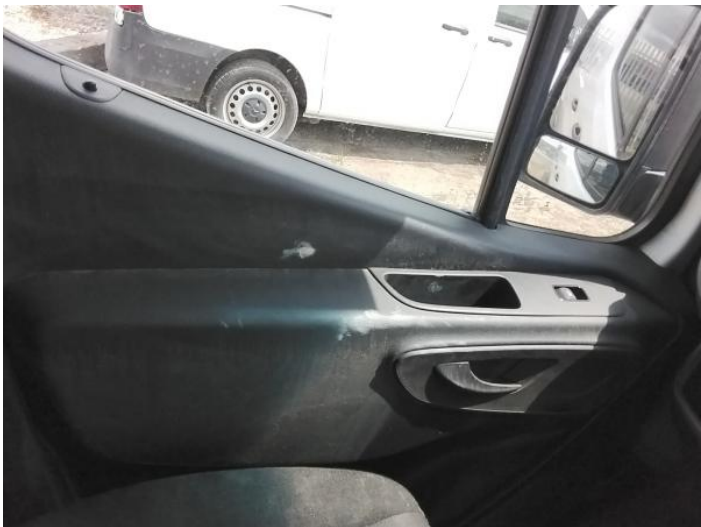
34: Door Pad nsf
Soiled
Heavy

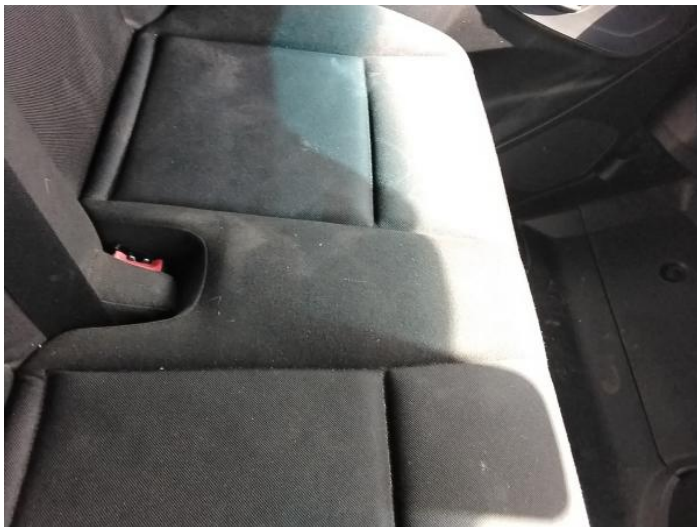
35: Seat Base Cover nsf
Soiled
Heavy
