VEHICLE INSPECTION REPORT

HD19NTN

Land Rover Discovery 3.0 SDV6 306 HSE

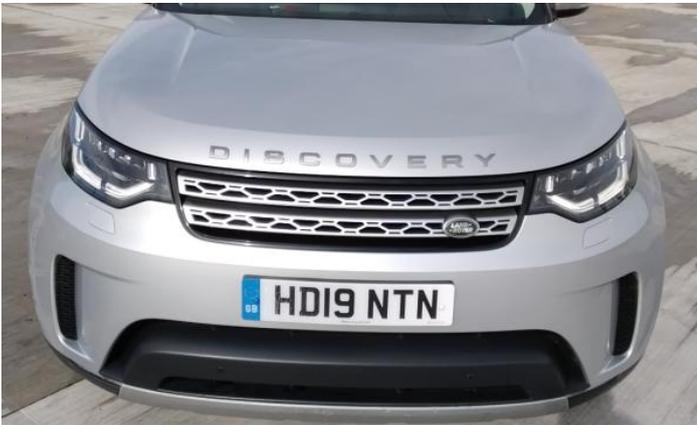
1: Bonnet
Chipped
Multiple Chips

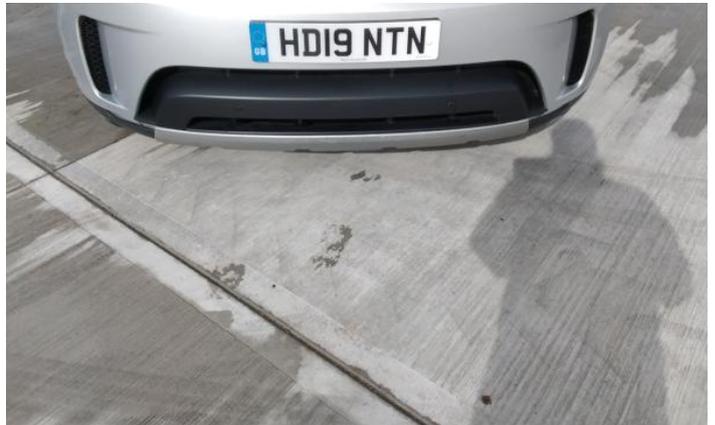
2: Bumper Front
Chipped
Multiple Chips

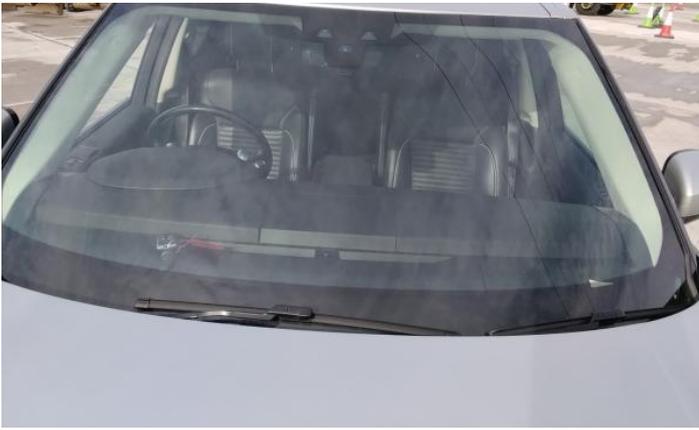
3: Screen Front
Cracked
Replace

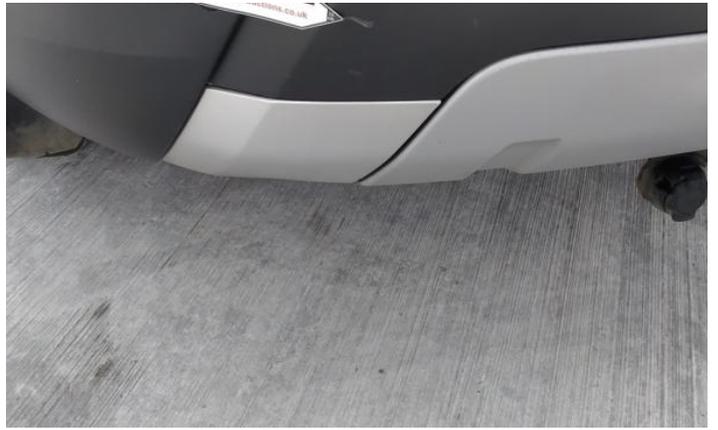
4: Bumper Rear
Scratched
25 to 100mm Thru Paint

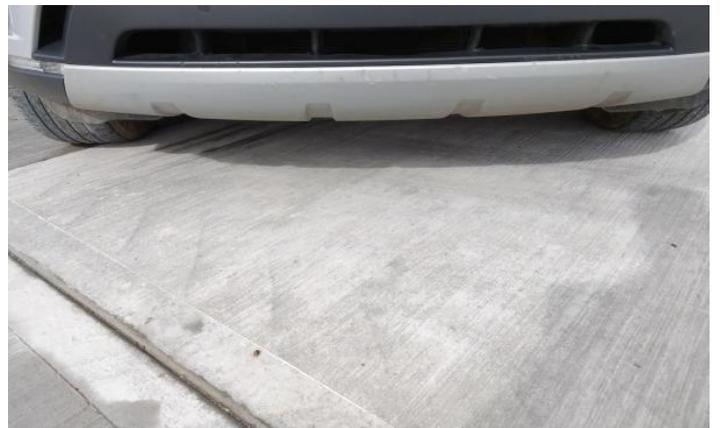
6: Bumper Front Moulding
Scratched (Painted)
Over 25mm Thru Paint

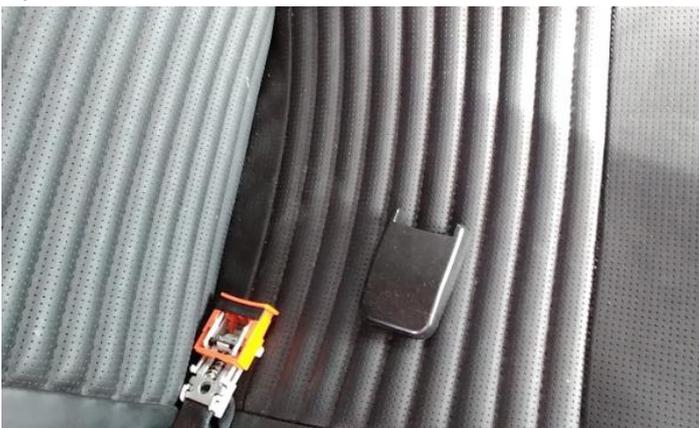
7: Seat Belt nsr
Broken
Replace

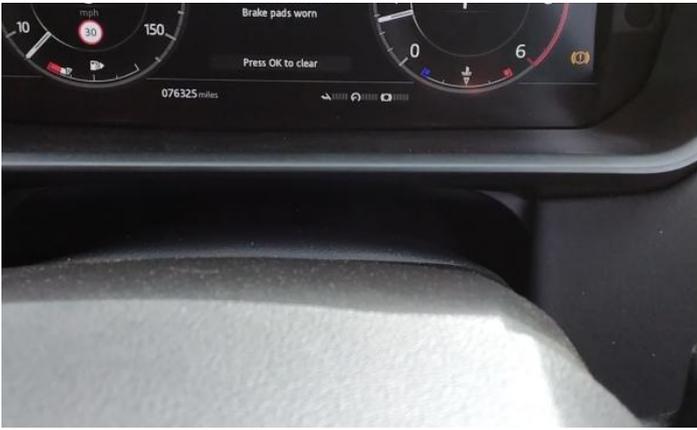
WARNING LIGHTS ON DASH KEYLESS IGNITION, E/ MIRRORS

9: Dash Warning Lights
 Displayed
 No Action
