VEHICLE INSPECTION REPORT

WX18XPF

Mercedes-Benz Sprinter 314 CDI

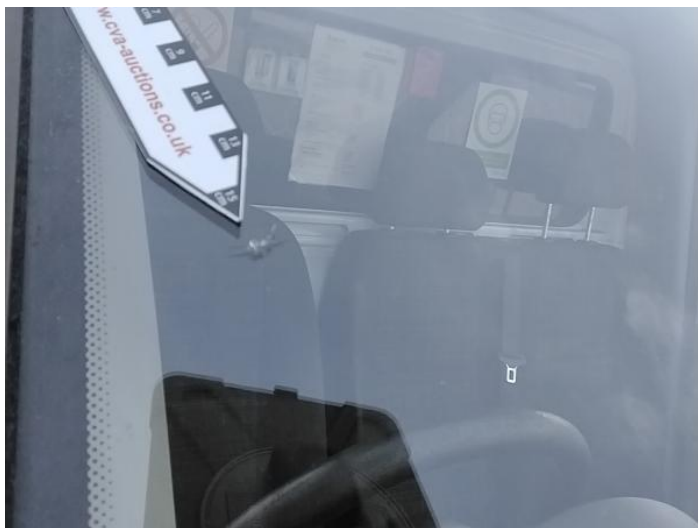
1: Screen Front
Chipped
Over 10mm

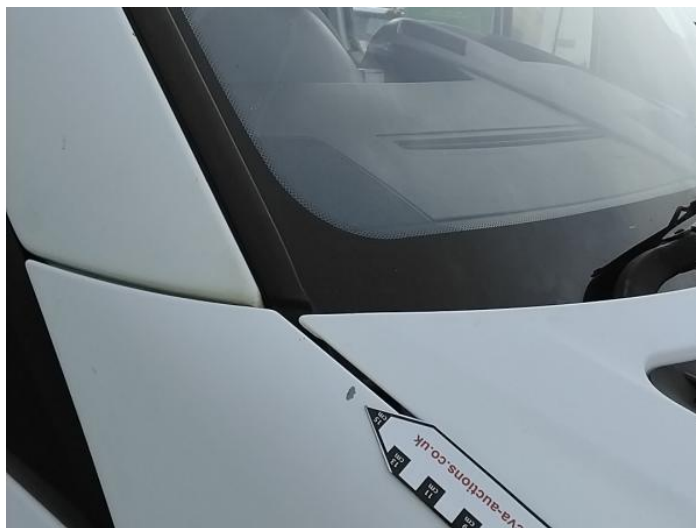
2: Wing osf
Chipped
Multiple Chips

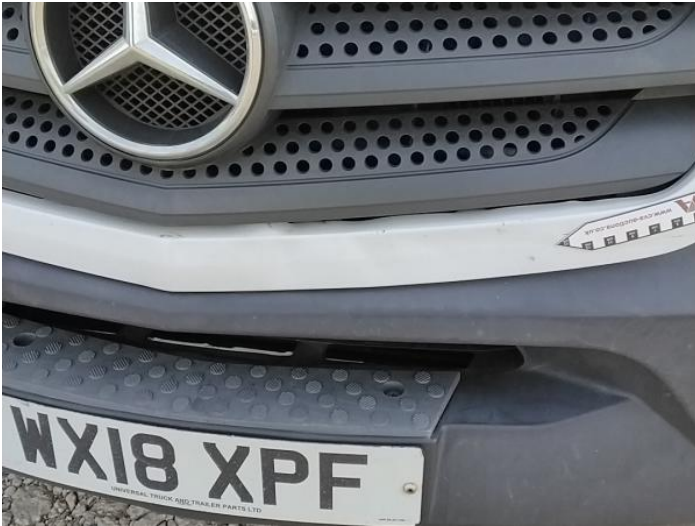
3: Panel Front
Dented
Over 30mm

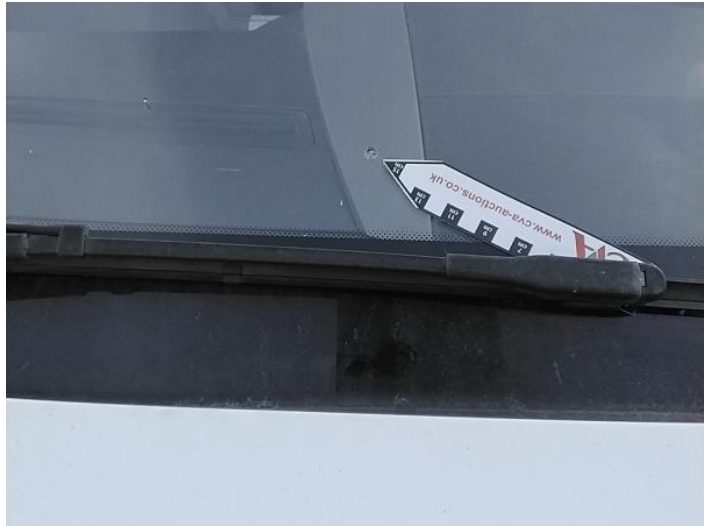
4: Screen Front
Chipped
Over 10mm

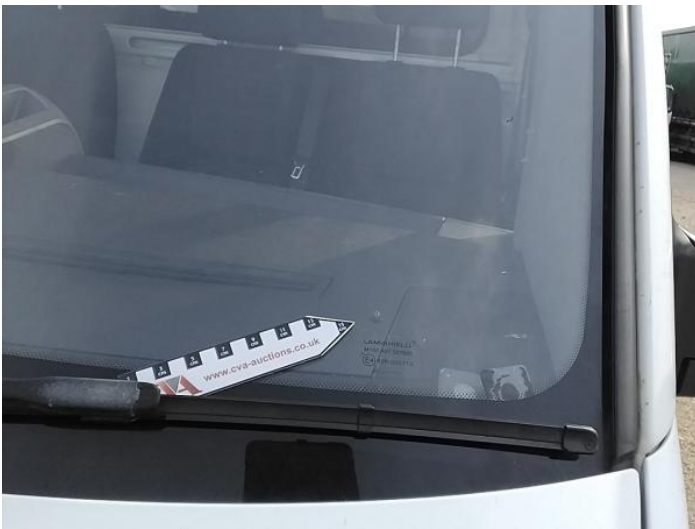
5: Screen Front
Chipped
Over 10mm

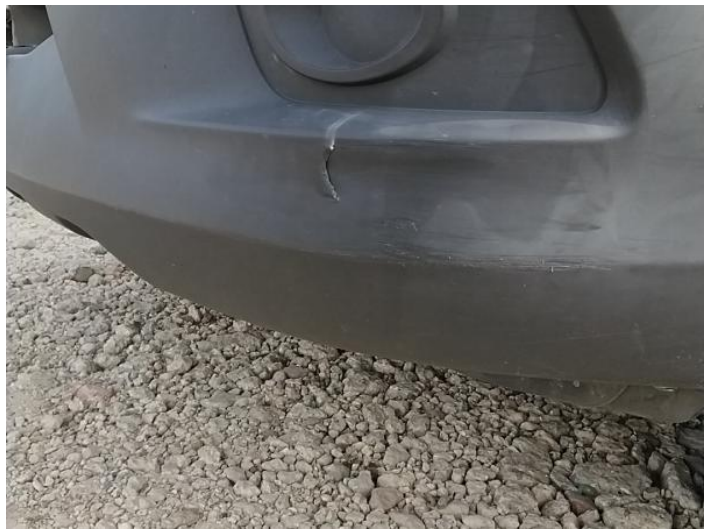
6: Bumper Front
Hole
Over 25mm

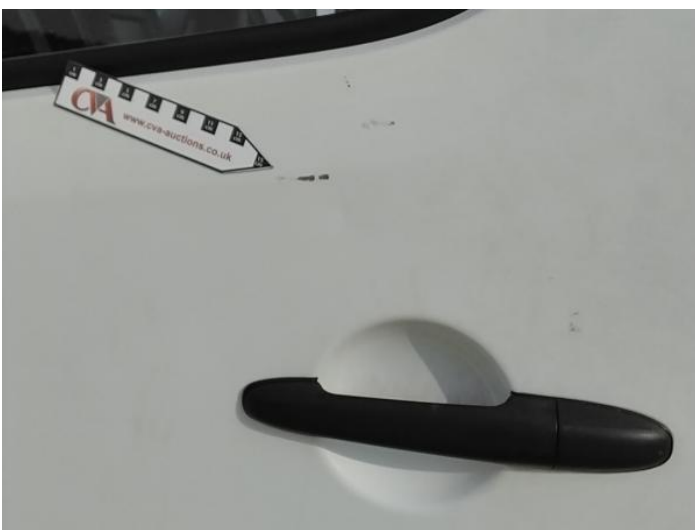
7: Door nsf
Scratched
Over 25mm Thru Paint

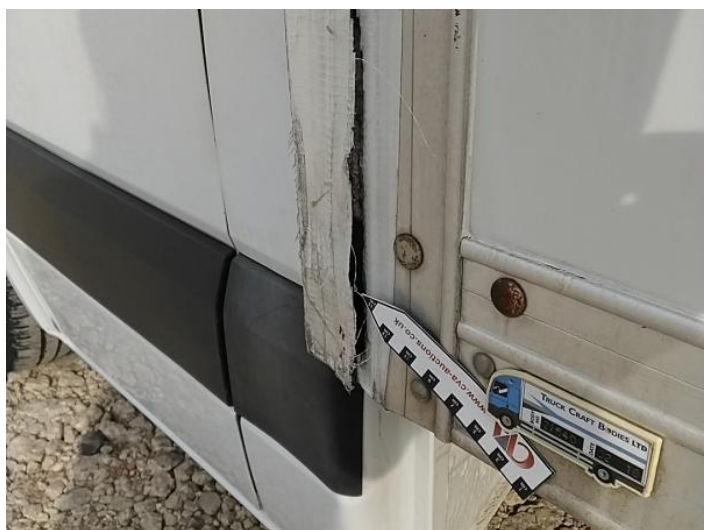
8: General Exterior
Soiled
Light

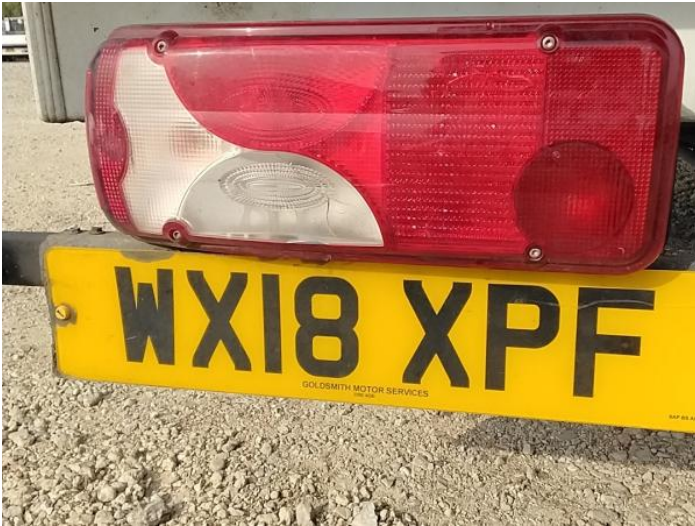
9: Lamp nsr
Broken
Replace

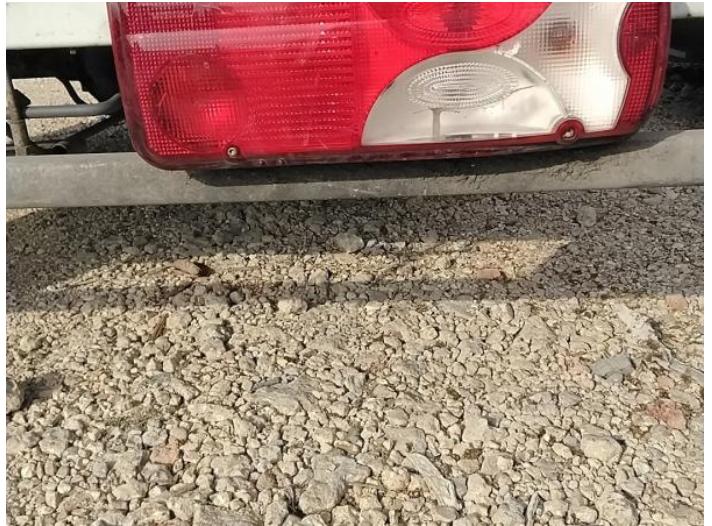
10: Lamp osr
Broken
Replace

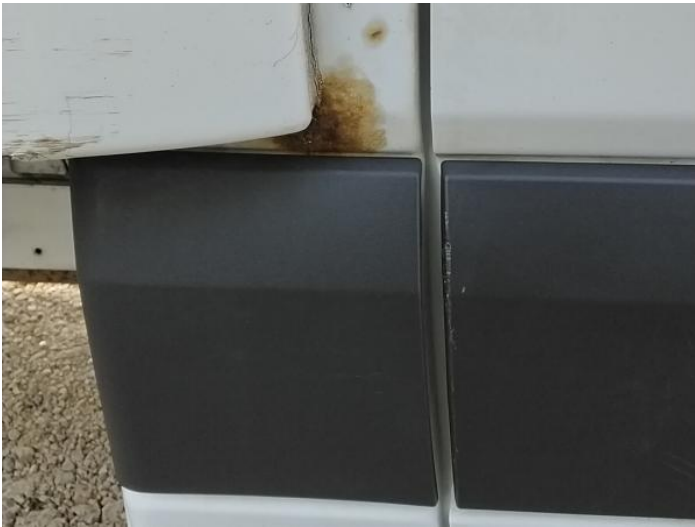
11: B Post os
Rusted
Over 5mm

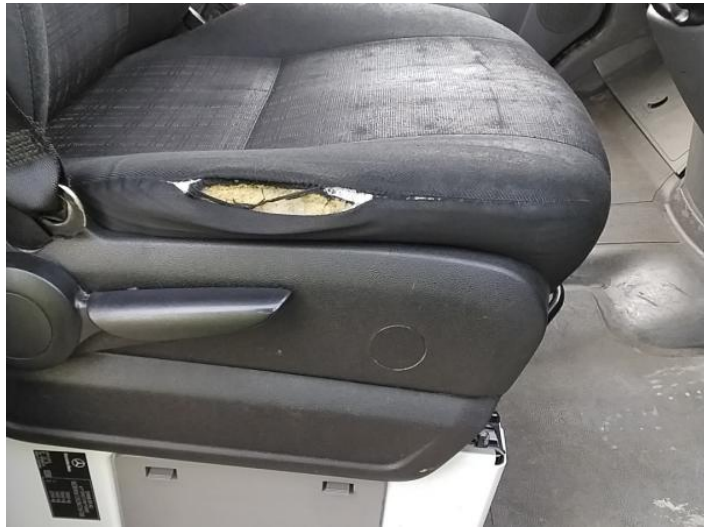
12: Seat Base Cover osf
Holed
Over 3mm

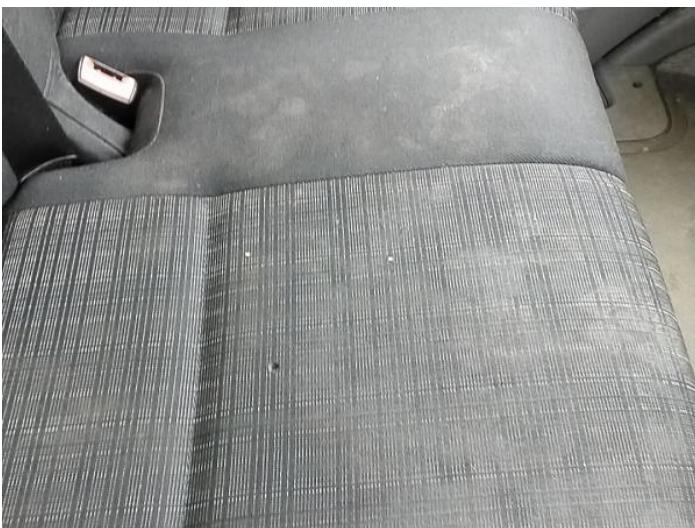
13: Seat Base Cover nsf
Holed
Over 3mm
