VEHICLE INSPECTION REPORT

PJ20ZZT

Mercedes-Benz Sprinter 314 CDI

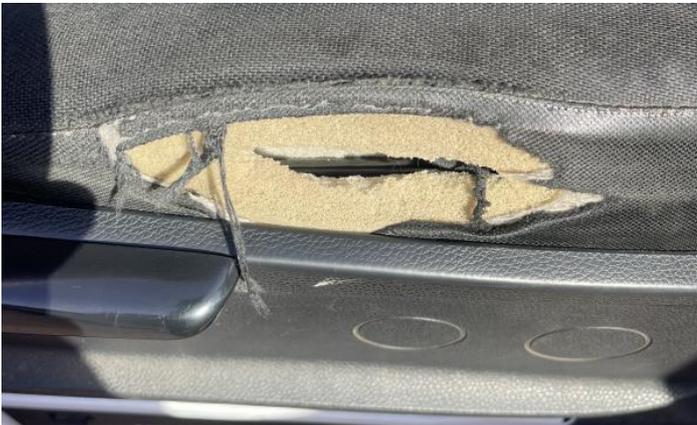
1: Seat Base Cover of
Torn
Over 3mm

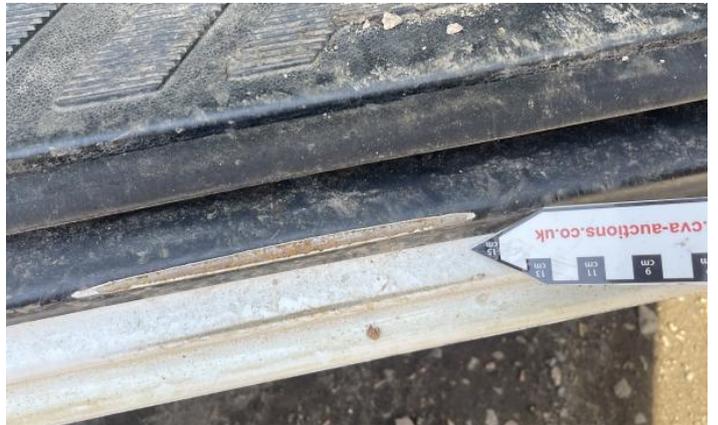
2: Sill os
Rusted
Over 5mm

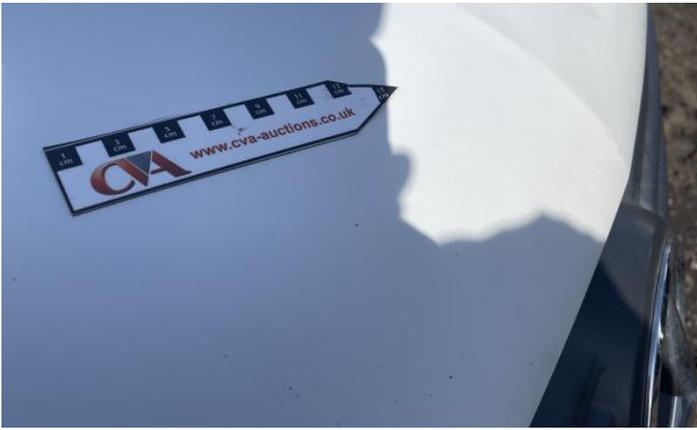
3: Bonnet
Dented
With Paint Damage

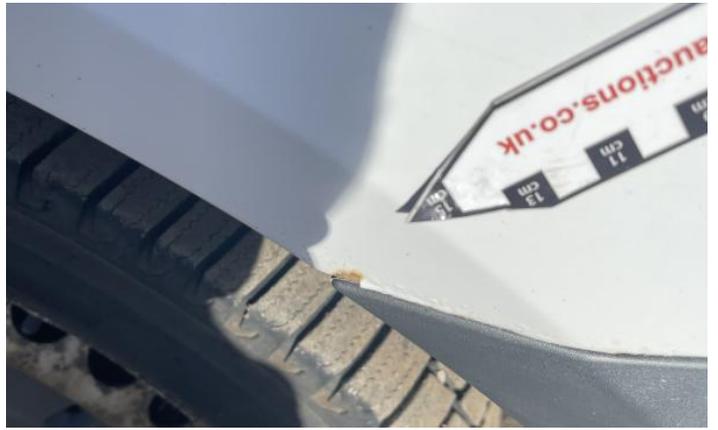
4: Wing nsf
Rusted
Over 5mm

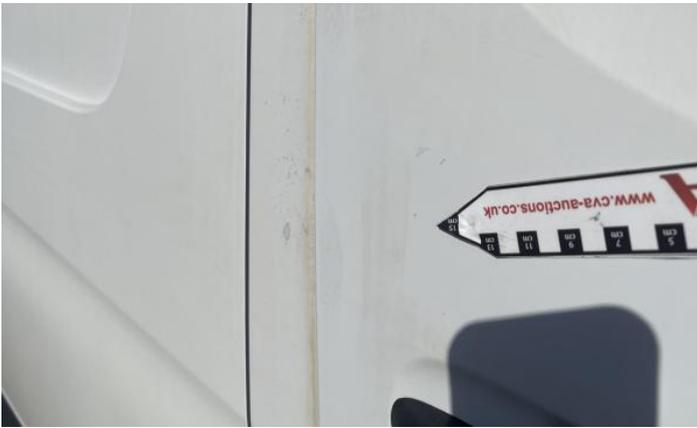
5: Door osf
Dented
With Paint Damage

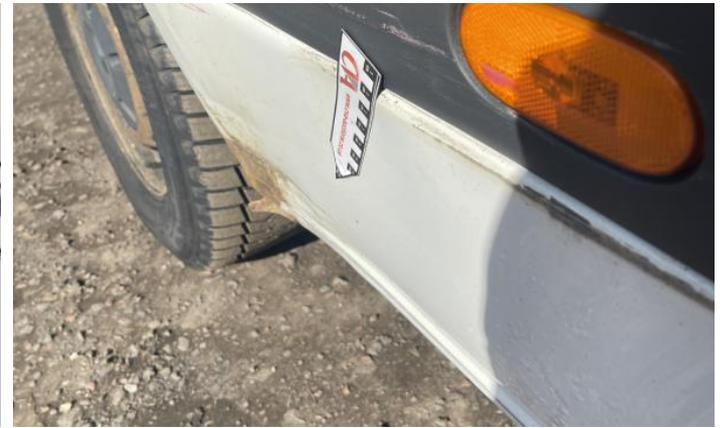
6: Qtr Panel osr
Dented
With Paint Damage

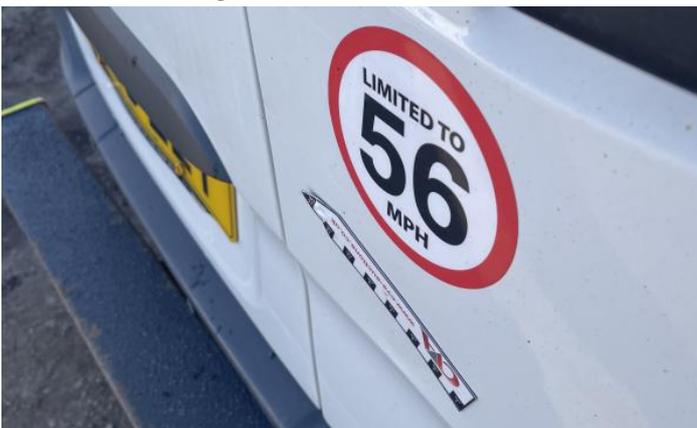
7: Tailgate
Dented
With Paint Damage

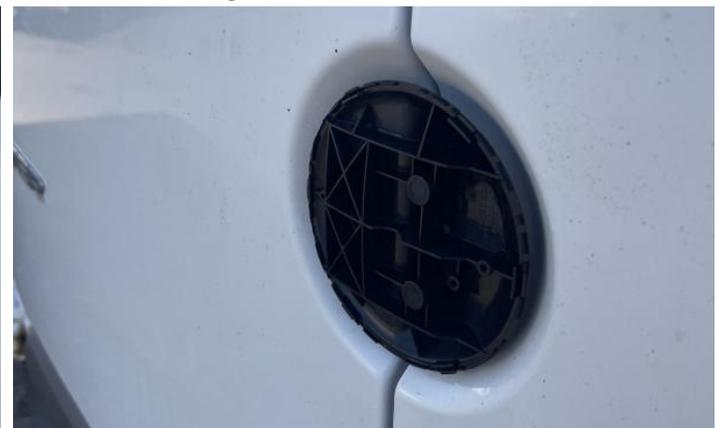
8: Badgedecal Rear
Broken
Replace

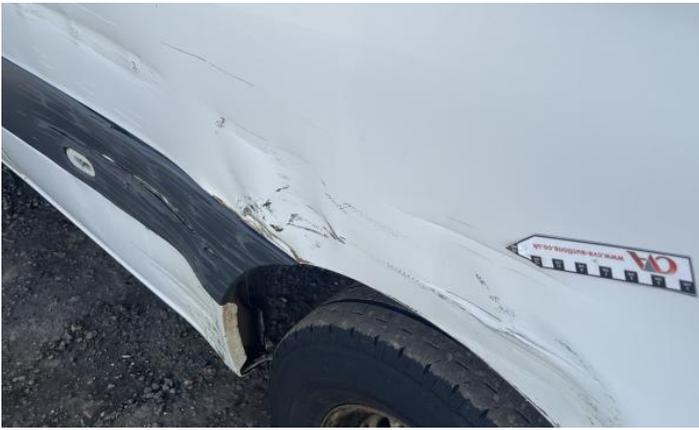
9: Qtr Panel nsr
Dented
With Paint Damage

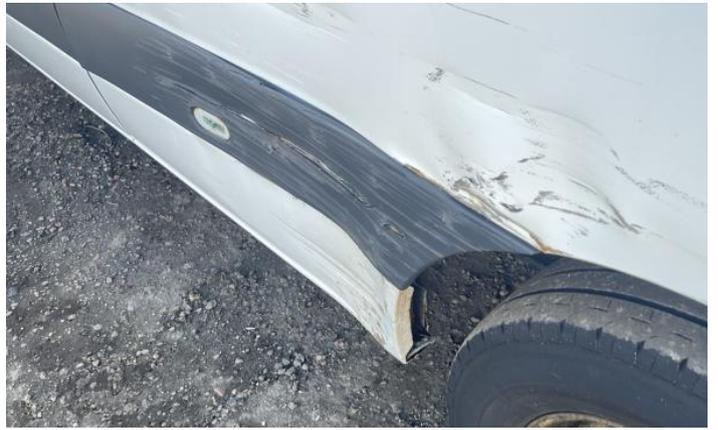
10: Qtr Panel Moulding ns
Broken
Replace

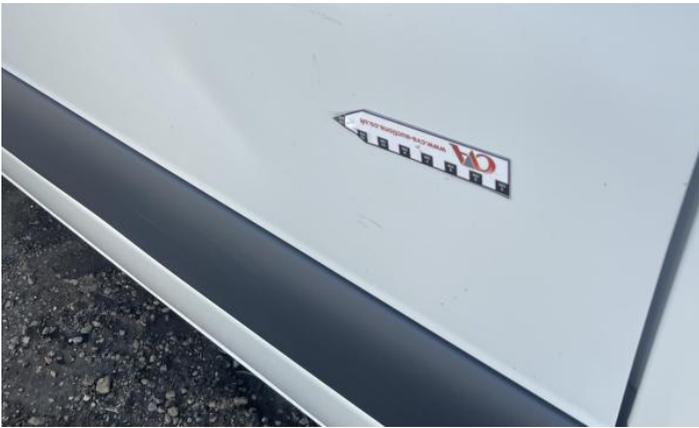
11: Door nsr
Dented
With Paint Damage

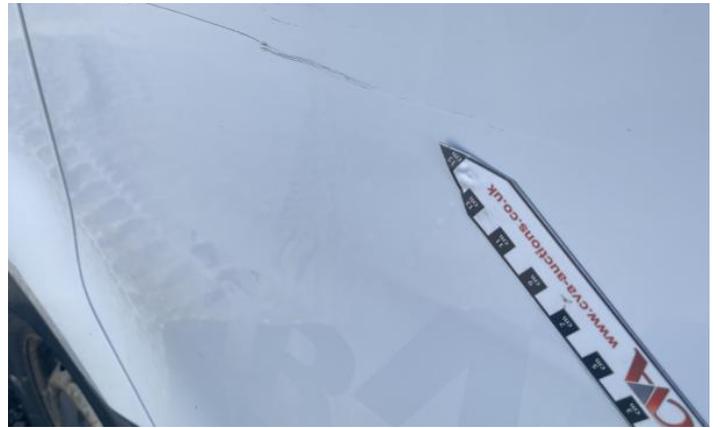
12: Door nsf
Dented
With Paint Damage

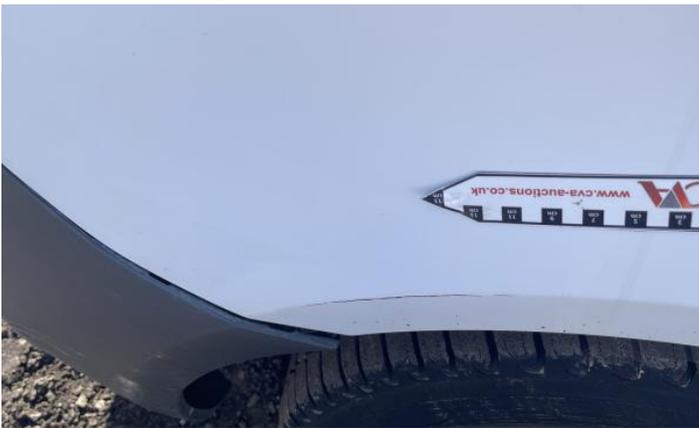
13: Wing nsf
Dented
Over 30mm

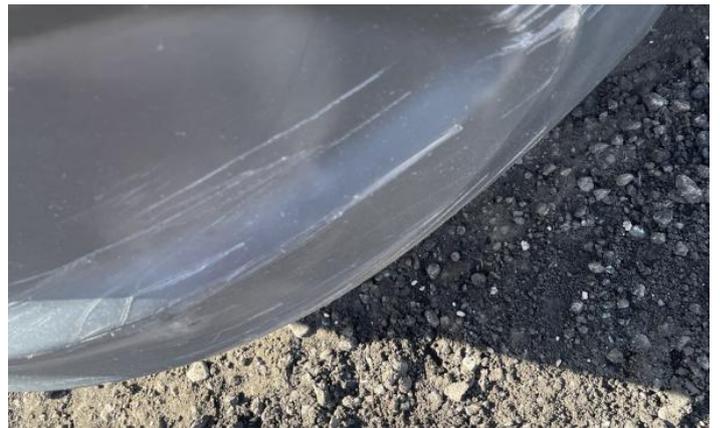
14: Bumper Front Moulding
Scuffed (Unpainted)
Over 100mm

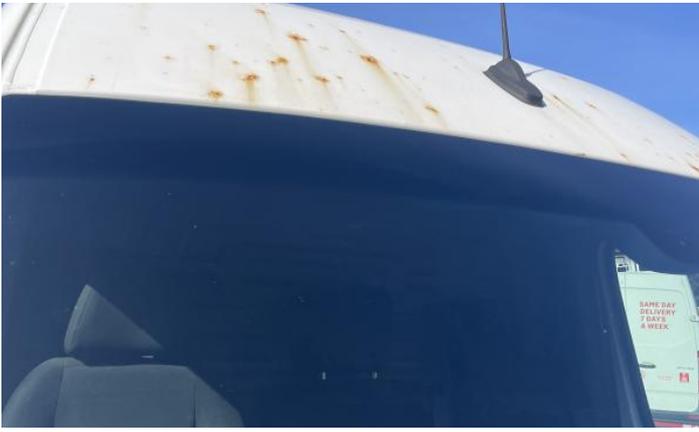
15: Roof
Rusted
Over 5mm
