VEHICLE INSPECTION REPORT

PJ20BNY

Mercedes-Benz Sprinter 314 CDI

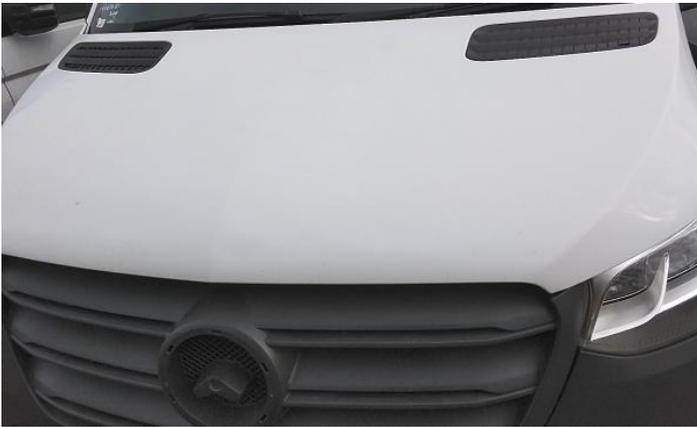
1: Bonnet
Chipped
Multiple Chips

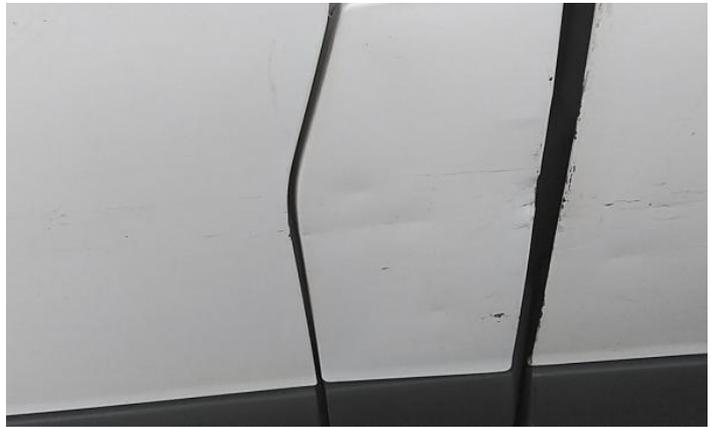
2: Fuel Flap
Dented
Over 30% Of Panel

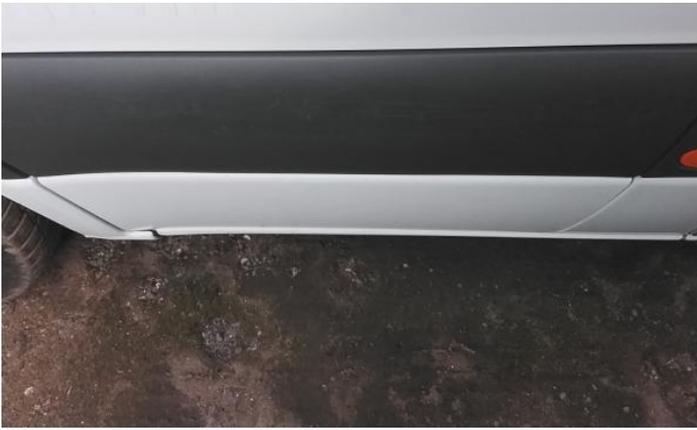
3: Door Moulding nsf
Scuffed (Unpainted)
Over 100mm

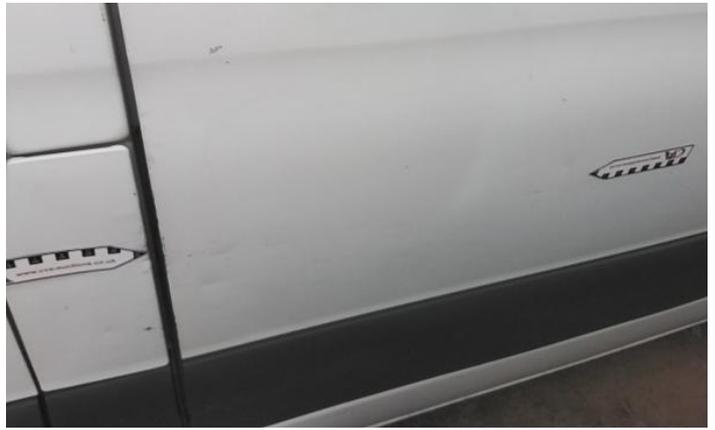
4: Qtr Panel nsr
Dented
With Paint Damage

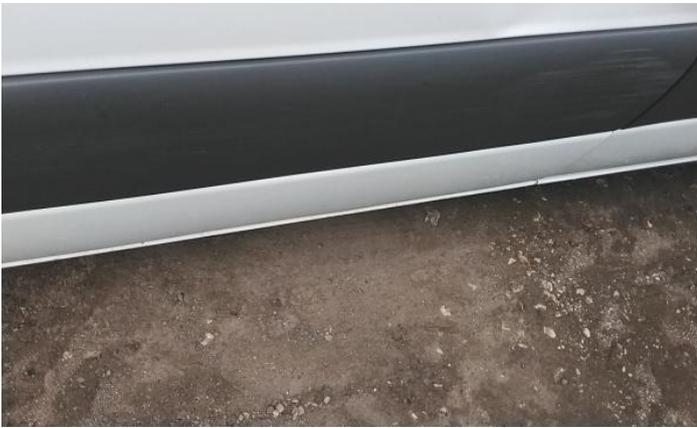
5: Qtr Panel Moulding ns
Scuffed (Unpainted)
Over 100mm

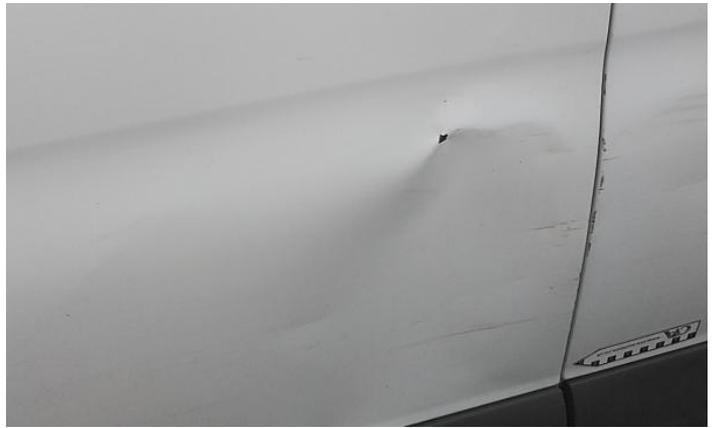
6: Qtr Panel nsr
Dented
With Paint Damage

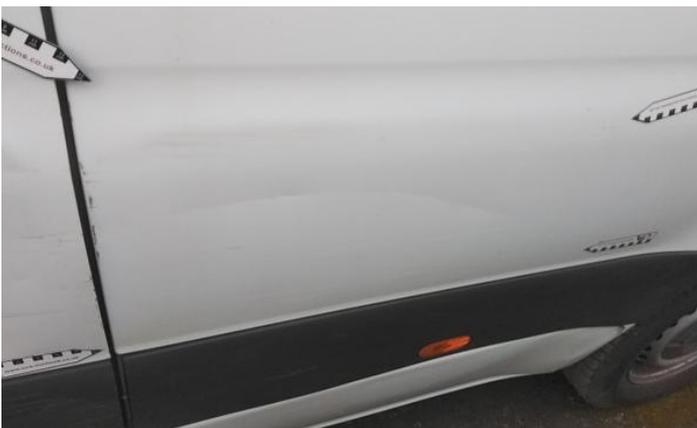
7: Qtr Panel nsr
Dented
With Paint Damage

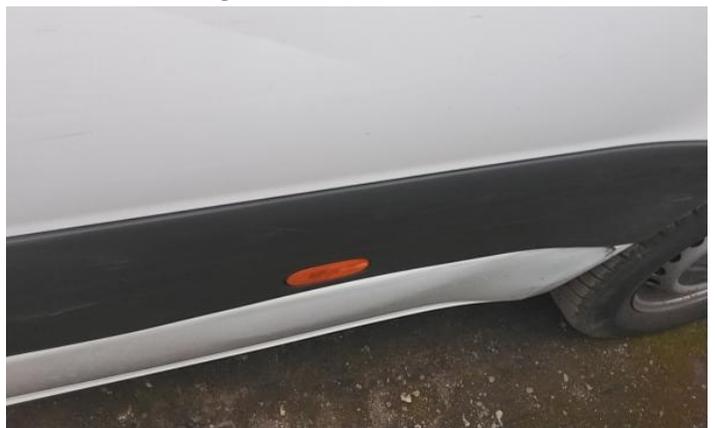
8: Qtr Panel Moulding ns
Scuffed (Unpainted)
Over 100mm

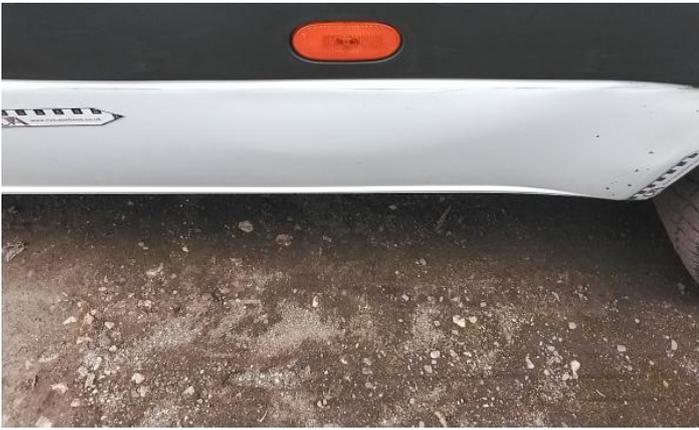
9: Qtr Panel nsr
Dented
Over 30mm

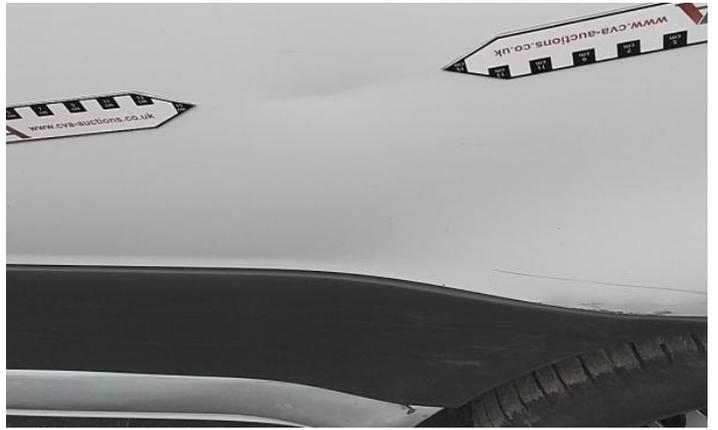
10: Qtr Panel nsr
Dented
Over 30mm

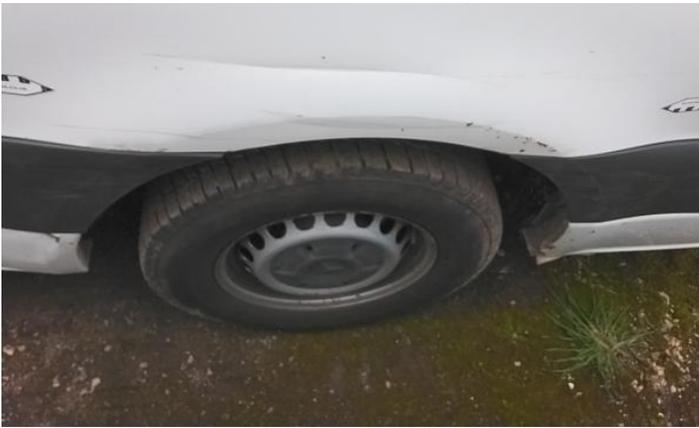
11: Qtr Panel nsr
Dented
With Paint Damage

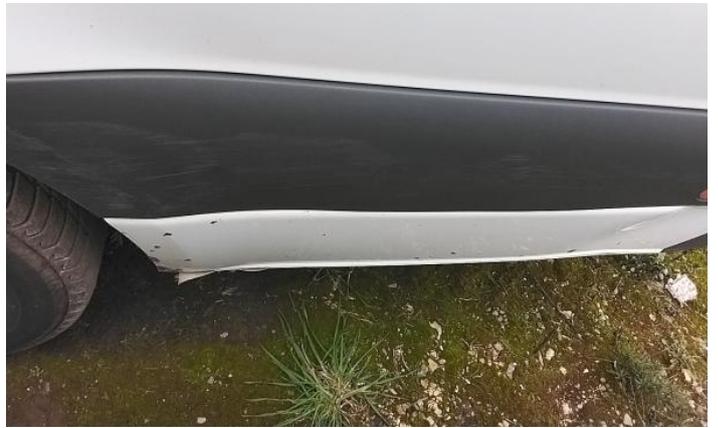
12: Qtr Panel Moulding ns
Scuffed (Unpainted)
Over 100mm

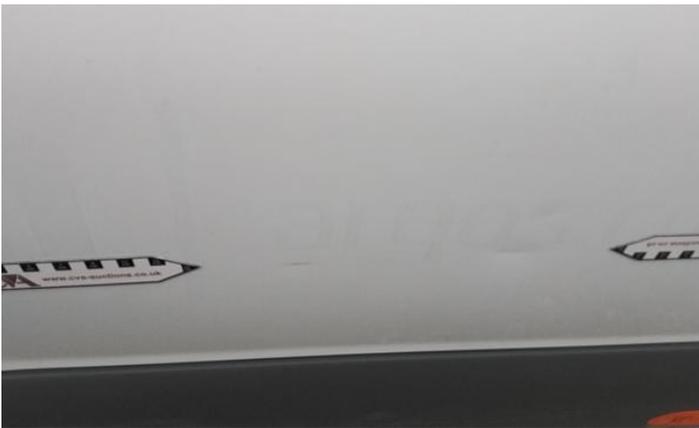
13: Qtr Panel nsr
Dented
With Paint Damage

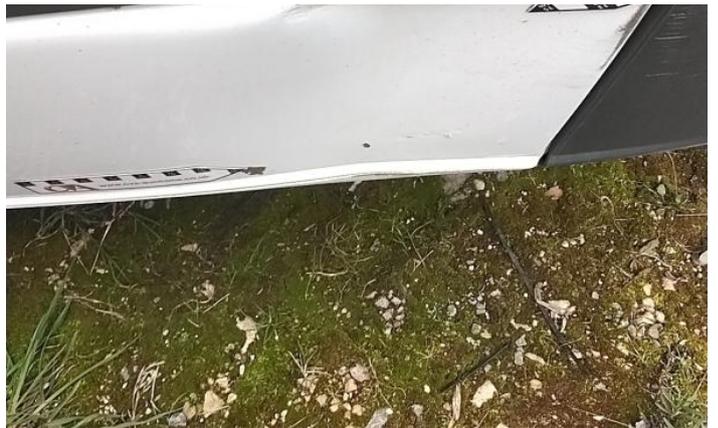
14: Qtr Panel nsr
Dented
With Paint Damage

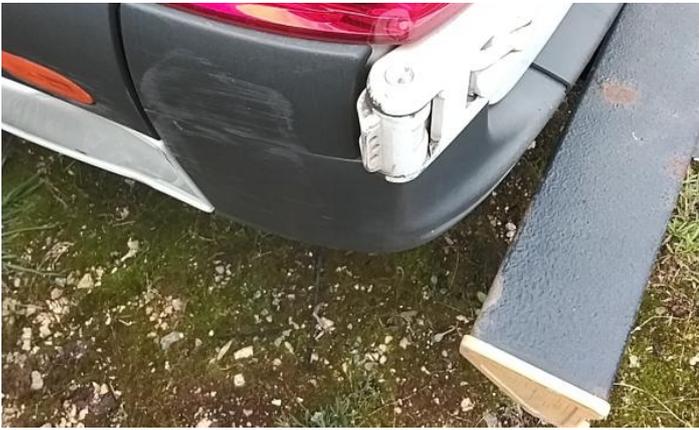
15: Bumper Rear Moulding
Scuffed (Unpainted)
Over 100mm

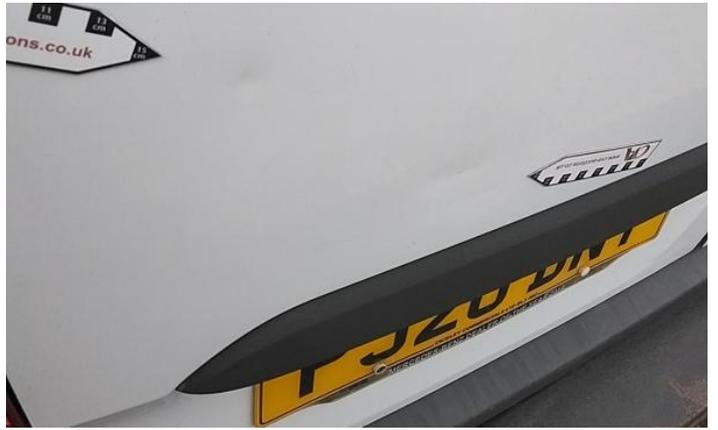
16: Door nsr
Dented
Over 30mm

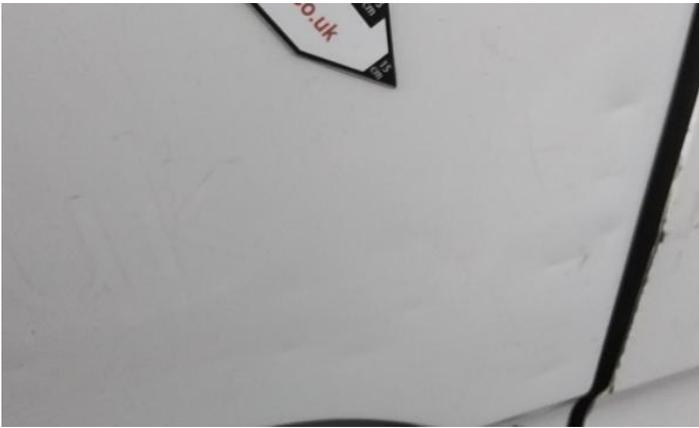
17: Door nsr
Dented
Over 30mm

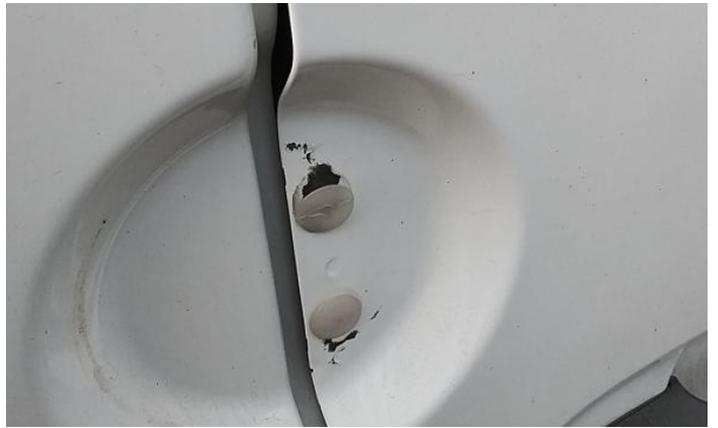
18: Badgedecal Rear
Missing
Replace

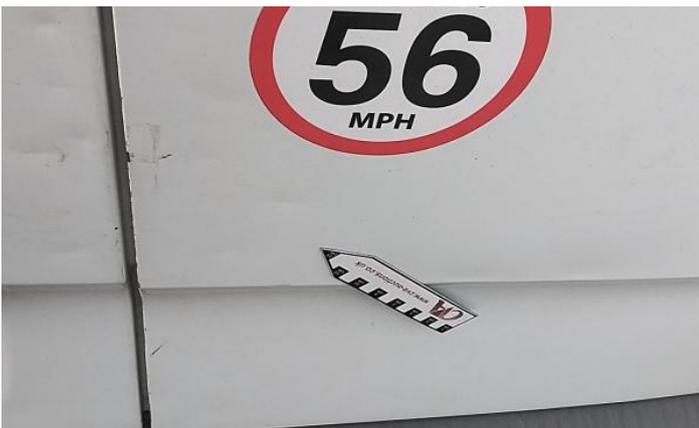
19: Door osr
Dented
Over 30mm

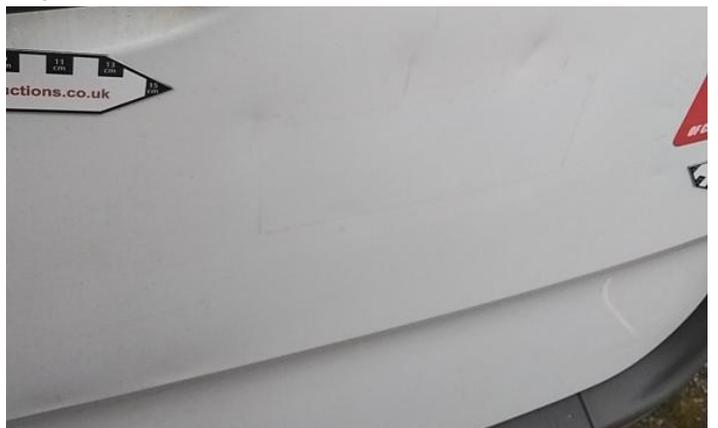
20: Door osr
Dented
Over 30mm

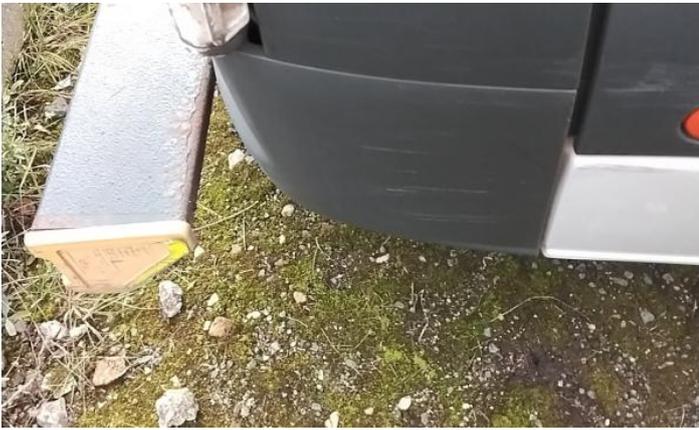
21: Bumper Rear Moulding
Scuffed (Unpainted)
Over 100mm

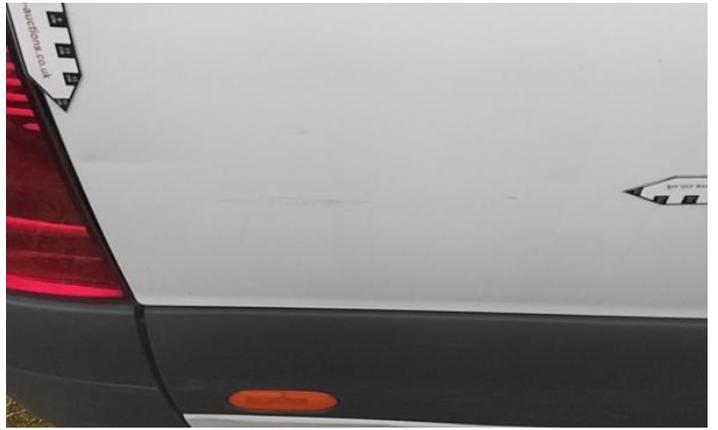
22: Qtr Panel osr
Dented
With Paint Damage

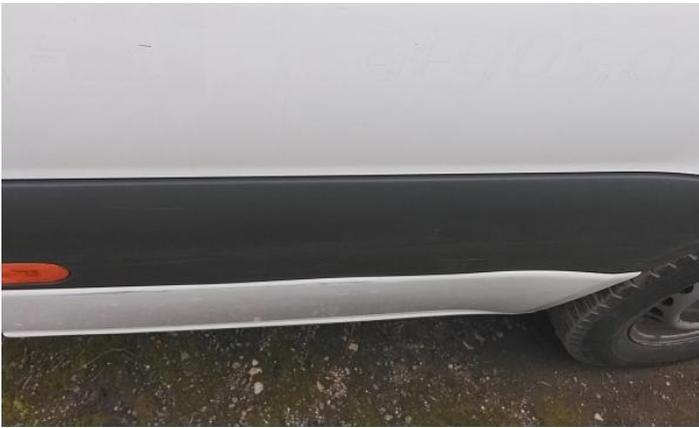
23: Qtr Panel Moulding os
Scuffed (Unpainted)
Over 100mm

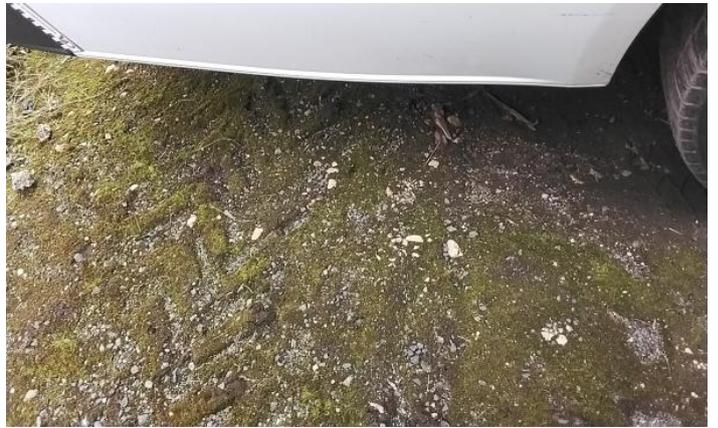
24: Qtr Panel osr
Dented
With Paint Damage

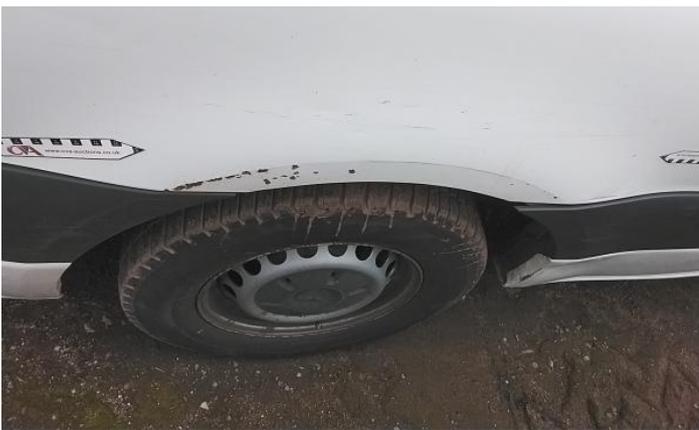
25: Qtr Panel osr
Dented
With Paint Damage

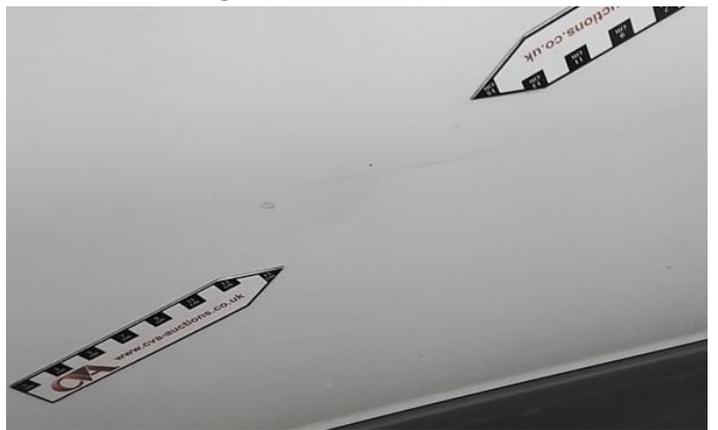
26: Qtr Panel osr
Dented
Over 30mm

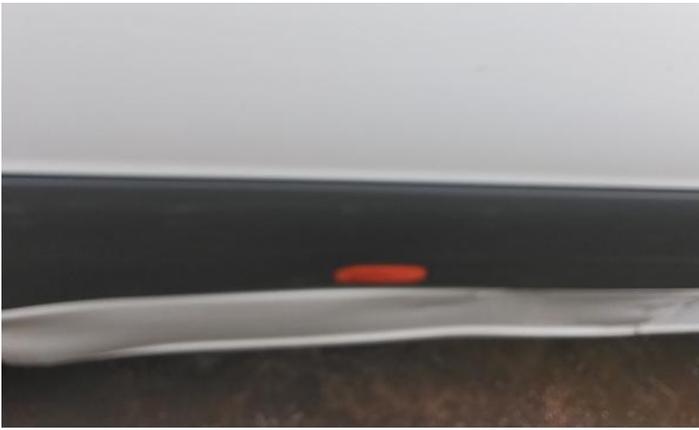
27: Qtr Panel Moulding os
Scuffed (Unpainted)
Over 100mm

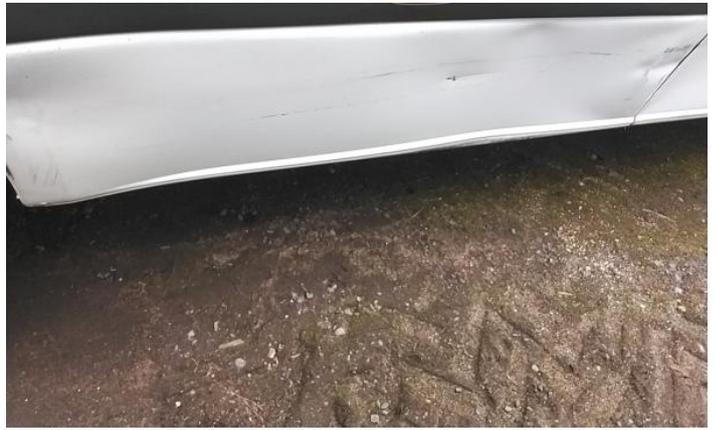
28: Qtr Panel osr
Dented
With Paint Damage

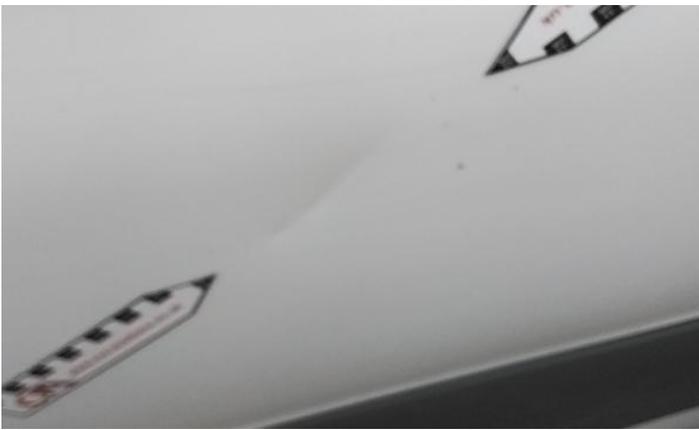
29: Qtr Panel osr
Dented
Over 30mm

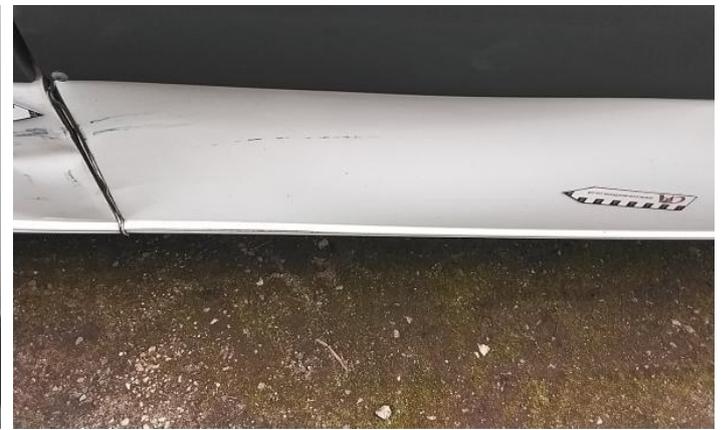
30: Qtr Panel osr
Dented
With Paint Damage

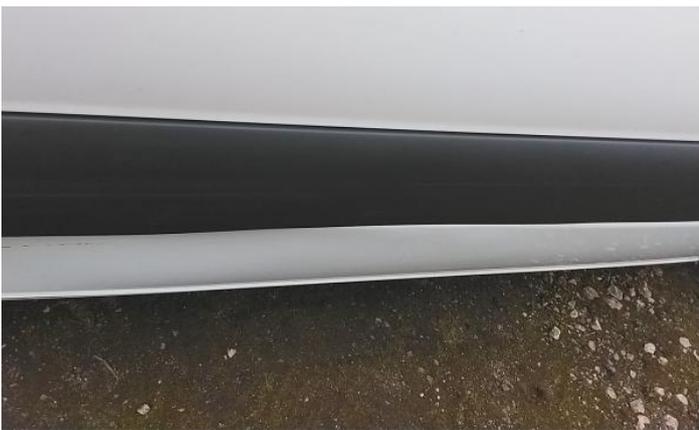
31: Qtr Panel Moulding os
Scuffed (Unpainted)
Over 100mm

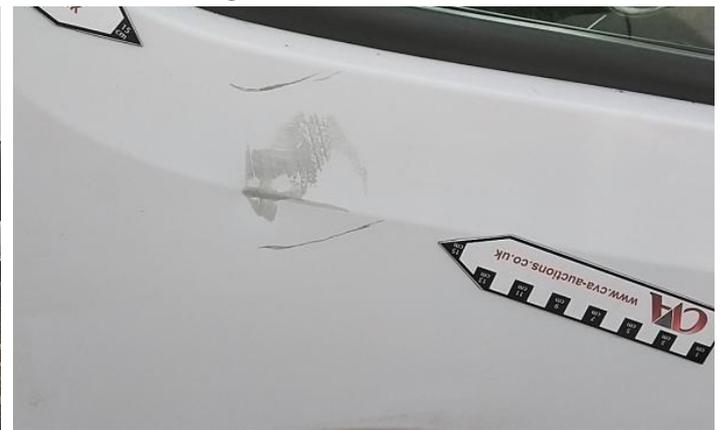
32: Door osf
Dented
With Paint Damage

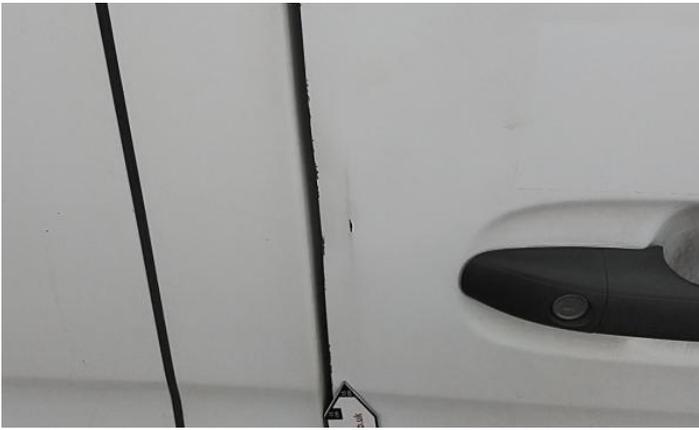
33: Door osf
Dented
With Paint Damage

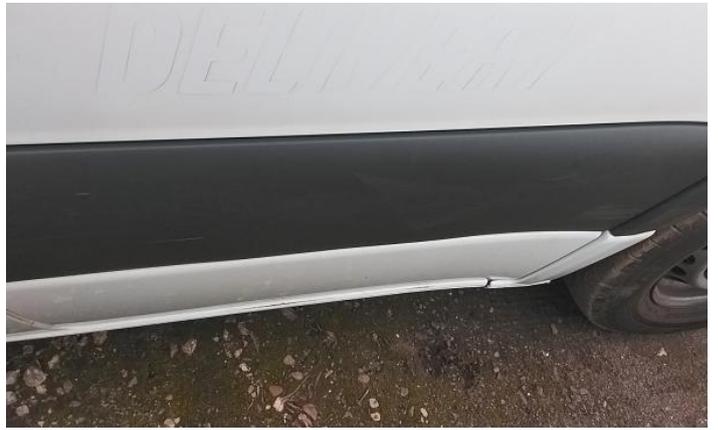
34: Door Moulding osf
Scuffed (Unpainted)
Over 100mm

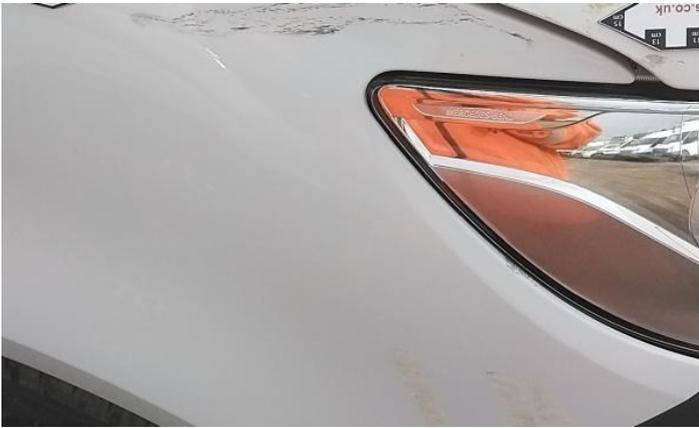
35: Wing osf
Dented
With Paint Damage

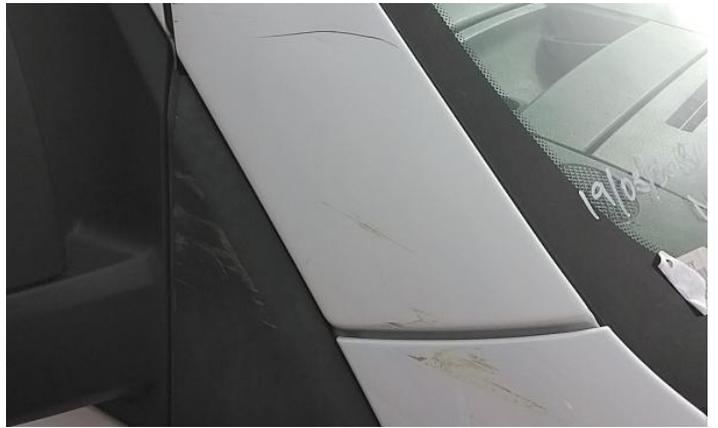
36: A Post osf
Dented
With Paint Damage

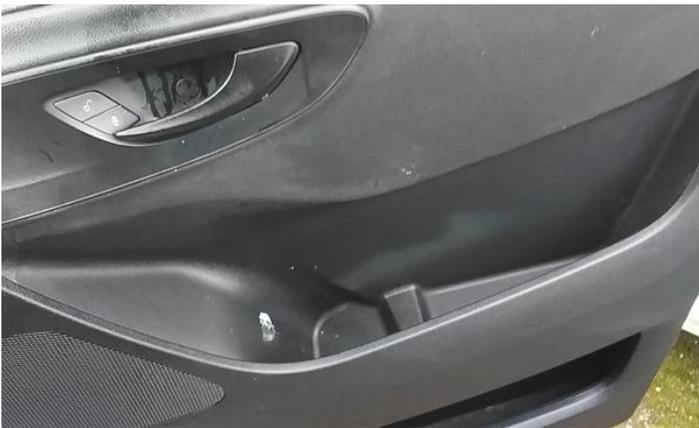
37: Door Pad osf
Soiled
Heavy

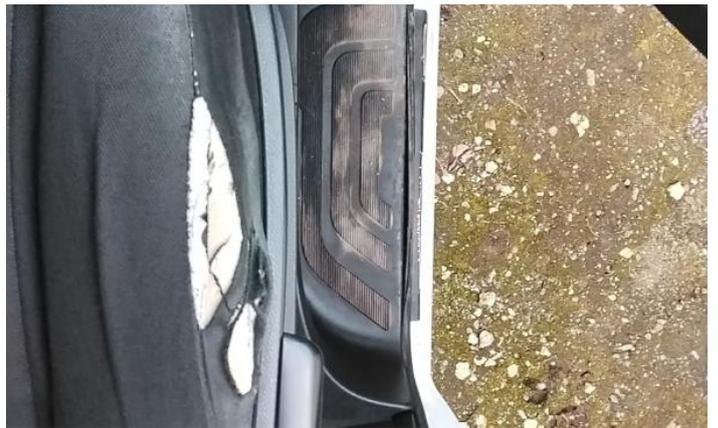
38: Seat Base Cover osf
Torn
Over 3mm

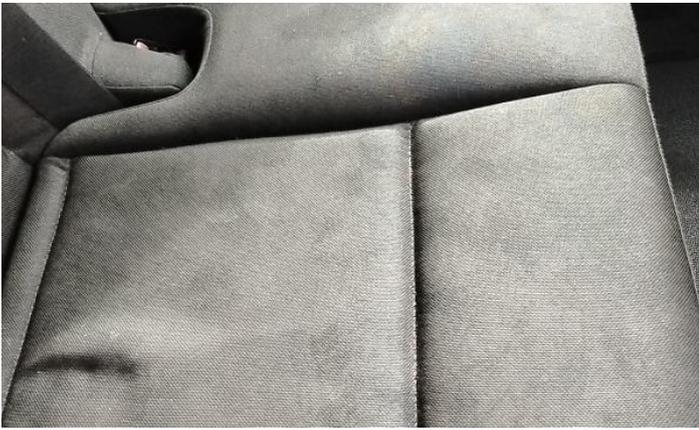
39: Seat Base Cover nsf
Soiled
Heavy

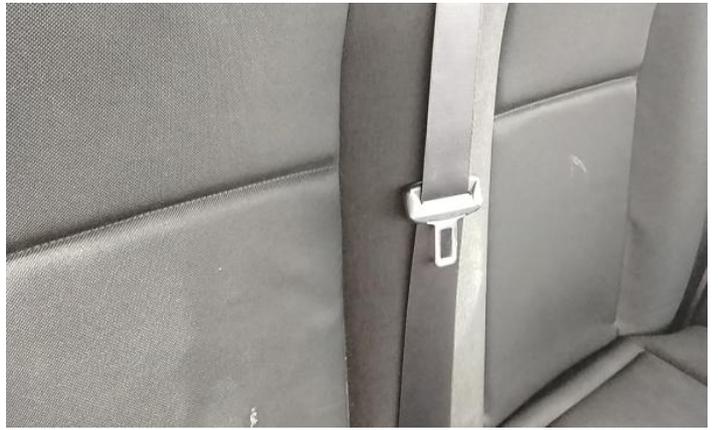
40: Seat Back Cover nsf
Soiled
Heavy
