VEHICLE INSPECTION REPORT

PJ20NEN

Mercedes-Benz Sprinter 314 CDI

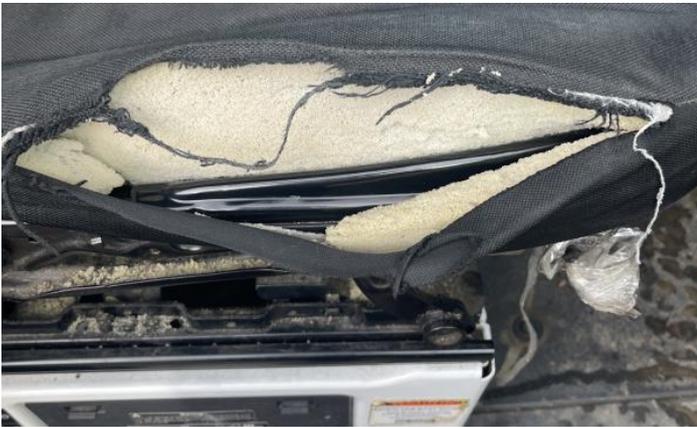
1: Seat Base Cover of
Torn
Over 3mm

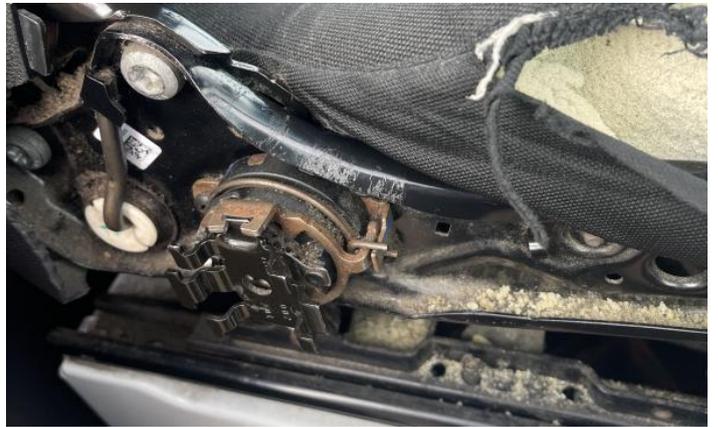
2: Seat Base Cover of
Missing
Replace

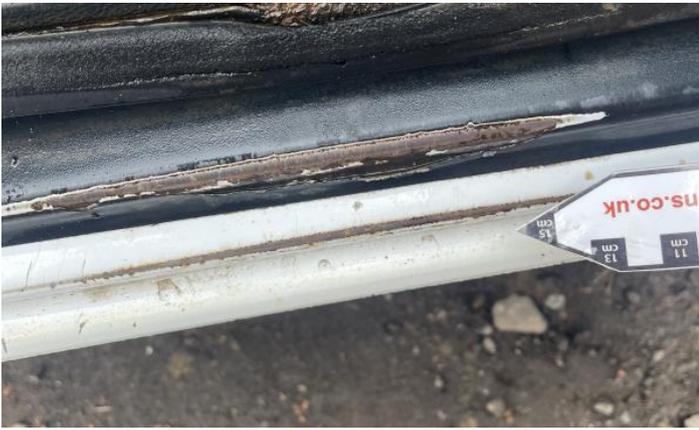
3: Sill os
Rusted
Over 5mm

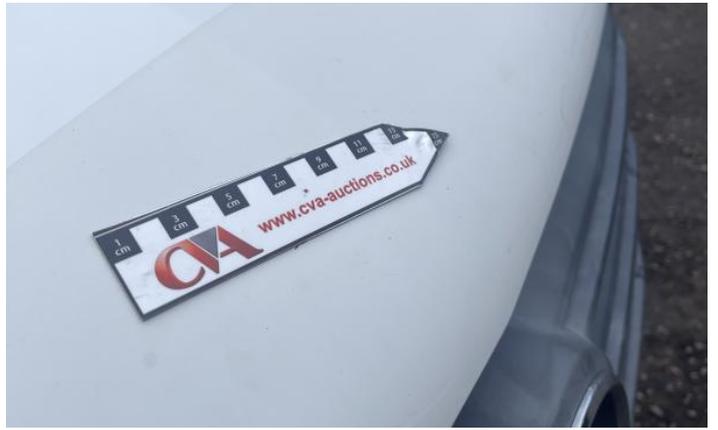
4: Bonnet
Dented
With Paint Damage

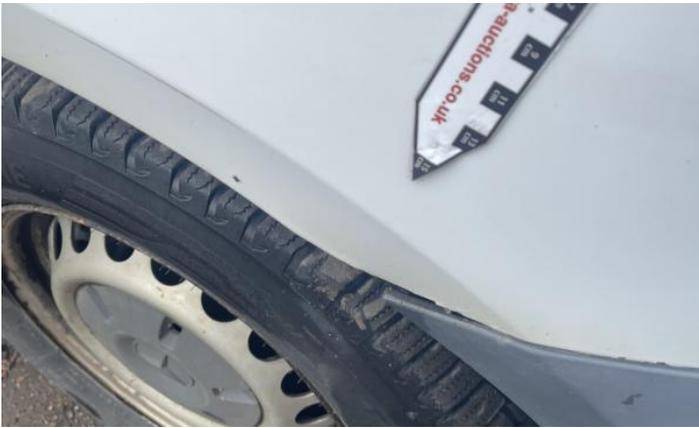
5: Wing osf
Dented
With Paint Damage

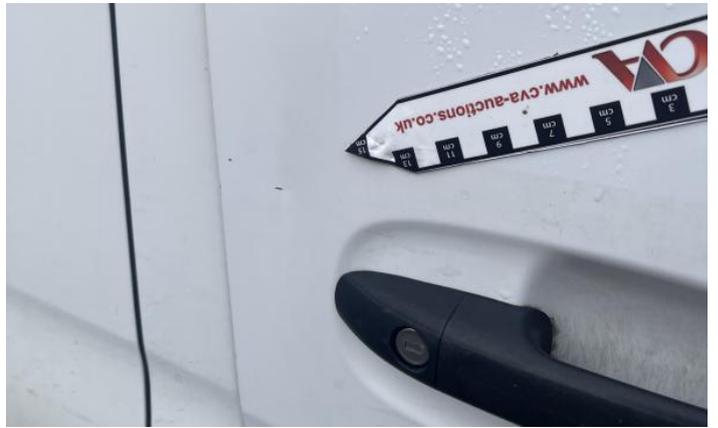
6: Door osf
Dented
With Paint Damage

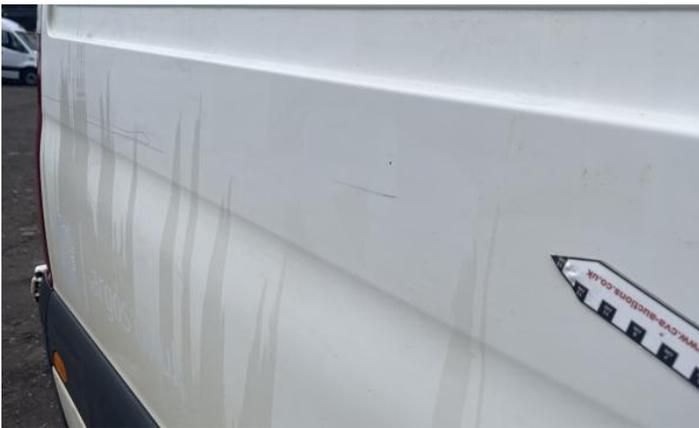
7: Qtr Panel osr
Dented
With Paint Damage

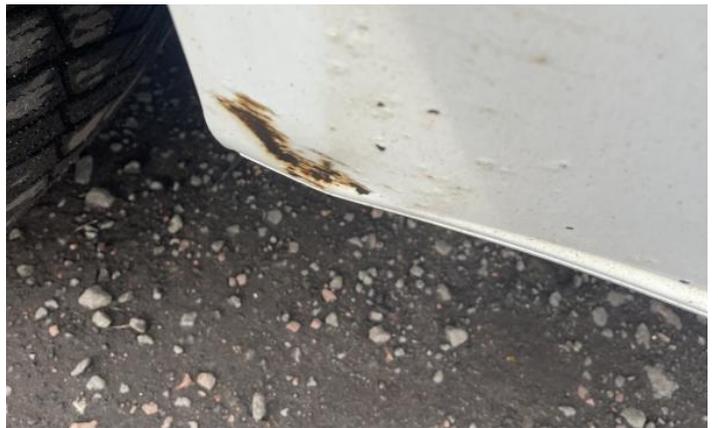
8: Sill os
Dented
With Paint Damage

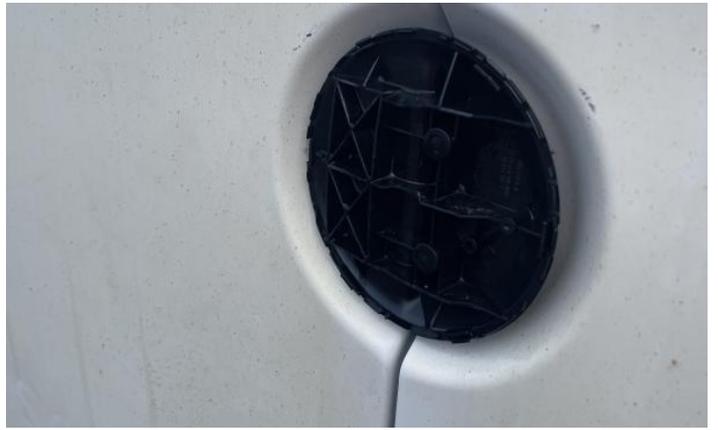
10: Badgedecal Rear
Broken
Replace

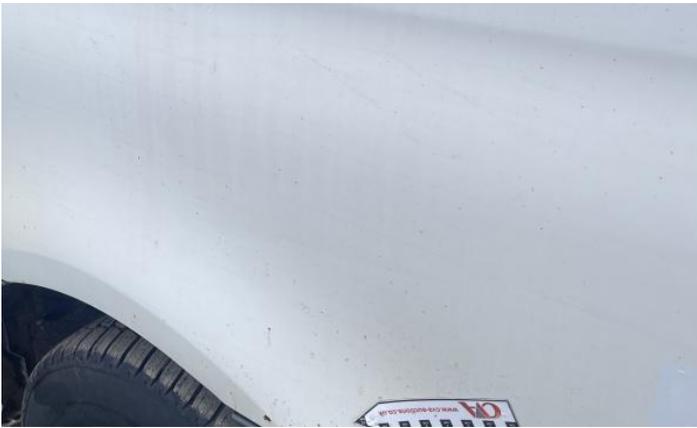
11: Qtr Panel nsr
Dented
With Paint Damage

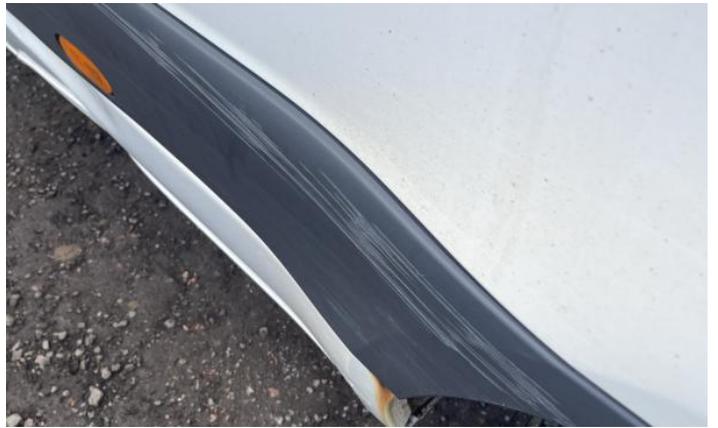
12: Qtr Panel Moulding ns
Scuffed (Unpainted)
Over 100mm

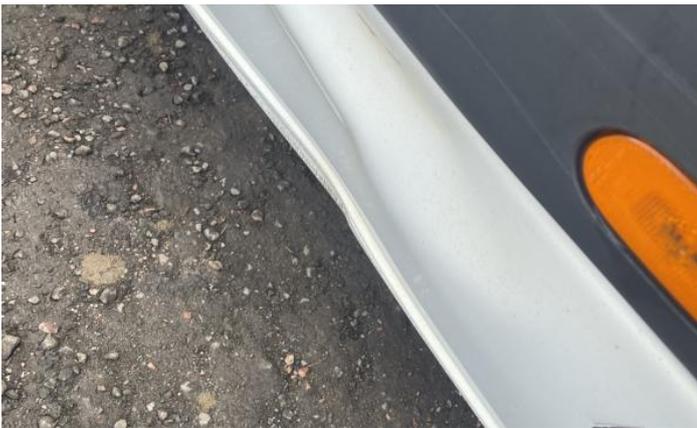
13: Sill ns
Dented
With Paint Damage

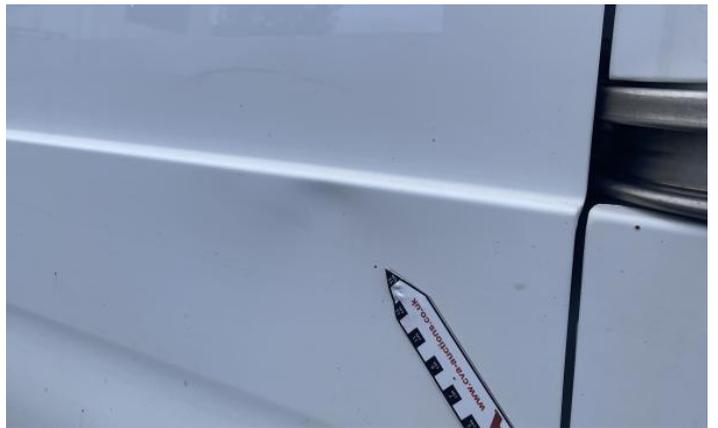
14: Door nsr
Dented
With Paint Damage

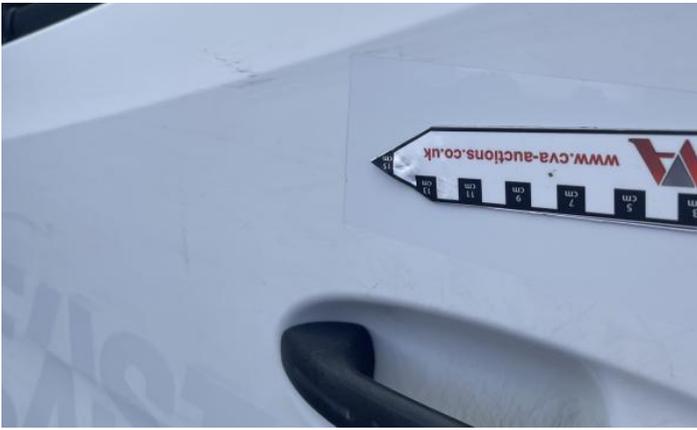
15: Door nsf
Dented
With Paint Damage

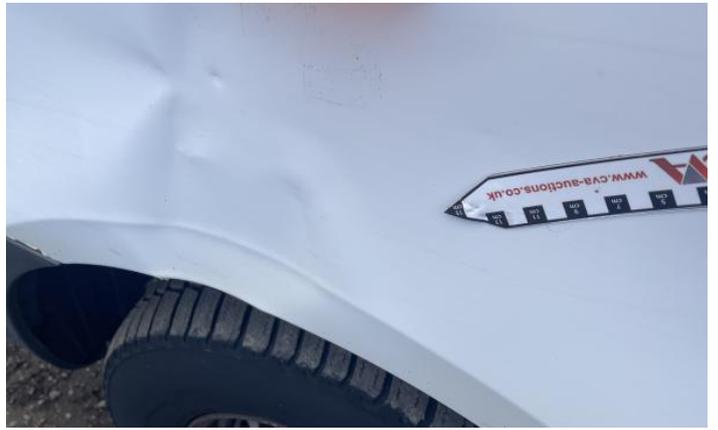
16: Wing nsf
Dented
With Paint Damage
