VEHICLE INSPECTION REPORT

PJ20KUH

Mercedes-Benz Sprinter 314 CDI

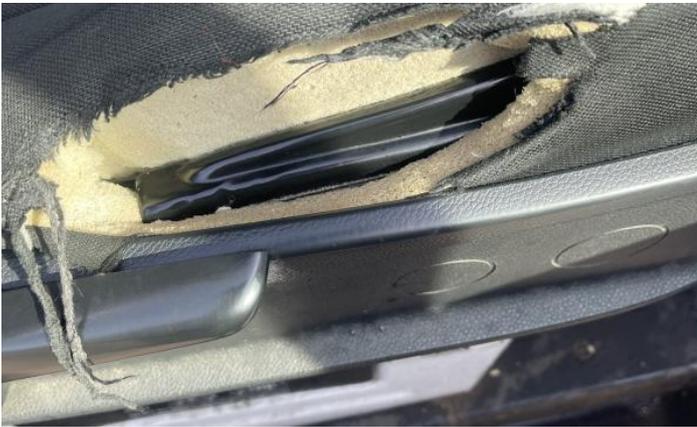
1: Seat Base Cover of
Torn
Over 3mm

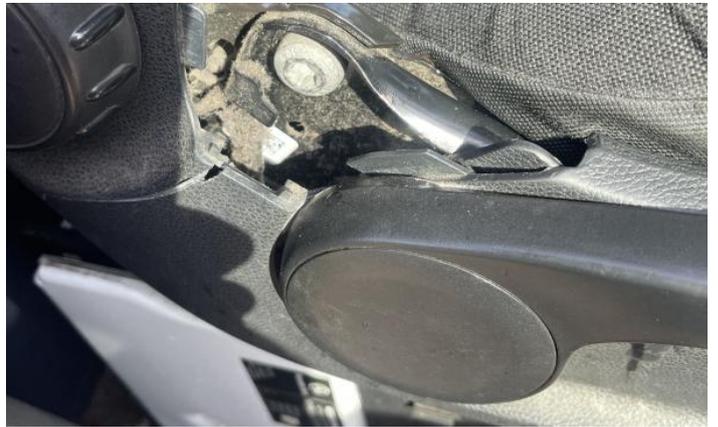
2: Seat Base Cover of
Missing
Replace

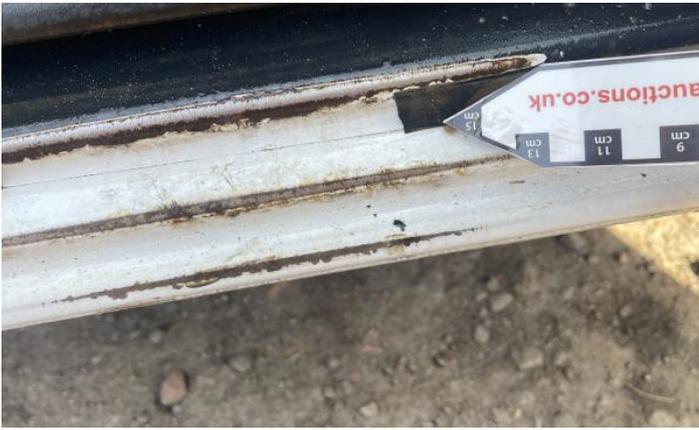
3: Sill os
Rusted
Over 5mm

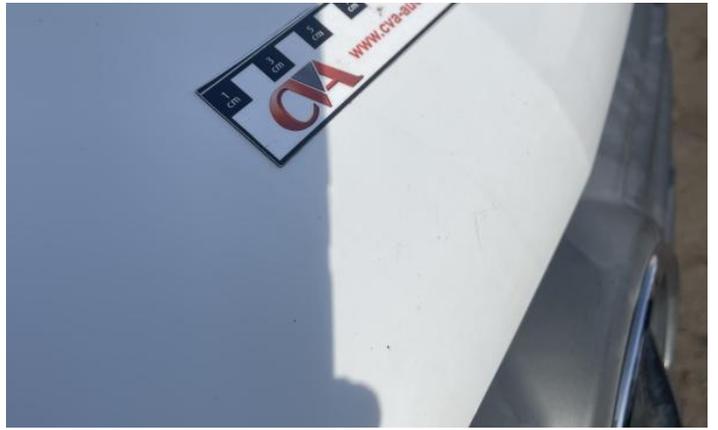
4: Bonnet
Dented
With Paint Damage

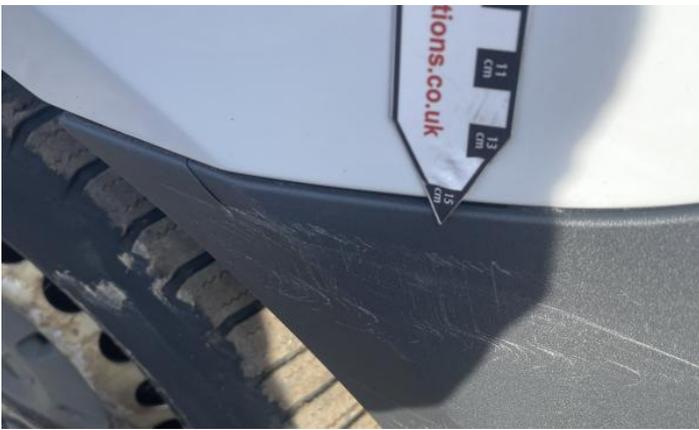
5: Bumper Front Moulding
Broken
Replace

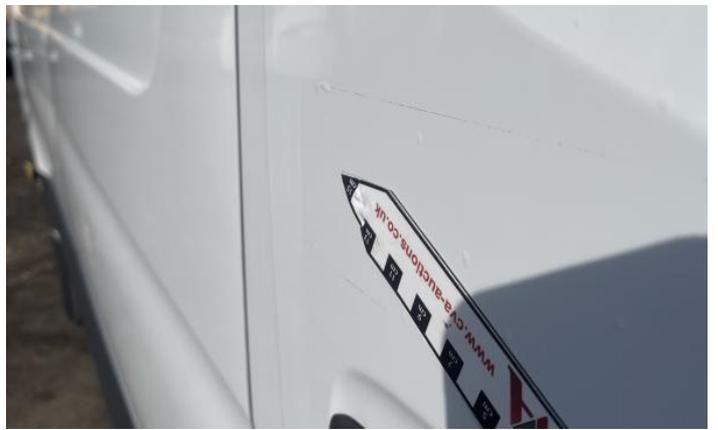
6: Door osf
Dented
Over 30mm

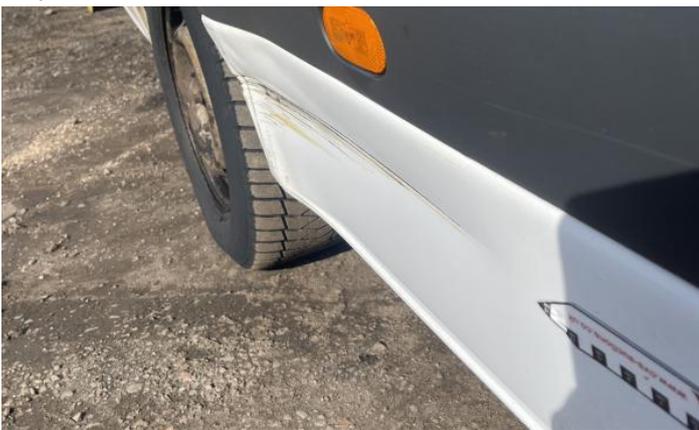
7: Qtr Panel osr
Dented
With Paint Damage

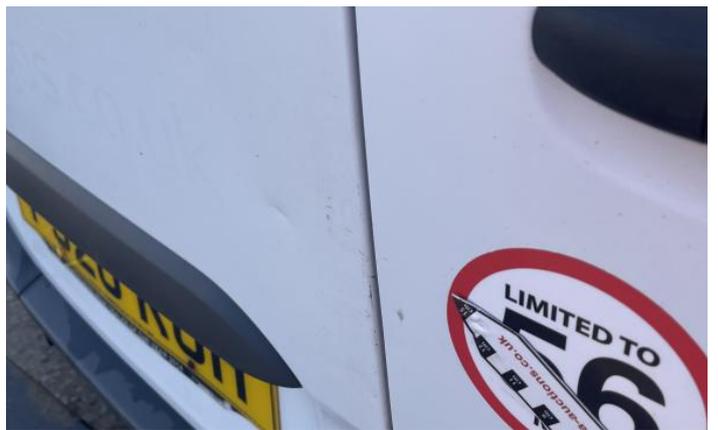
8: Tailgate
Dented
With Paint Damage

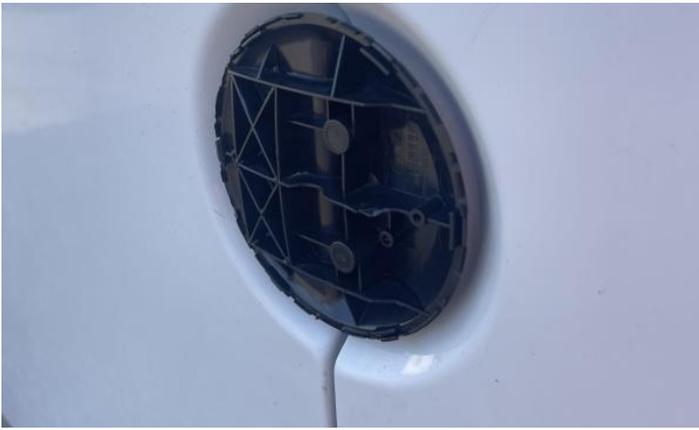
9: Badgedecal Rear
Broken
Replace

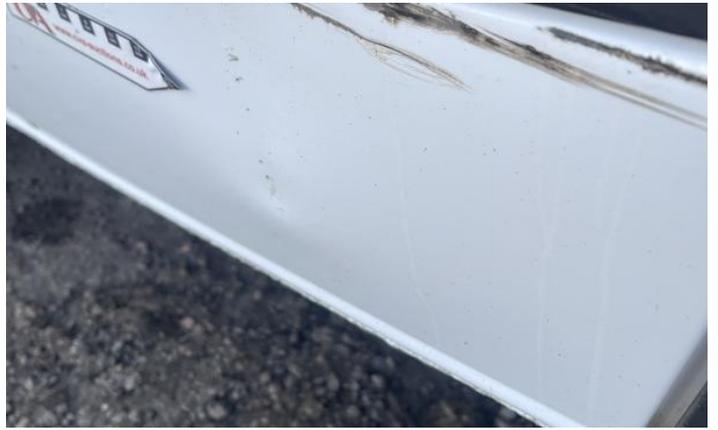
10: Qtr Panel nsr
Dented
With Paint Damage

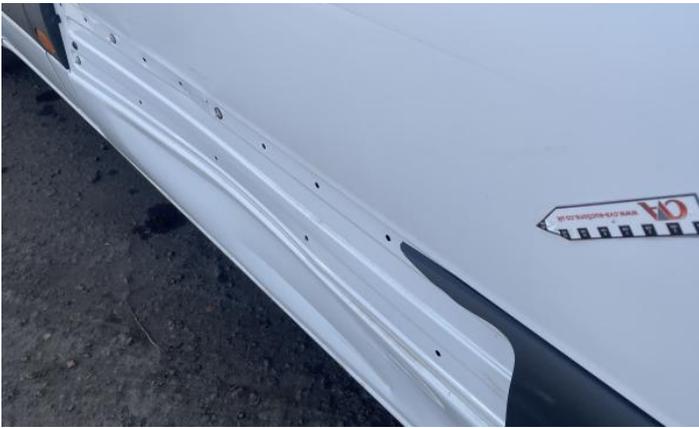
11: Door nsr
Dented
With Paint Damage

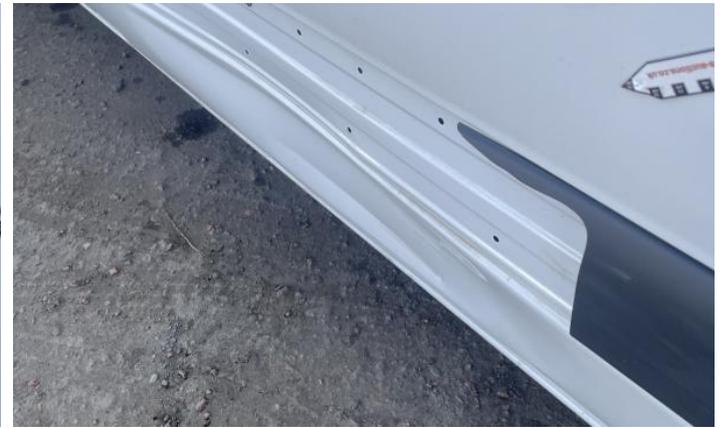
12: Door Moulding nsr
Broken
Replace

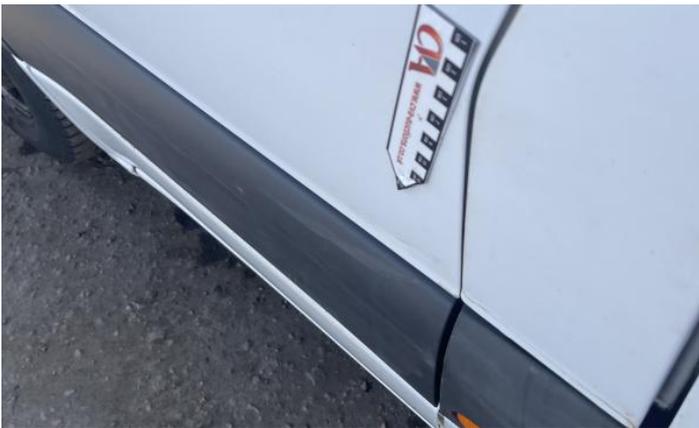
13: Door nsf
Dented
With Paint Damage

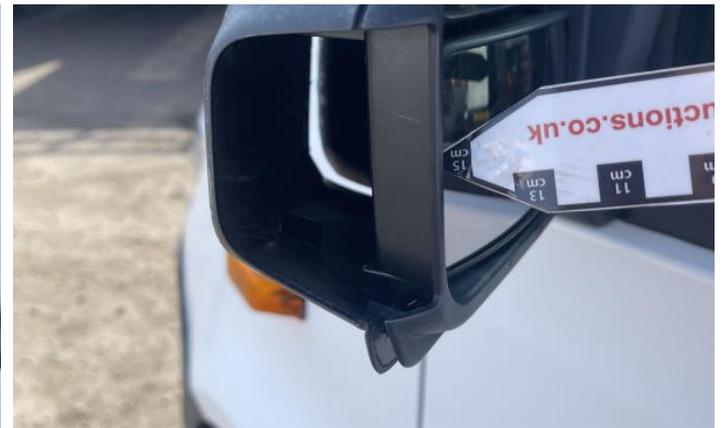
14: Flasher Side Repeater ns
Missing
Replace

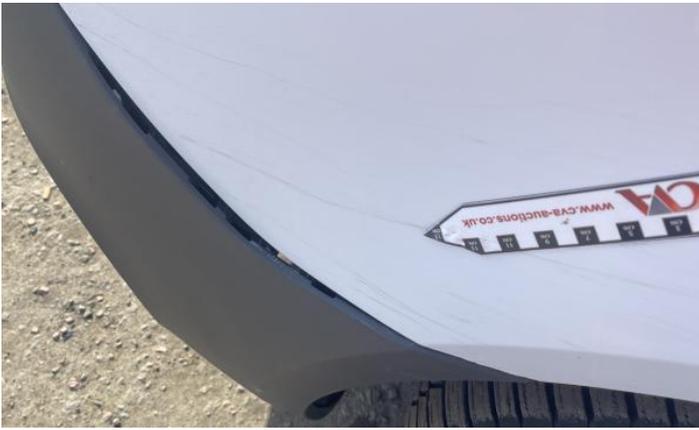
15: Wing nsf
Dented
With Paint Damage
