# VEHICLE INSPECTION REPORT

**DL16UNY**

## Ford Transit Custom 270 2.2 TDCi 125ps Limited

**Non Runner**

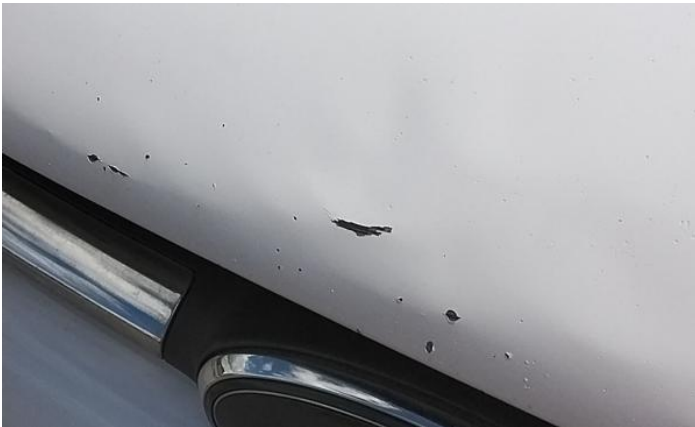
1: Bonnet  
Chipped  
Multiple Chips

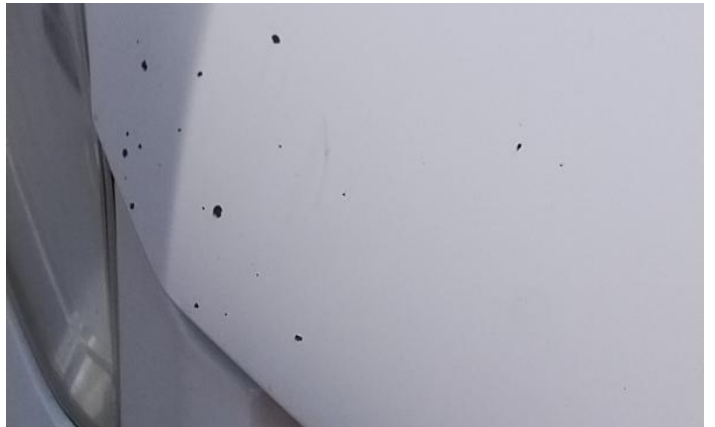
2: Bonnet  
Chipped  
Multiple Chips

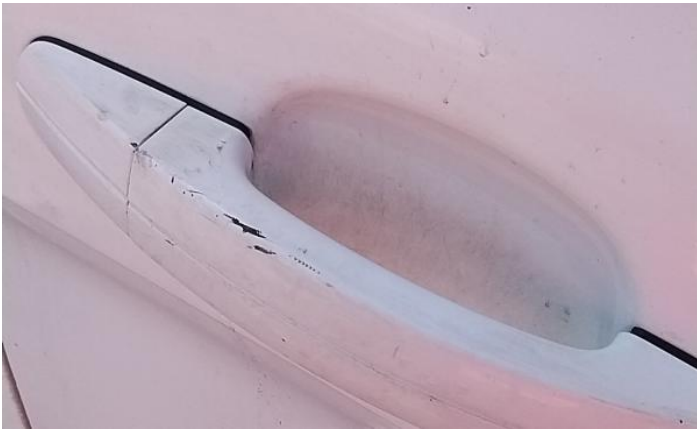
3: Handle Outer osf  
Scratched (Painted)  
UpTo 25mm Thru Paint

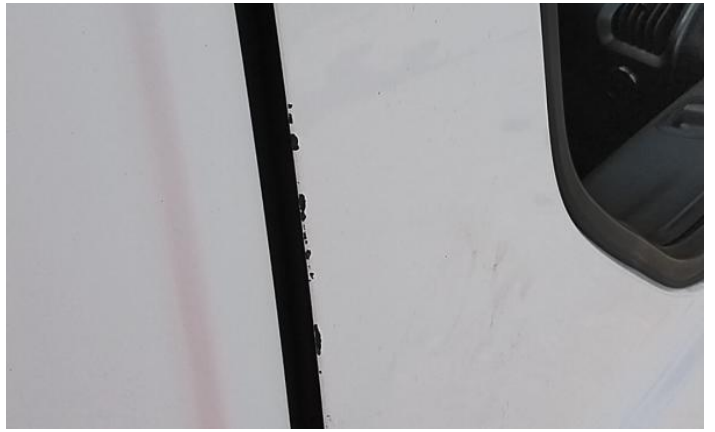
4: Door osf  
Chipped  
Edge Chip

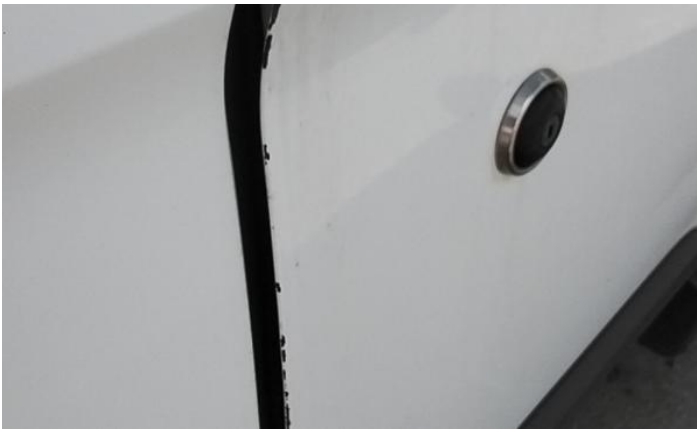
5: Door osf  
Chipped  
Edge Chip

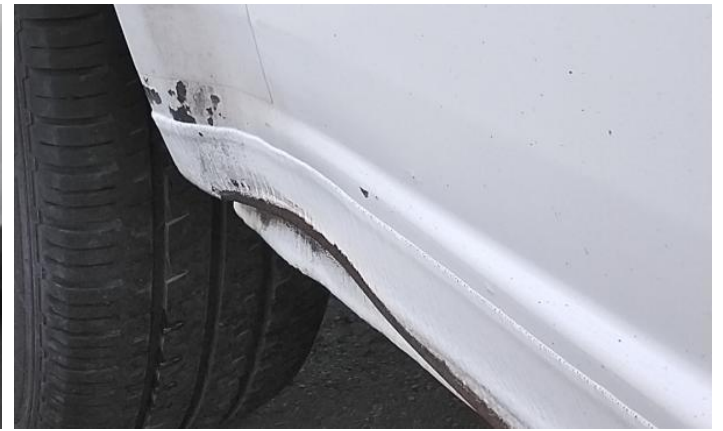
6: Panel Rear  
Dented  
With Paint Damage

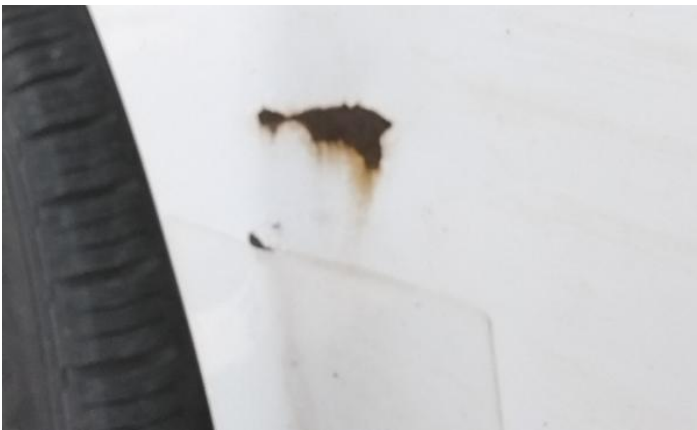
7: Panel Rear  
Scratched  
Rusted

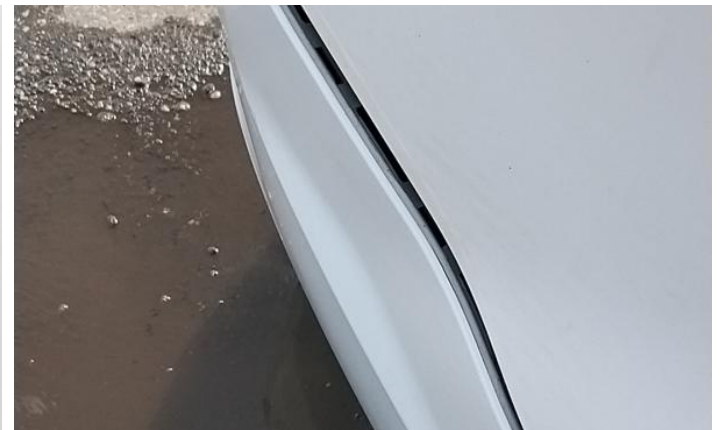
8: Bumper Rear  
Insecure  
Action Required

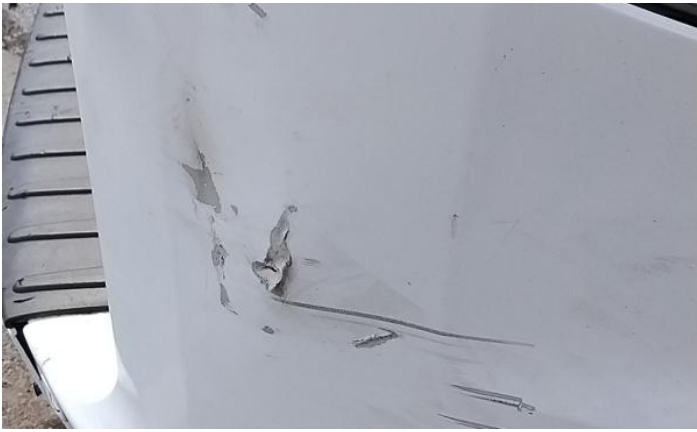
9: Bumper Rear  
Scratched  
Over 100mm Thru Paint

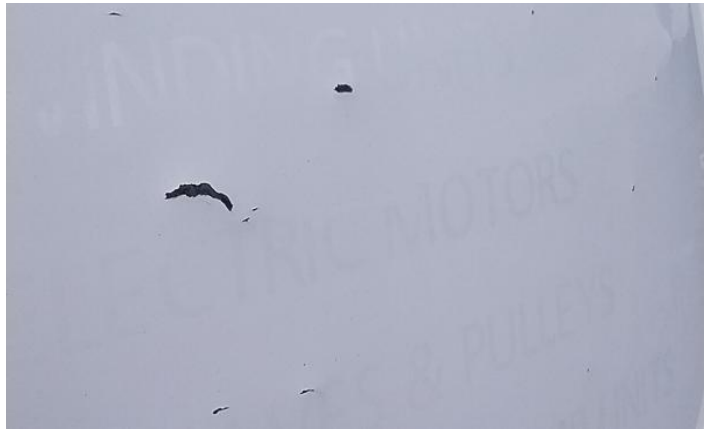
10: Door osr  
Chipped  
Multiple Chips

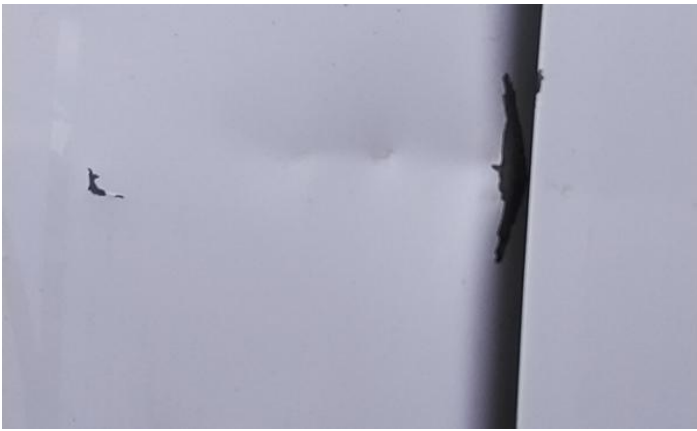
11: Door nsr  
Dented  
With Paint Damage

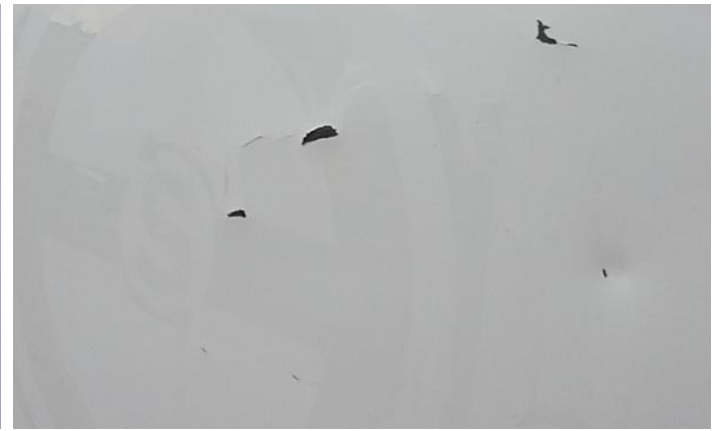
12: Door nsr  
Scratched  
Over 25mm Thru Paint

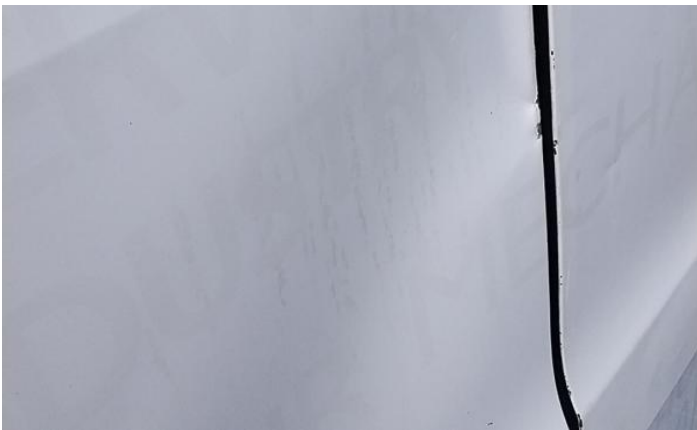
13: Door nsr  
Dented  
Over 30% Of Panel

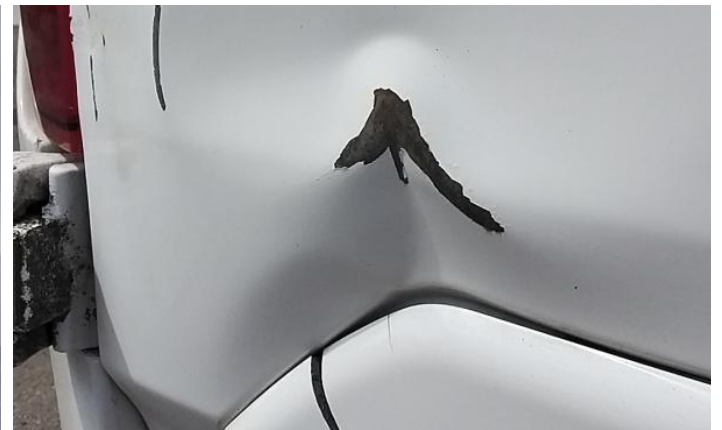
14: Door nsr  
Dented  
With Paint Damage

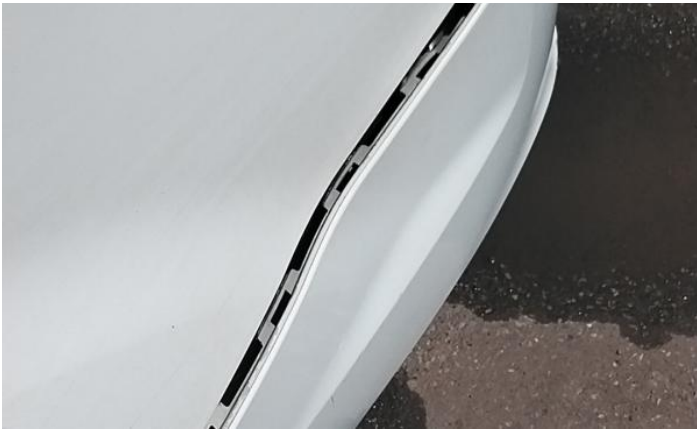
15: Bumper Rear  
Insecure  
Action Required

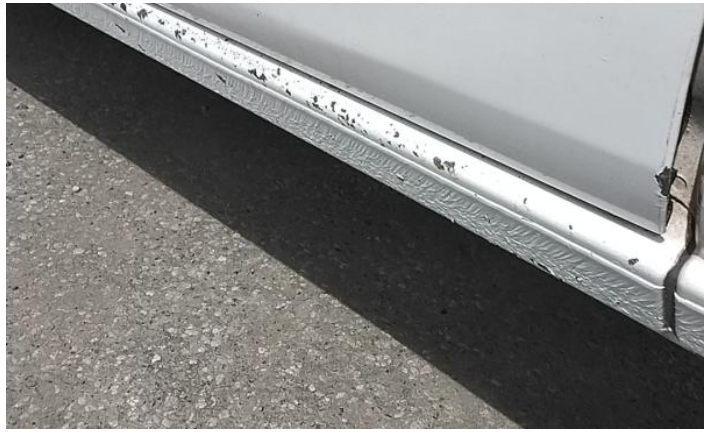
16: Sill ns  
Chipped  
Multiple Chips

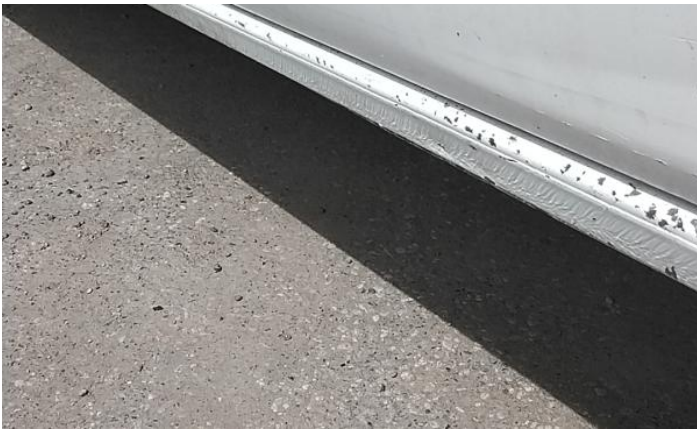
17: Sill ns  
Chipped  
Multiple Chips

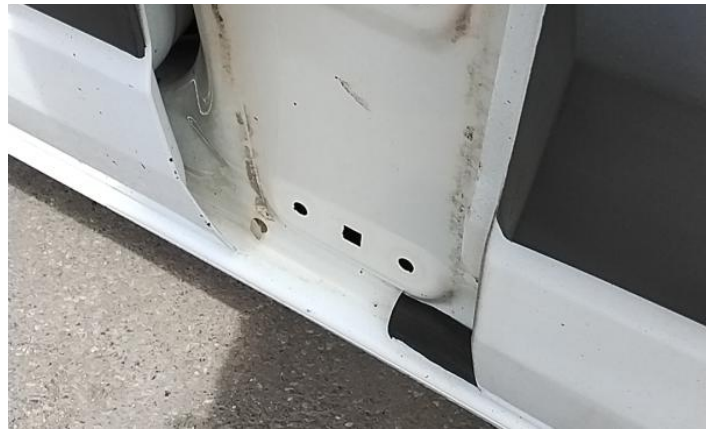
18: Sill Panel Trim ns  
Missing  
Replace

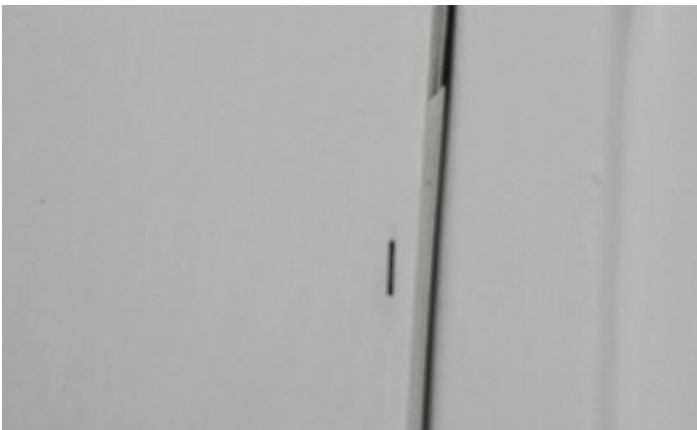
19: Door nsf  
Scratched  
UpTo 25mm Thru Paint

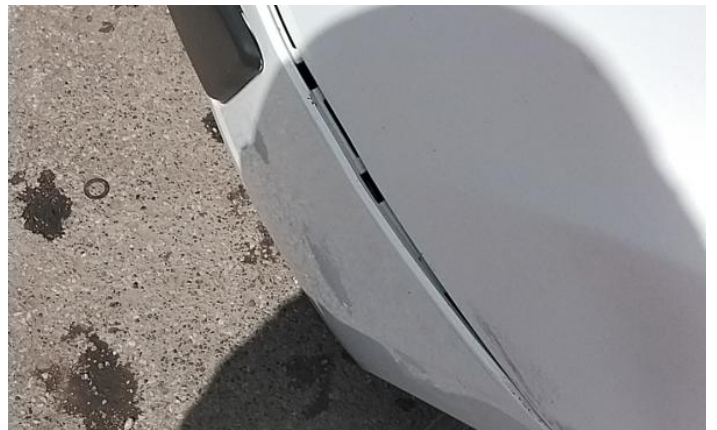
20: Bumper Front  
Insecure  
Action Required

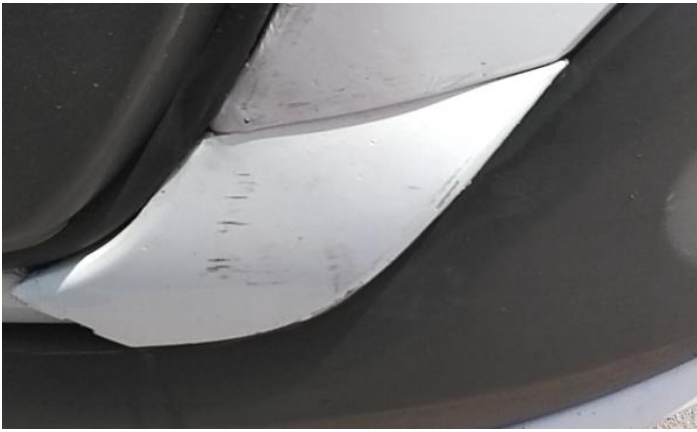
21: Bumper Front  
 Scratched  
 UpTo 25mm Thru Paint
