# VEHICLE INSPECTION REPORT

**DY68DHC**

## Vauxhall Vivaro 2700 1.6 CDTI 120PS SPORTIVE

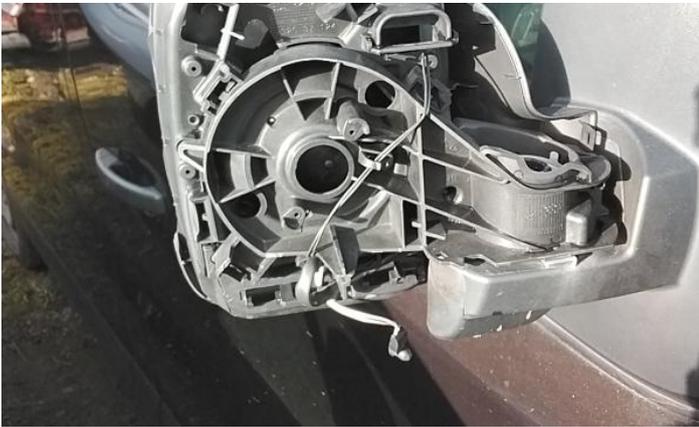
1: Door Mirror Assy osf  
Broken  
Replace

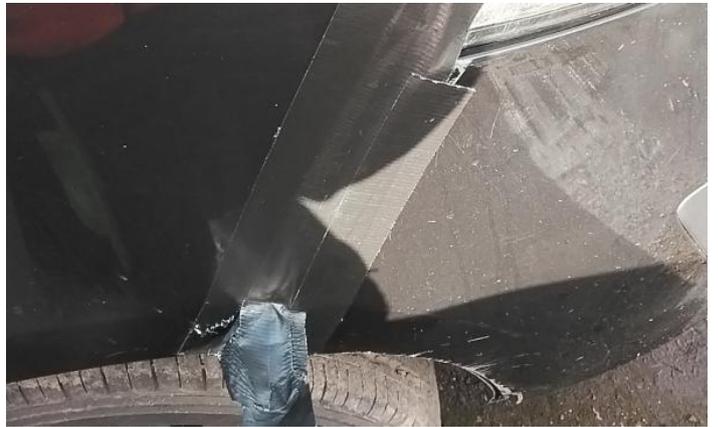
2: Bumper Front  
Insecure  
Action Required

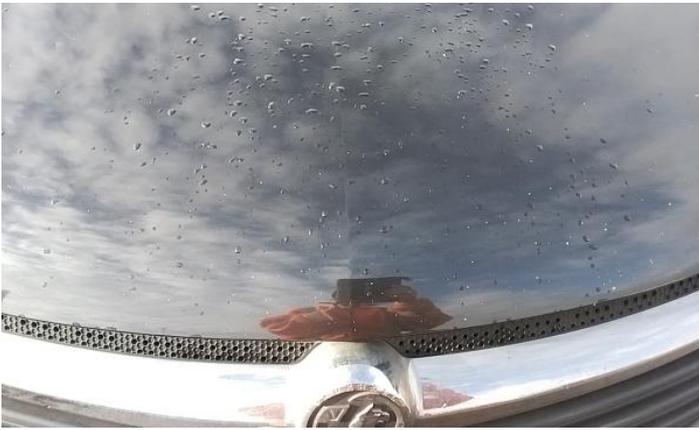
3: Bonnet  
Chipped  
Multiple Chips

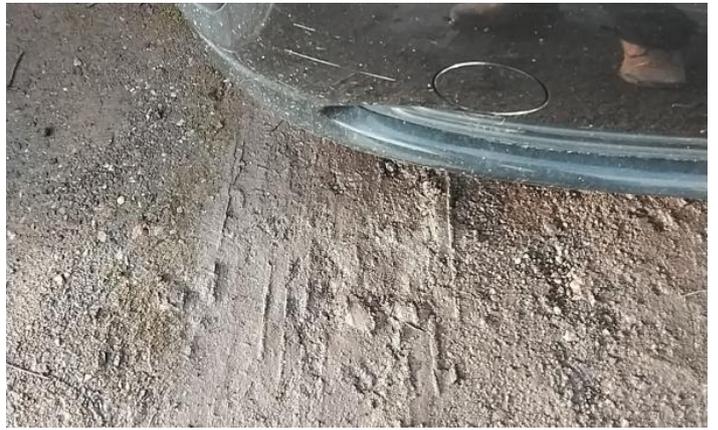
4: Bumper Front  
Scratched  
Over 100mm Thru Paint

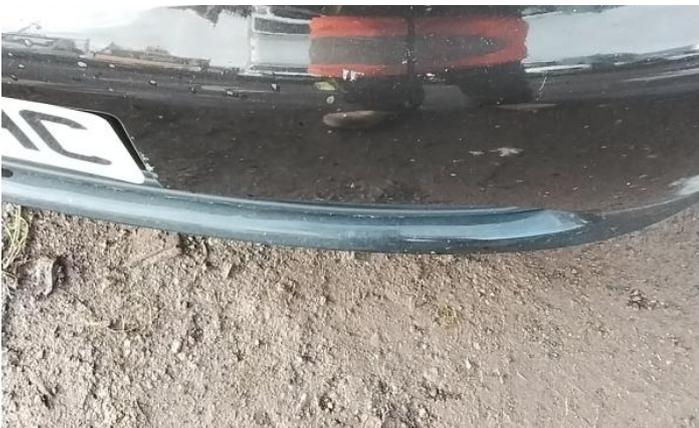
5: Bumper Front  
Chipped  
Multiple Chips

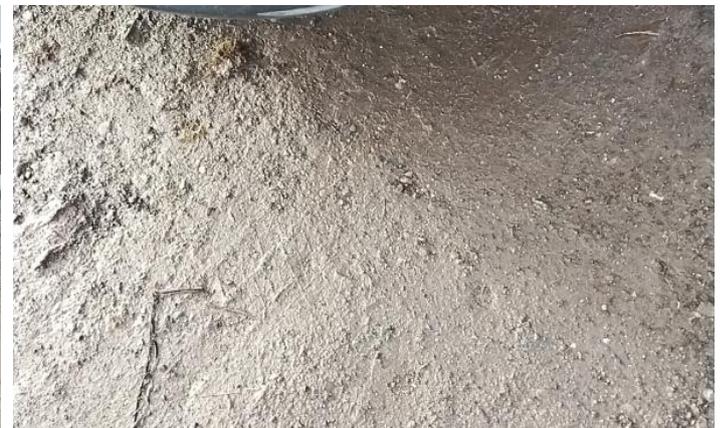
6: Bumper Front  
Scratched  
25 to 100mm Thru Paint

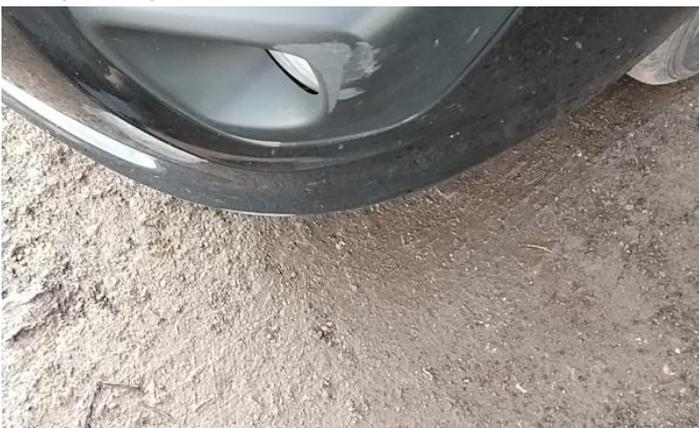
7: Bumper Front Moulding  
Scuffed (Unpainted)  
Up To 100mm

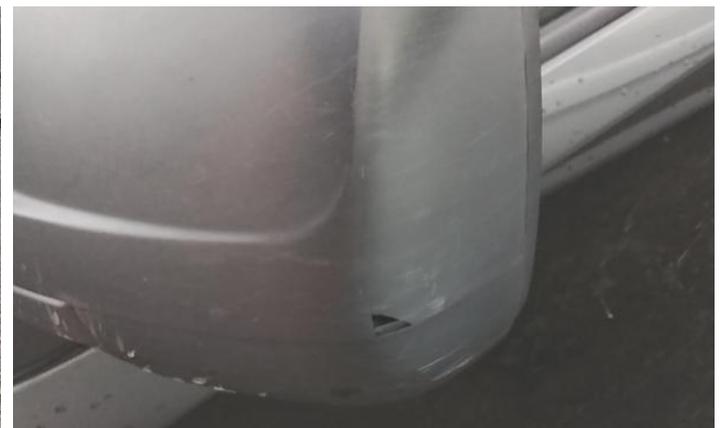
8: Door Mirror Assy nsf  
Broken  
Replace

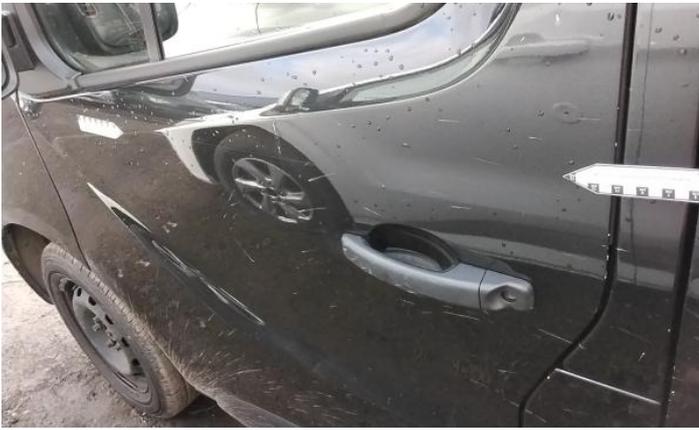
9: Door nsf  
Scratched  
Over 25mm Thru Paint

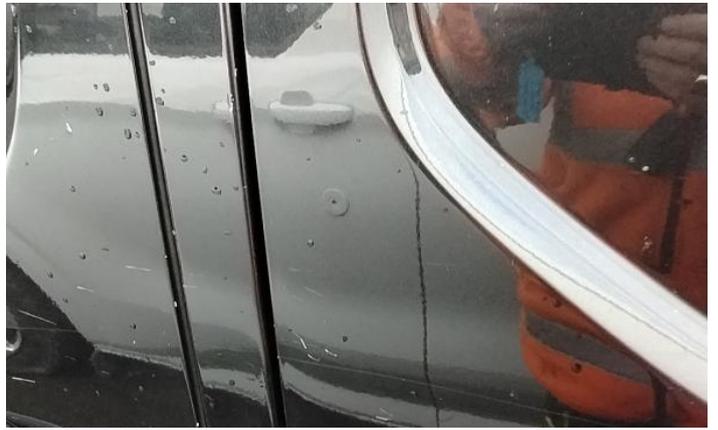
10: Qtr Panel nsr  
Scratched  
Over 25mm Thru Paint

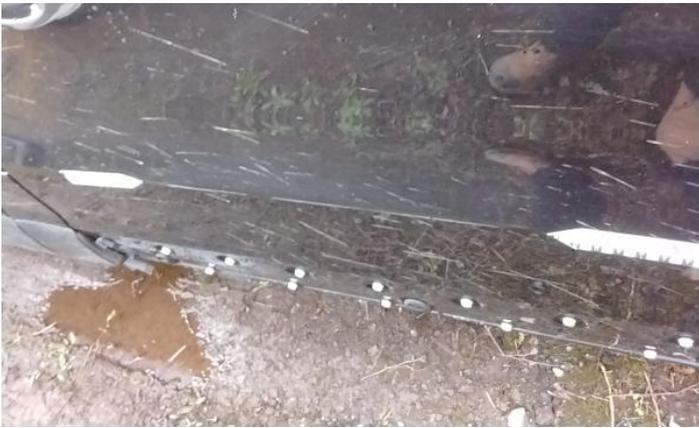
11: Qtr Panel nsr  
Scratched  
Over 25mm Thru Paint

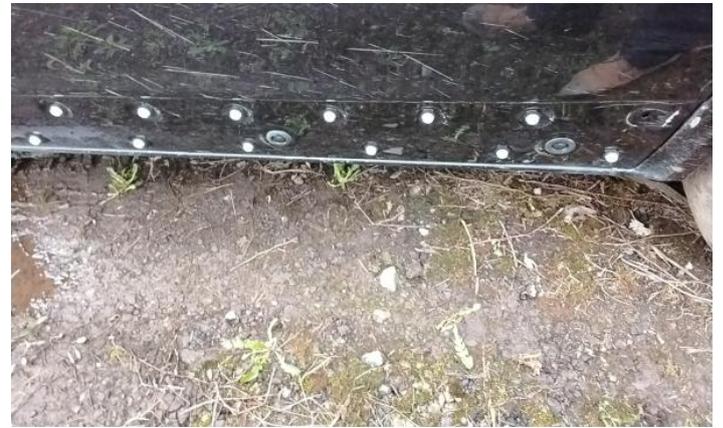
12: Qtr Panel Moulding ns  
Missing  
Replace

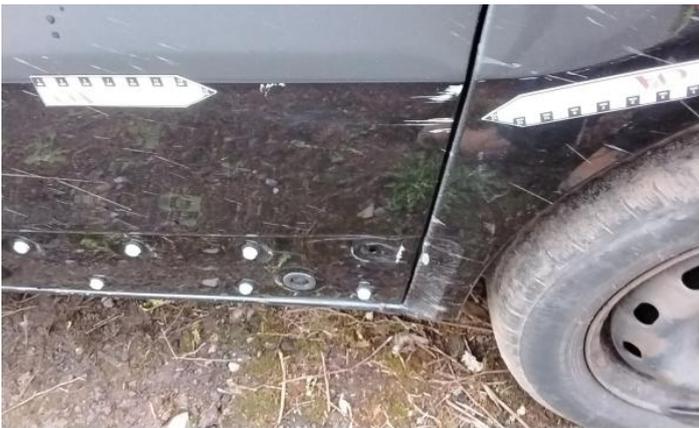
13: Qtr Panel nsr  
Scratched  
Over 25mm Thru Paint

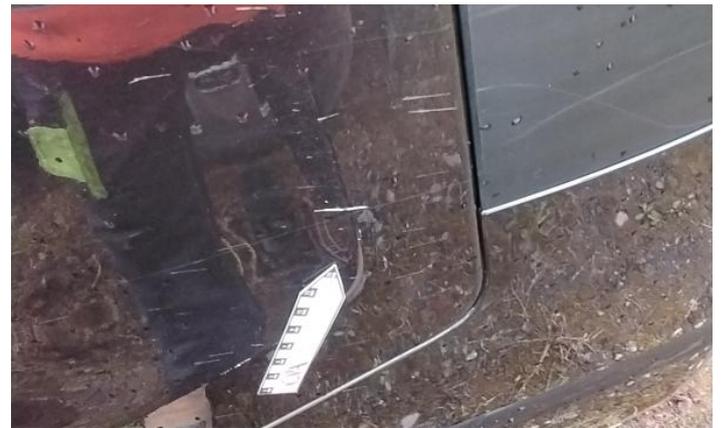
14: Qtr Panel nsr  
Scratched  
Over 25mm Thru Paint

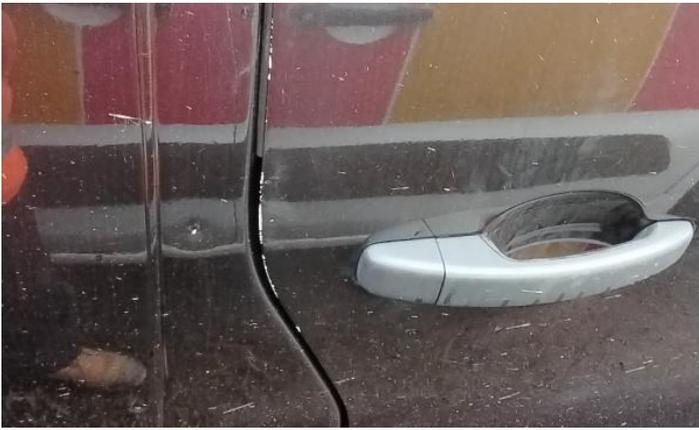
15: Door osf  
 Scratched  
 Over 25mm Thru Paint

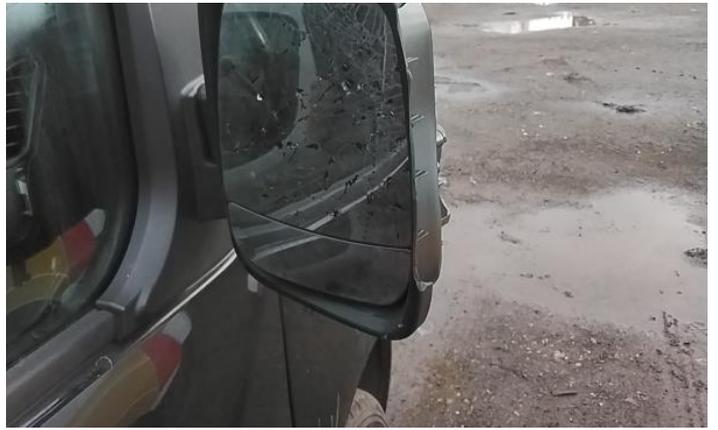
16: Door Mirror Glass os  
 Broken  
 Replace

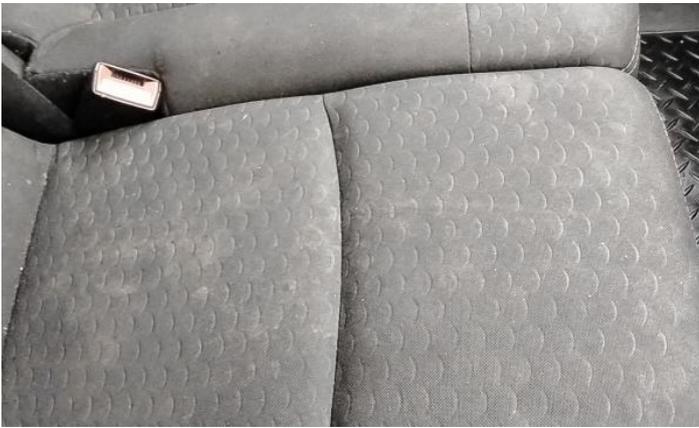
17: Seat Base Cover nsf  
 Soiled  
 Heavy

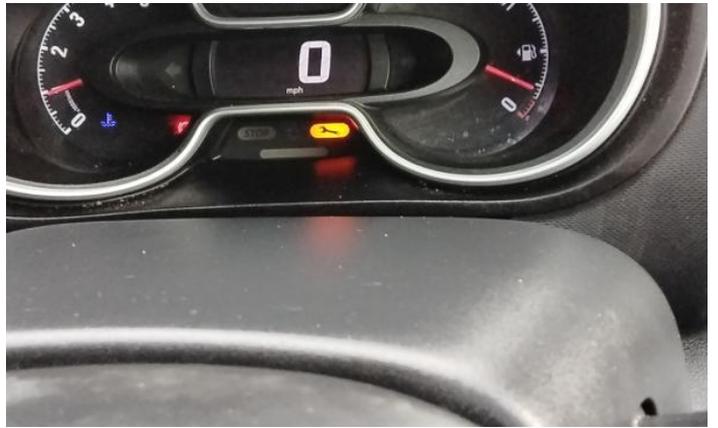
18: Dash Warning Lights  
 Displayed  
 No Action
