VEHICLE INSPECTION REPORT

HX23YMH

Mercedes-Benz Atego 1223

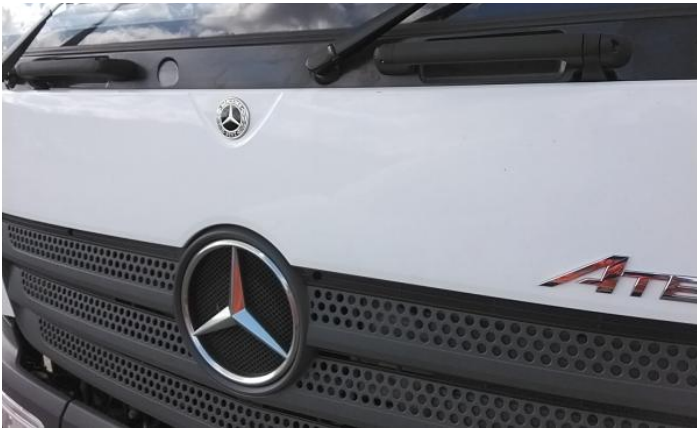
1: Bonnet
Chipped
Multiple Chips

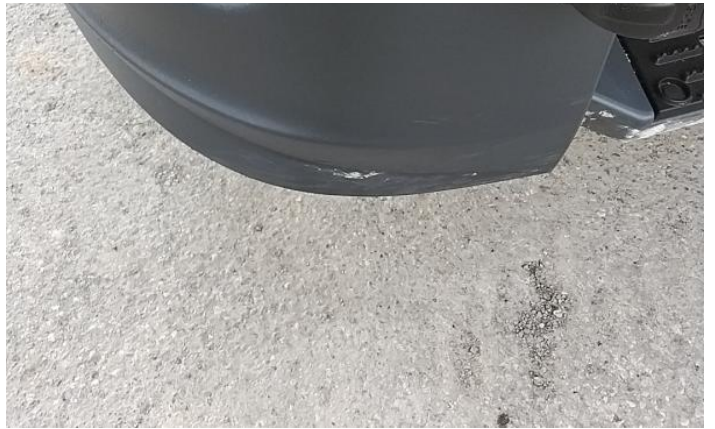
2: Bumper Front
Scratched
Over 100mm Thru Paint

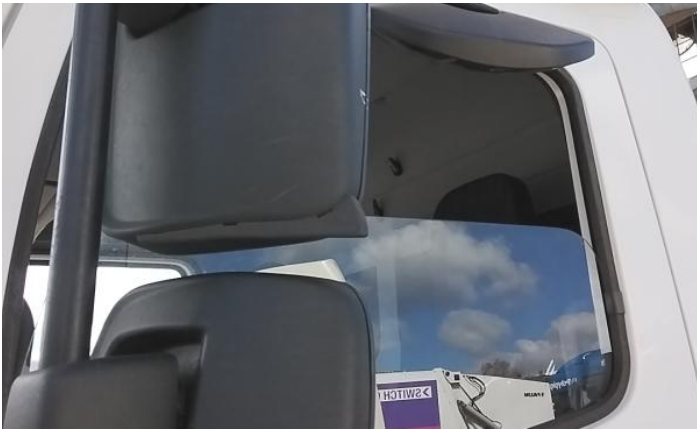
3: Door Mirror Assy nsf
Scuffed (Unpainted)
UpTo 100mm

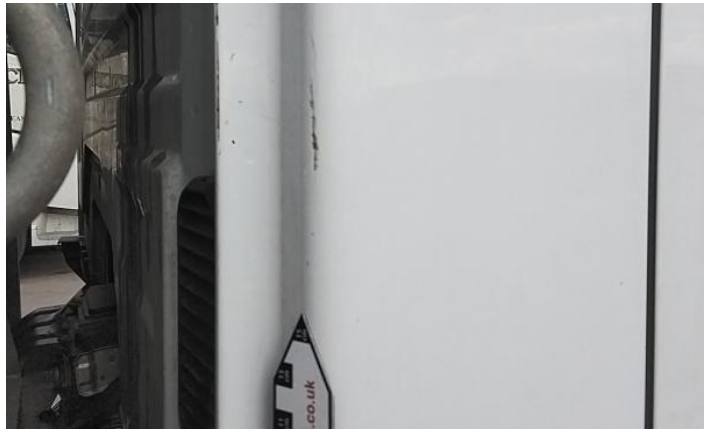
4: B Post os
Scratched
Over 25mm Thru Paint

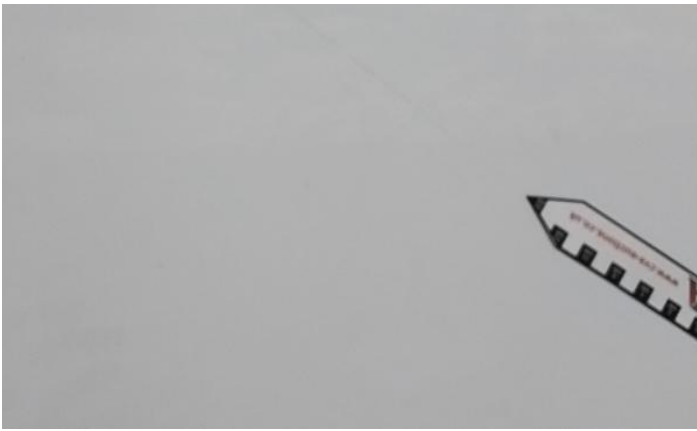
5: Door osf
Scratched
Over 25mm Not Thru Paint

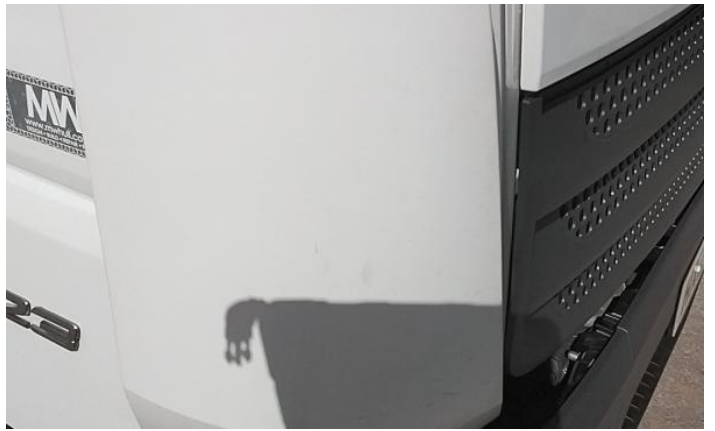
6: Panel Front
Scratched
UpTo 25mm Not Thru Paint

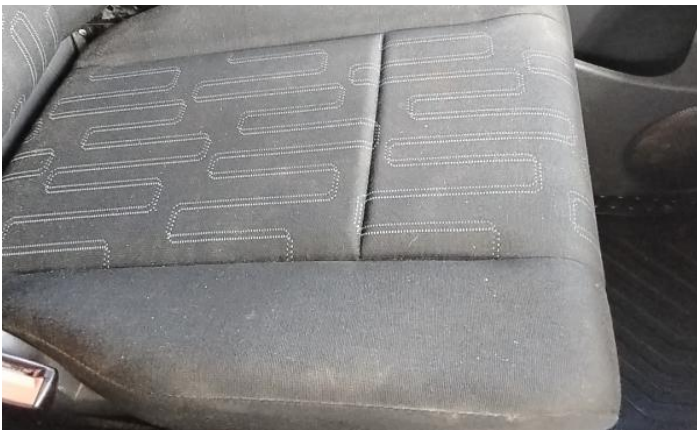
7: Seat Base Cover nsf
Soiled
Heavy
