# **VEHICLE INSPECTION REPORT**

### Daf LF LF 180

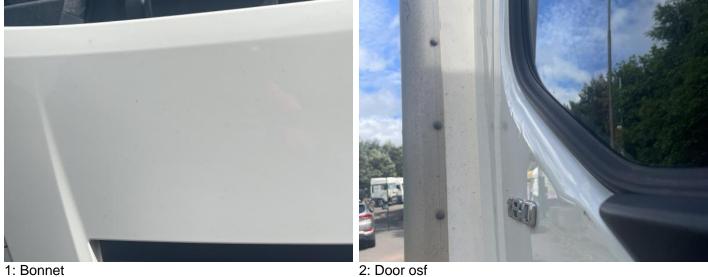
1: Bonnet Chipped 1 To 5

2: Door osf Dented Over 30mm

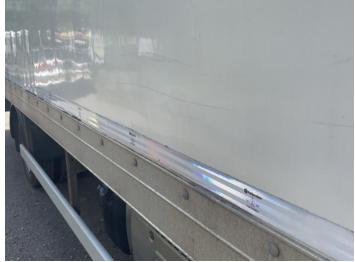
3: Qtr Panel osr Scratched UpTo 25mm Not Thru Paint 4: Tailgate Rusted Over 5mm
