VEHICLE INSPECTION REPORT

WO19HDZ

Mercedes-Benz Sprinter 314 CDI

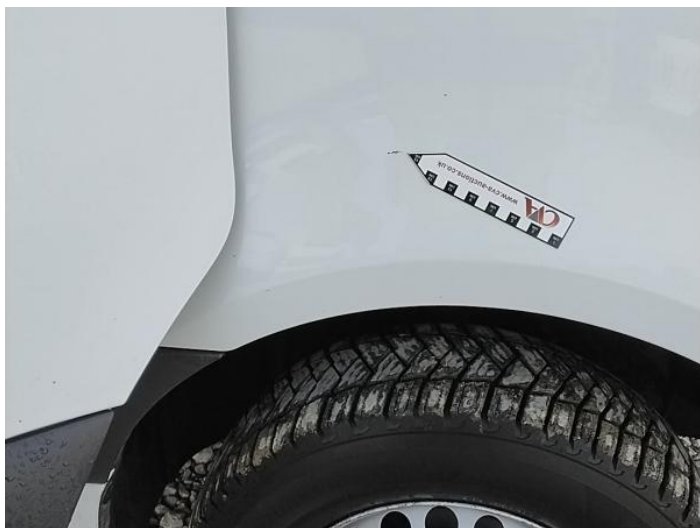
1: Wing of
Scratched
Up To 25mm Thru Paint

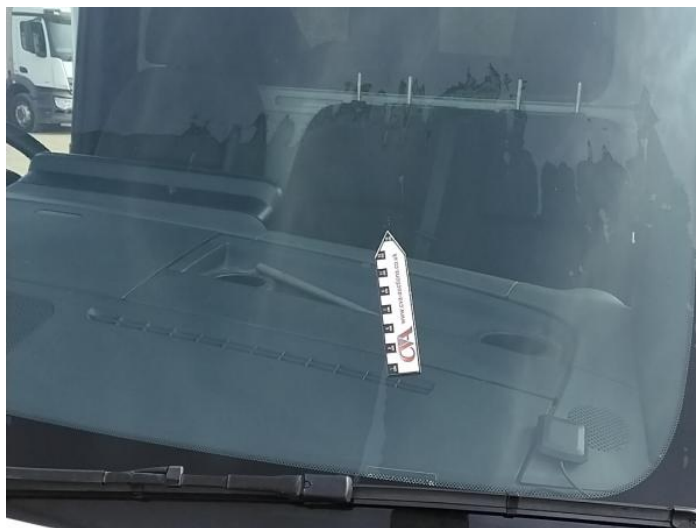
2: Screen Front
Chipped
Over 10mm

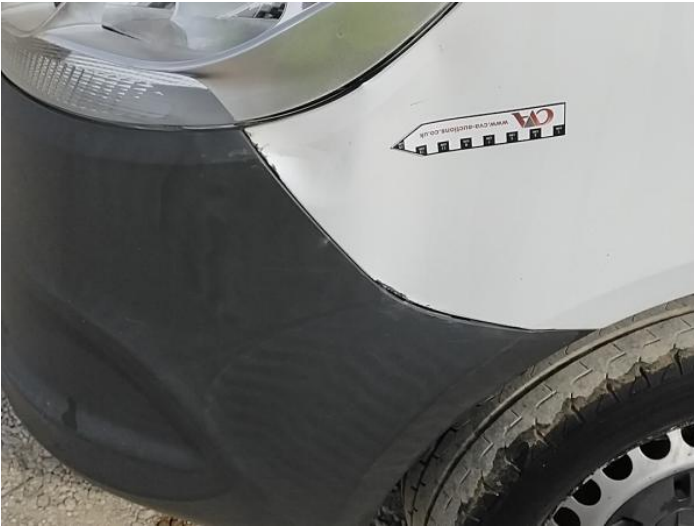
3: Wing nsf
Dented
With Paint Damage

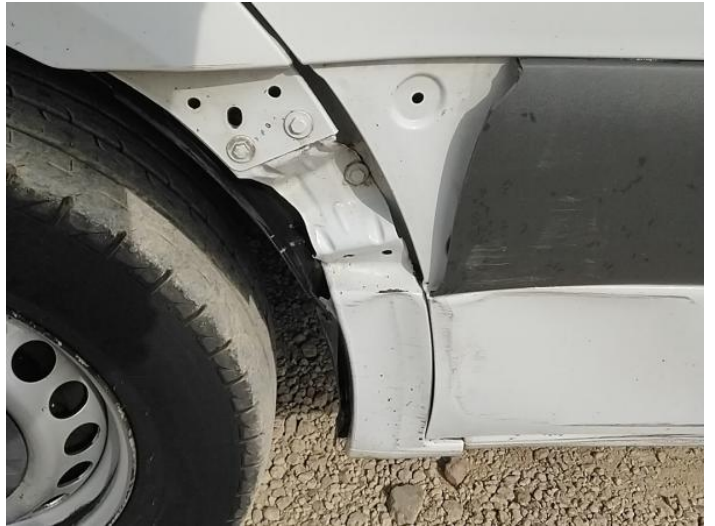
4: Door Moulding nsf
Broken
Replace

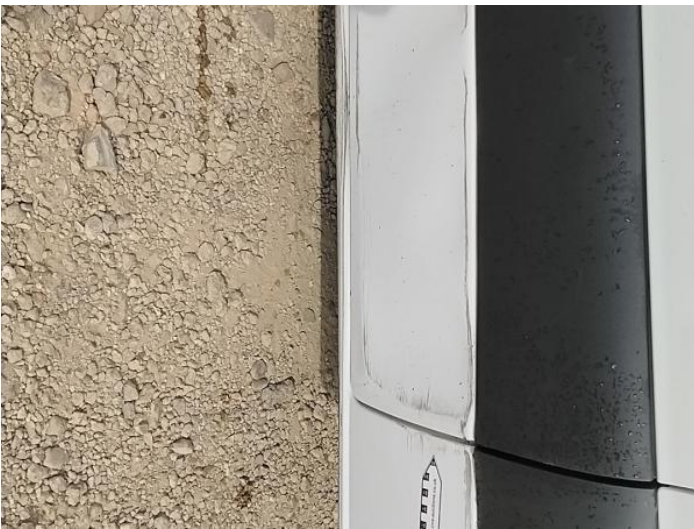
5: Door nsf
Dented
With Paint Damage

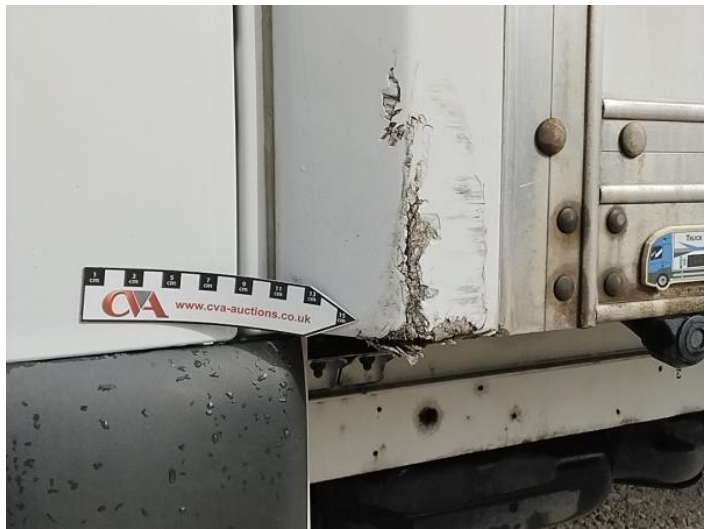
6: B Post ns
Hole
Over 10mm

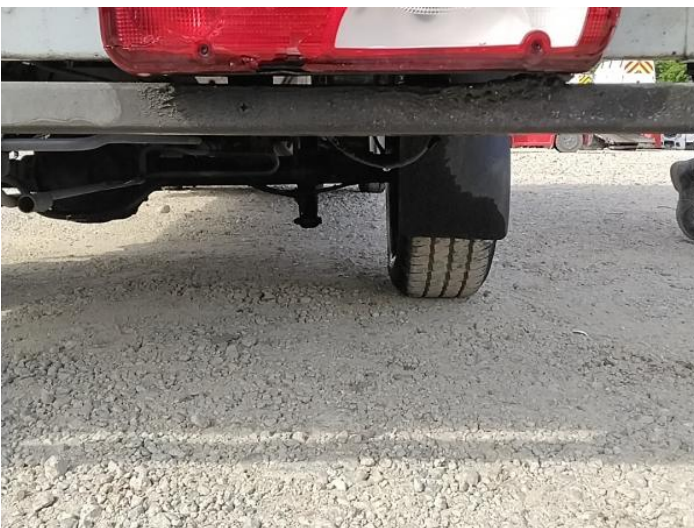
7: Lamp osr
Broken
Replace

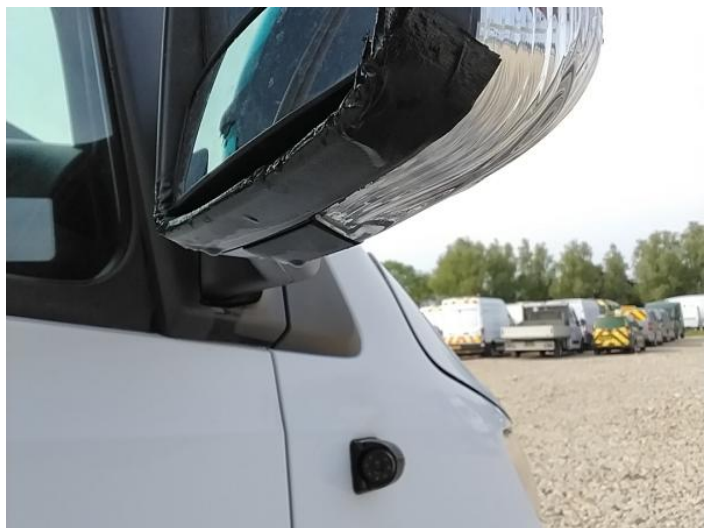
8: Door Mirror Assy osf
Broken
Replace

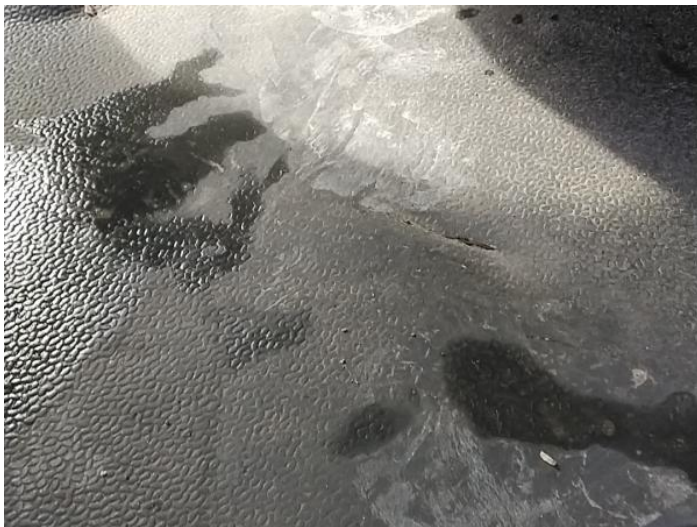
9: Carpets Front
Holed
Over 3mm

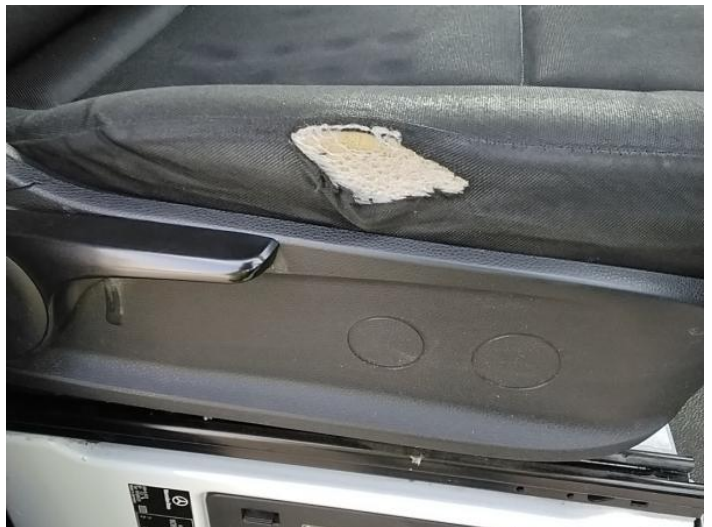
10: Seat Base Cover nsf
Holed
Over 3mm
