VEHICLE INSPECTION REPORT

RV70DFD

Iveco Eurocargo 75E16

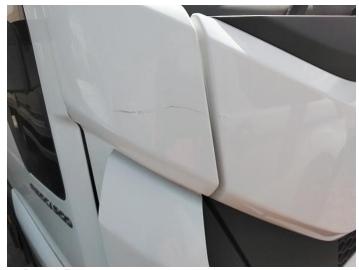
2: Bumper Front Cracked Over 25mm

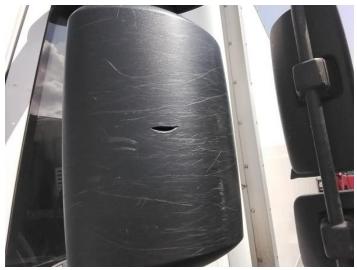
3: Door Mirror Assy osf Broken Replace

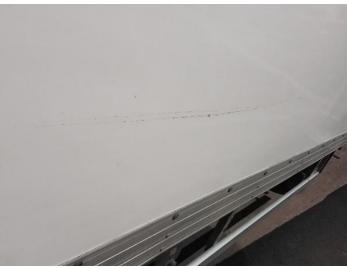
4: Qtr Panel nsr Scratched Over 25mm Not Thru Paint

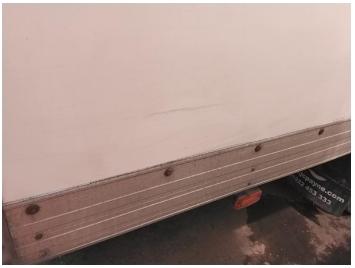
5: Qtr Panel osr Scratched Over 25mm Not Thru Paint

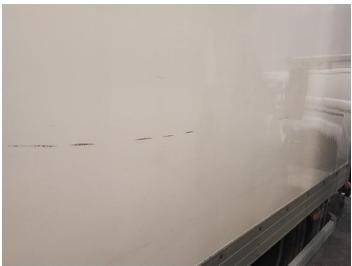
6: Qtr Panel osr Scratched Over 25mm Thru Paint

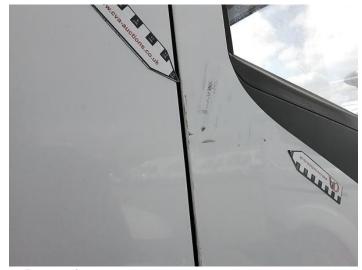
7: Door osf Scratched Over 25mm Thru Paint

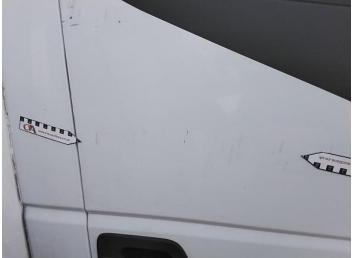
8: Door osf Scratched Over 25mm Thru Paint

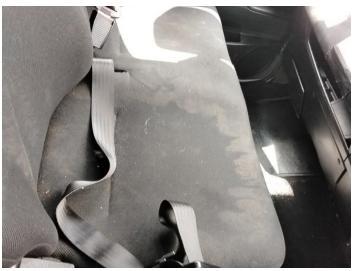
9: Seat Base Cover nsf Soiled Heavy
