VEHICLE INSPECTION REPORT

KW15BWV

Volvo FL 240

Non Runner

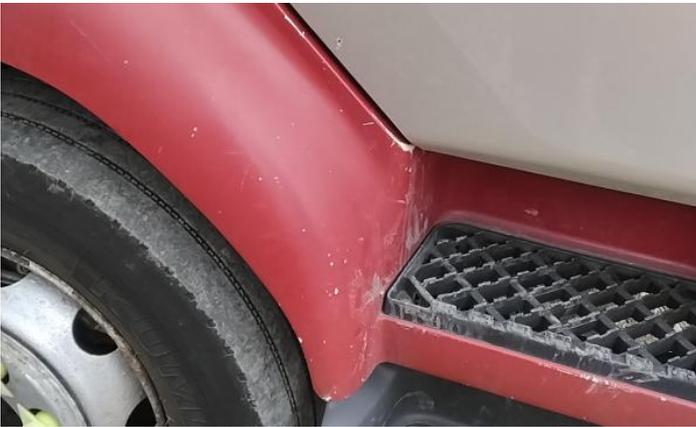
1: Door osf
Chipped
1 To 5

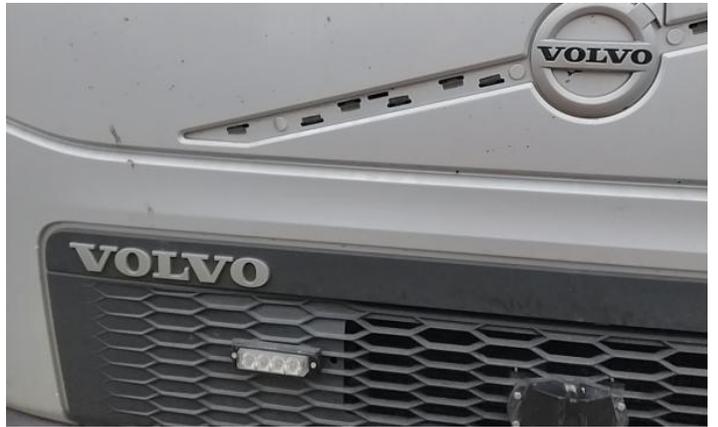
2: Bumper Front
Chipped
Multiple Chips

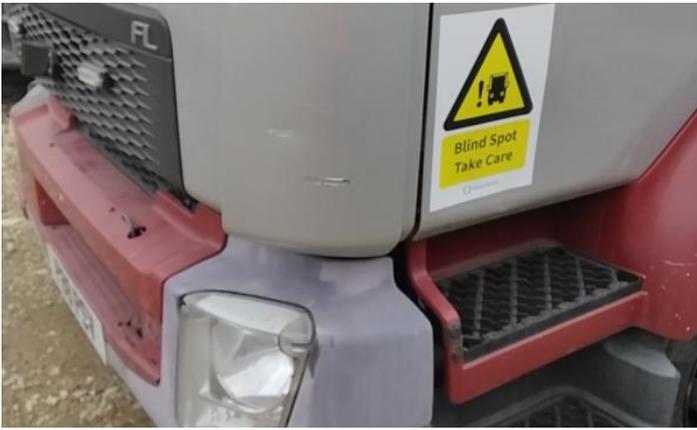
3: Wing nsf
 Scratched
 Over 25mm Thru Paint
