VEHICLE INSPECTION REPORT

PJ20XNR

Mercedes-Benz Sprinter 314 CDI

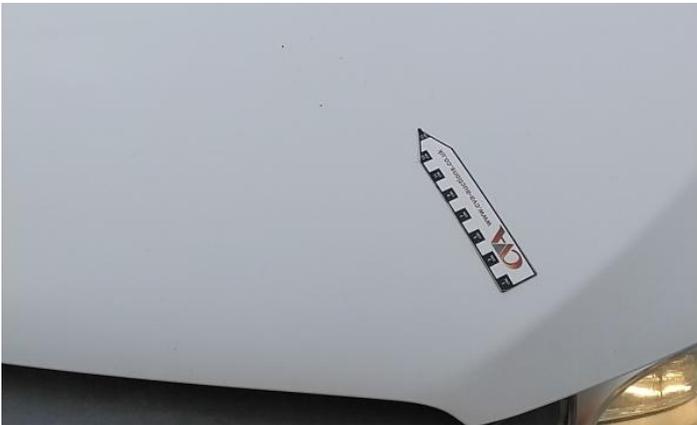
1: Bonnet
Chipped
Multiple Chips

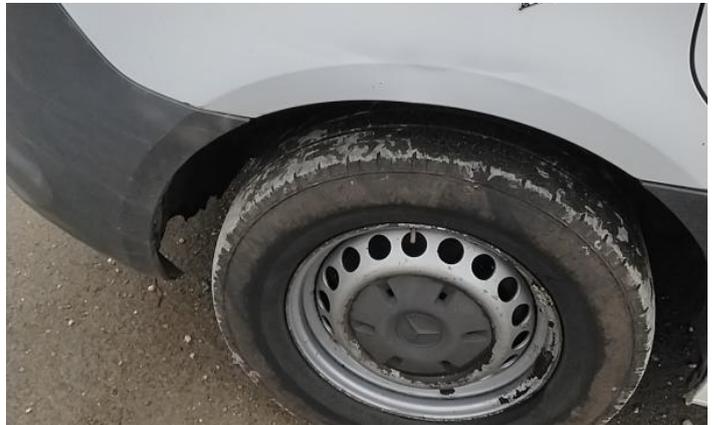
2: Wing nsf
Dented
Over 30mm

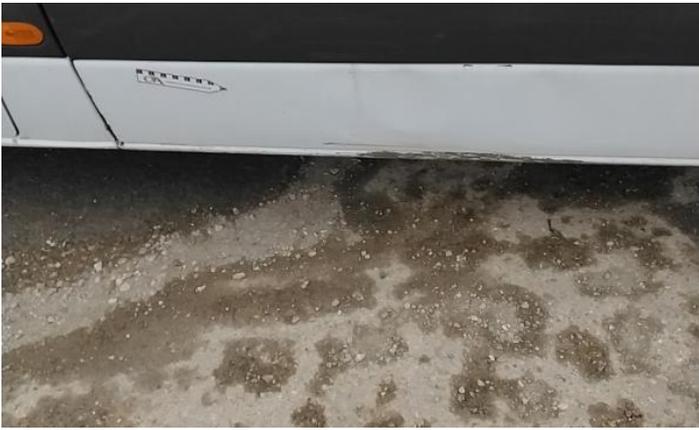
3: Sill ns
Dented
Over 30mm

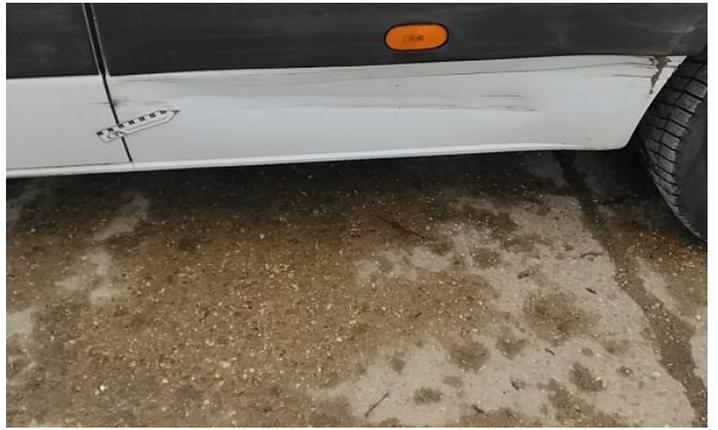
4: Sill ns
Dented
With Paint Damage

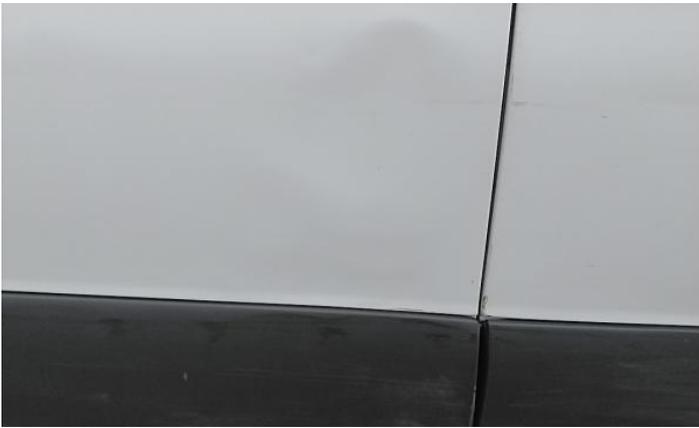
5: Door nsr
Dented
Over 30mm

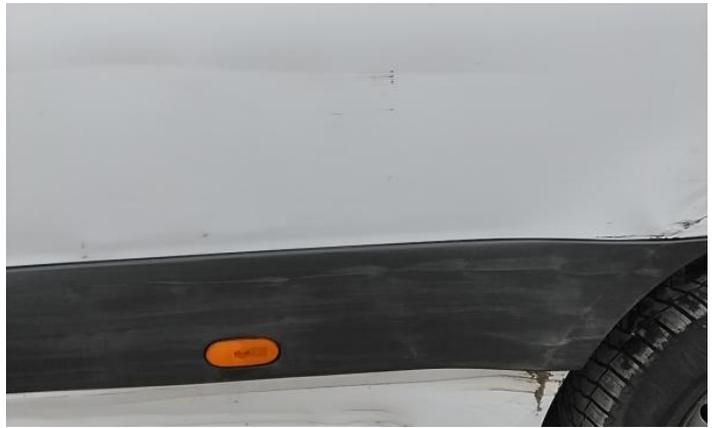
6: Qtr Panel nsr
Dented
Over 30mm

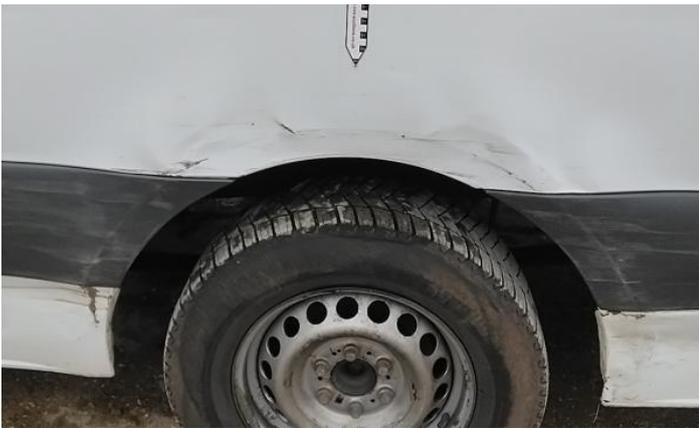
7: Qtr Panel nsr
Dented
Over 30mm

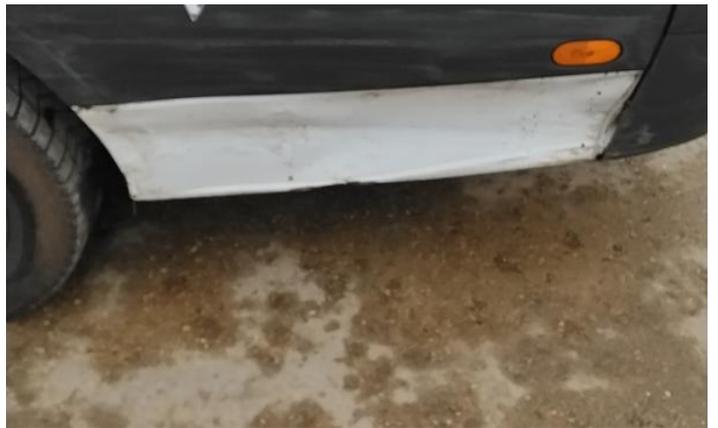
8: Sill ns
Dented
Over 30mm

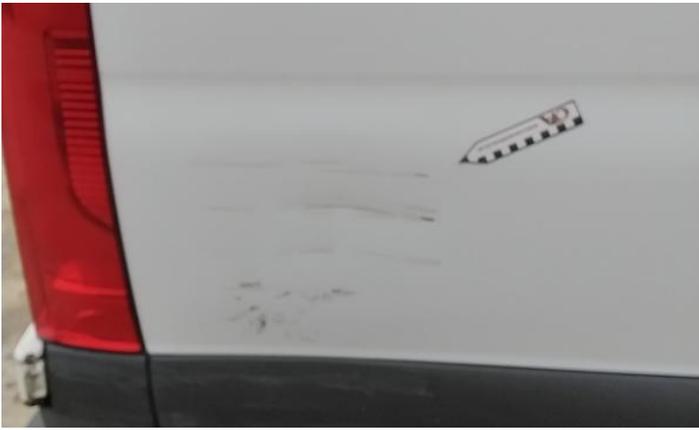
9: Qtr Panel osr
Scratched
Over 25mm Thru Paint

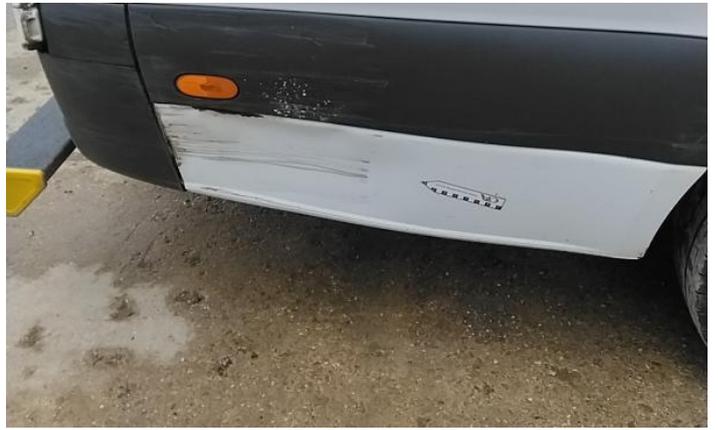
10: Sill os
Dented
Over 30mm

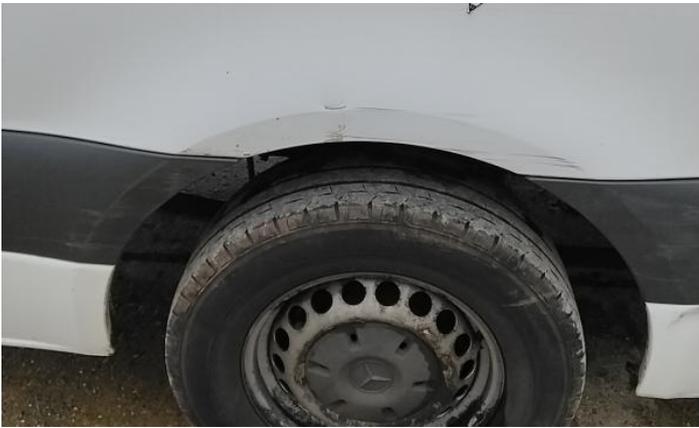
11: Qtr Panel osr
Dented
Over 30mm

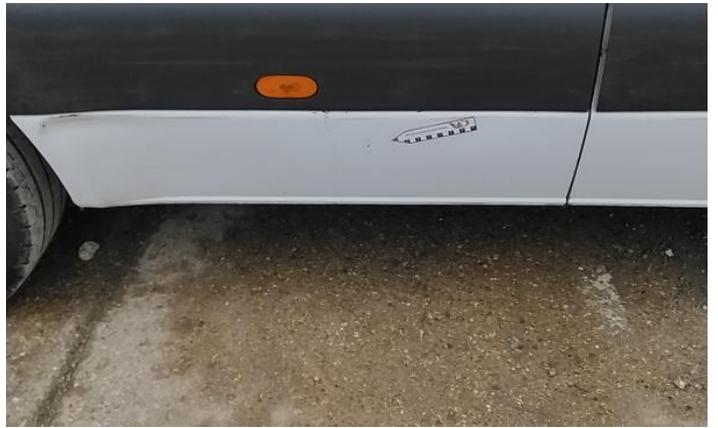
12: Sill os
Dented
Over 30mm

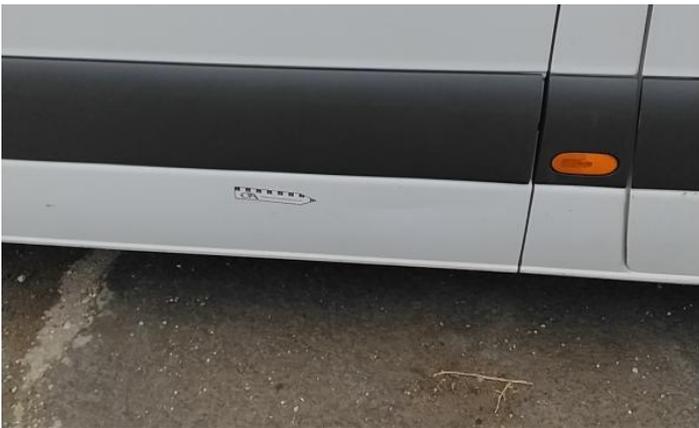
13: Sill os
Dented
Over 30mm
