# VEHICLE INSPECTION REPORT

**WN12CGO**

## Mercedes-Benz Sprinter 513 CDI

SIDE LOAD DOOR, VERSALIFT ET36NF (YEAR 2012), PLATFORM HEIGHT 12.9M

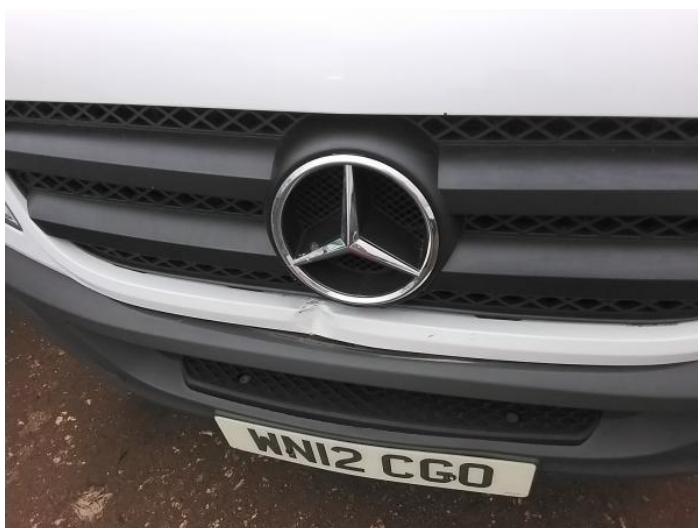
1: Bonnet  
Dented  
Over 30mm

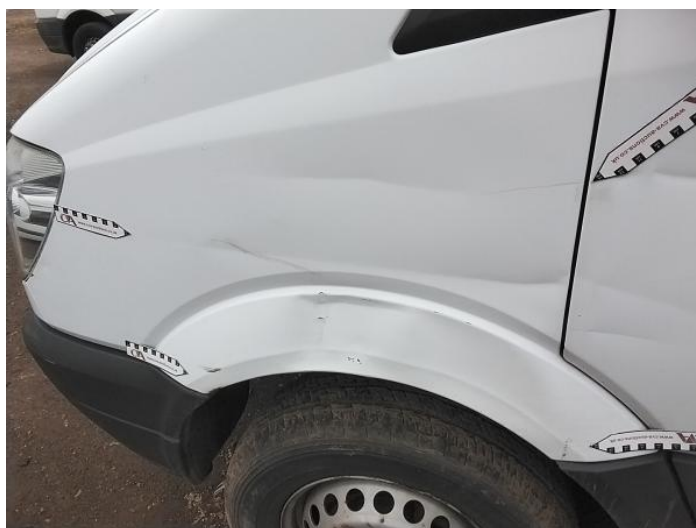
2: Wing nsf  
Dented  
Over 30% Of Panel

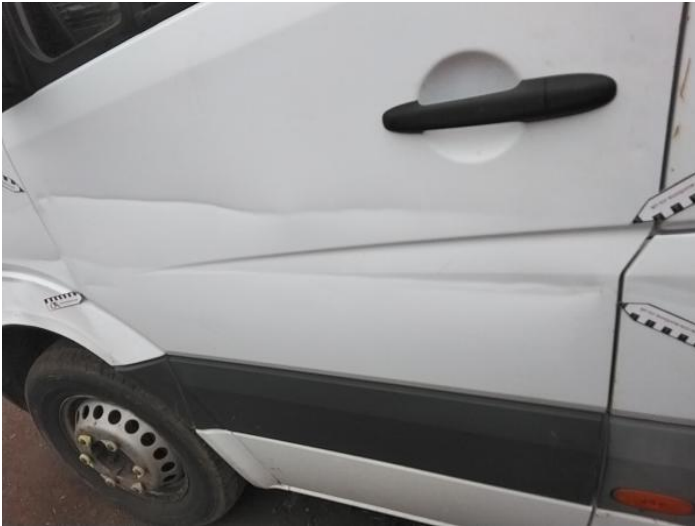
3: Door nsf  
Dented  
Over 30mm

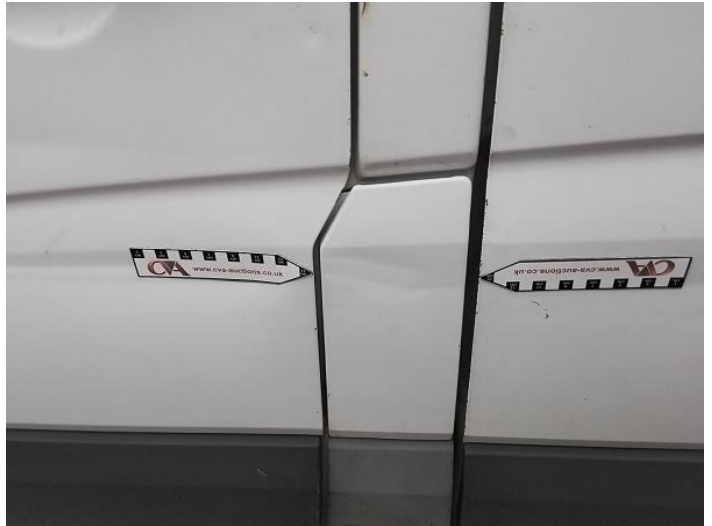
4: B Post ns  
Dented  
Over 30mm

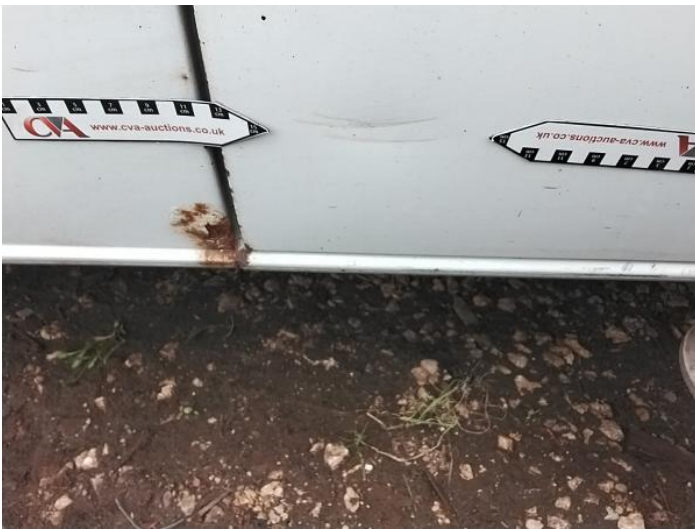
5: Qtr Panel nsr  
Dented  
Over 30mm

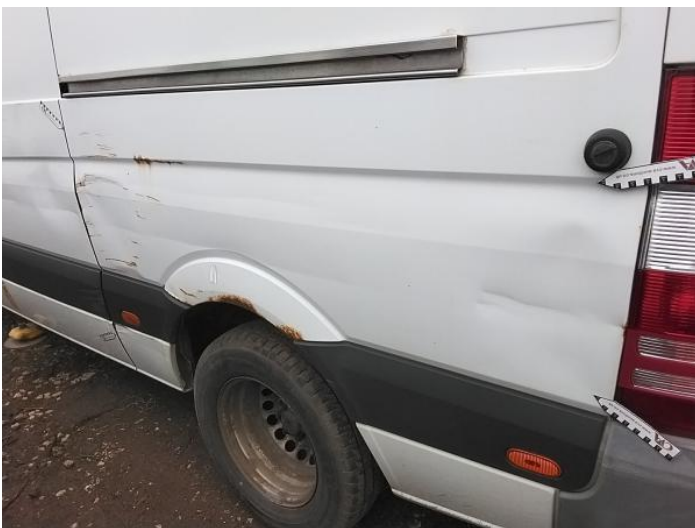
7: Qtr Panel nsr  
Dented  
Over 30% Of Panel

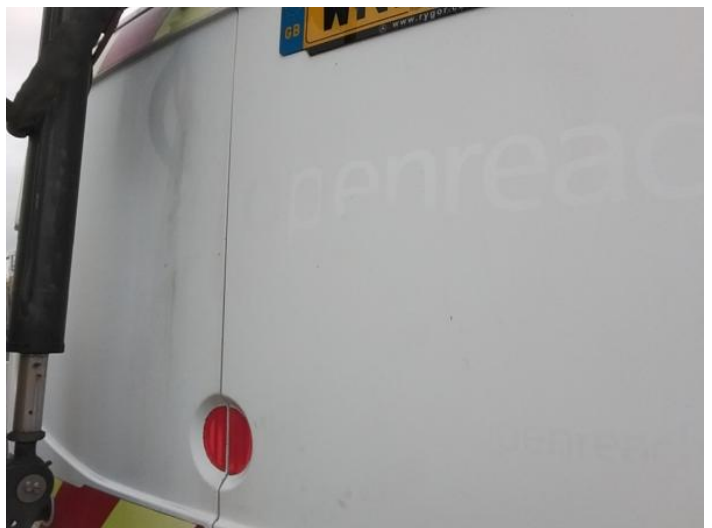
8: Door osr  
Chipped  
Multiple Chips

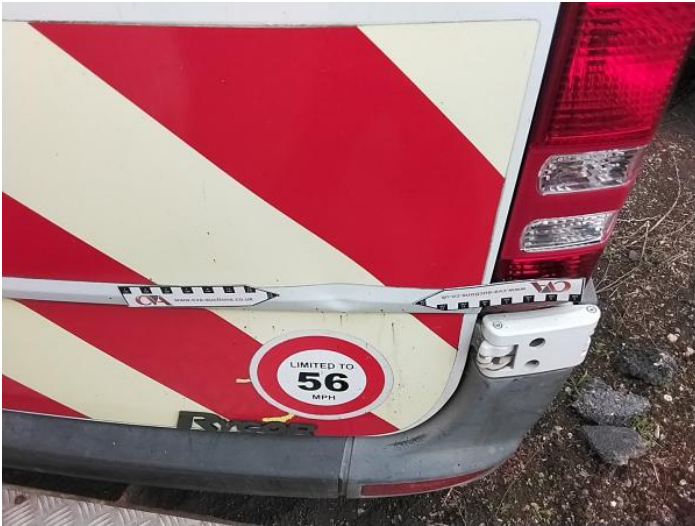
9: Door osr  
Dented  
Over 30mm

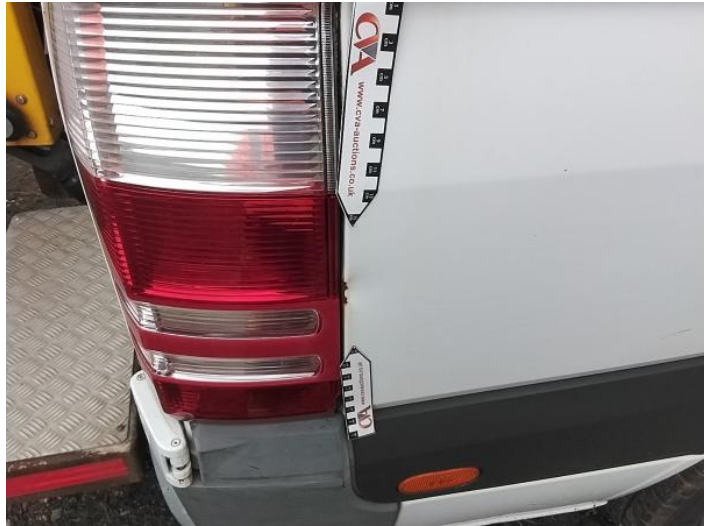
10: Qtr Panel osr  
Dented  
Over 30mm

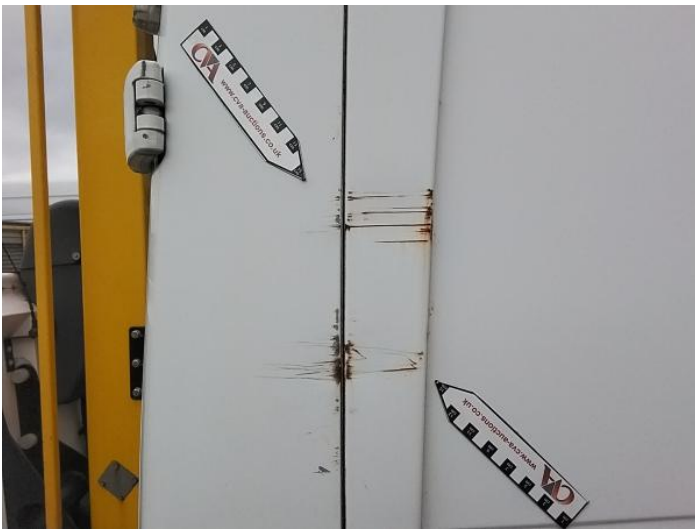
11: Qtr Panel osr  
Dented  
Over 30mm

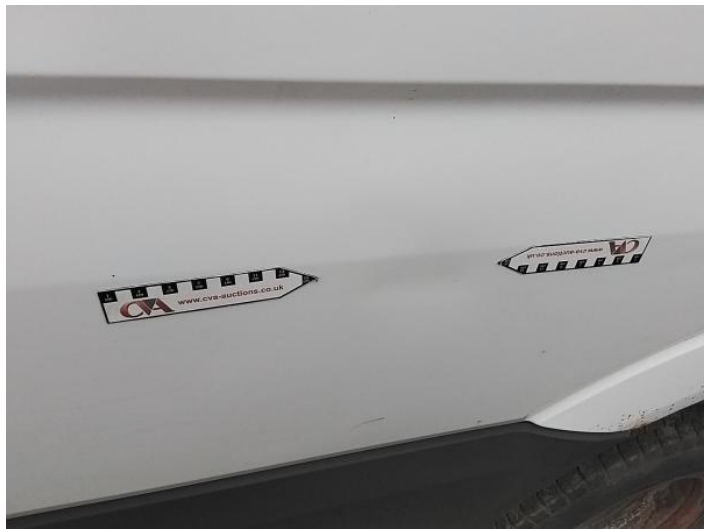
12: Qtr Panel osr  
Dented  
Over 30mm

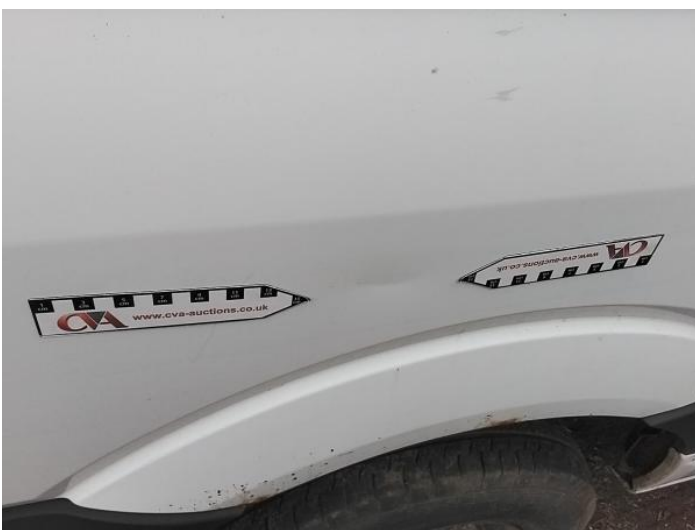
13: Qtr Panel osr  
Dented  
Over 30mm

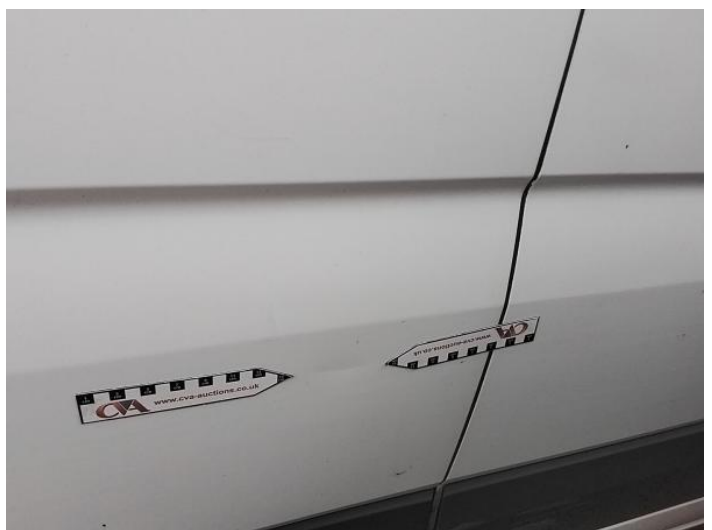
14: Qtr Panel osr  
Dented  
Over 30mm

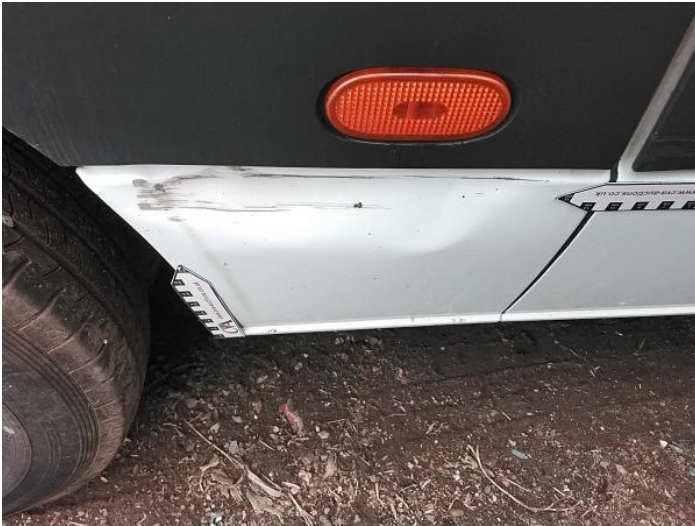
15: Qtr Panel osr  
Dented  
Over 30mm

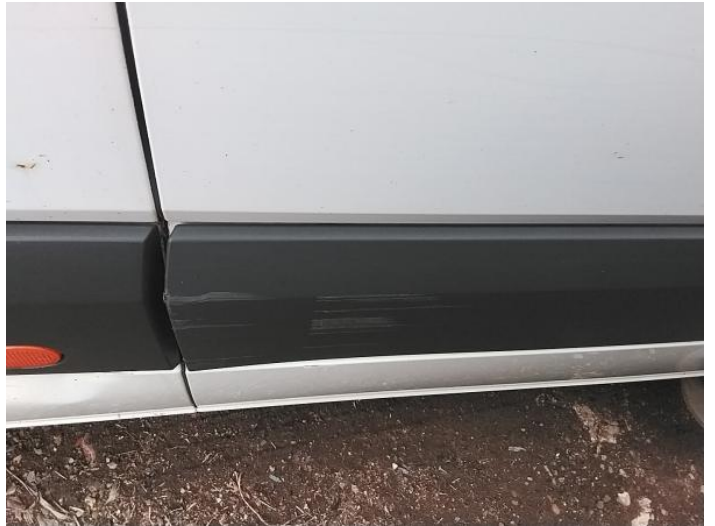
16: Qtr Panel Moulding os  
Scuffed (Unpainted)  
Over 100mm

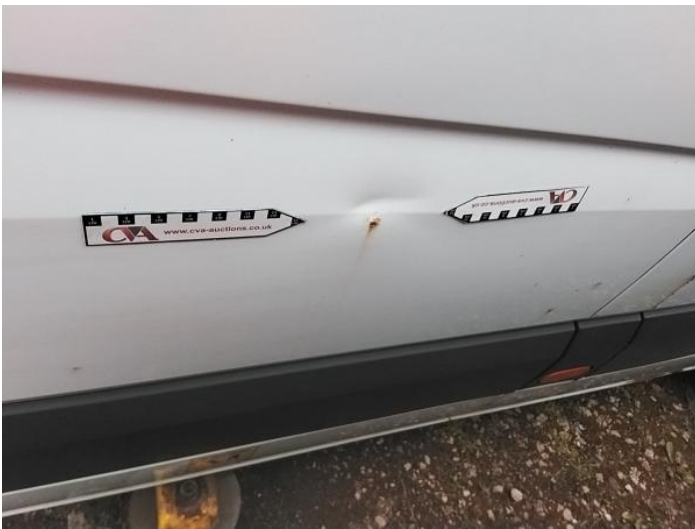
17: Qtr Panel osr  
Dented  
Over 30mm

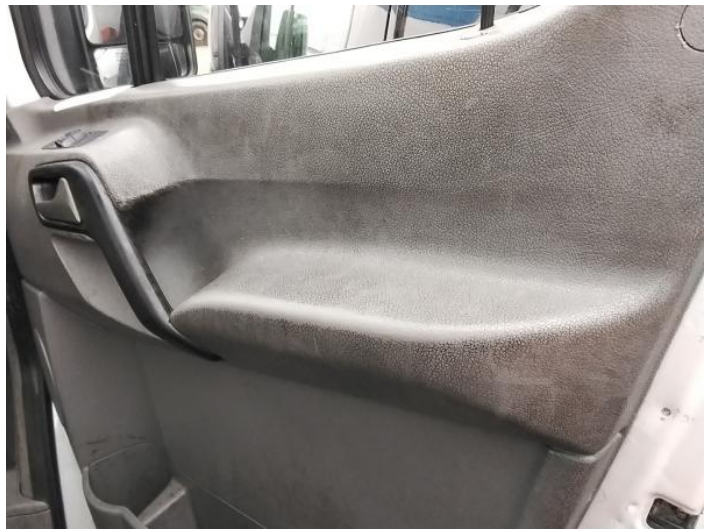
18: Door Pad osf  
Soiled  
Heavy

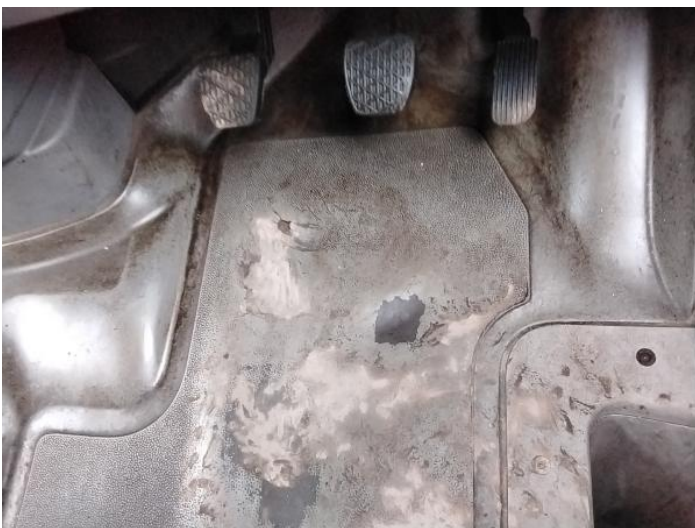
19: Carpets Front  
Torn  
Over 10mm

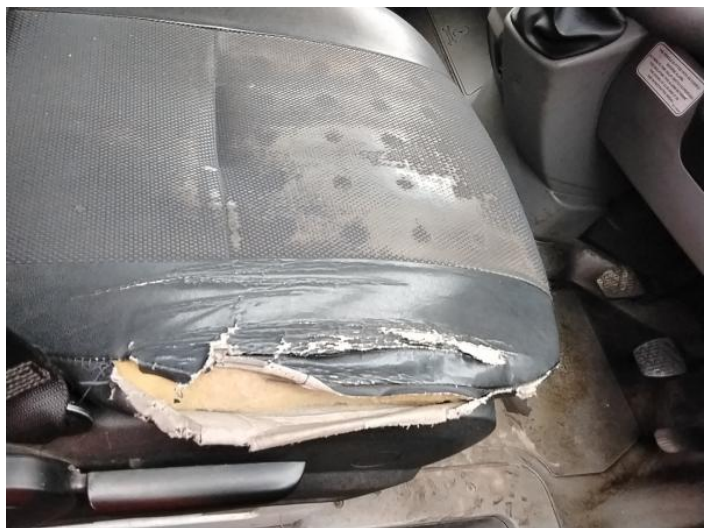
20: Seat Base Cover osf  
Torn  
Over 3mm

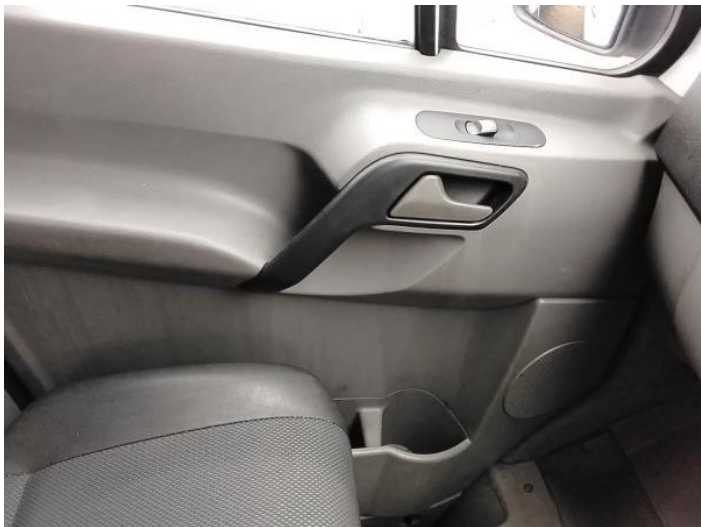
21: Door Pad nsf  
Soiled  
Heavy
