VEHICLE INSPECTION REPORT

PF20JYJ

Mercedes-Benz Sprinter 314 CDI

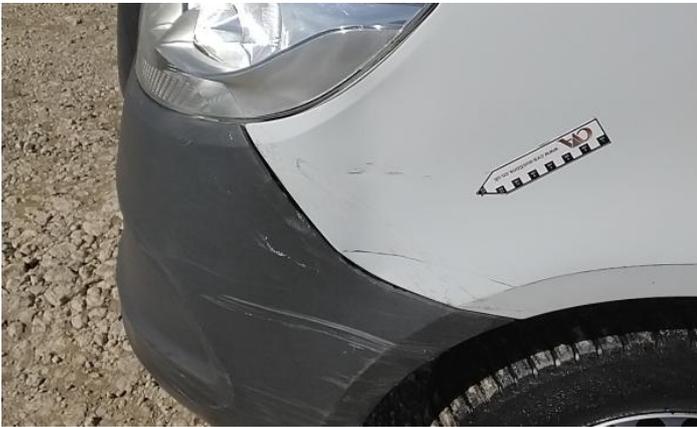
1: Wing nsf
Dented
Over 30mm

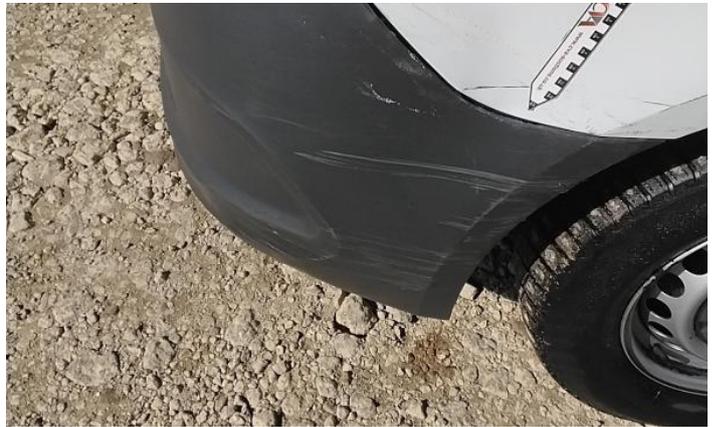
2: Bumper Front
Insecure
Action Required

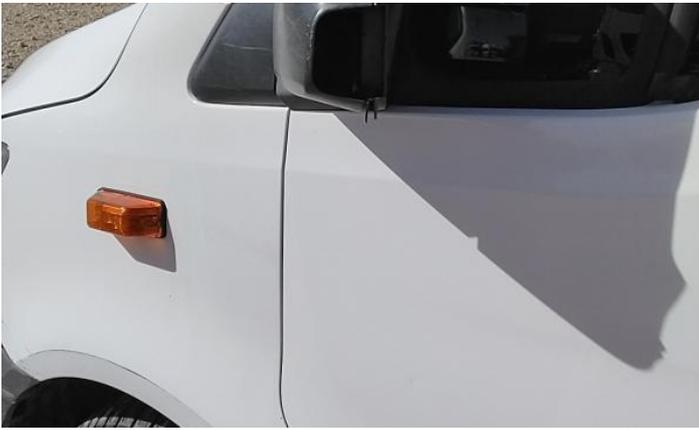
3: Door Mirror Assy nsf
Broken
Replace

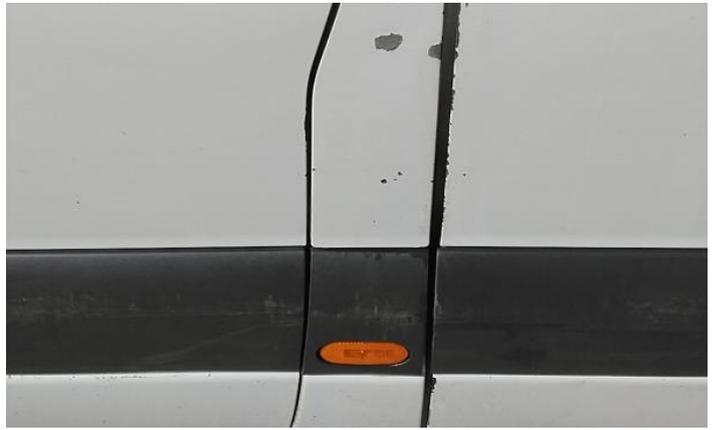
4: D Post ns
Chipped
Over 5mm

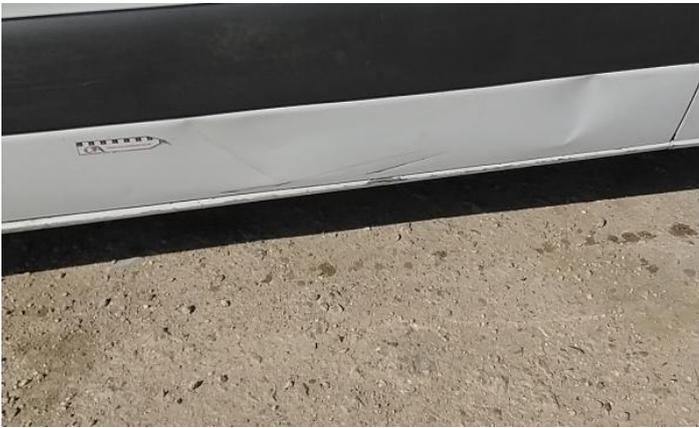
5: Sill ns
Dented
Over 30mm

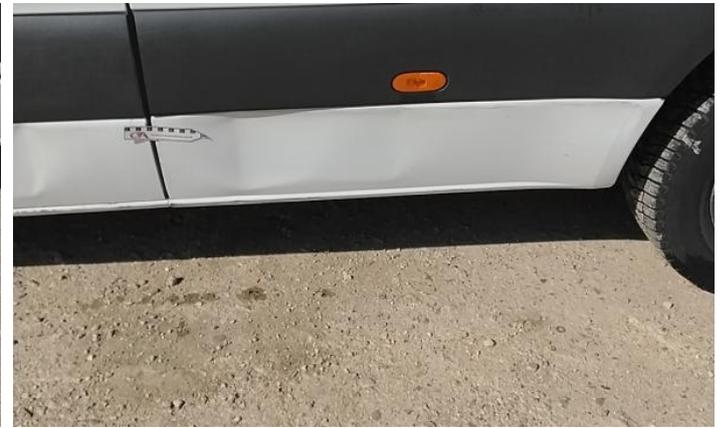
6: Sill ns
Dented
Over 30mm

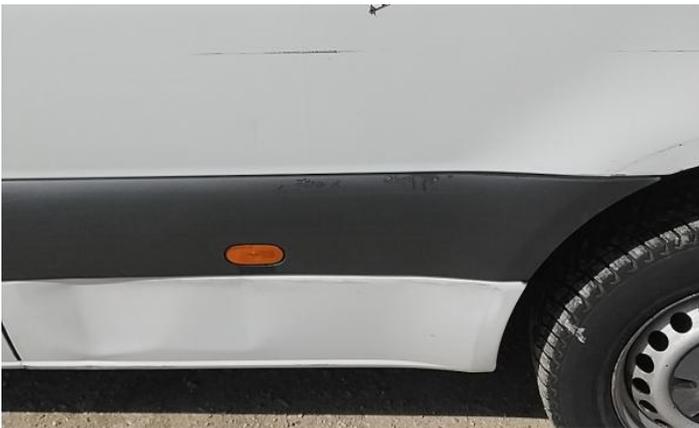
7: Qtr Panel nsr
Scratched
Over 25mm Thru Paint

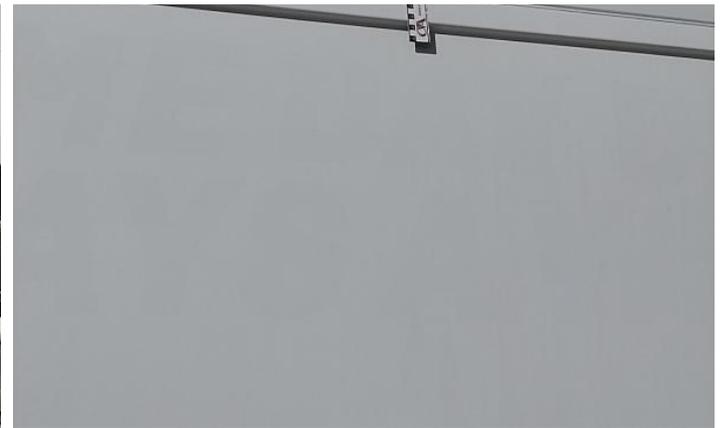
8: Qtr Panel nsr
Scratched
Over 25mm Thru Paint

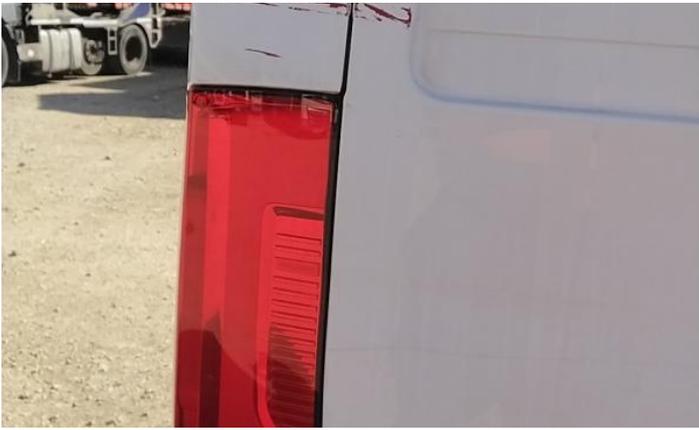
9: Qtr Panel osr
Scratched
Over 25mm Thru Paint

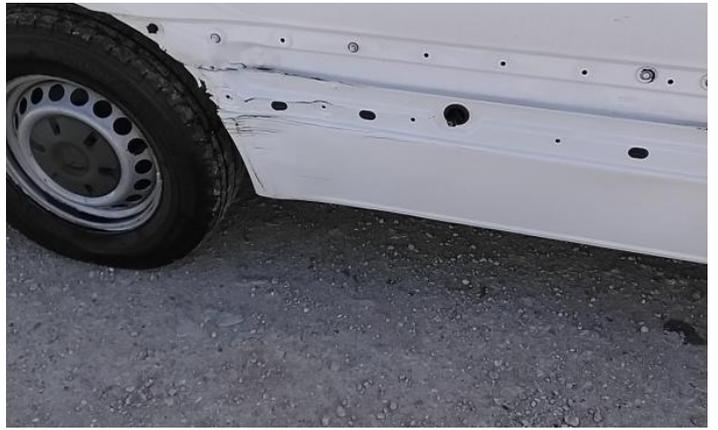
10: Sill Panel Trim os
Missing
Replace

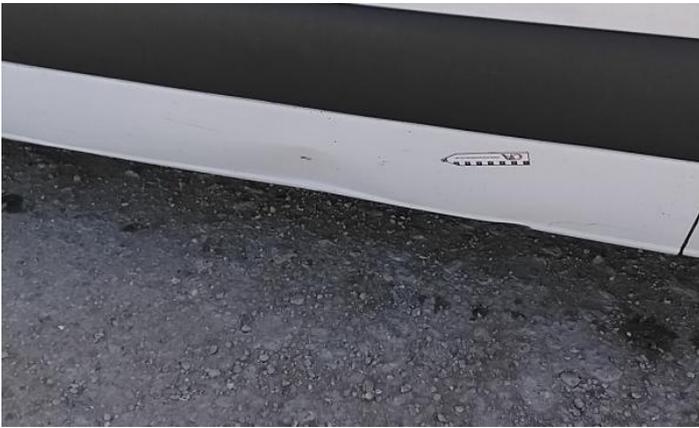
11: Sill os
Dented
Over 30mm

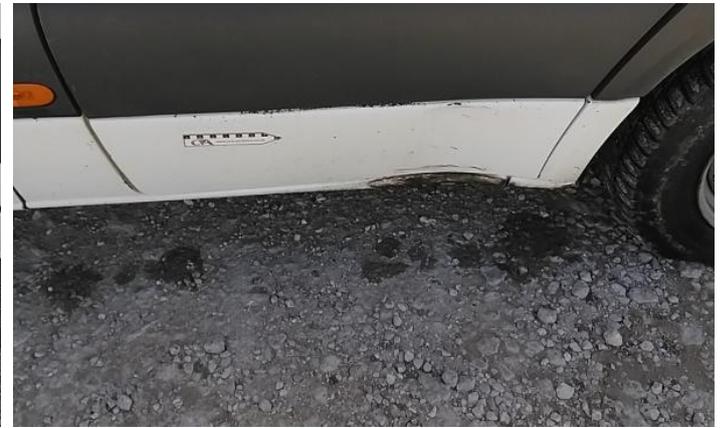
12: Sill os
Dented
Over 30mm

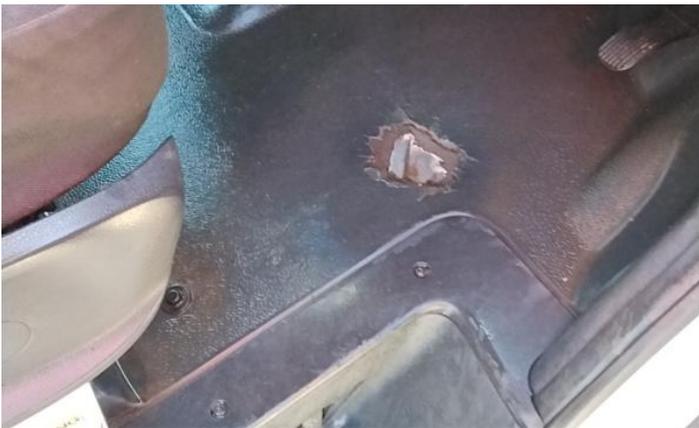
13: Carpets Front
Holed
Over 3mm
