VEHICLE INSPECTION REPORT

BL64AEX

Mercedes-Benz Actros 1840

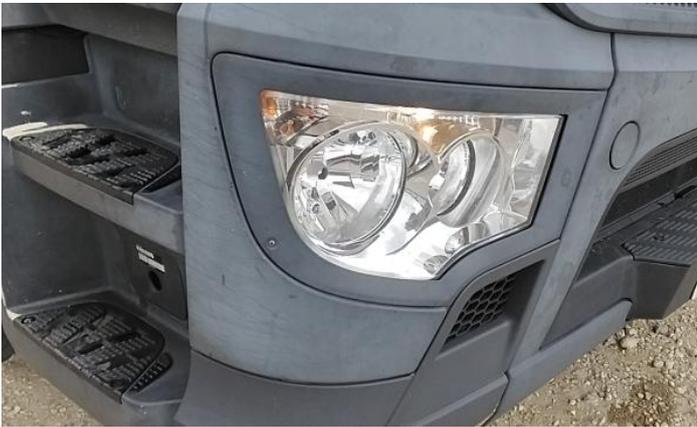
1: Bumper Front Moulding
Scuffed (Unpainted)
Over 100mm

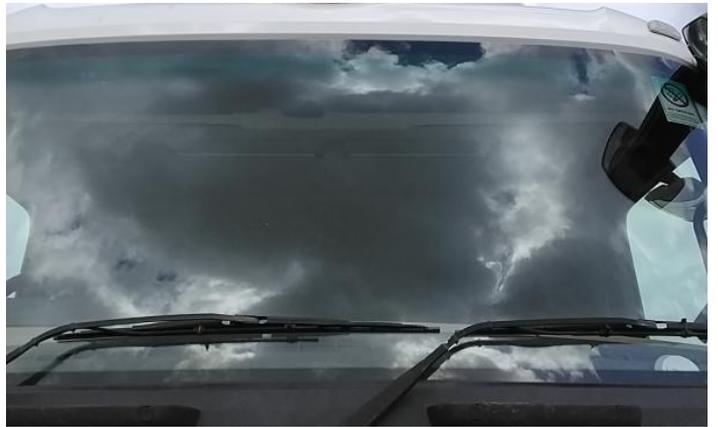
2: Screen Front
Chipped
Up To 10mm

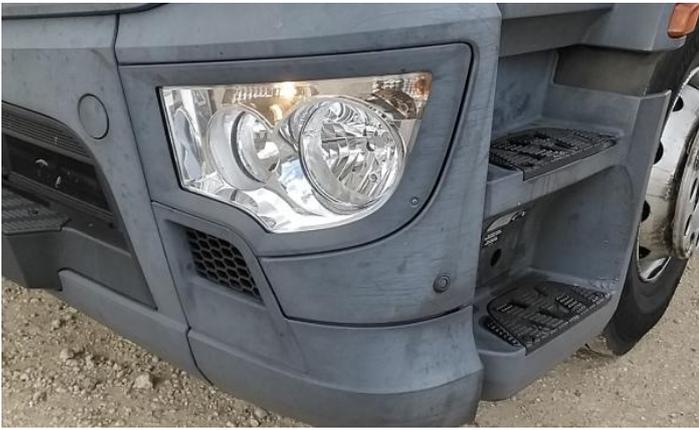
3: Bumper Front Moulding
Scuffed (Unpainted)
Over 100mm

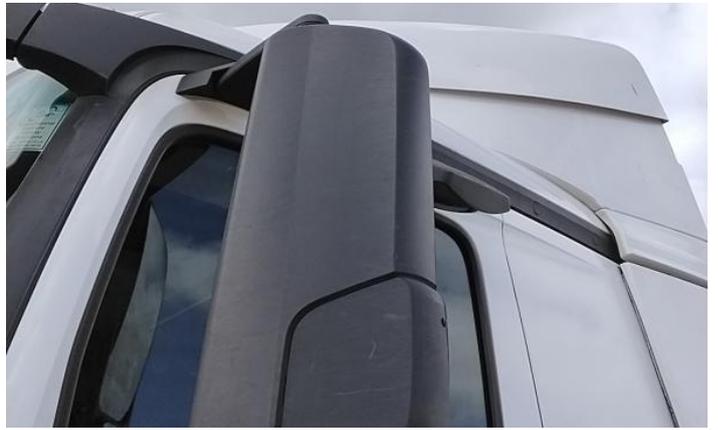
4: Door Mirror Assy nsf
Scuffed (Unpainted)
Over 100mm

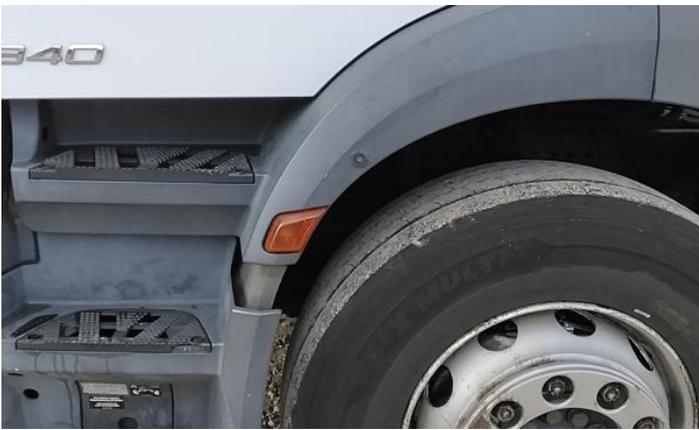
5: Wing Front Arch Extension ns
Scuffed (Unpainted)
Over 100mm

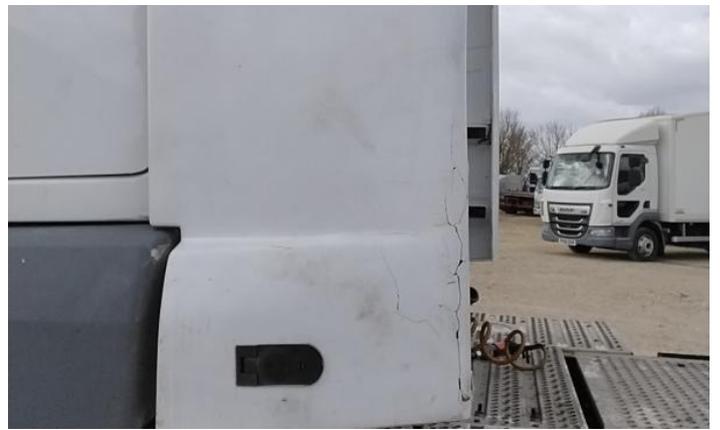
6: Qtr Panel nsr
Cracked
Replace

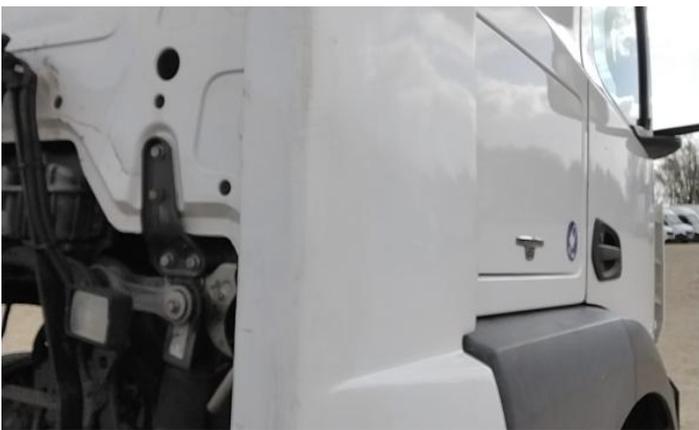
7: Qtr Panel osr
Cracked
Replace

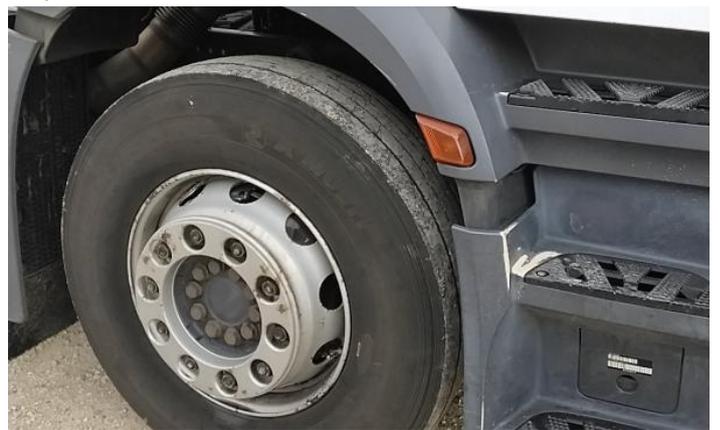
8: Wing Front Arch Extension os
Scuffed (Unpainted)
Over 100mm

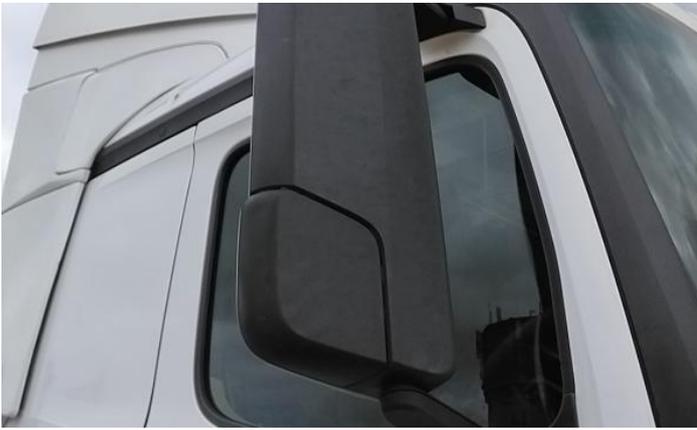
9: Door Mirror Assy osf
Scuffed (Unpainted)
UpTo 100mm

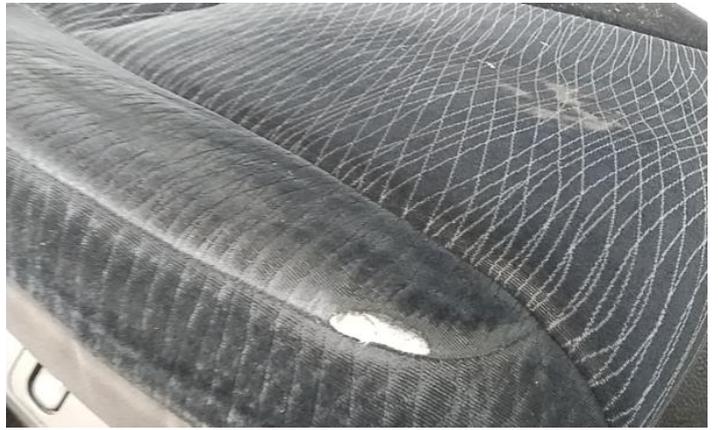
10: Seat Base Cover osf
Holed
Over 3mm
