VEHICLE INSPECTION REPORT

PO13ECJ

Daf LF 45.140

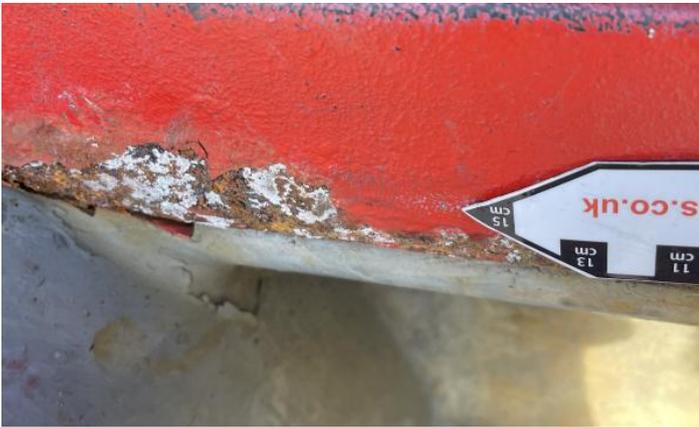
1: Sill os
Rusted
Over 5mm

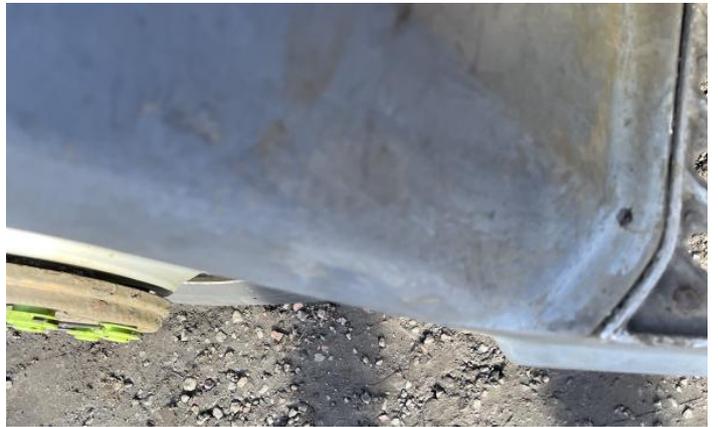
2: Door Moulding osf
Scuffed (Unpainted)
Over 100mm

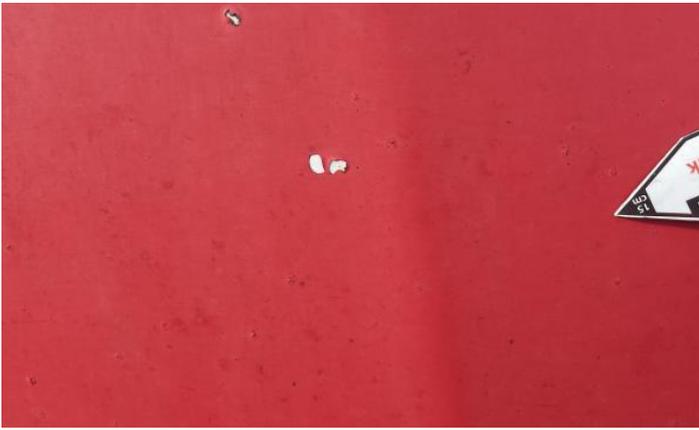
3: Bonnet
Chipped
Multiple Chips

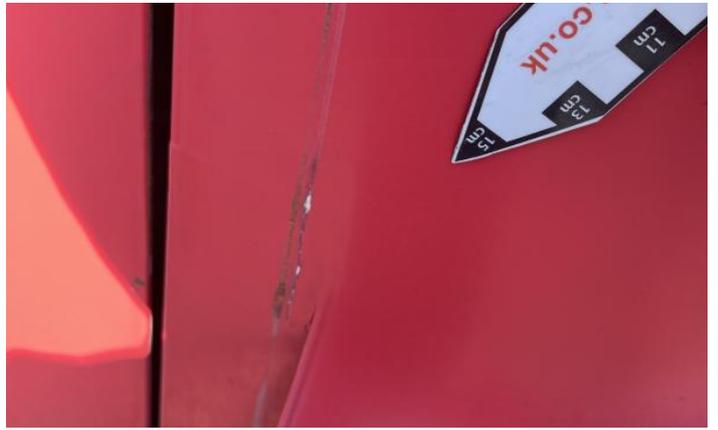
4: Wing osf
Scratched
Over 25mm Not Thru Paint

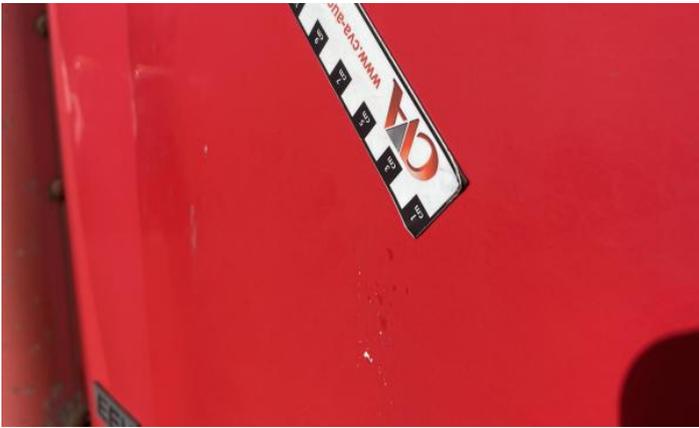
5: Door osf
Dented
With Paint Damage

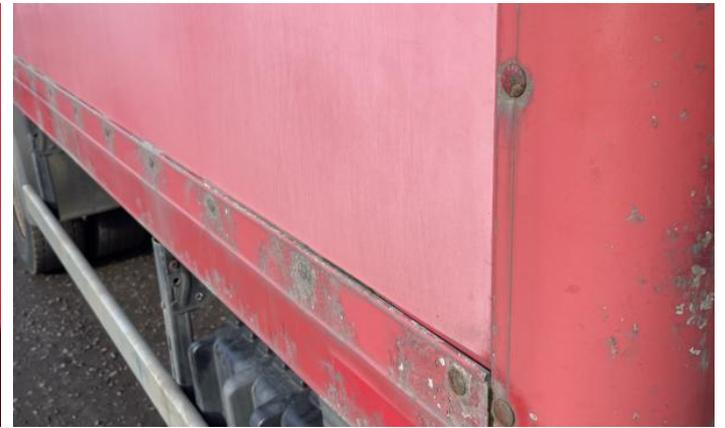
6: Qtr Panel osr
Rusted
Over 5mm

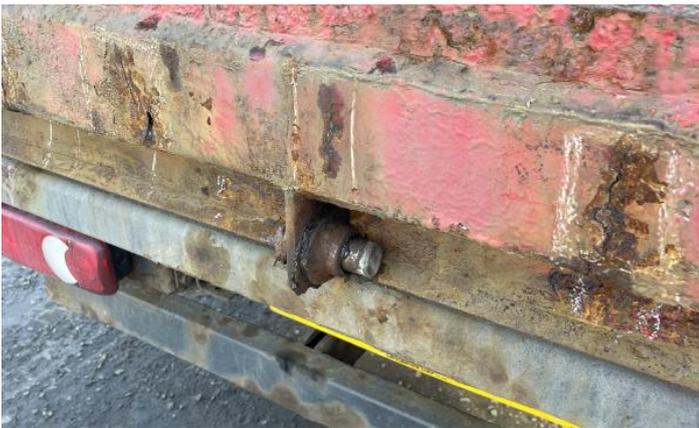
7: Tailgate
Rusted
Over 5mm

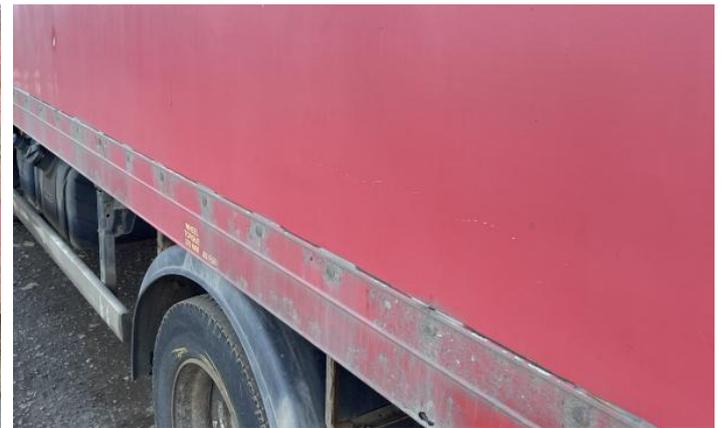
8: Qtr Panel nsr
Rusted
Over 5mm

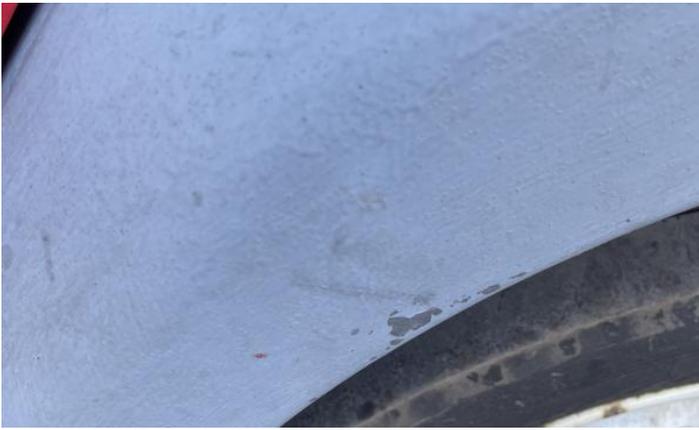
9: Door Moulding nsf
 Scuffed (Unpainted)
 Over 100mm
