VEHICLE INSPECTION REPORT

PF20JYC

Mercedes-Benz Sprinter 314 CDI

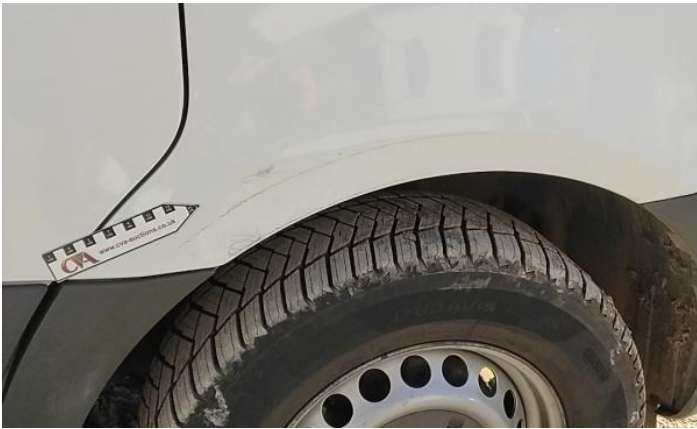
1: Wing of
Dented
With Paint Damage

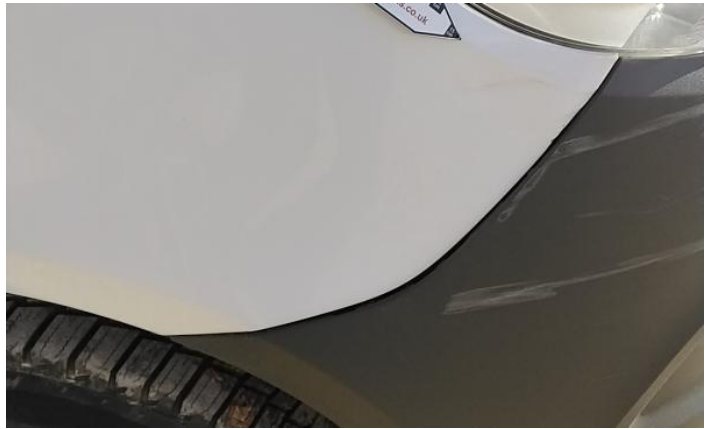
2: Wing of
Dented
With Paint Damage

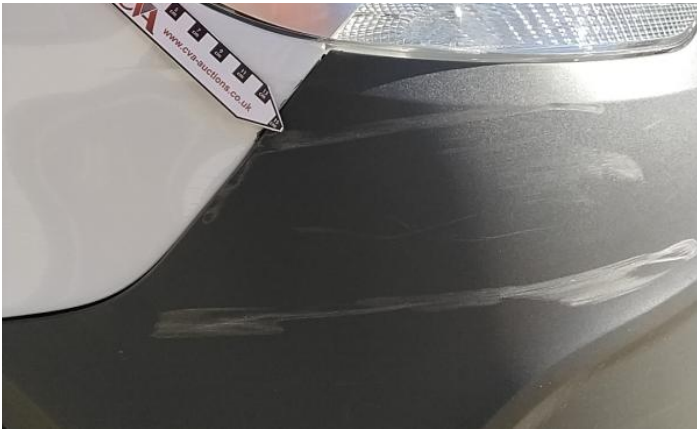
3: Bumper Front Moulding
Scuffed (Unpainted)
Over 100mm

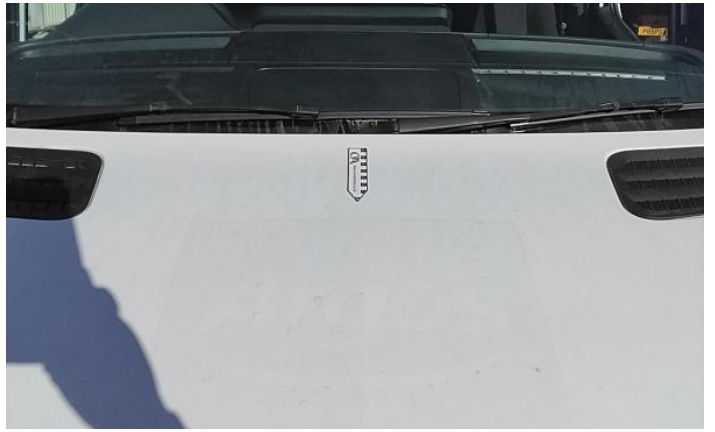
4: Bonnet
Chipped
Multiple Chips

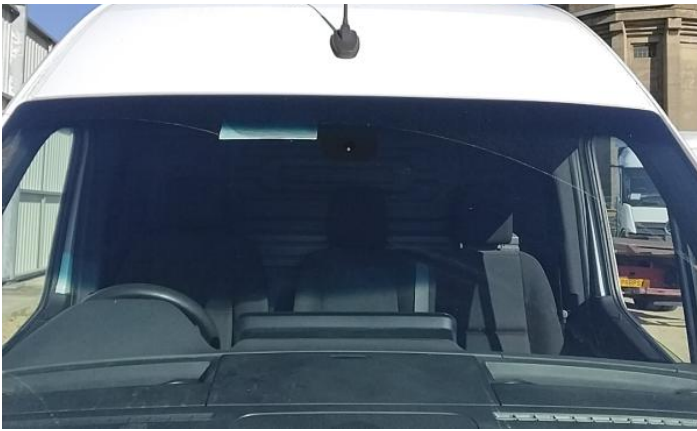
5: Screen Front
Chipped
Up To 10mm

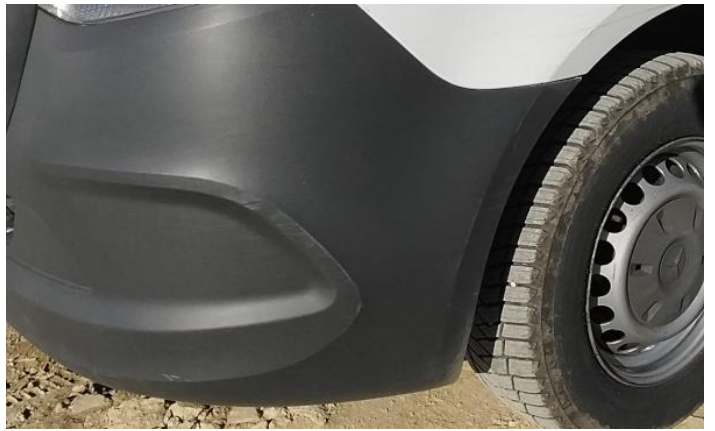
6: Bumper Front Moulding
Scuffed (Unpainted)
Over 100mm

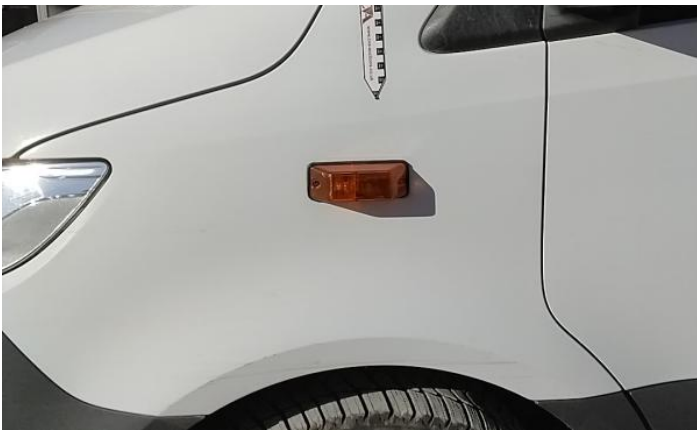
7: Wing nsf
Scratched
Over 25mm Thru Paint

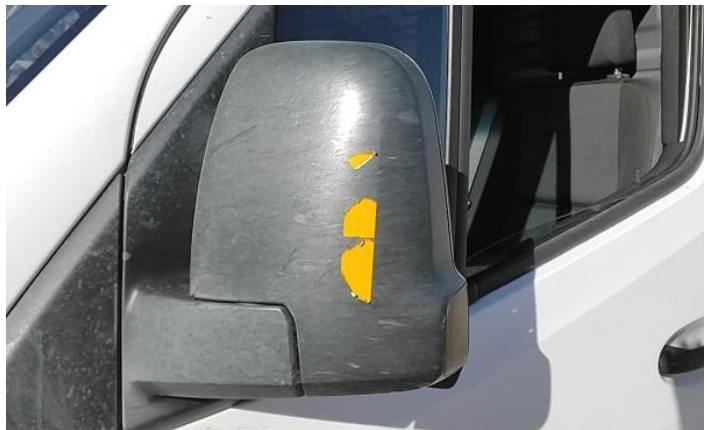
8: Door Mirror Assy nsf
Scuffed (Unpainted)
Over 100mm

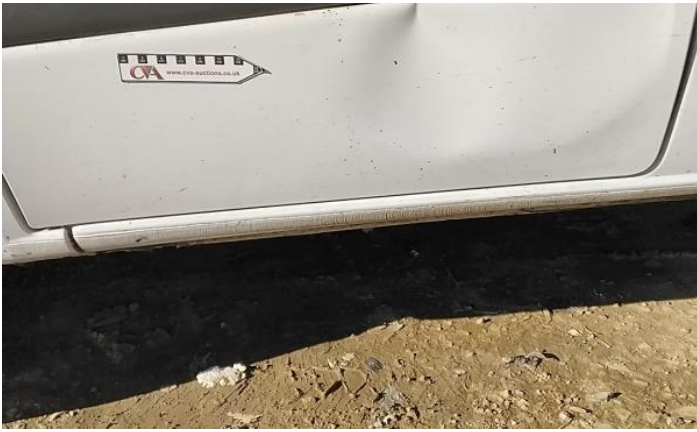
9: Door nsf
Dented
With Paint Damage

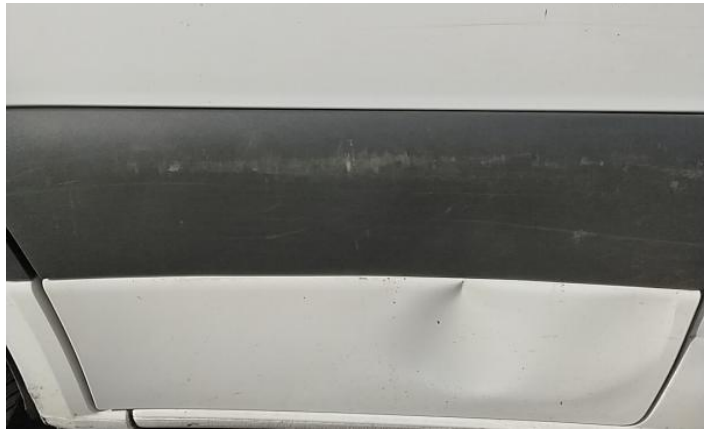
10: Door Moulding nsf
Scuffed (Unpainted)
Over 100mm

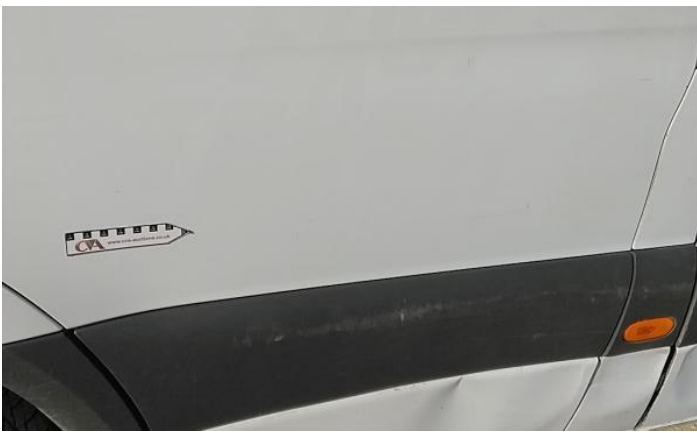
11: Door nsf
Scratched
Over 25mm Not Thru Paint

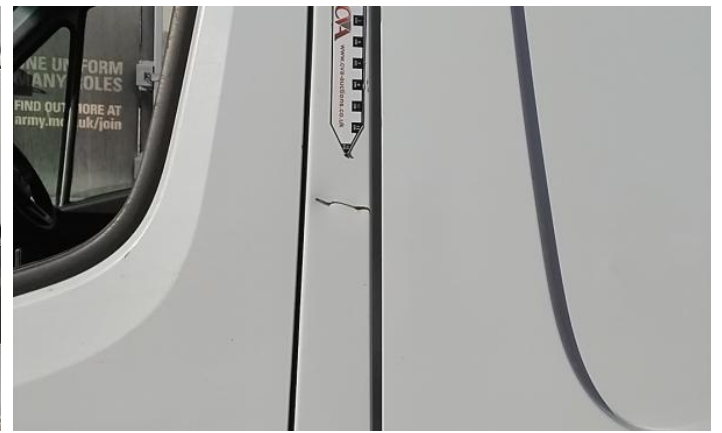
12: B Post ns
Scratched
Up To 25mm Thru Paint

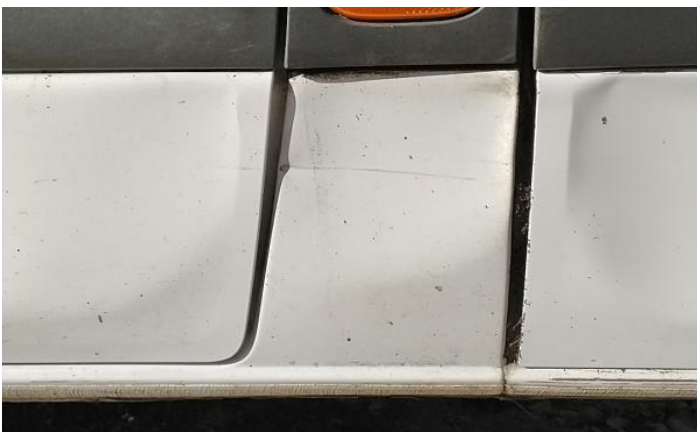
13: B Post ns
Dented
With Paint Damage

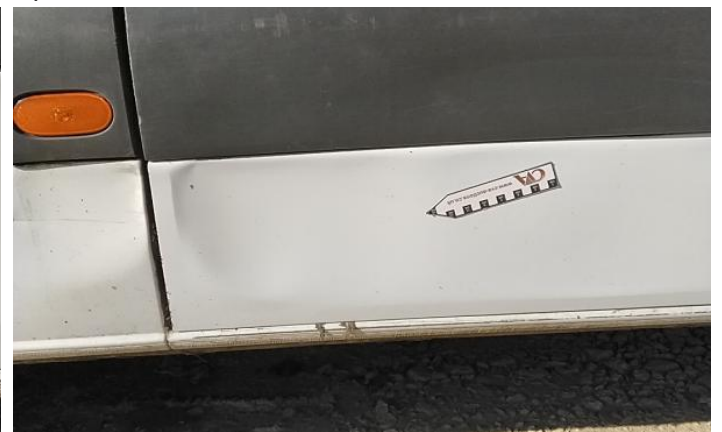
14: Door nsr
Dented
Over 30mm

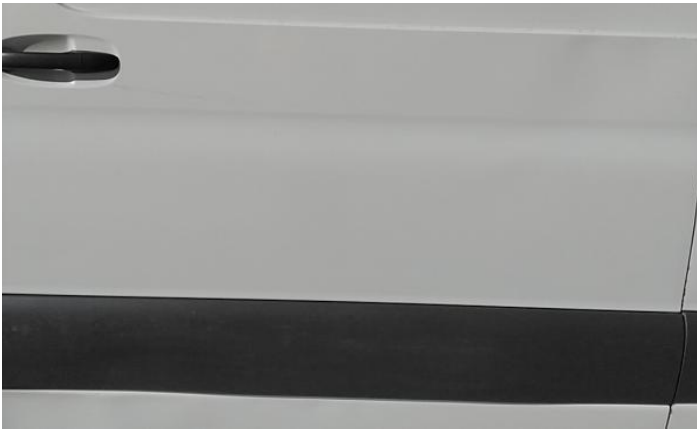
15: Door Moulding nsr
Scuffed (Unpainted)
Over 100mm

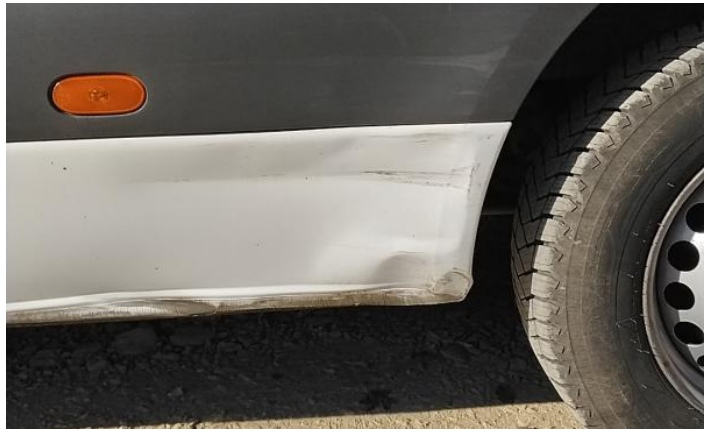
16: Qtr Panel nsr
Dented
With Paint Damage

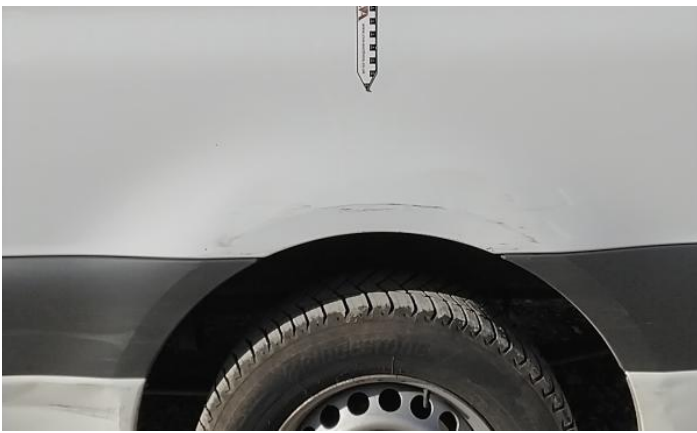
17: Qtr Panel nsr
Scratched
Over 25mm Not Thru Paint

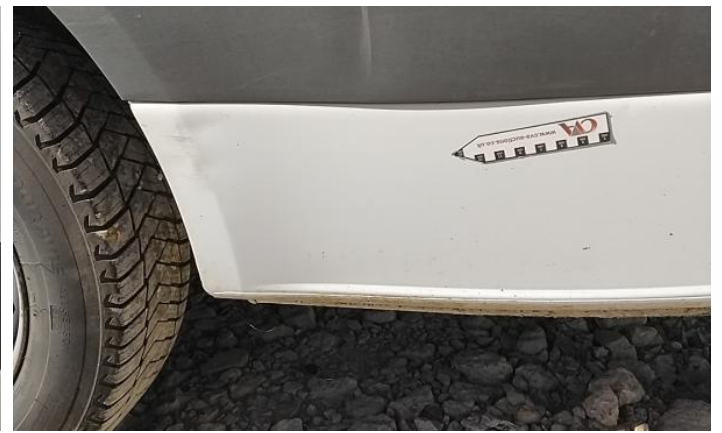
18: Qtr Panel nsr
Dented
Between 10mm + 30mm

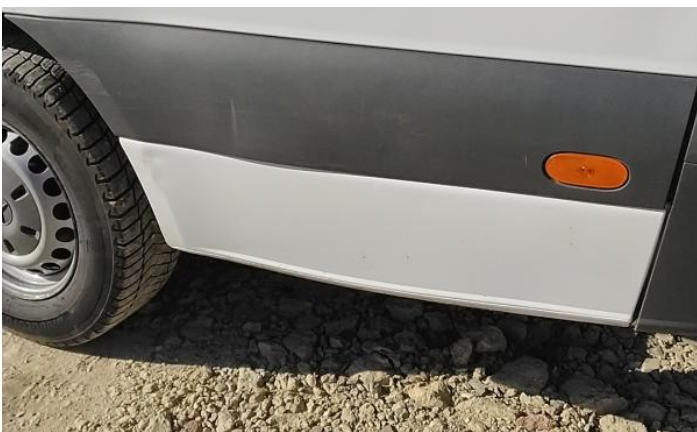
19: Qtr Panel Moulding ns
Scuffed (Unpainted)
Over 100mm

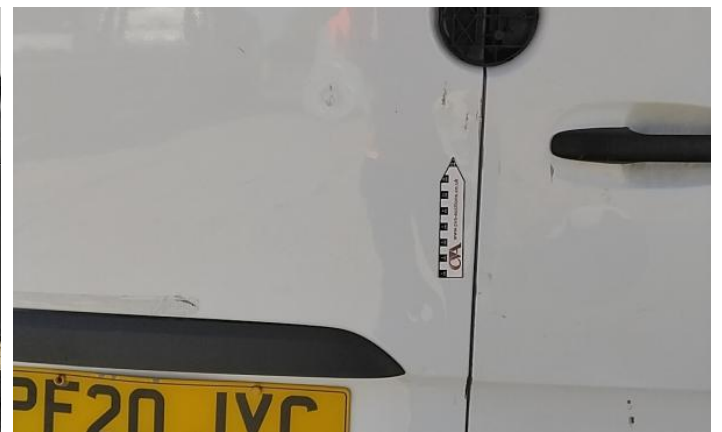
20: Door nsr
Dented
With Paint Damage

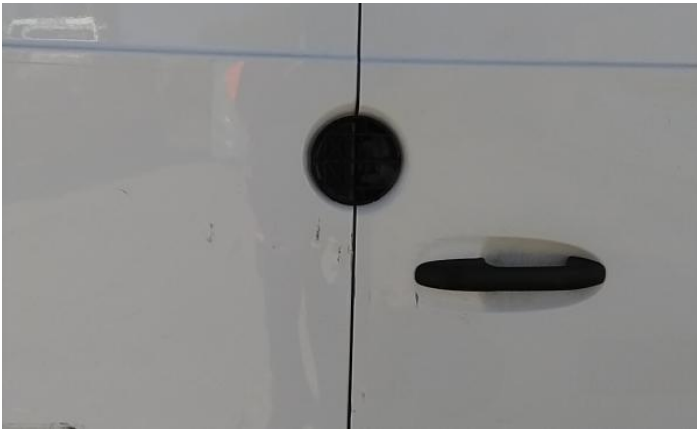
21: Badgedecal Rear
Missing
Replace

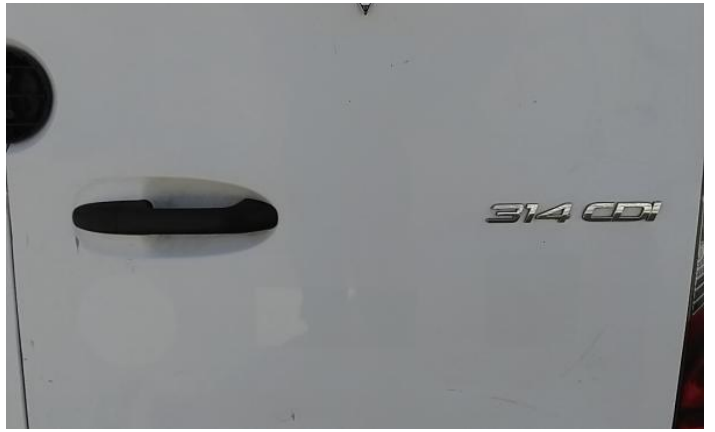
22: Door osr
Dented
Over 30mm

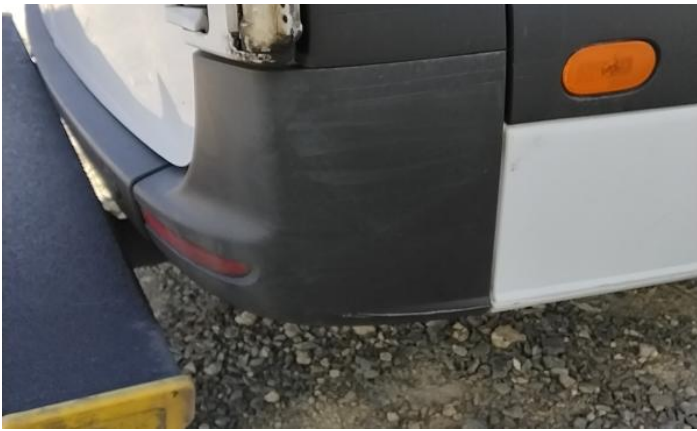
23: Bumper Rear Moulding
Scuffed (Unpainted)
Over 100mm

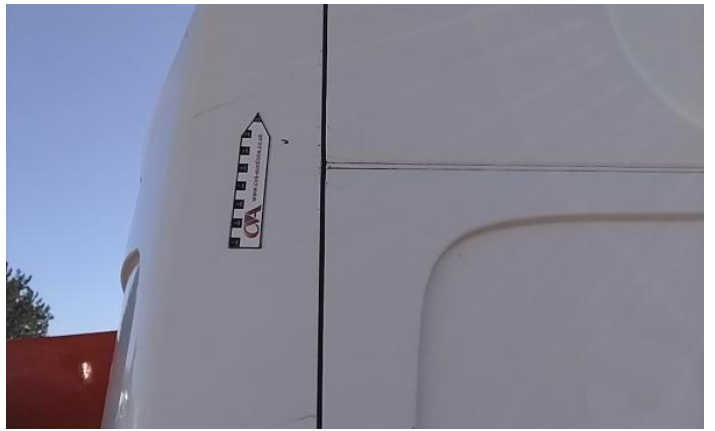
24: Qtr Panel osr
Dented
Over 30mm

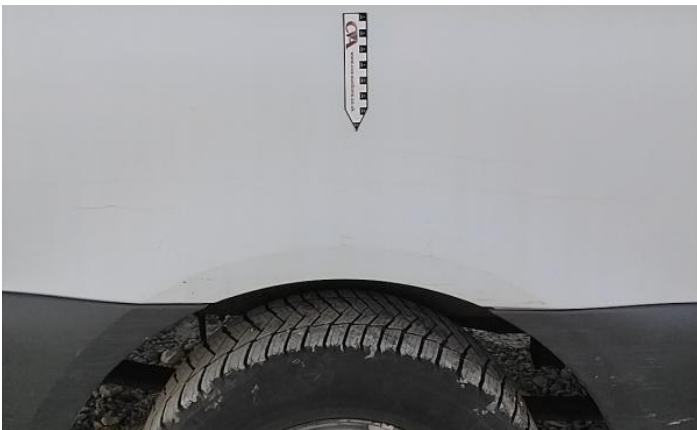
25: Qtr Panel osr
Scratched
Over 25mm Not Thru Paint

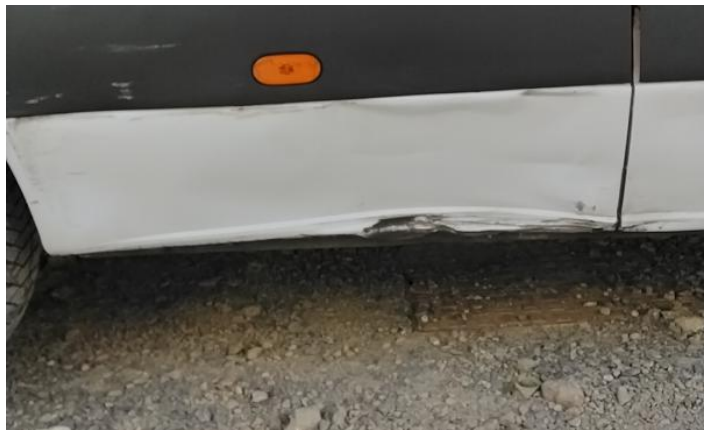
26: Qtr Panel osr
Dented
With Paint Damage

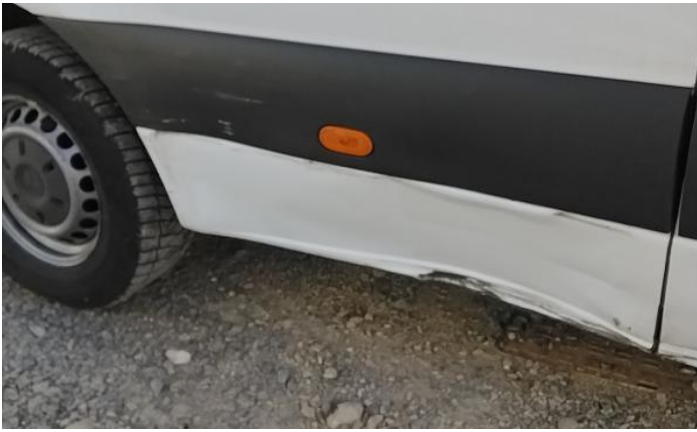
27: Qtr Panel Trim os
Scuffed
Over 25mm

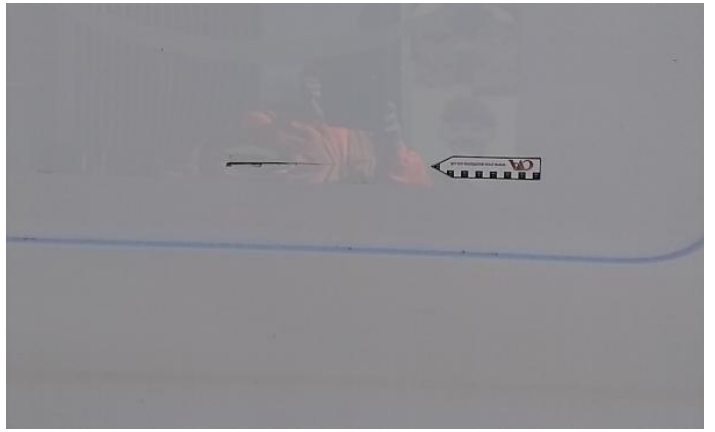
28: Qtr Panel osr
Dented
With Paint Damage

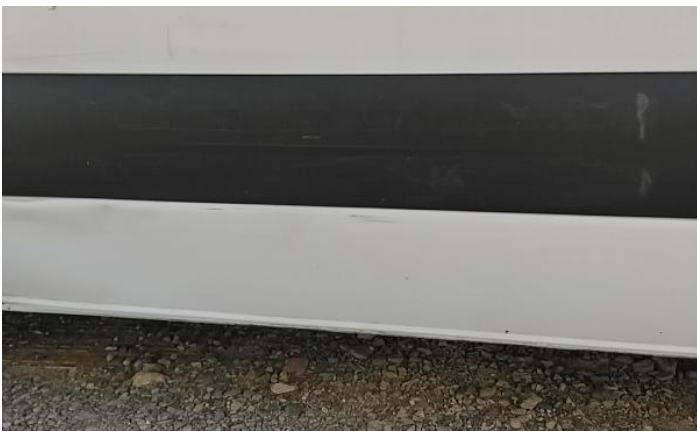
29: Qtr Panel Moulding os
Scuffed (Unpainted)
Over 100mm

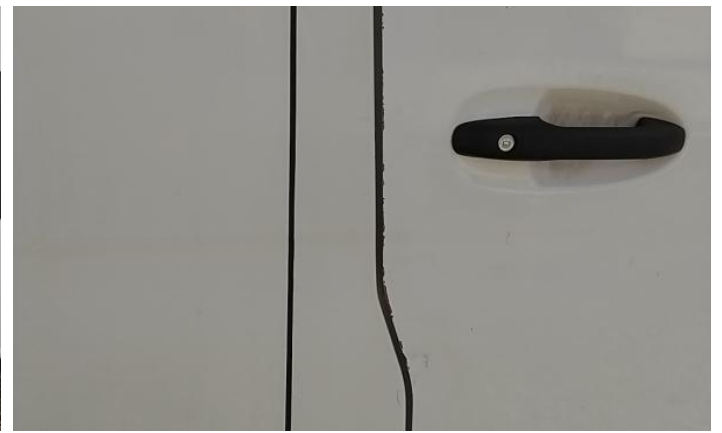
30: Door osf
Chipped
Edge Chip

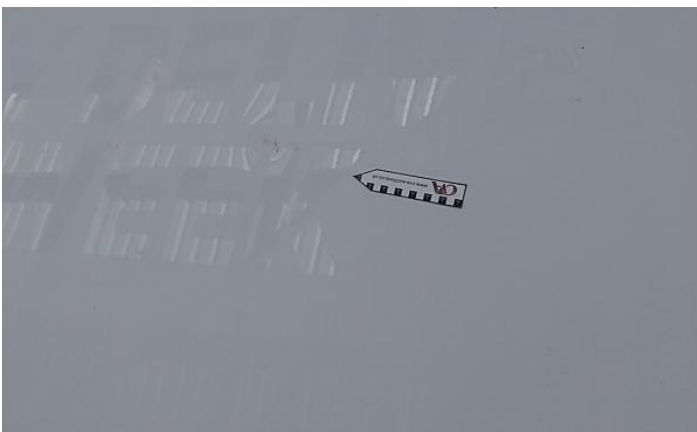
31: Qtr Panel osr
Dented
With Paint Damage

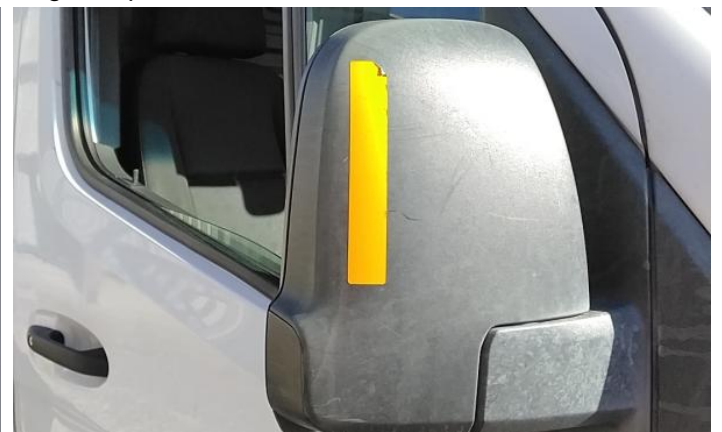
32: Door Mirror Assy osf
Scuffed (Unpainted)
Over 100mm

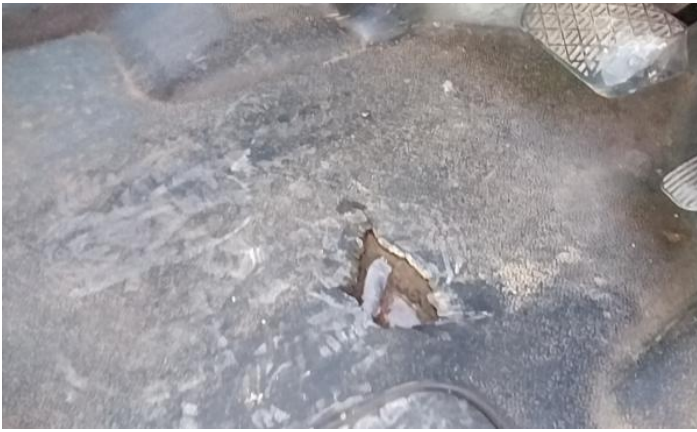
33: Carpets Front
 Holed
 Over 3mm
