VEHICLE INSPECTION REPORT

PJ20WSZ

Mercedes-Benz Sprinter 314 CDI

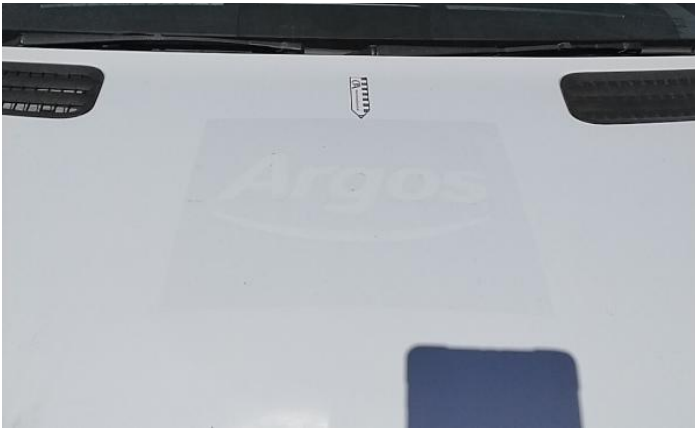
1: Bonnet
Chipped
Multiple Chips

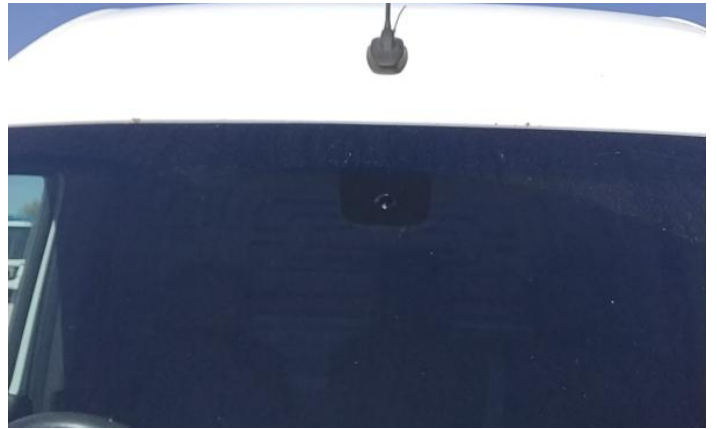
2: Panel Front
Chipped
Multiple Chips

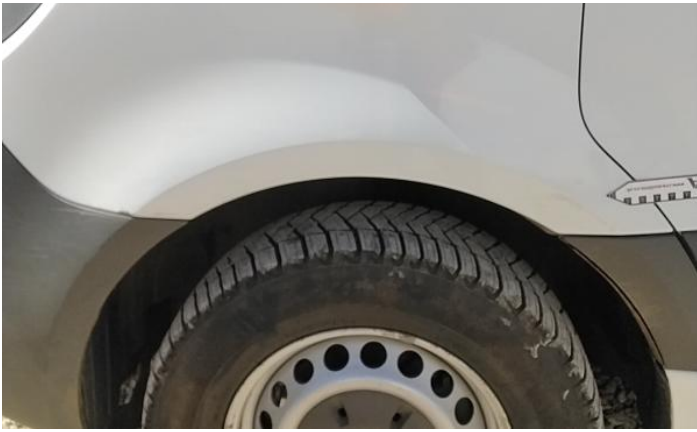
3: Wing nsf
Scratched
Over 25mm Not Thru Paint

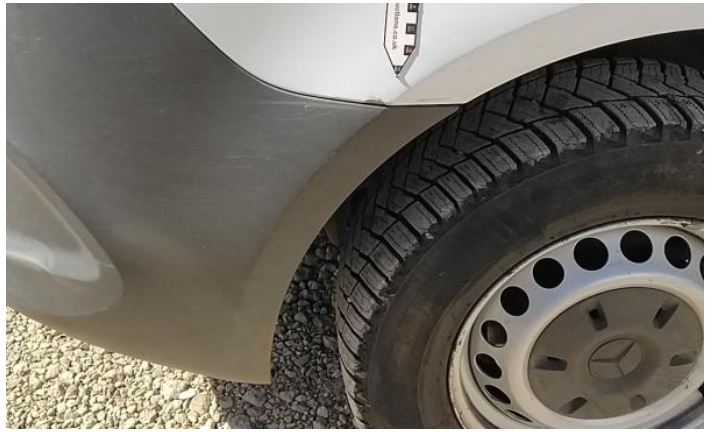
4: Wing nsr
Scratched
Up To 25mm Thru Paint

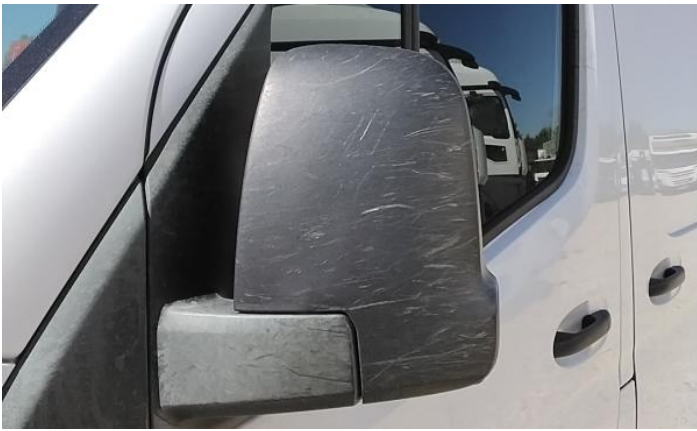
5: Door Mirror Assy nsf
Scuffed (Unpainted)
Over 100mm

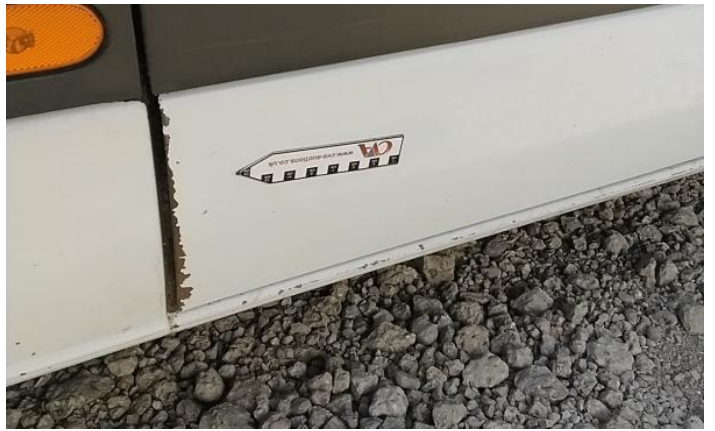
6: Door nsr
Scratched
Over 25mm Thru Paint

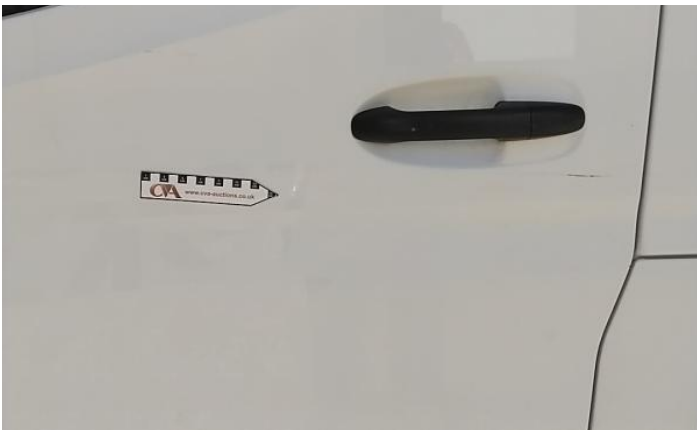
7: Door nsf
Scratched
Over 25mm Not Thru Paint

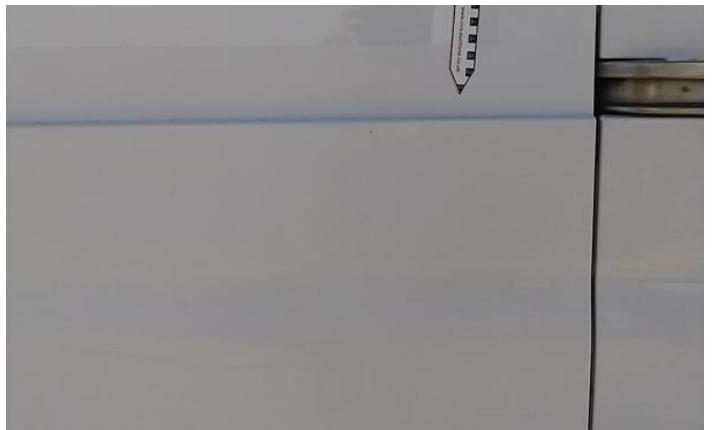
8: Door nsr
Dented
Over 30mm

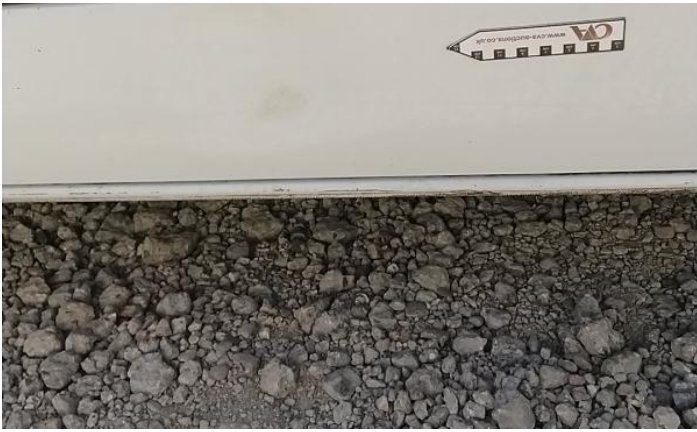
9: Door nsr
Dented
Over 30mm

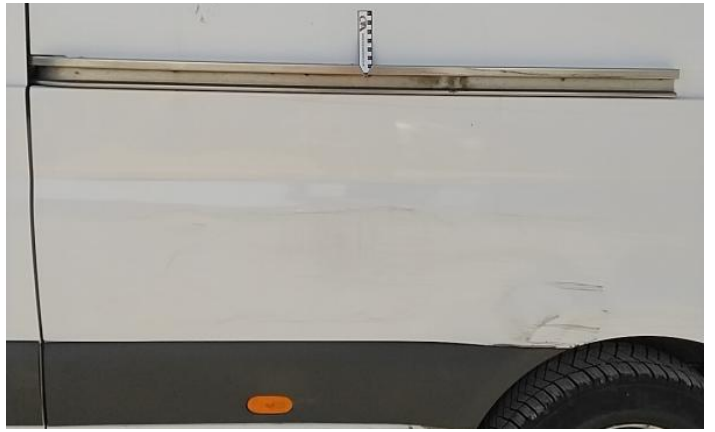
10: Qtr Panel nsr
Dented
With Paint Damage

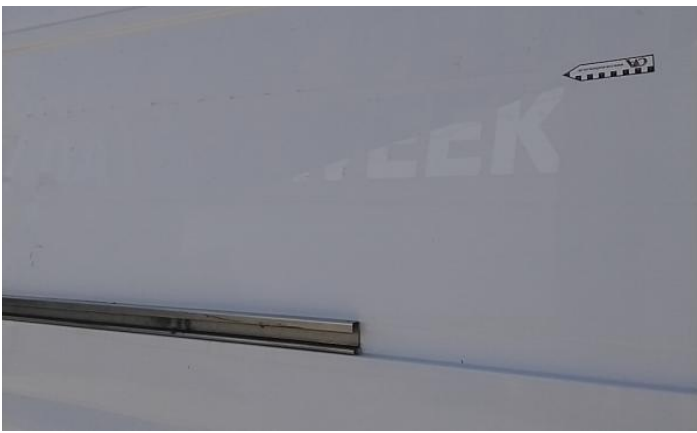
11: Qtr Panel nsr
Scratched
Over 25mm Not Thru Paint

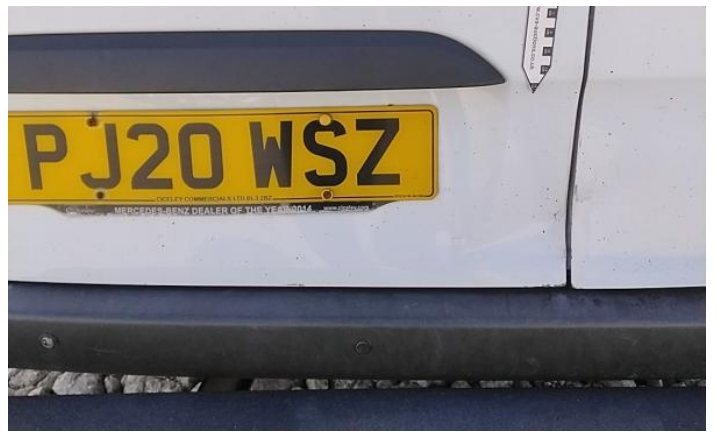
12: Door nsr
Dented
Over 30mm

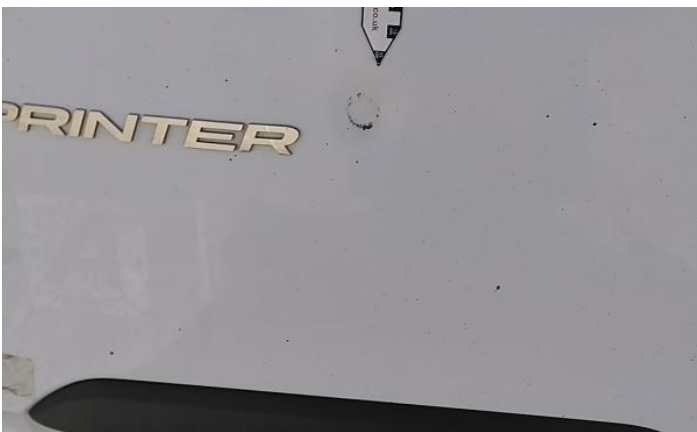
13: Door nsr
Dented
With Paint Damage

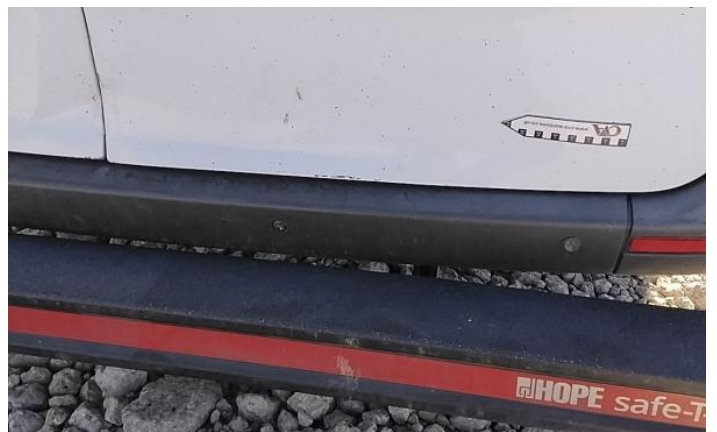
14: Door osr
Dented
Over 30mm

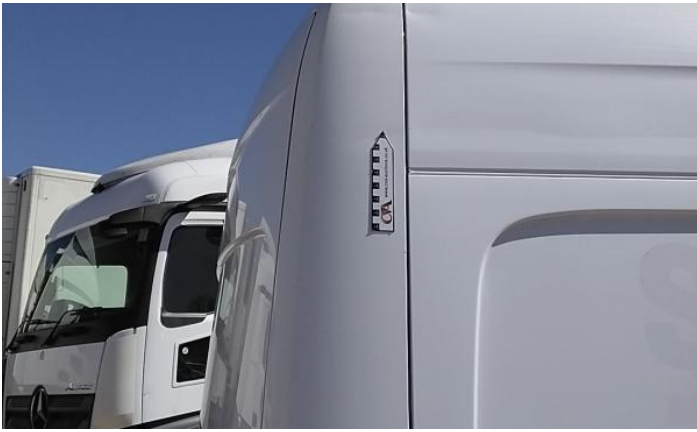
15: Qtr Panel osr
Dented
Over 30mm

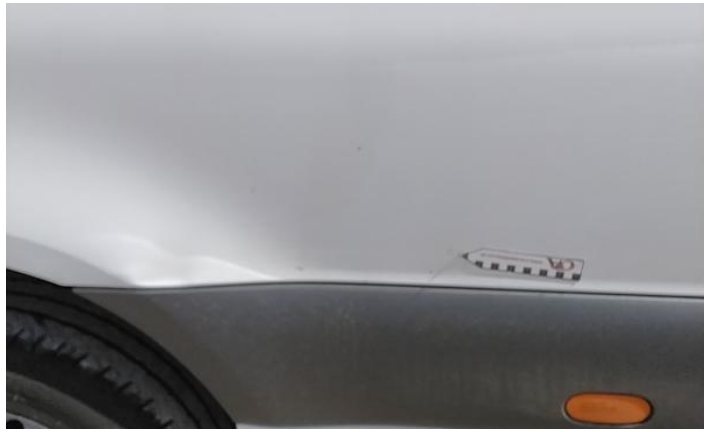
16: Qtr Panel osr
Dented
With Paint Damage

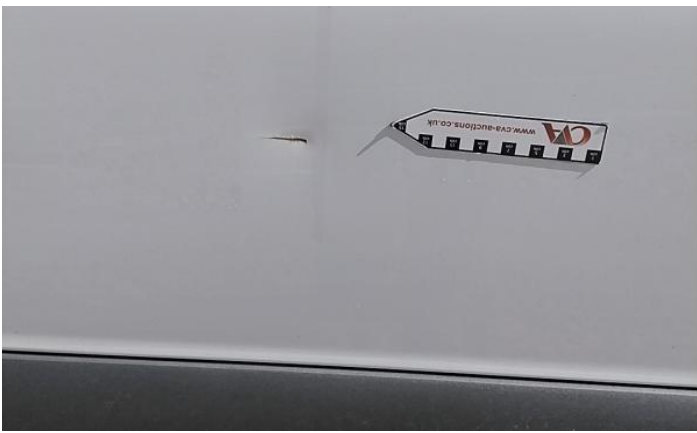
17: Qtr Panel osr
Dented
With Paint Damage

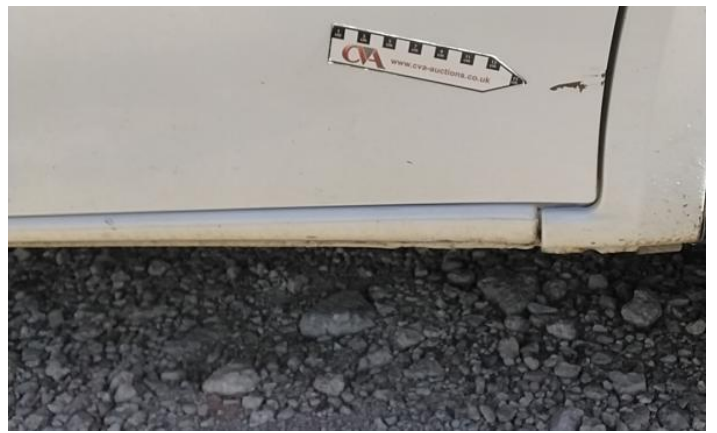
18: Door osf
Dented
With Paint Damage

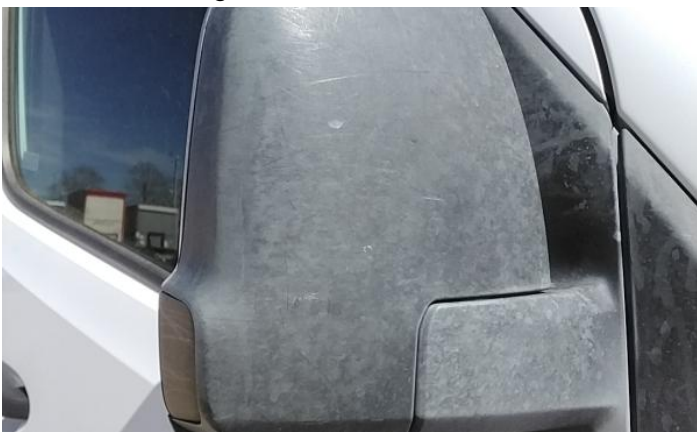
19: Door Mirror Assy osf
Scuffed (Unpainted)
Over 100mm

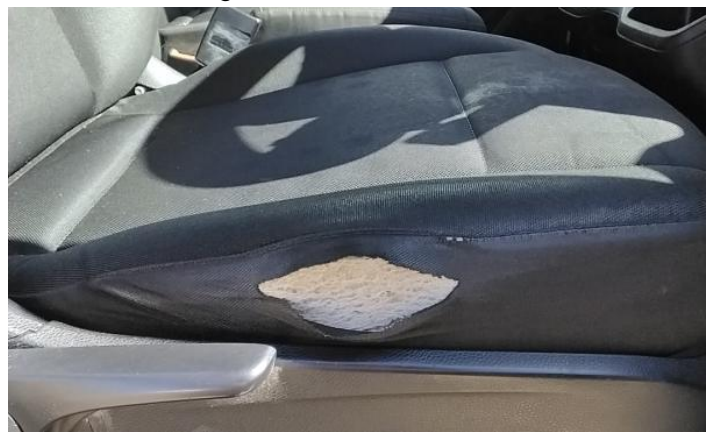
20: Seat Base Cover osf
Holed
Over 3mm
