VEHICLE INSPECTION REPORT

PE63NVG

Daf LF 55.220

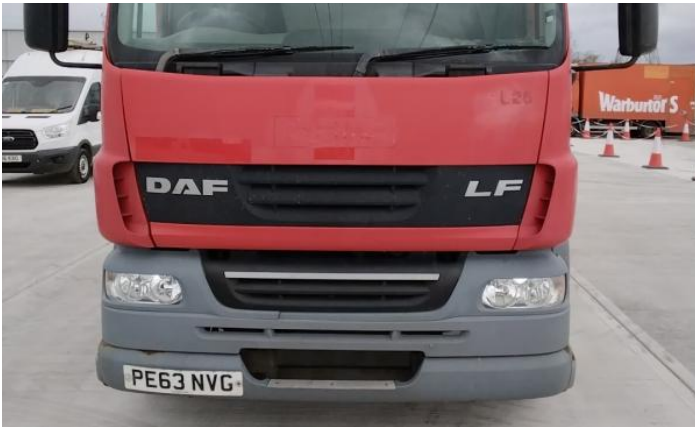
1: Bonnet
Chipped
Multiple Chips

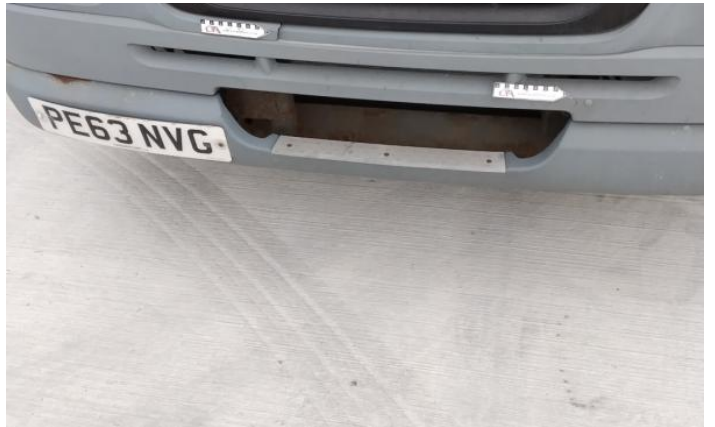
2: Bumper Front
Cracked
Over 25mm

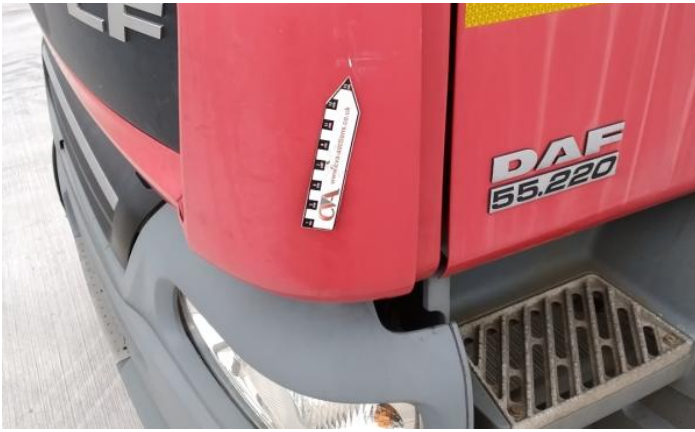
3: Moulding nsf Wing
 Scratched (Painted)
 Over 25mm Thru Paint

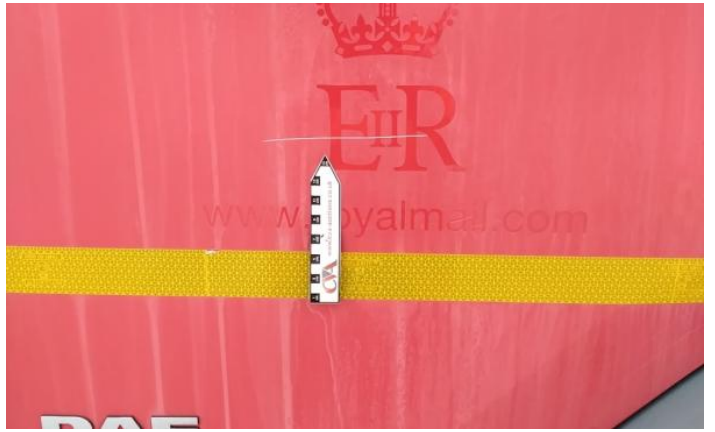
4: Door nsf
 Scratched
 Over 25mm Thru Paint

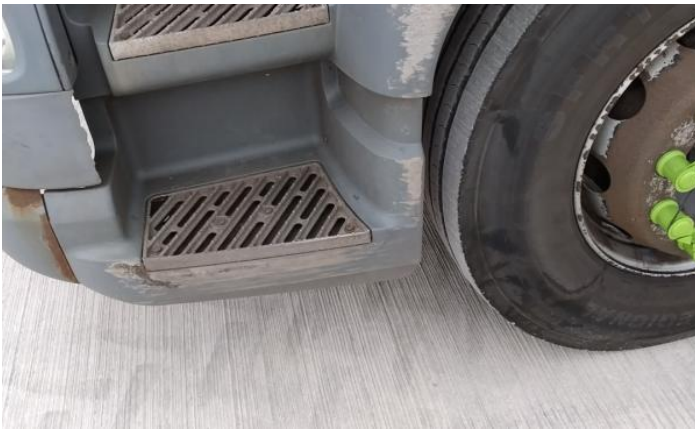
5: Wing Front Arch Extension ns
 Scratched (Painted)
 Over 25mm Thru Paint

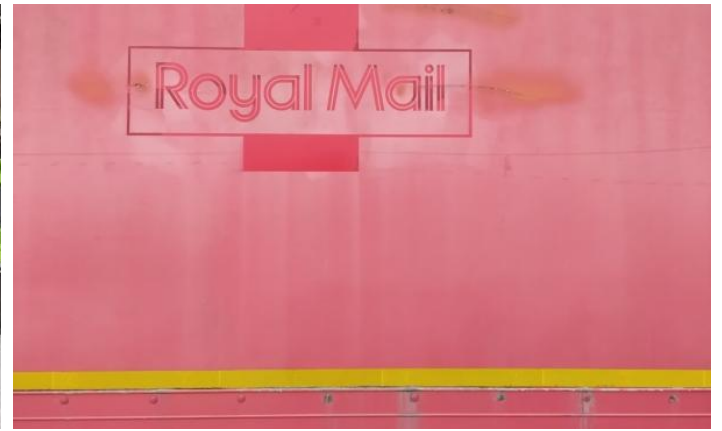
6: Qtr Panel osr
 Cracked
 Replace

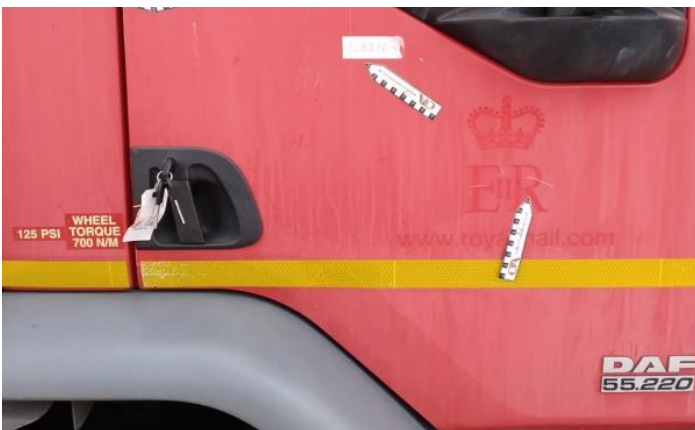
7: Door nsf
 Scratched
 Over 25mm Thru Paint

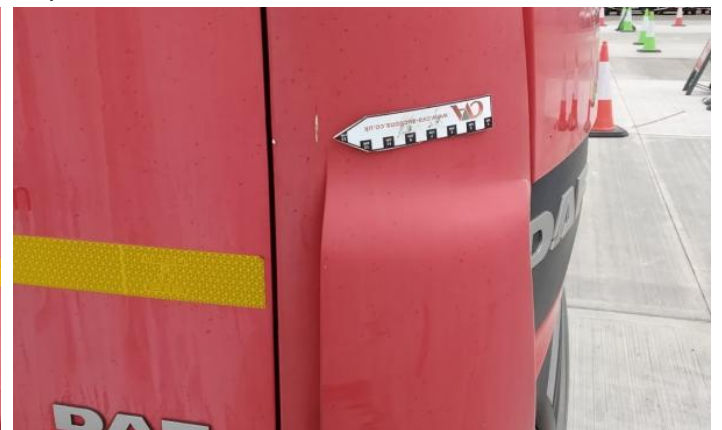
8: Moulding osf Wing
 Scratched (Painted)
 Over 25mm Thru Paint

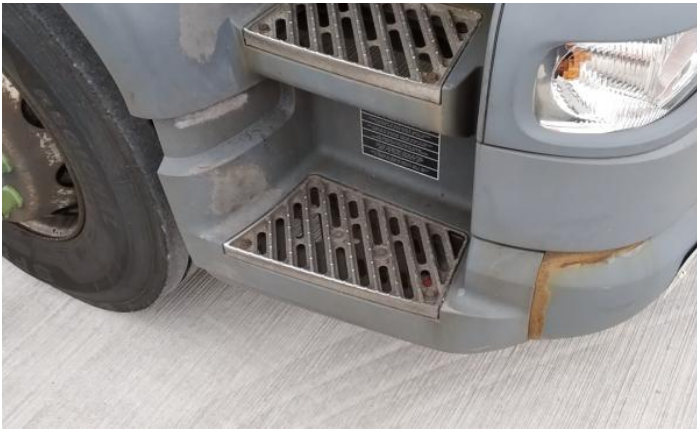
9: Wing Front Arch Extension os
Scuffed (Unpainted)
Over 100mm

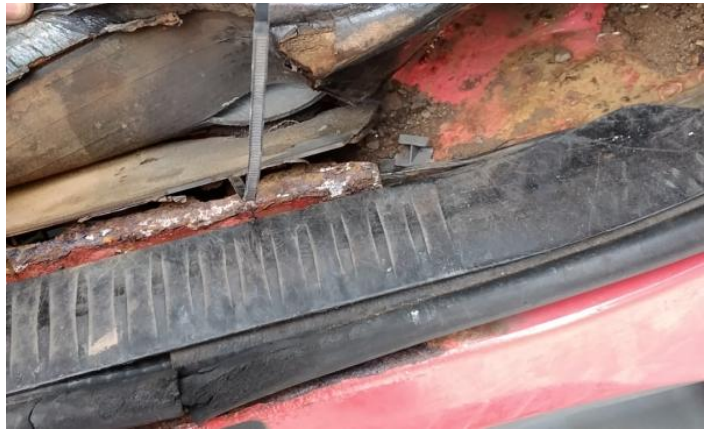
10: Carpets Front
Holed
Over 3mm
