VEHICLE INSPECTION REPORT

MX64AKJ

Mercedes-Benz Actros

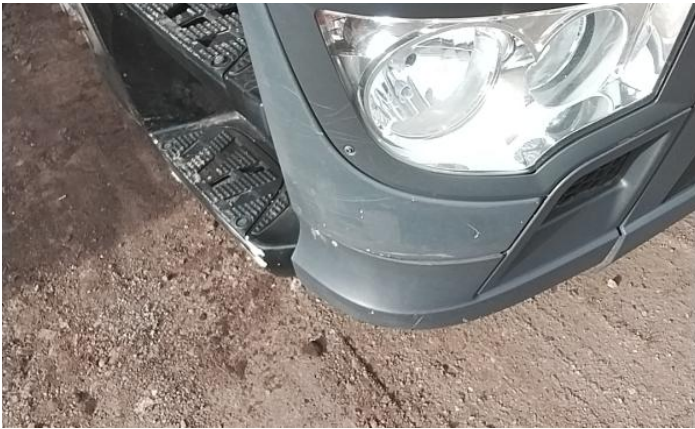
1: Bumper Front
Scratched
Over 100mm Thru Paint

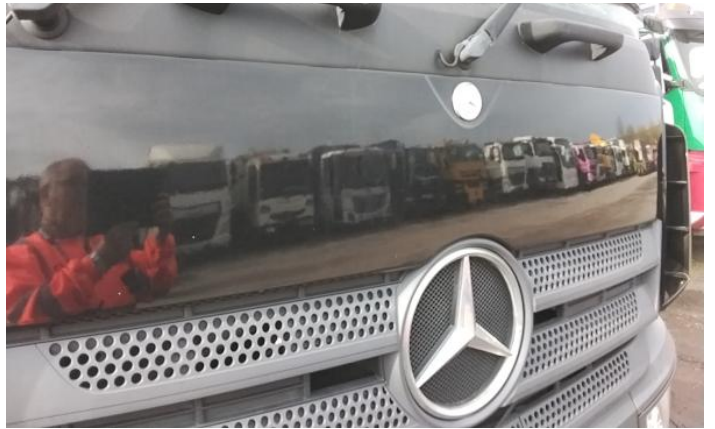
2: Bonnet
Chipped
Multiple Chips

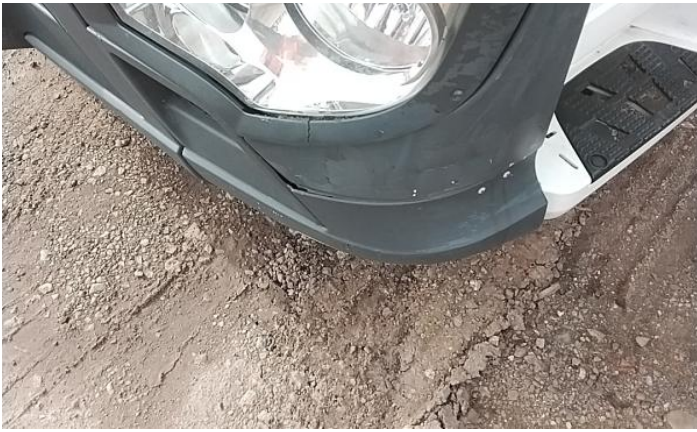
3: Panel Front
Cracked
Replace

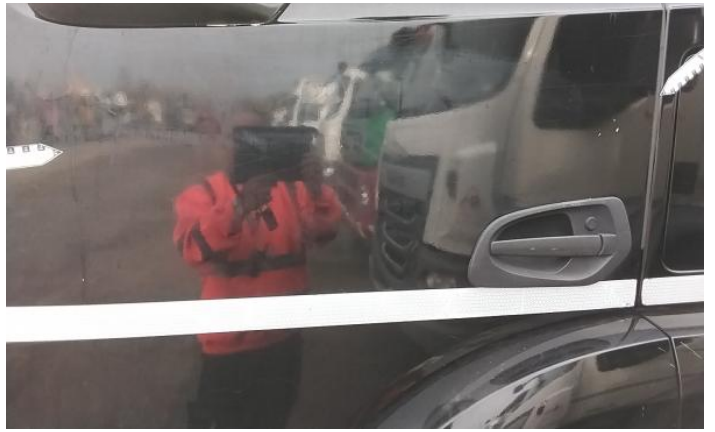
4: Door nsf
Scratched
Over 25mm Thru Paint

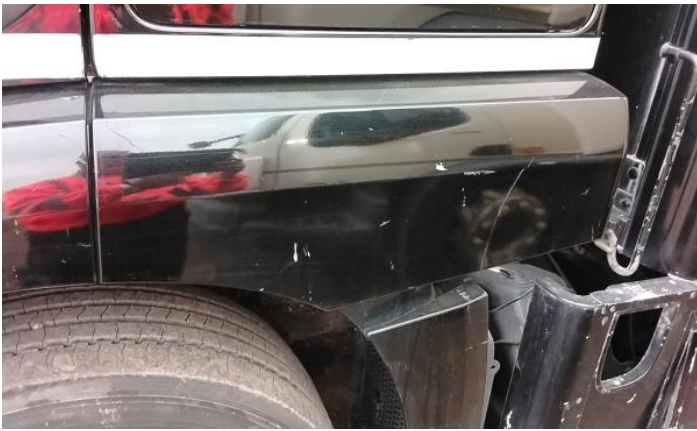
5: Qtr Panel Moulding ns
Scratched (Painted)
Over 25mm Thru Paint

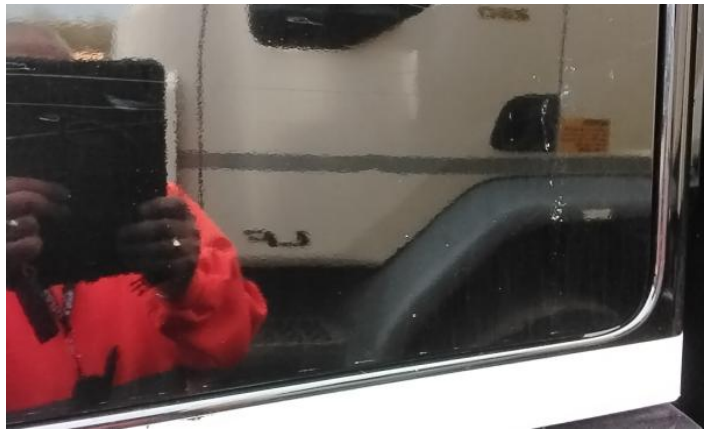
6: Qtr Panel nsr
Chipped
Multiple Chips

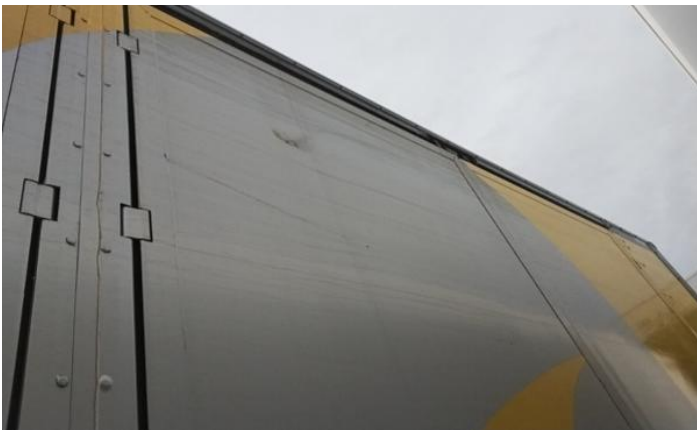
7: Qtr Panel nsr
Scratched
Over 25mm Thru Paint

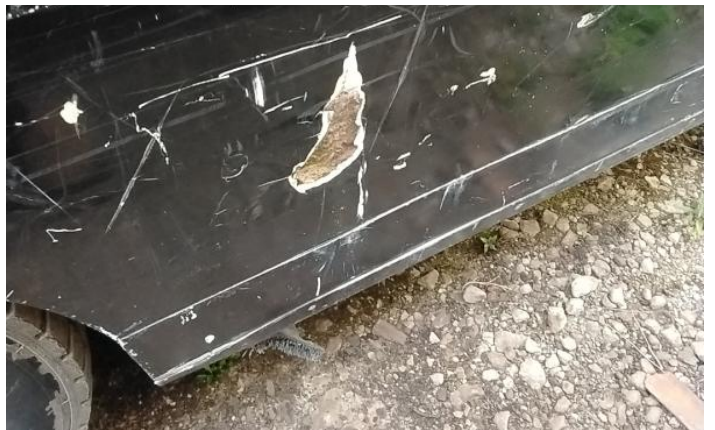
8: Qtr Panel Moulding ns
Scratched (Painted)
Over 25mm Thru Paint

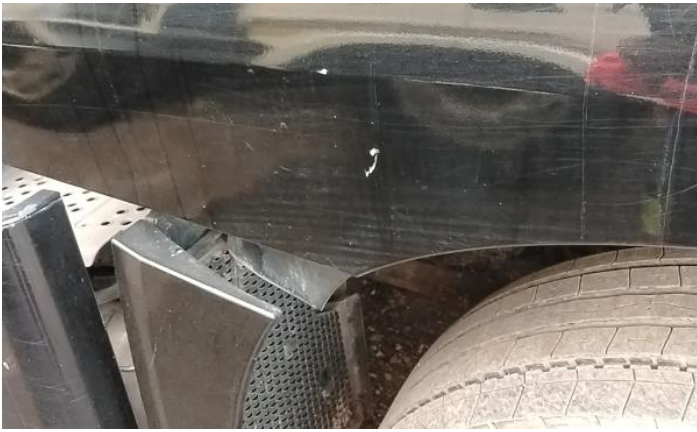
9: Qtr Panel Moulding os
Scratched (Painted)
Over 25mm Thru Paint

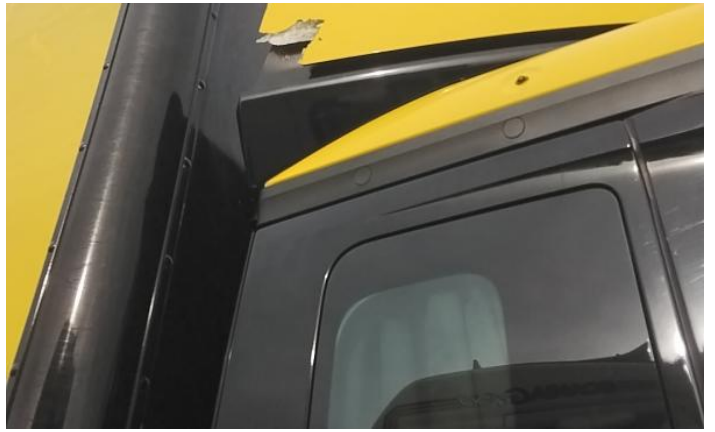
10: Qtr Panel Trim os
Broken
Replace

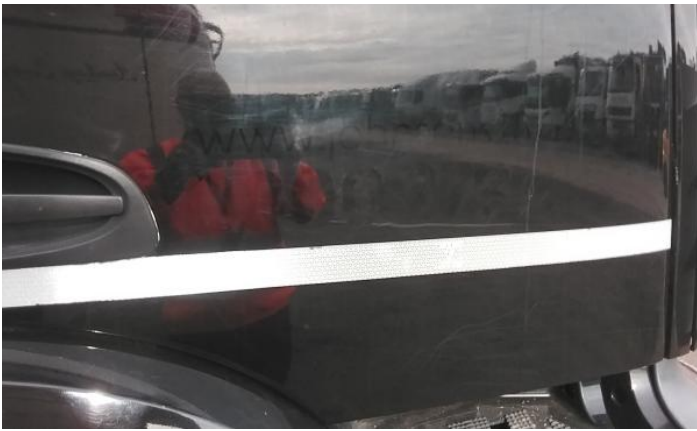
11: Door osf
Scratched
Over 25mm Not Thru Paint

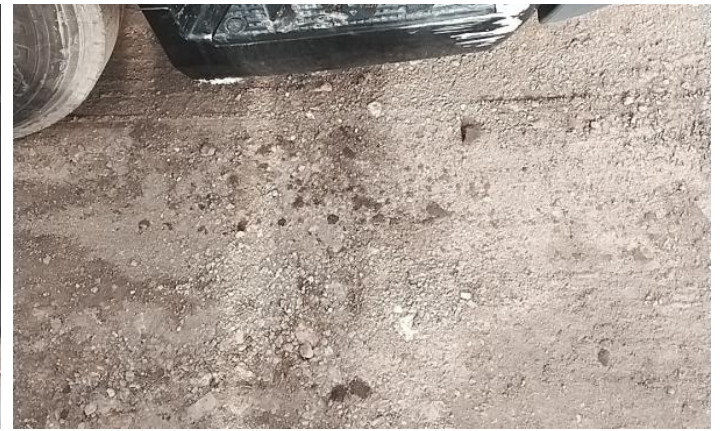
12: Bumper Front Moulding
Scratched (Painted)
Over 25mm Thru Paint
