COMMERCIAL VEHICLE AUCTIONS LTD
THE UK'S MOST ESTABLISHED COMMERCIAL VEHICLE AUCTIONEERS

VEHICLE INSPECTION REPORT

PJ20ZYW

Mercedes-Benz Sprinter 314 CDI

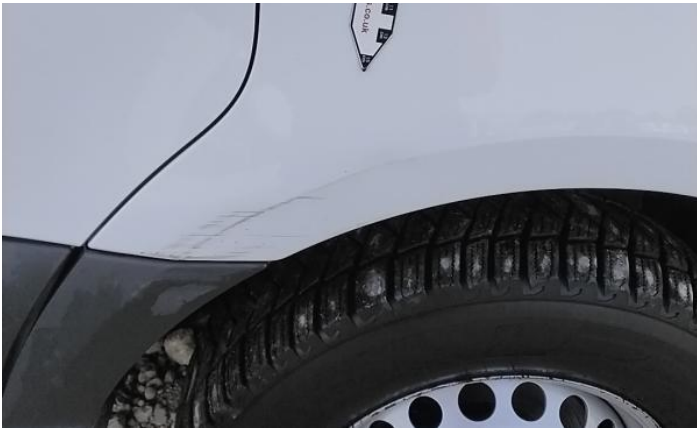
1: Wing of
Dented
With Paint Damage

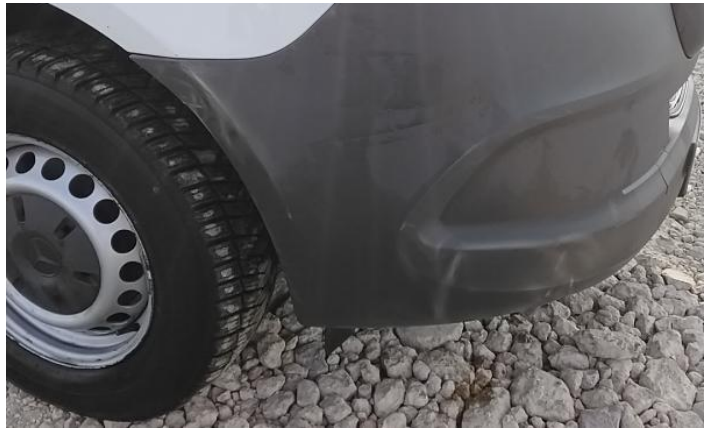
2: Bumper Front Moulding
Scuffed (Unpainted)
Over 100mm

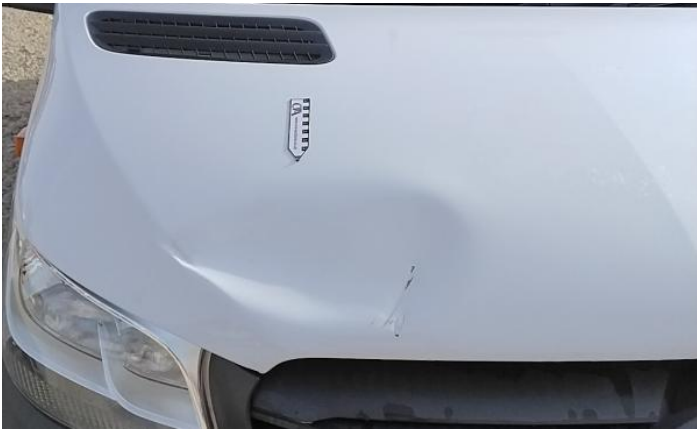
3: Bonnet
Dented
With Paint Damage

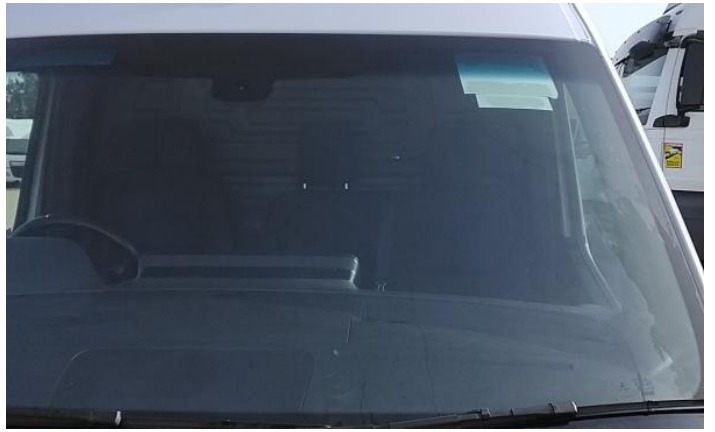
4: Screen Front
Chipped
Over 10mm

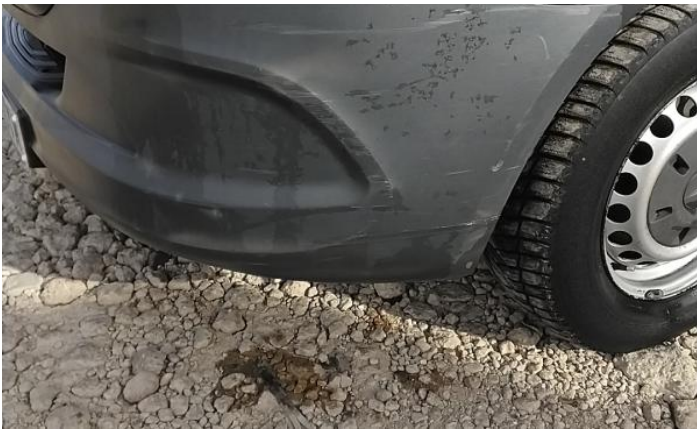
5: Bumper Front Moulding
Scuffed (Unpainted)
Over 100mm

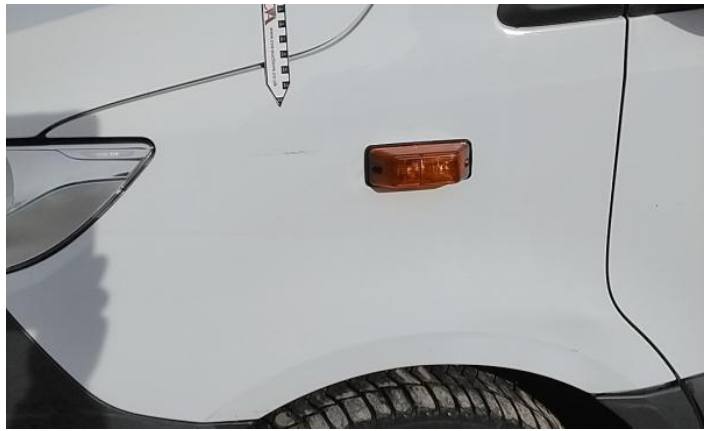
6: Wing nsf
Scratched
Over 25mm Not Thru Paint

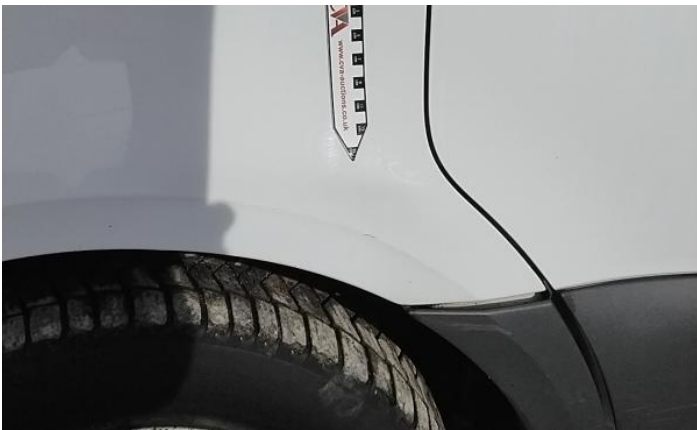
7: Wing nsf
Dented
Between 10mm + 30mm

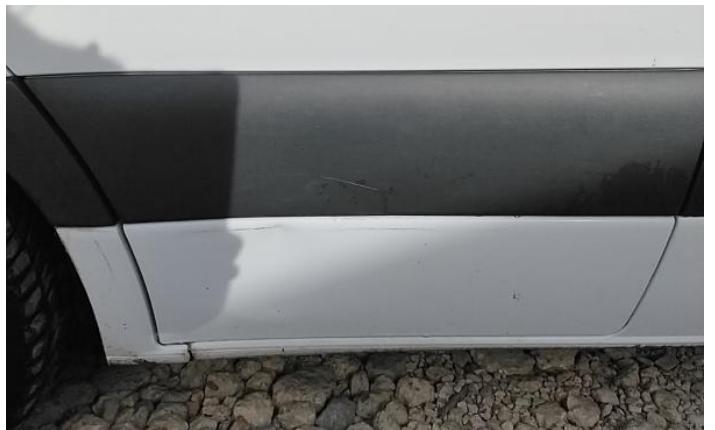
8: Door Moulding nsf
Scuffed (Unpainted)
Over 100mm

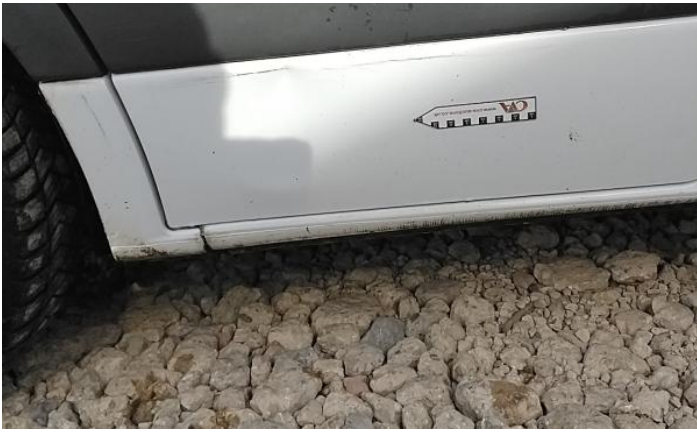
9: Door nsf
Dented
Between 10mm + 30mm

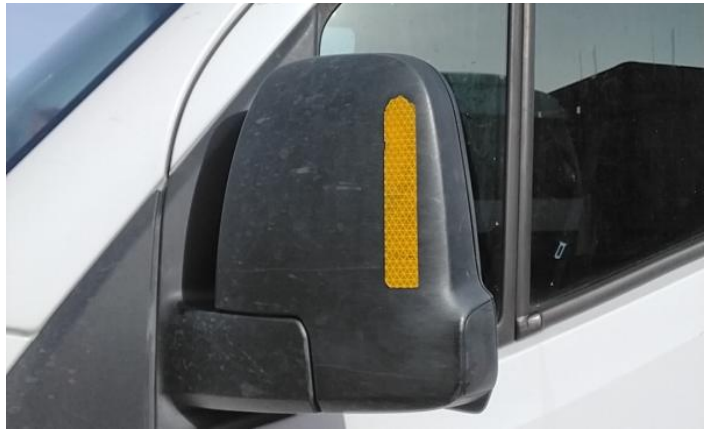
10: Door Mirror Assy nsf
Scuffed (Unpainted)
Over 100mm

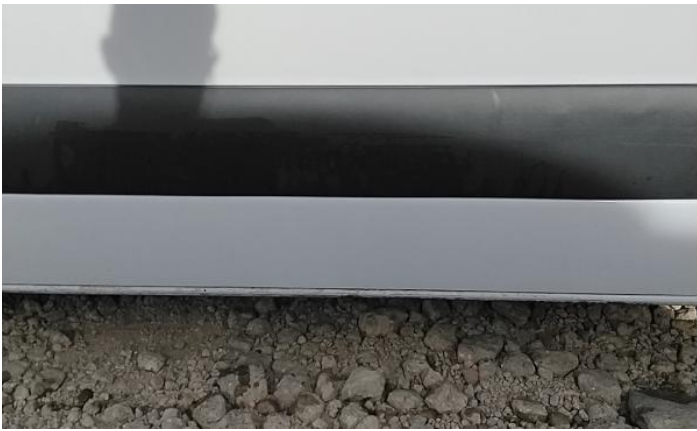
11: Door Moulding nsr
Scuffed (Unpainted)
Over 100mm

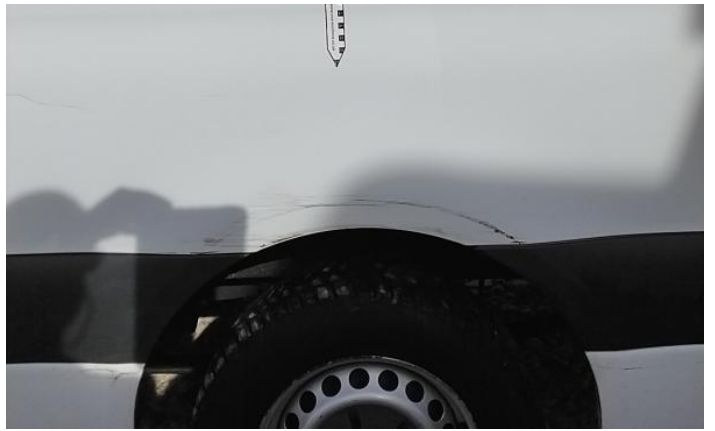
12: Qtr Panel nsr
Scratched
Over 25mm Thru Paint

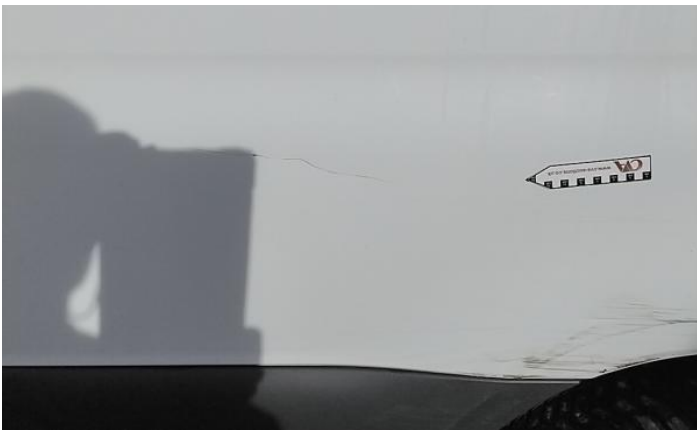
13: Qtr Panel nsr
Dented
With Paint Damage

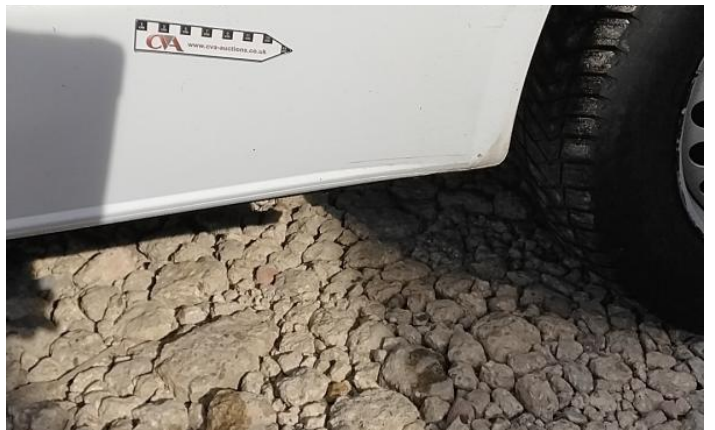
14: Qtr Panel nsr
Dented
With Paint Damage

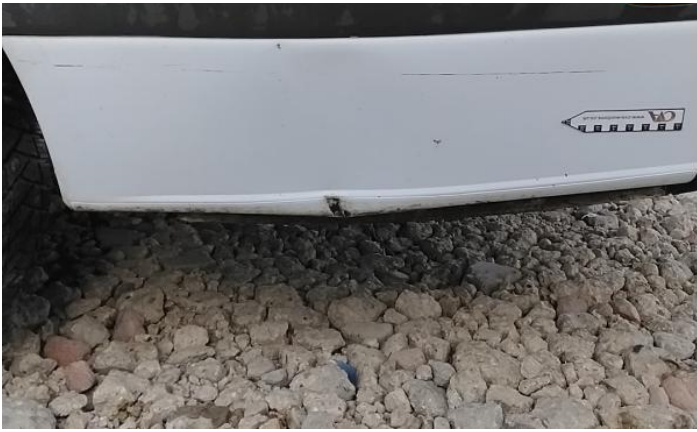
15: Sill ns
Dented
With Paint Damage

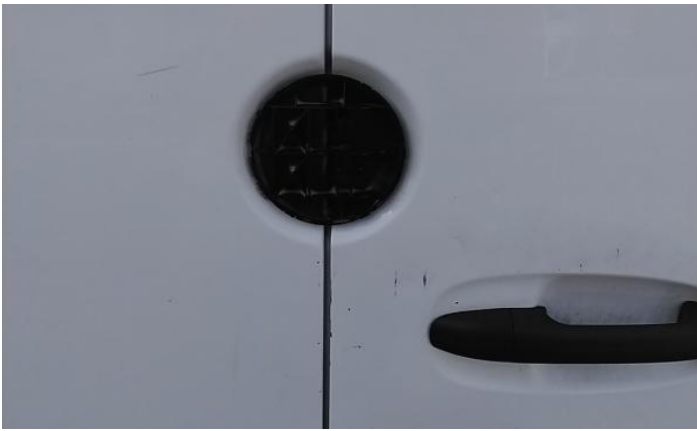
17: Badgedecal Rear
Missing
Replace

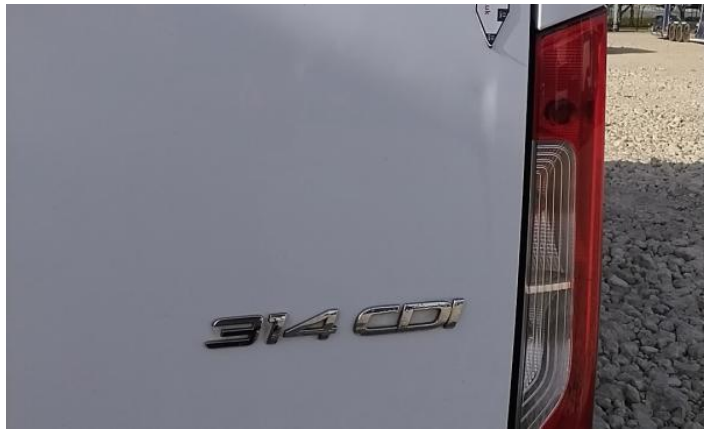
18: Door osr
Dented
Between 10mm + 30mm

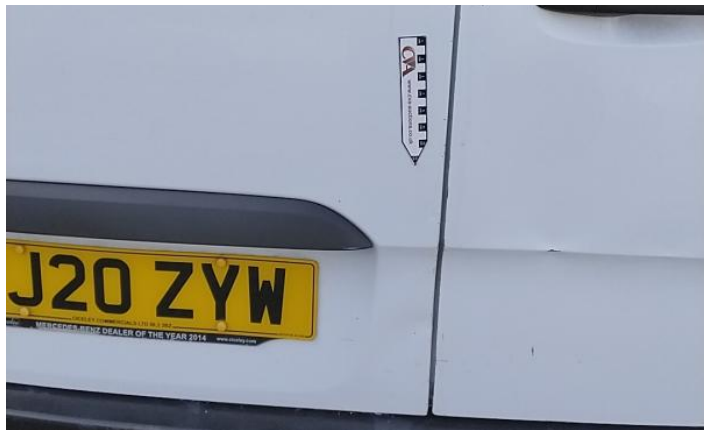
19: Door osr
Dented
With Paint Damage

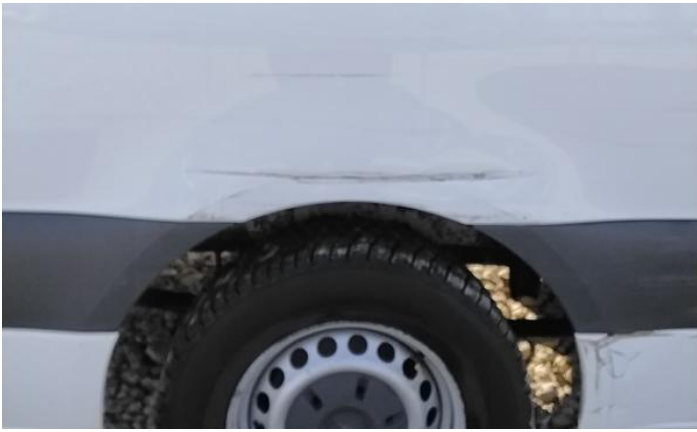
21: Qtr Panel osr
Dented
With Paint Damage

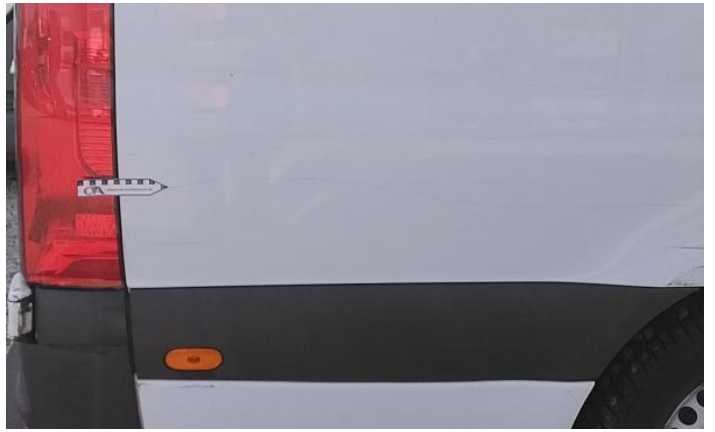
22: Qtr Panel osr
Scratched
Over 25mm Not Thru Paint

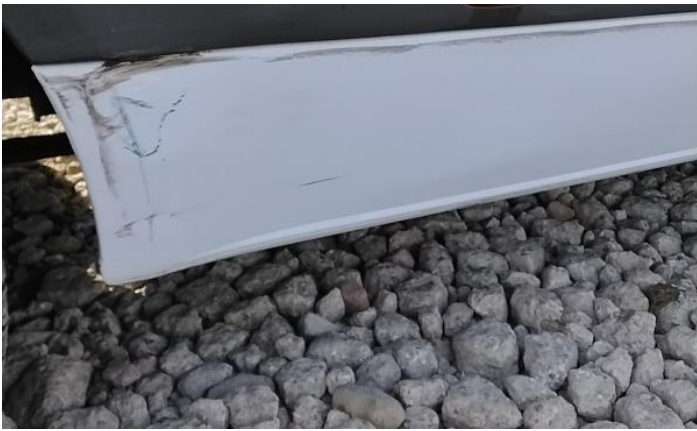
23: Qtr Panel osr
Dented
With Paint Damage

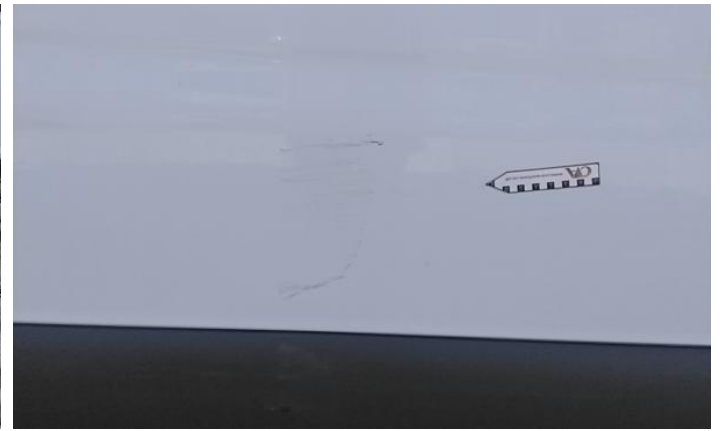
24: Qtr Panel osr
Scratched
Over 25mm Not Thru Paint

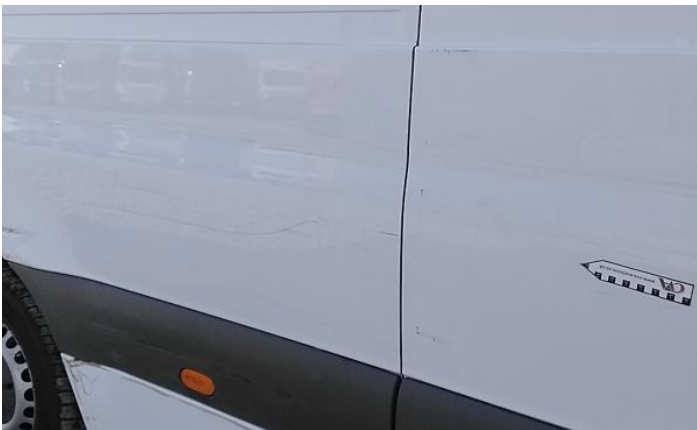
25: Qtr Panel osr
Scratched
Over 25mm Not Thru Paint

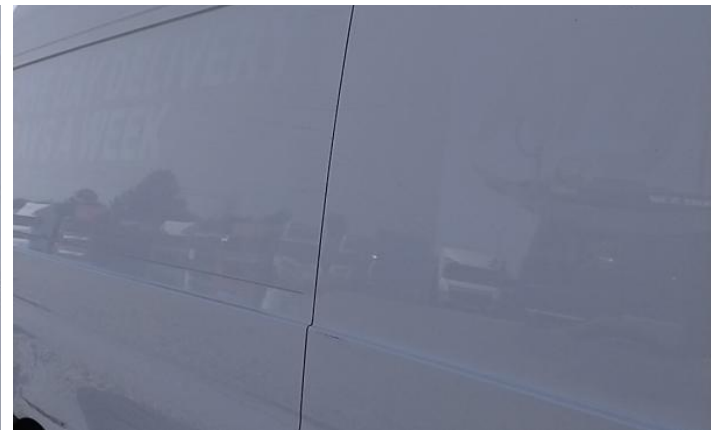
26: Qtr Panel osr
Scratched
Over 25mm Not Thru Paint

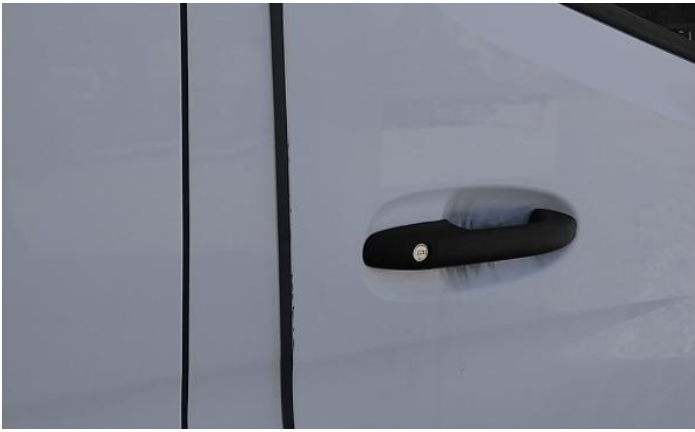
27: Door osf
Chipped
Edge Chip

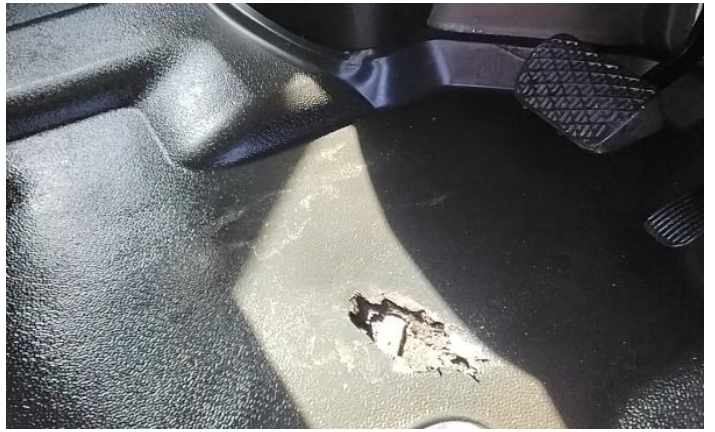
28: Carpets Front
Holed
Over 3mm

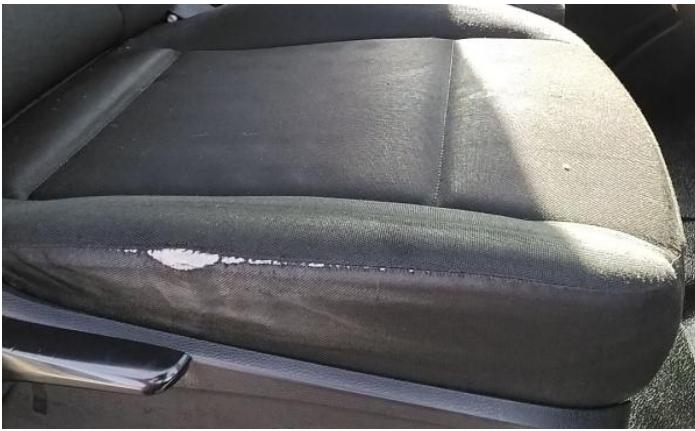
29: Seat Base Cover osf
Holed
Over 3mm
