VEHICLE INSPECTION REPORT

DE19WUM

Isuzu N75 190

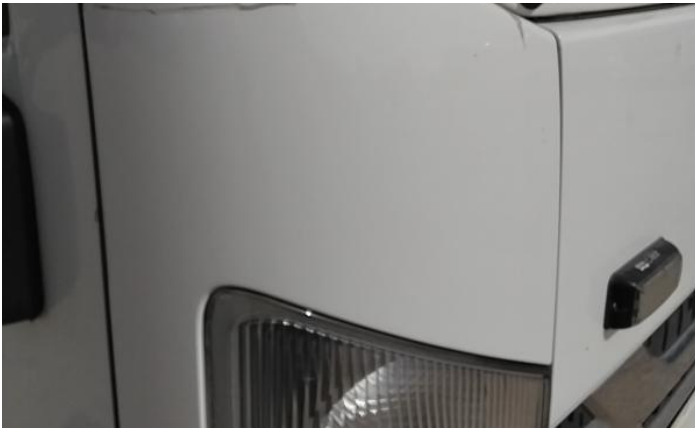
1: Wing of
Scratched
Over 25mm Thru Paint

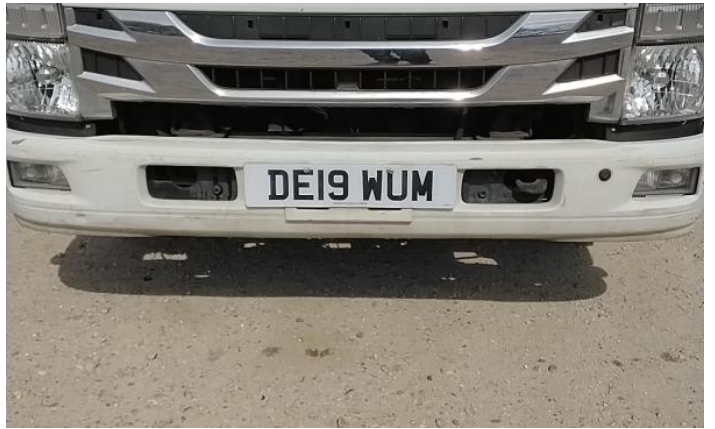
2: Bumper Front
Scratched
Over 25mm Not Thru Paint

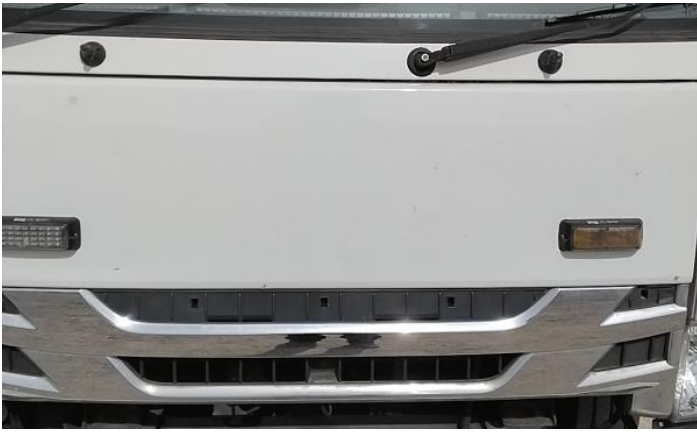
3: Bonnet
Chipped
Multiple Chips

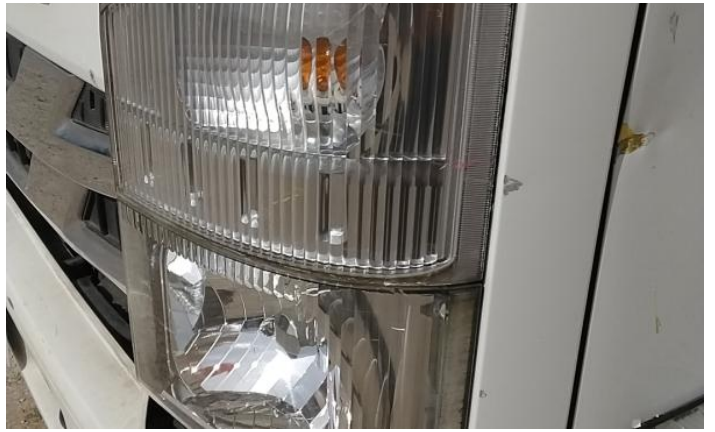
4: Headlamps
Broken
Replace

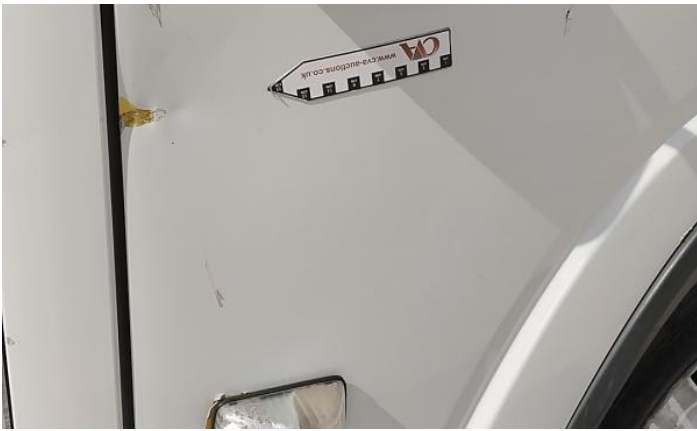
5: Door nsf
Dented
With Paint Damage

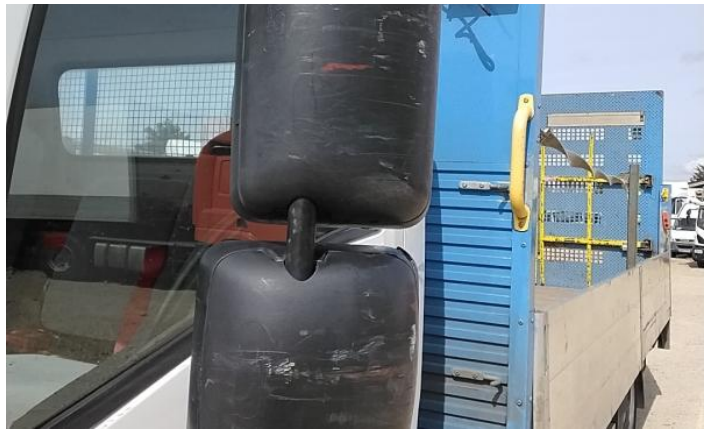
6: Door Mirror Assy nsf
Scuffed (Unpainted)
Over 100mm

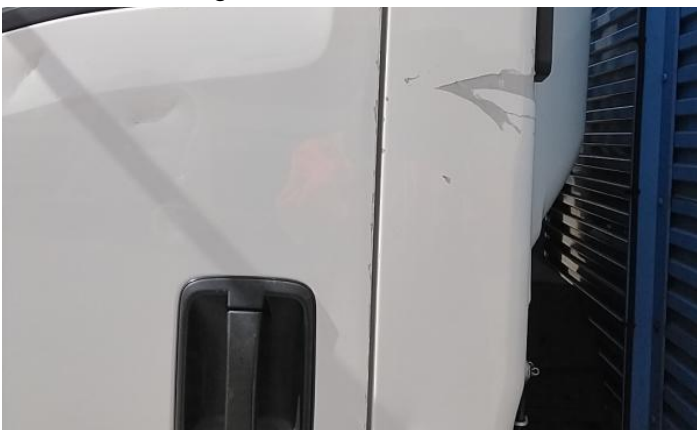
7: Door nsf
Chipped
Edge Chip

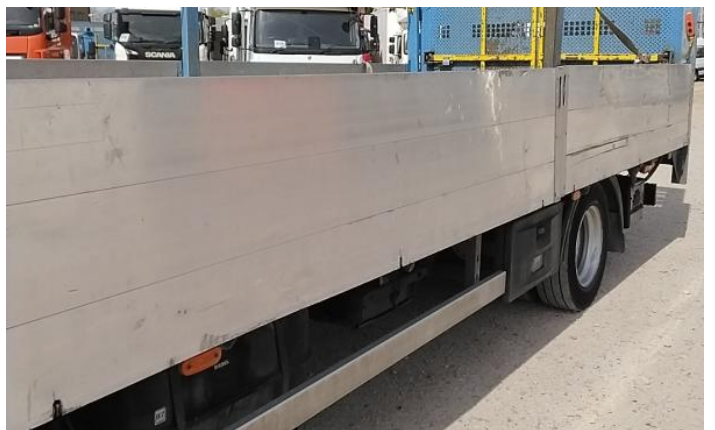
8: Qtr Panel nsr
Scratched
Over 25mm Thru Paint

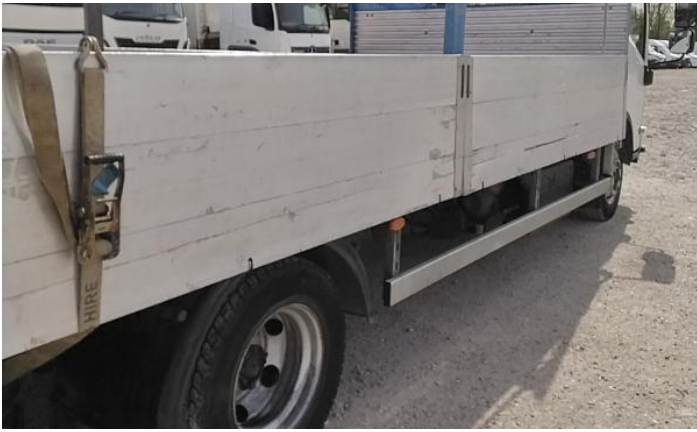
9: Qtr Panel osr
Scratched
Over 25mm Thru Paint

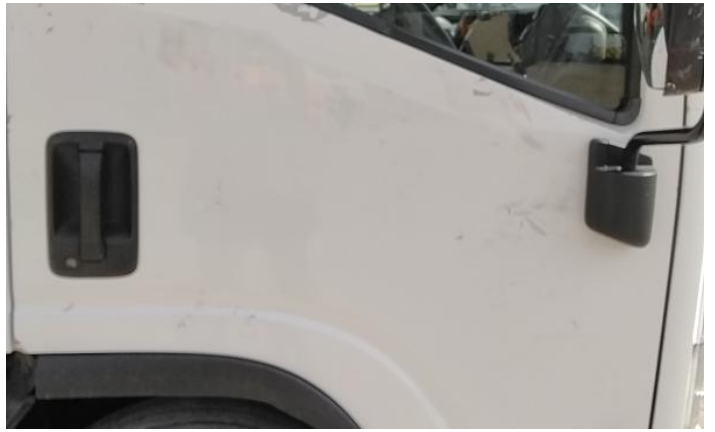
10: Door osf
Scratched
Over 25mm Not Thru Paint

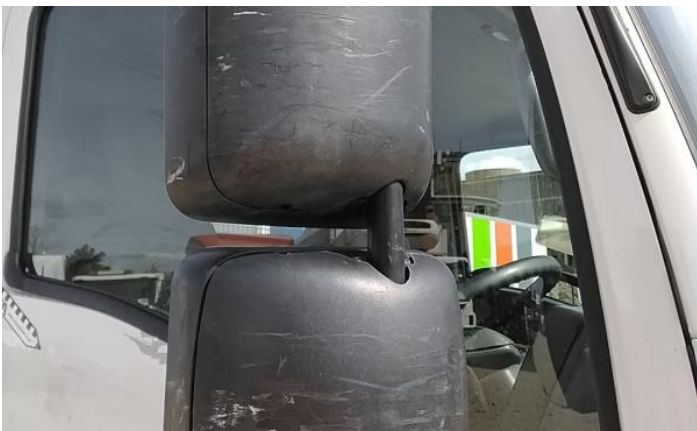
11: Door Mirror Assy osf
Scuffed (Unpainted)
Over 100mm

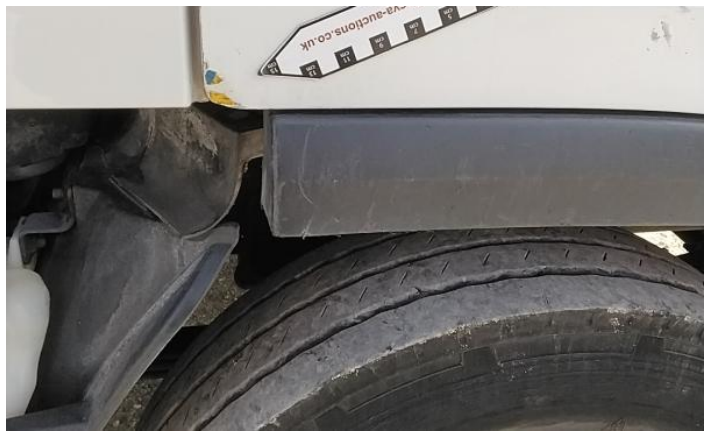
12: Door osf
Dented
With Paint Damage

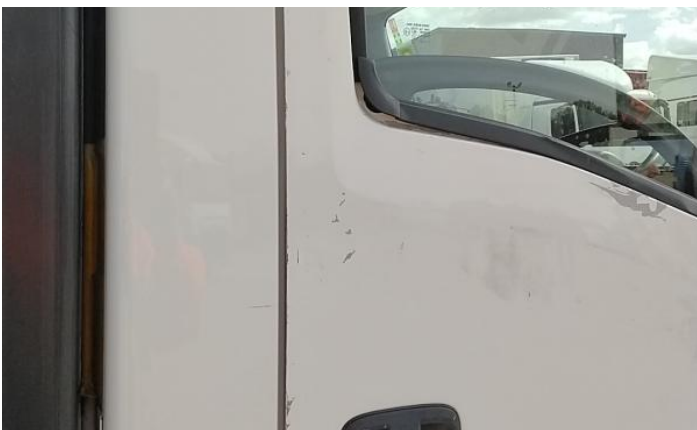
13: Door osf
Chipped
Edge Chip

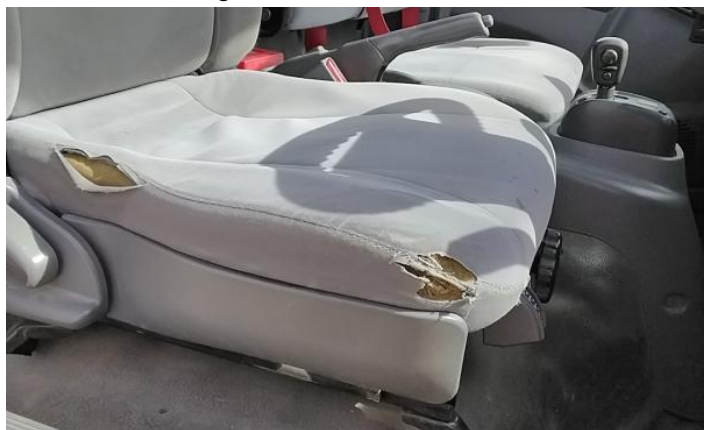
14: Seat Base Cover osf
Holed
Over 3mm
