# VEHICLE INSPECTION REPORT

**BJ19ZWG**

## Iveco Eurocargo 120-210

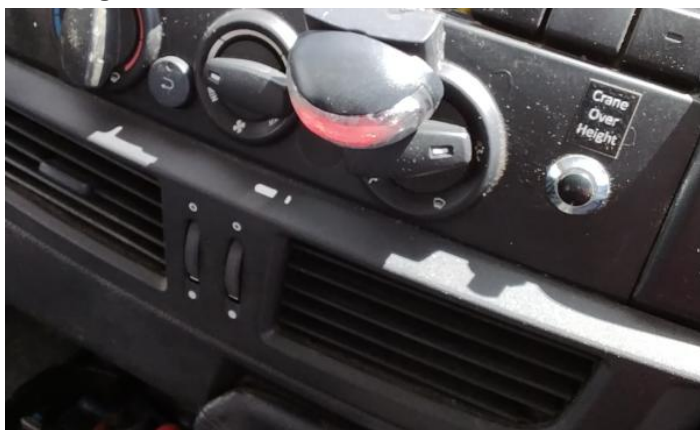
1: Switches And Controls  
Broken  
Replace

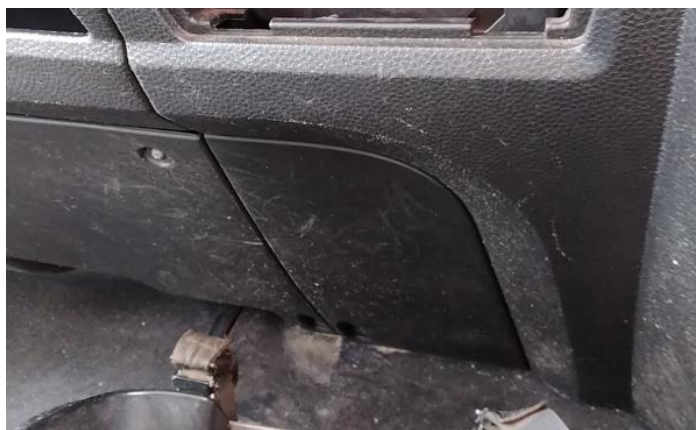
2: Fascia Trim  
Missing  
Replace

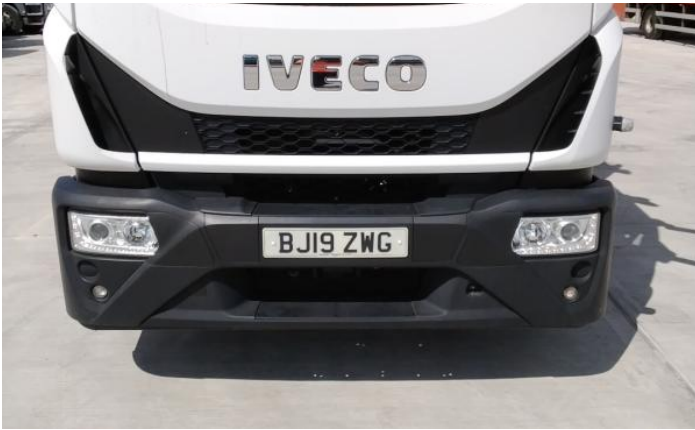
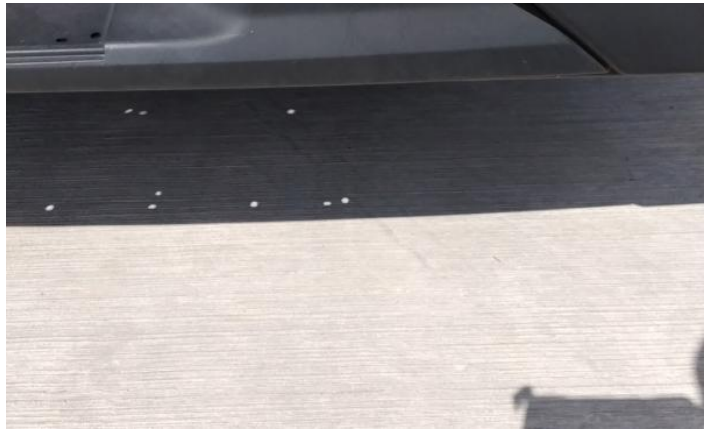
3: Bonnet  
Chipped  
Multiple Chips

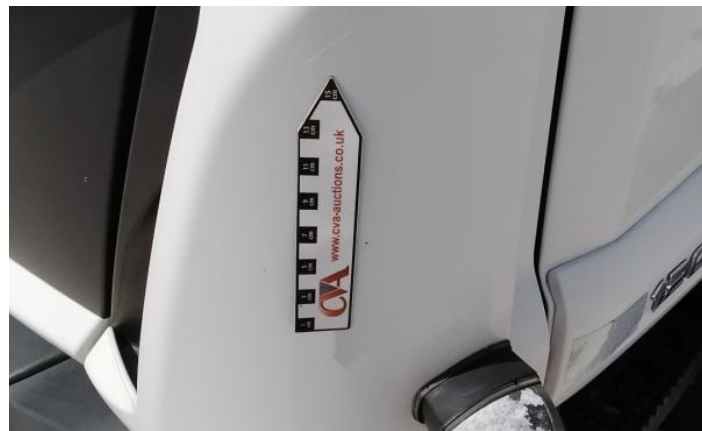
4: Bumper Front Moulding  
Missing  
Replace

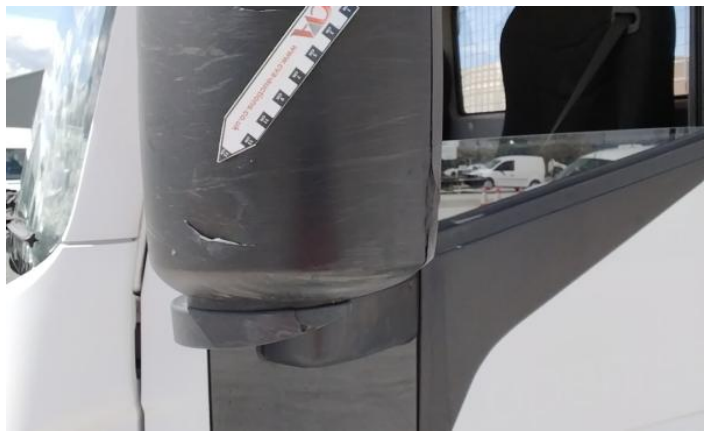
5: Moulding nsf Wing  
Scratched (Painted)  
Over 25mm Thru Paint

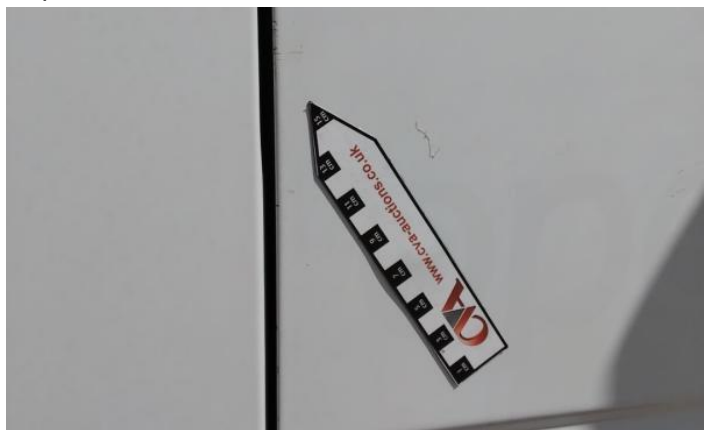
7: Panel Rear  
Cracked  
Replace

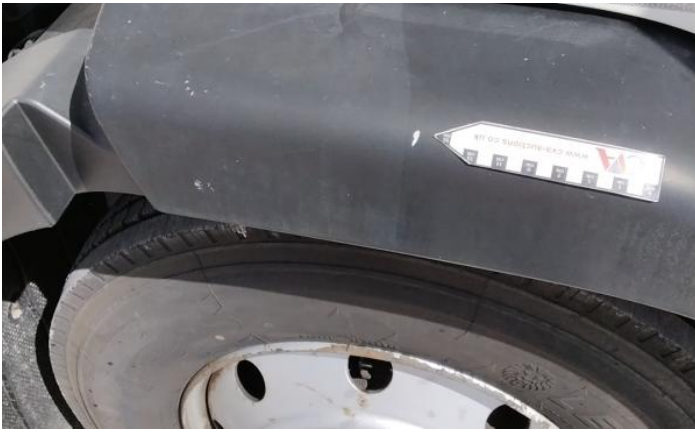
9: Wing Front Arch Extension os  
Scratched (Painted)  
Over 25mm Thru Paint

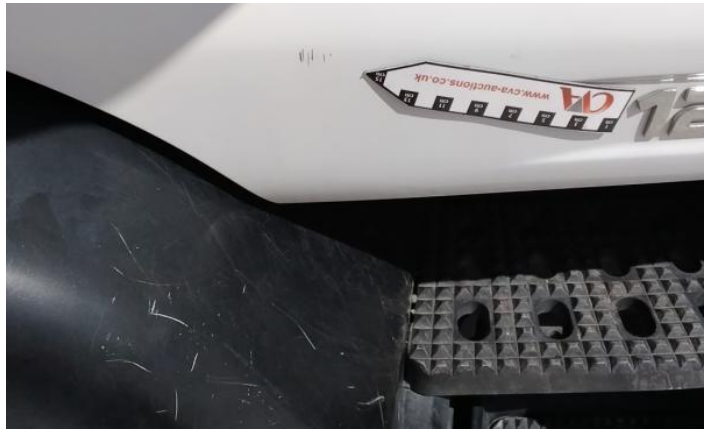
10: Door osf  
Scratched  
Over 25mm Thru Paint

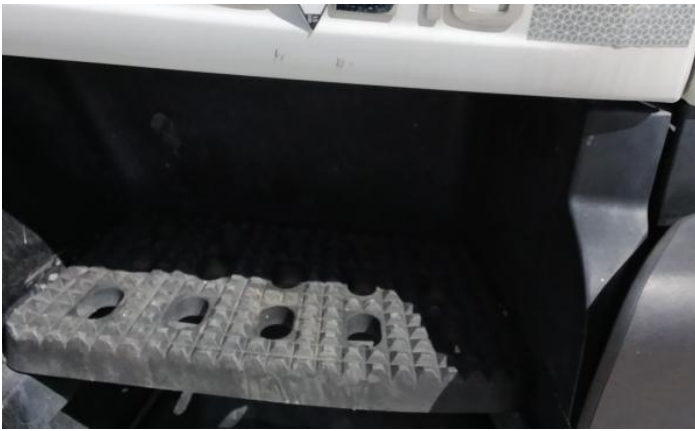
11: Door osf  
Scratched  
Over 25mm Thru Paint

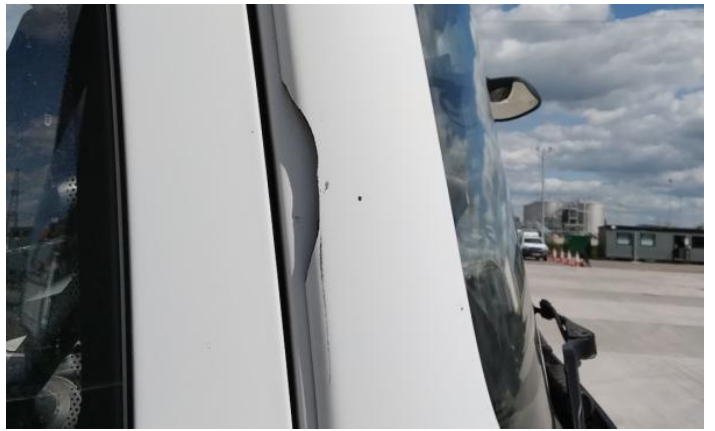
12: A Post os  
Cracked  
Replace

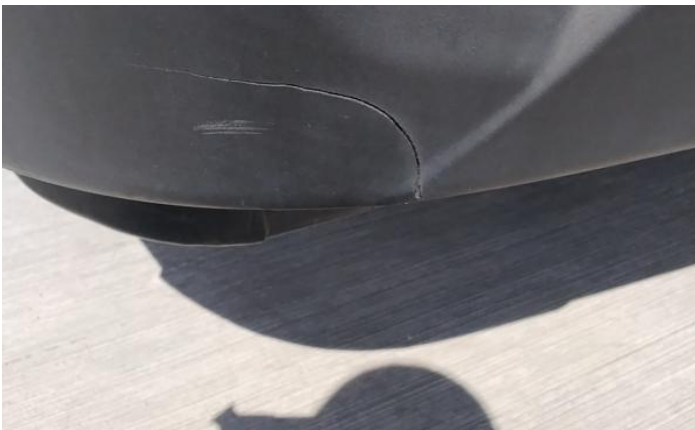
13: Bumper Front  
Cracked  
Over 25mm
