VEHICLE INSPECTION REPORT

PF18YFD

Fiat Doblo II 1.3 MULTIJET 16V 95PS

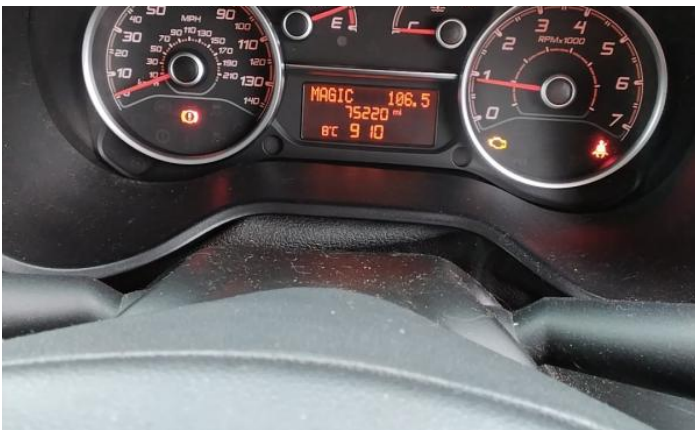
1: Dash Warning Lights
Displayed
No Action

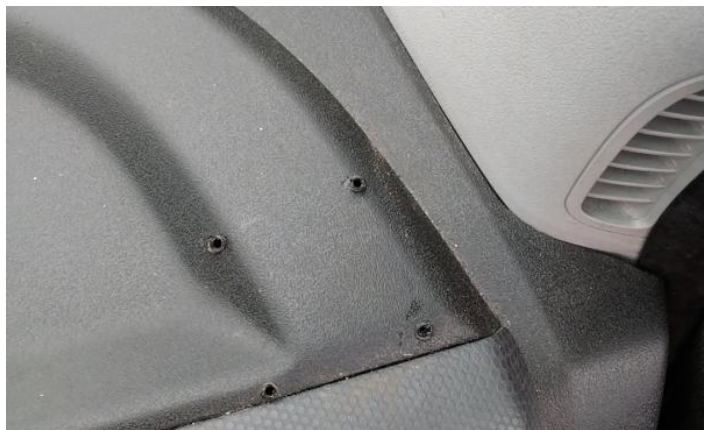
2: Centre Console Front
Holed
Over 3mm

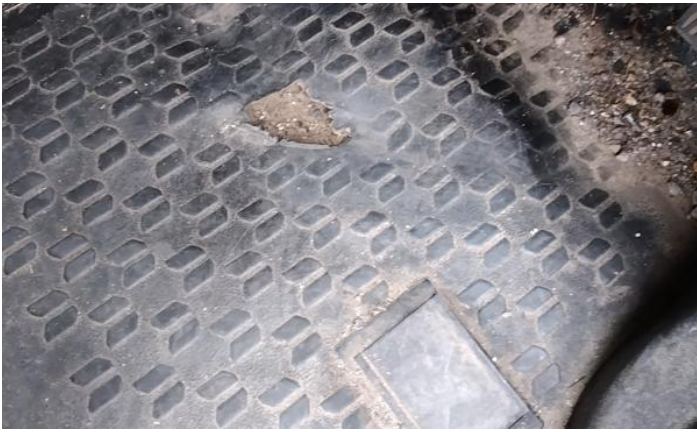
3: Carpets Front
Holed
Over 3mm

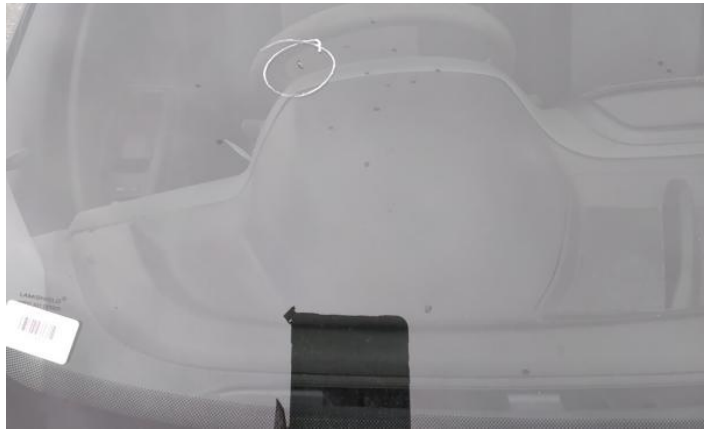
4: Screen Front
Chipped
Up To 10mm

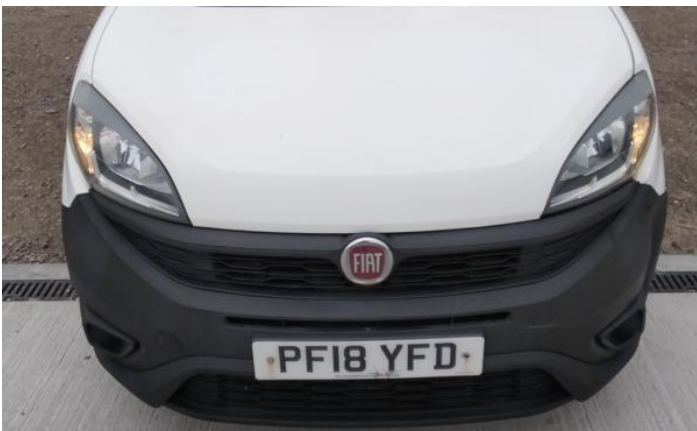
5: Bonnet
Chipped
Multiple Chips

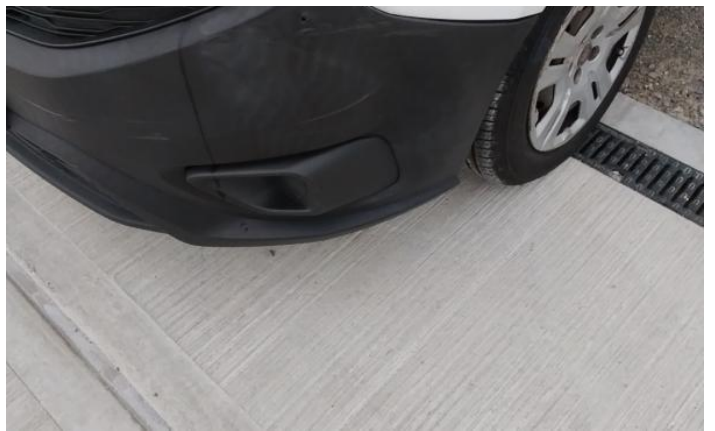
6: Bumper Front
Insecure
Action Required

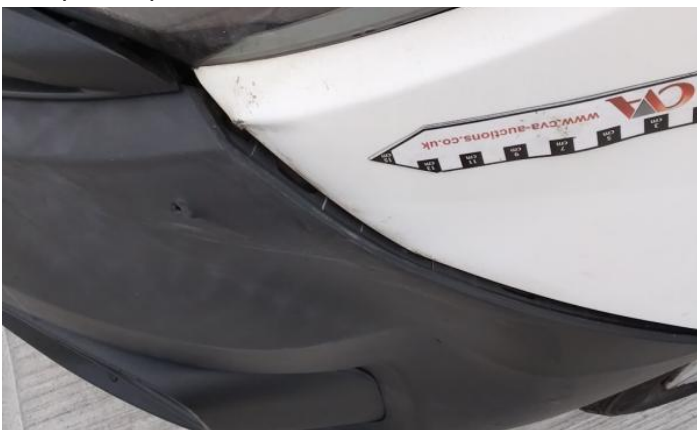
7: Wing nsf
Dented
With Paint Damage

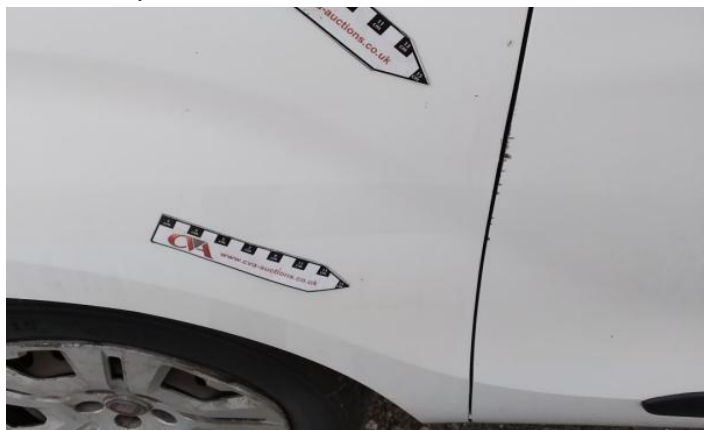
8: Wing nsf
Chipped
Multiple Chips

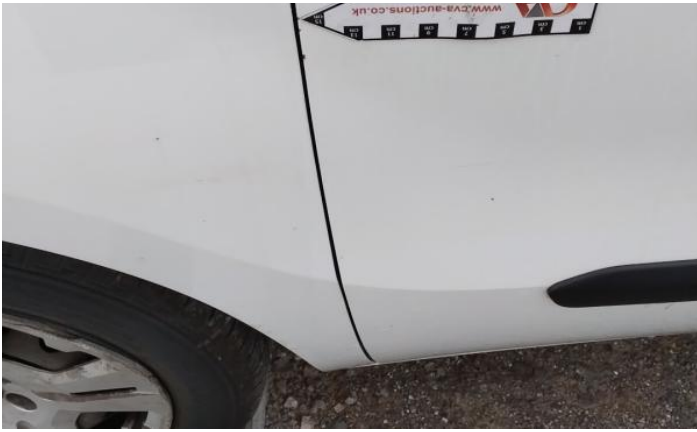
9: Door nsf
Chipped
Multiple Chips

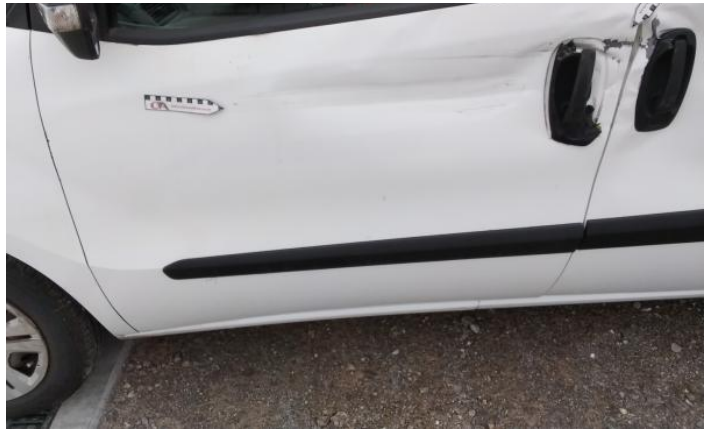
10: Door nsf
Dented
Hail - Severe

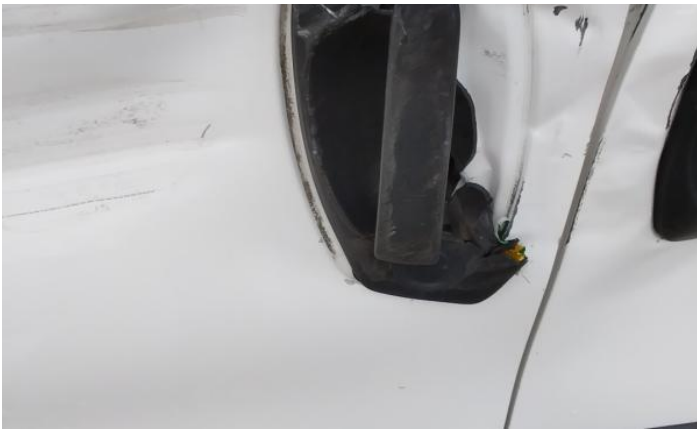
11: Handle Outer nsf
Broken
Replace

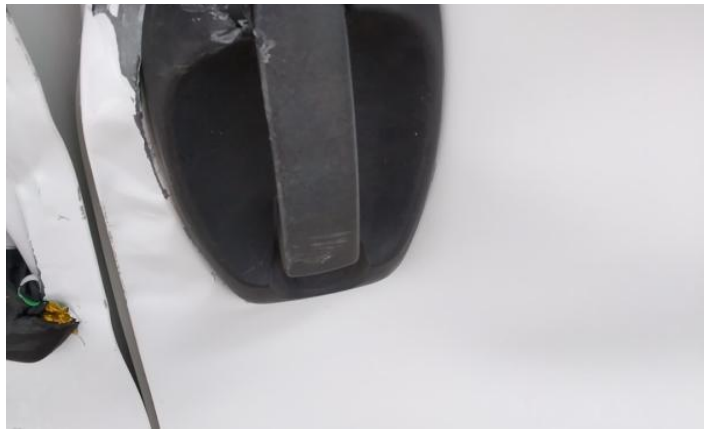
12: Handle Outer nsr
Broken
Replace

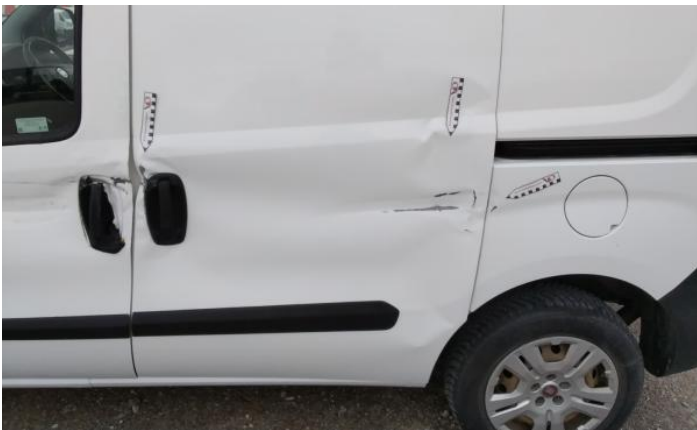
13: Qtr Panel nsr
Dented
Hail - Severe

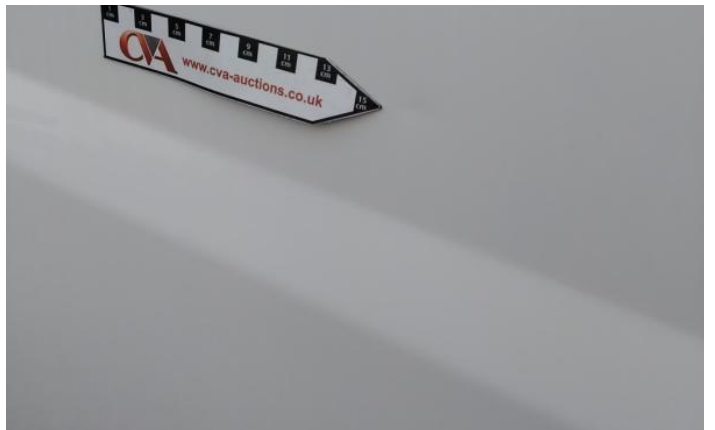
14: Qtr Panel osr
Dented
Between 10mm + 30mm

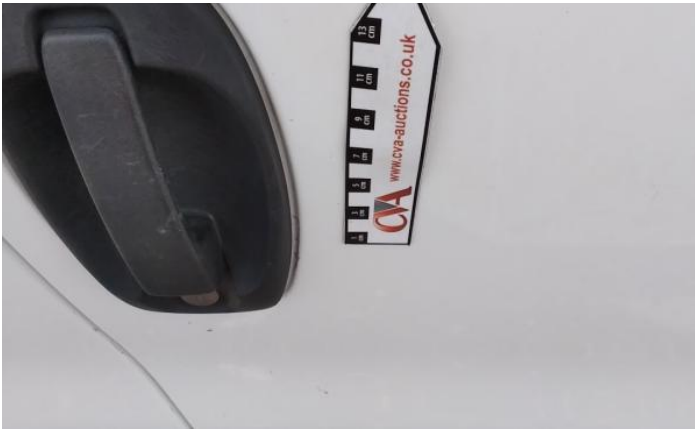
15: Door osf
Dented
With Paint Damage

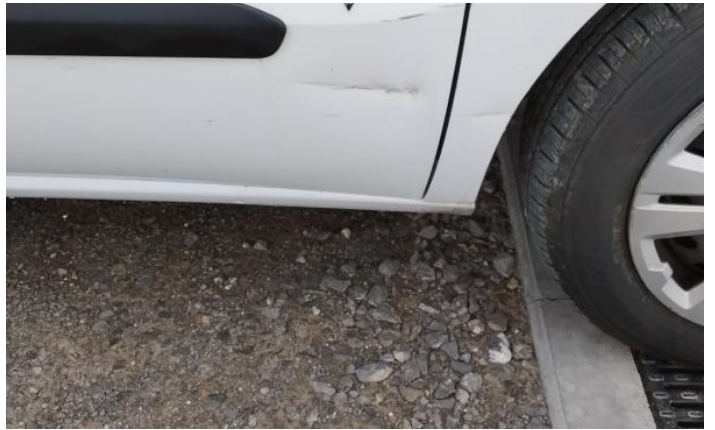
16: Door osf
Dented
With Paint Damage

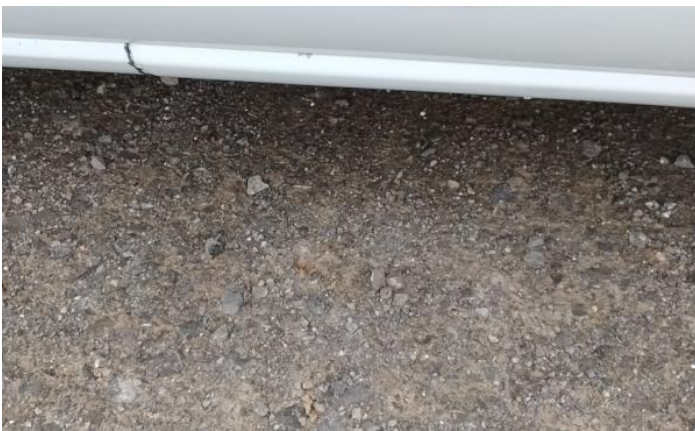
17: Door osf
Dented
Between 10mm + 30mm

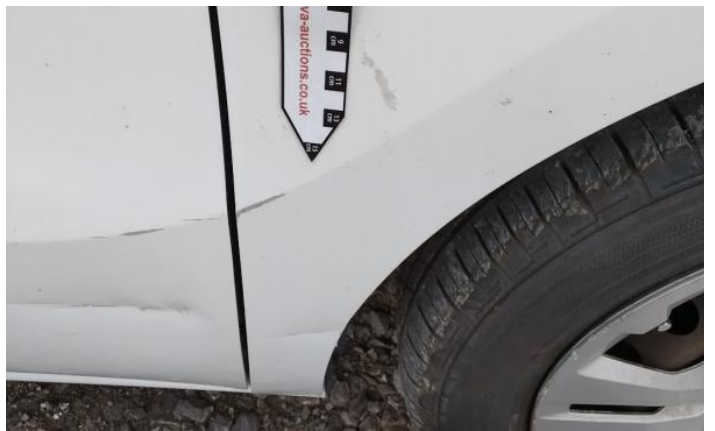
18: Wing osf
Dented
With Paint Damage

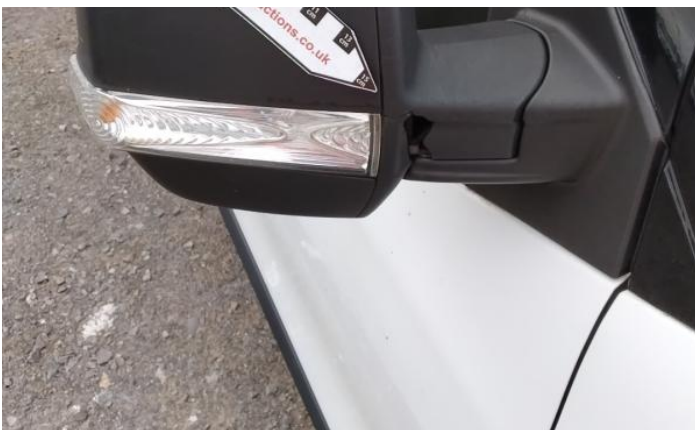
19: Door Mirror Assy osf
Broken
Replace

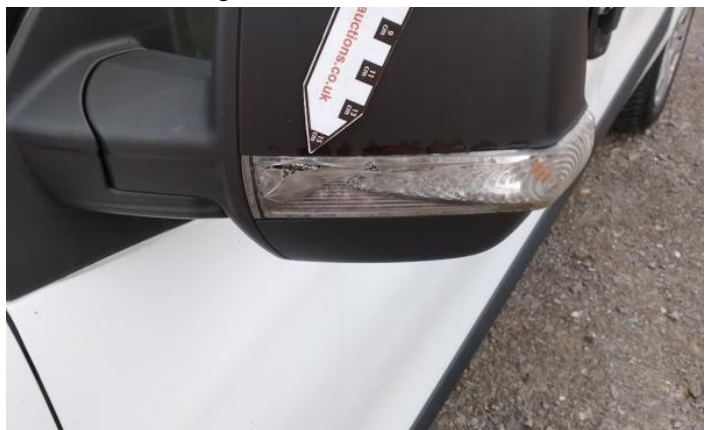
20: Door Mirror Assy nsf
Broken
Replace

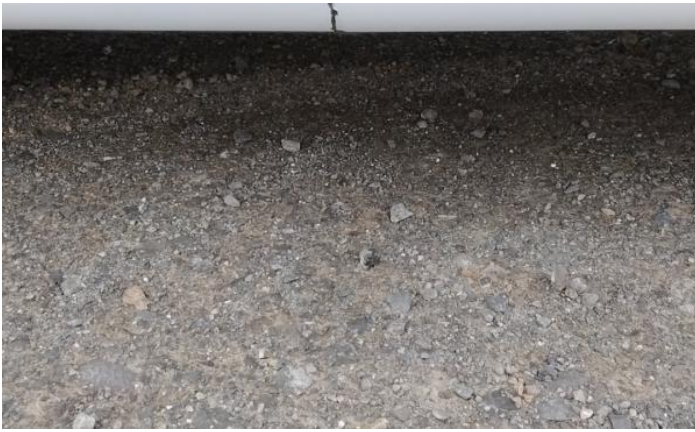
21: Sill os
Cracked
Replace

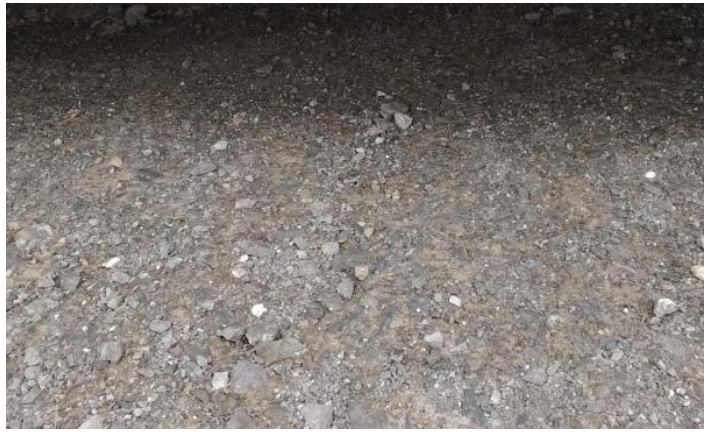
22: Sill ns
Cracked
Replace

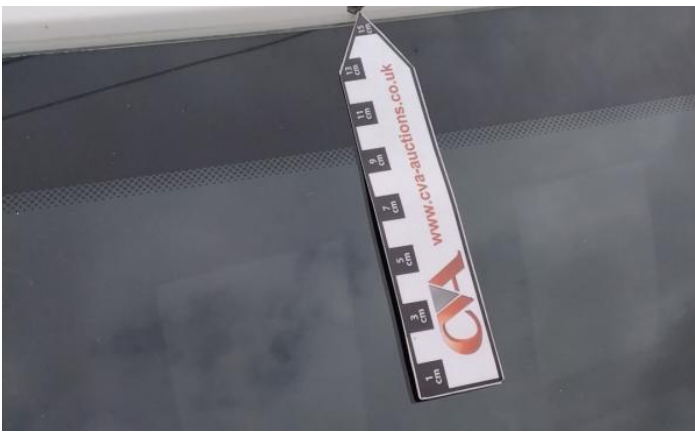
23: Roof
Rusted
Over 5mm
