COMMERCIAL VEHICLE AUCTIONS LTD
THE UK'S MOST ESTABLISHED COMMERCIAL VEHICLE AUCTIONEERS

VEHICLE INSPECTION REPORT

PJ66BFU

Daf LF 150

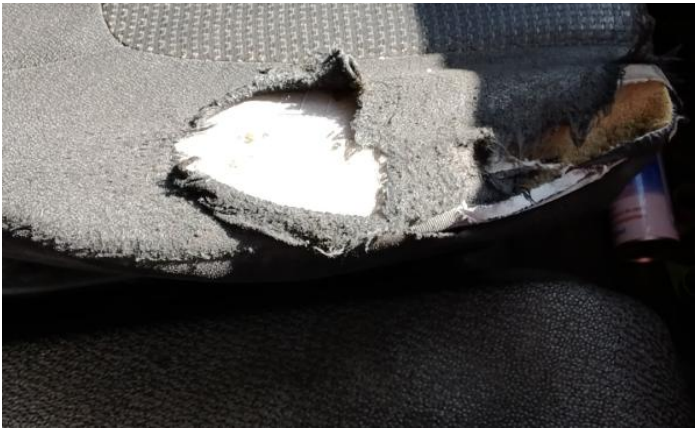
1: Seat Base Cover of
Holed
Over 3mm

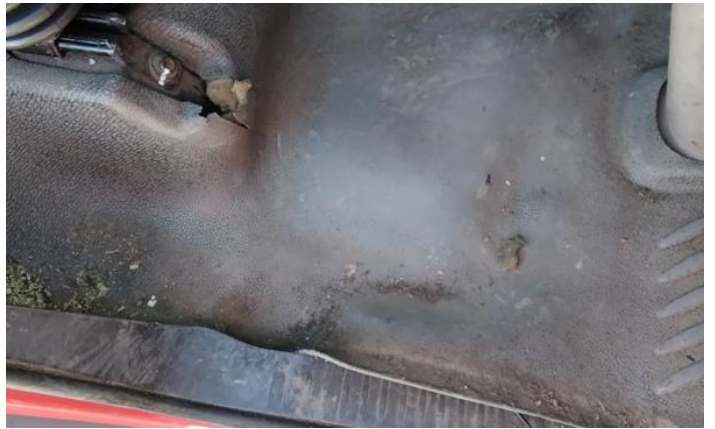
2: Carpets Front
Holed
Over 3mm

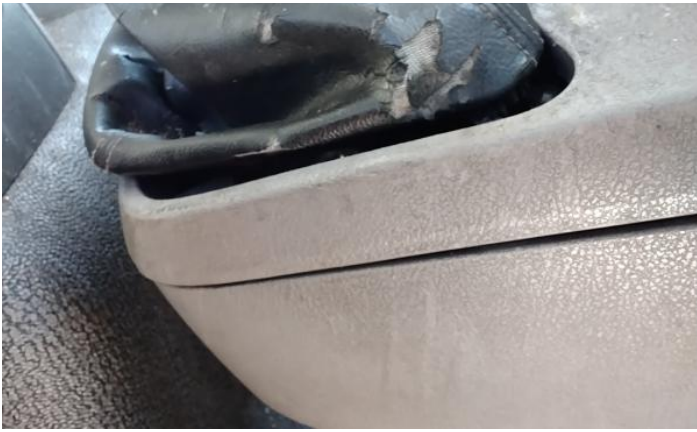
3: Fascia Trim
Damaged
Replace

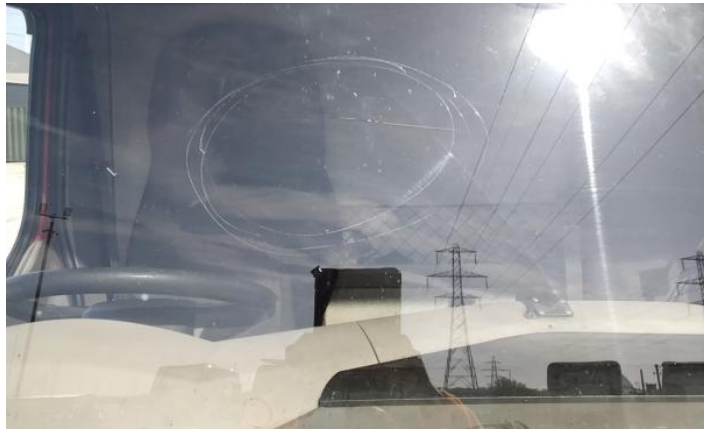
4: Screen Front
Cracked
Replace

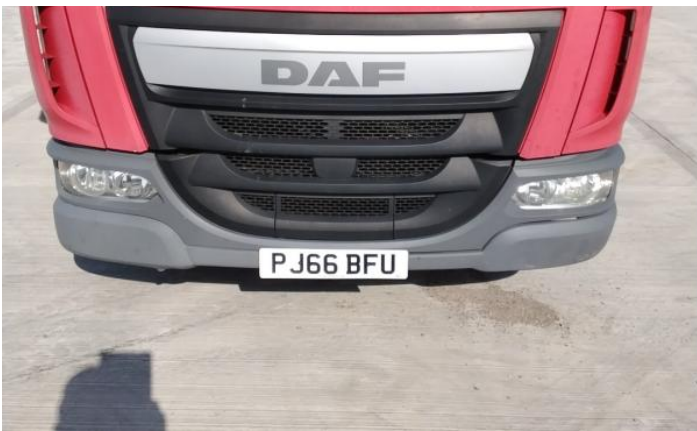
5: Bonnet
Chipped
Multiple Chips

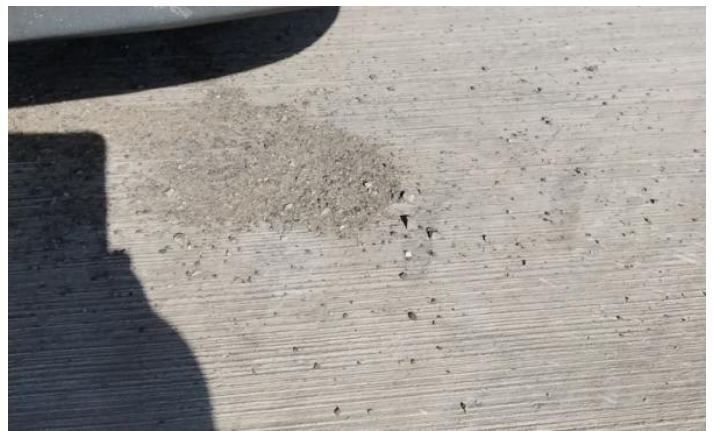
6: Bumper Front
Scratched
Over 100mm Thru Paint

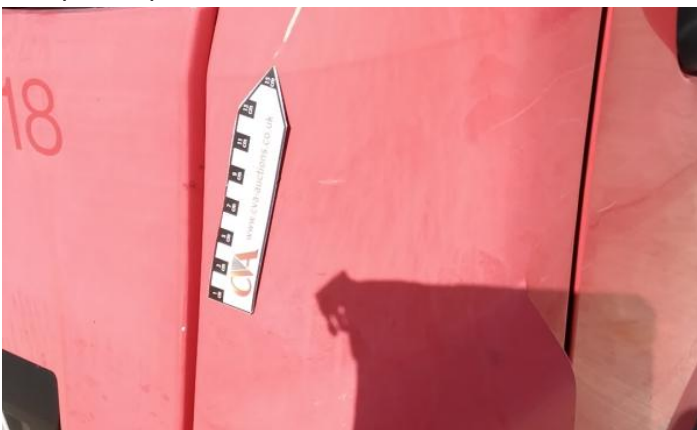
7: Moulding nsf Wing
Scratched (Painted)
Over 25mm Thru Paint

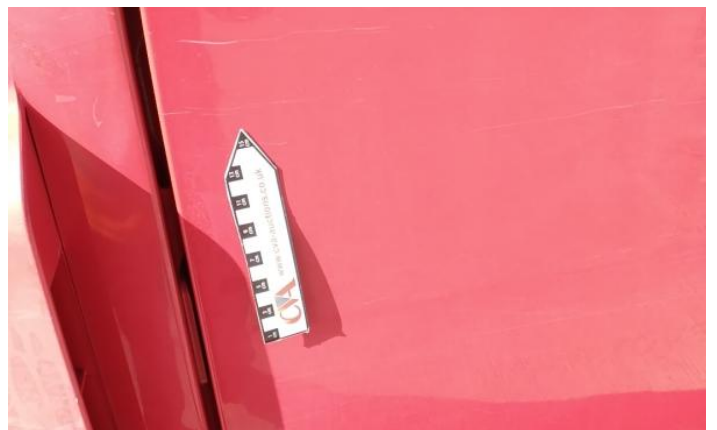
8: Door nsf
Scratched
Over 25mm Thru Paint

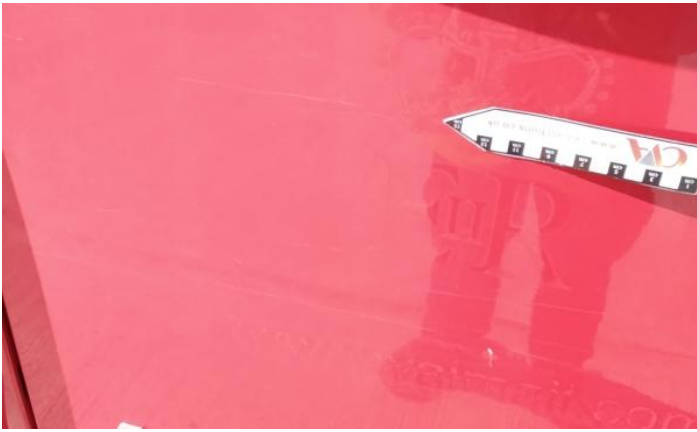
9: Door nsf
Scratched
UpTo 25mm Not Thru Paint

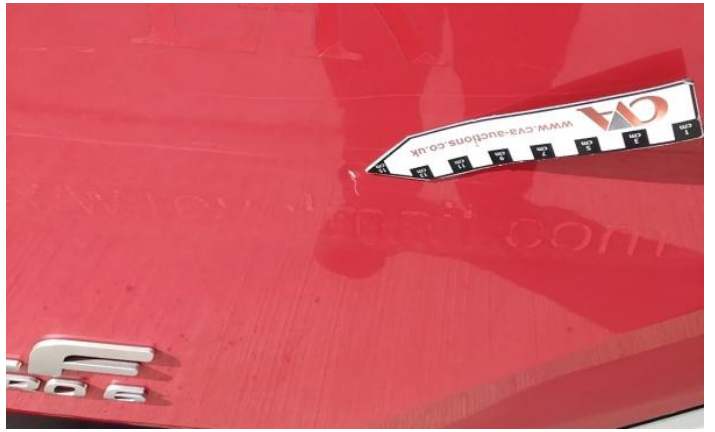
10: Door nsf
Dented
With Paint Damage

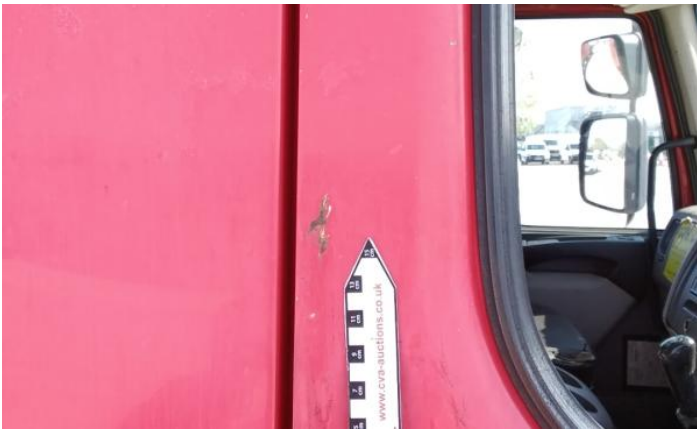
11: Door osf
Scratched
Over 25mm Thru Paint

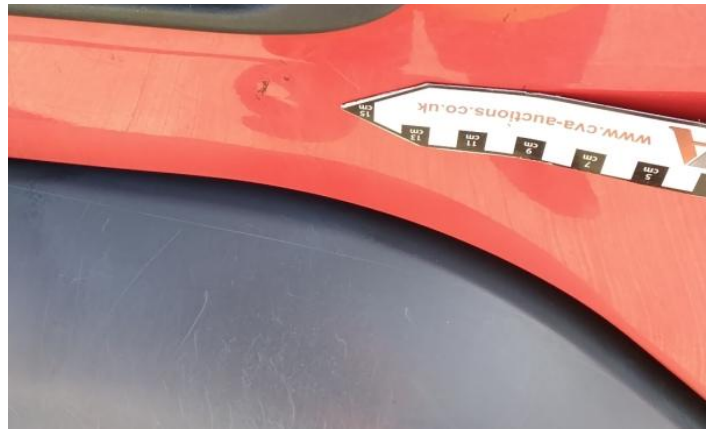
12: Door osf
Dented
Between 10mm + 30mm

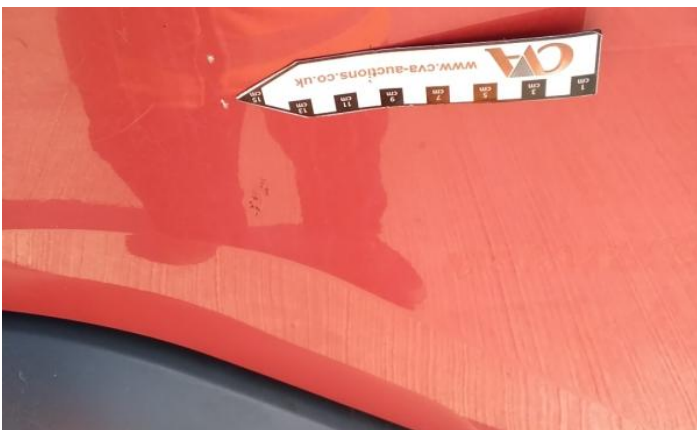
13: Door osf
Dented
With Paint Damage

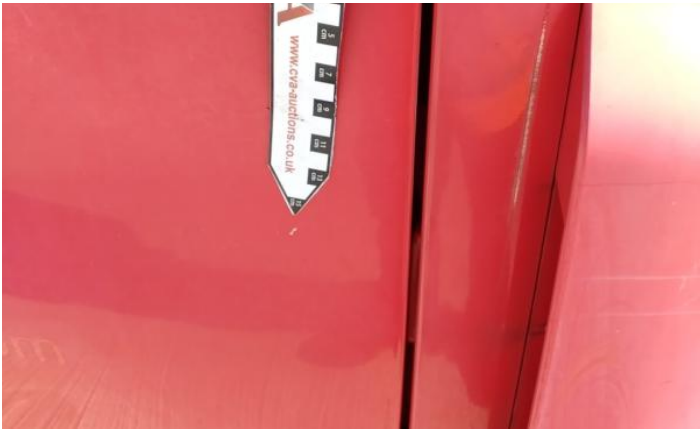
15: Door osf
 Scratched
 Over 25mm Thru Paint

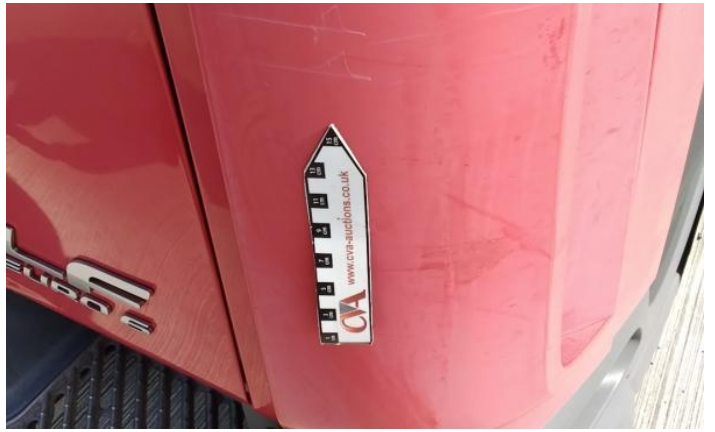
16: Moulding osf Wing
 Scratched (Painted)
 Over 25mm Thru Paint

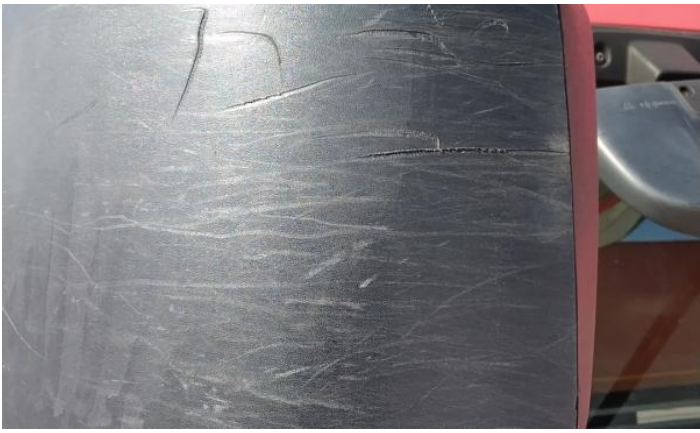
17: Door Moulding nsf
 Broken
 Replace
