# VEHICLE INSPECTION REPORT

**BF23YOM**

## Iveco Eurocargo 120-210

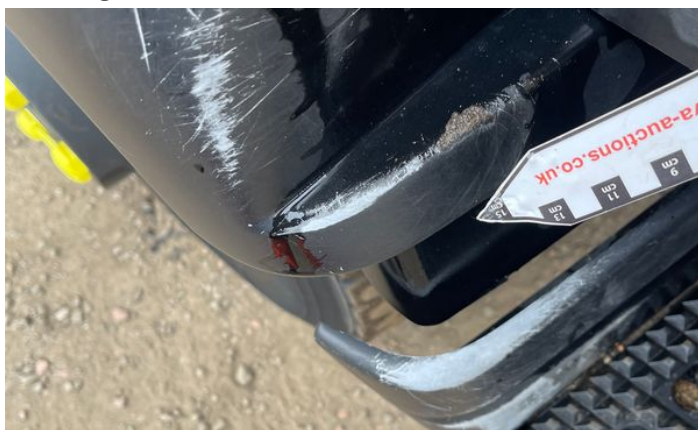
1: Door Moulding of  
Scuffed (Unpainted)  
Over 100mm

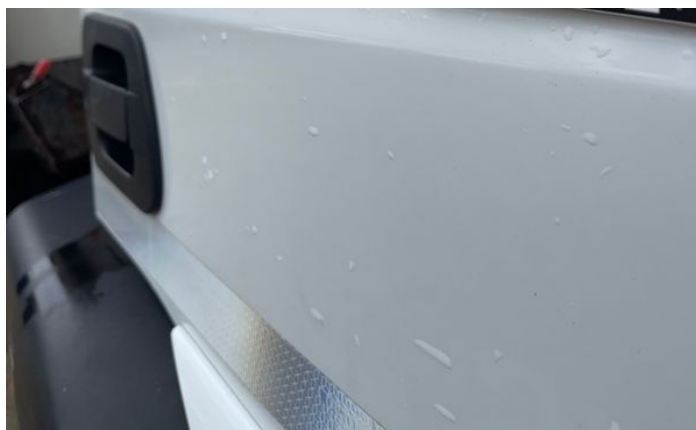
2: Door of  
Dented  
Over 30mm

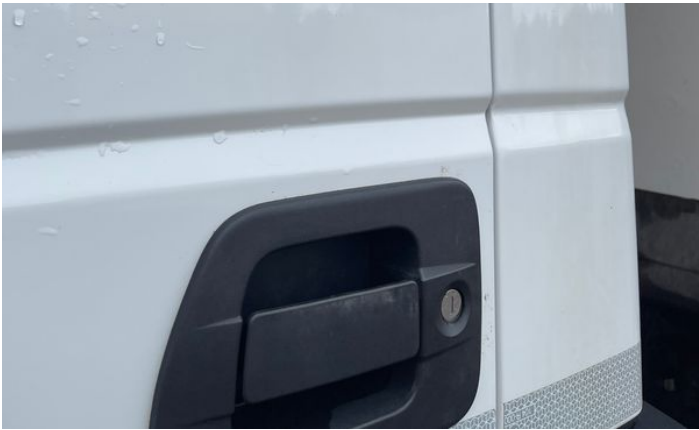
3: Door nsf  
Dented  
With Paint Damage

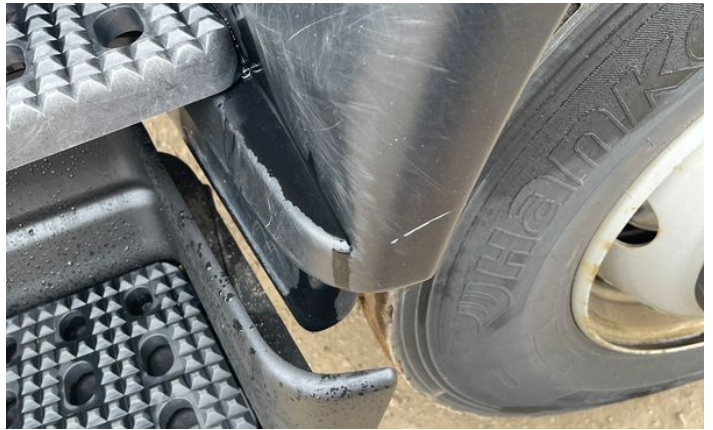
4: Door Moulding nsf  
Scuffed (Unpainted)  
Over 100mm
