# VEHICLE INSPECTION REPORT

**BF23YOL**

## Iveco Eurocargo 120-210

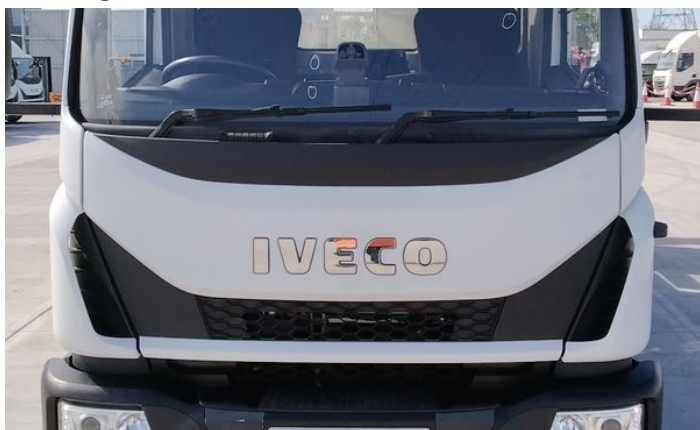
1: Screen Front  
Chipped  
Over 10mm

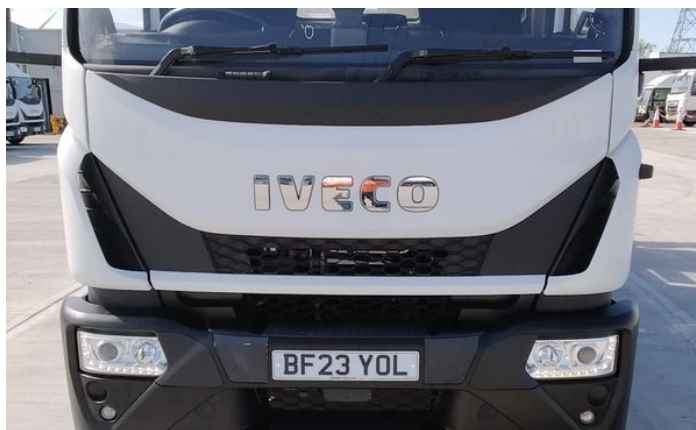
2: Bonnet  
Chipped  
Multiple Chips

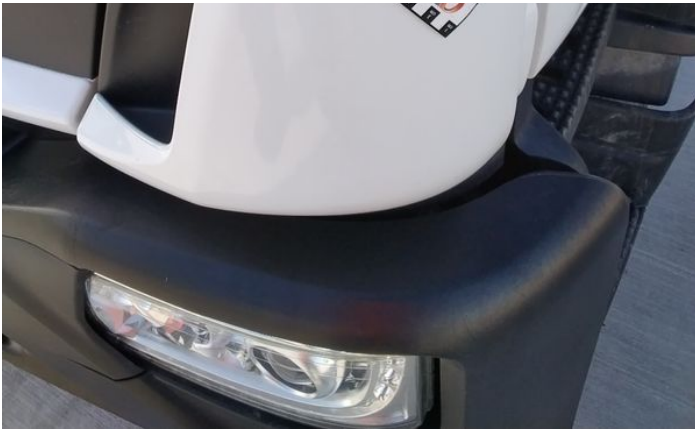
3: Moulding nsf Wing  
Scratched (Painted)  
UpTo 25mm Thru Paint

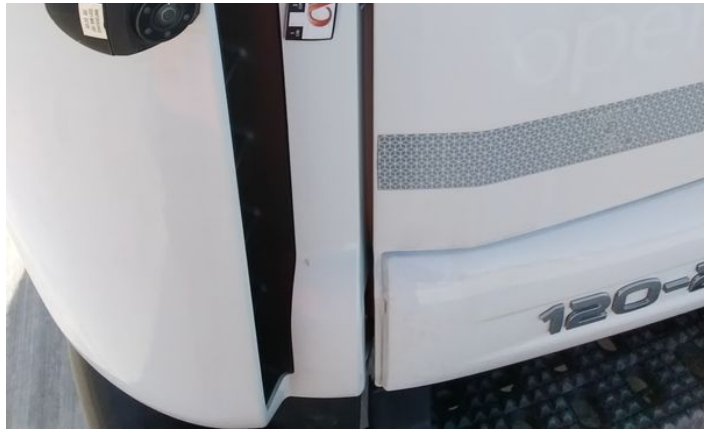
4: Wing nsf  
Scratched  
Over 25mm Thru Paint

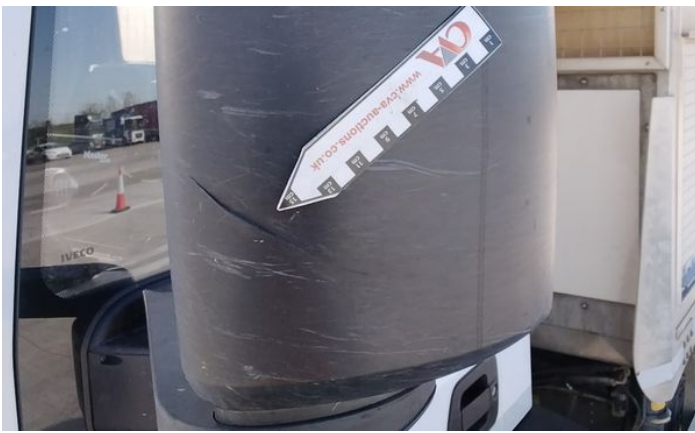
5: Door Mirror Assy nsf  
Broken  
Replace

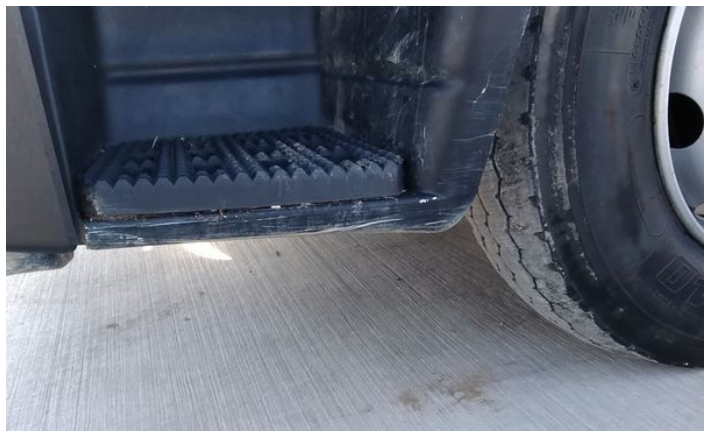
6: Wing nsf  
Cracked  
Replace

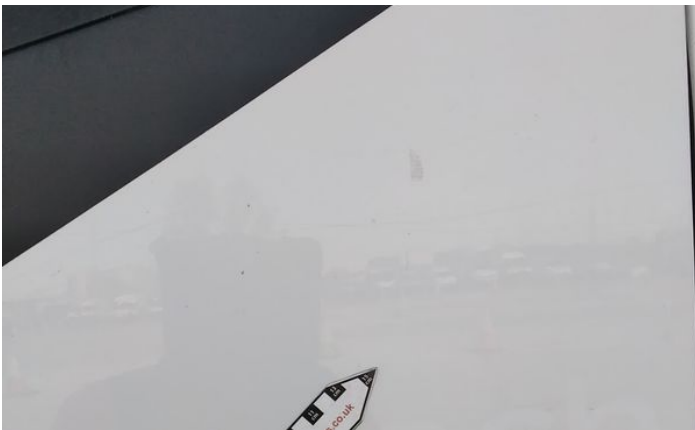
7: Door nsf  
Scratched  
Over 25mm Not Thru Paint

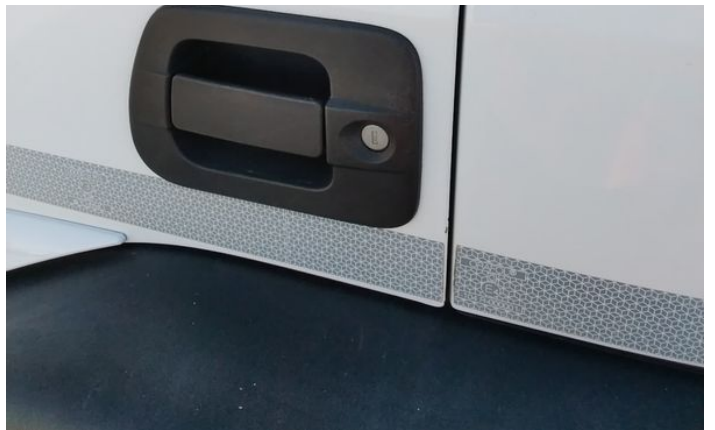
8: Door nsf  
Scratched  
UpTo 25mm Thru Paint

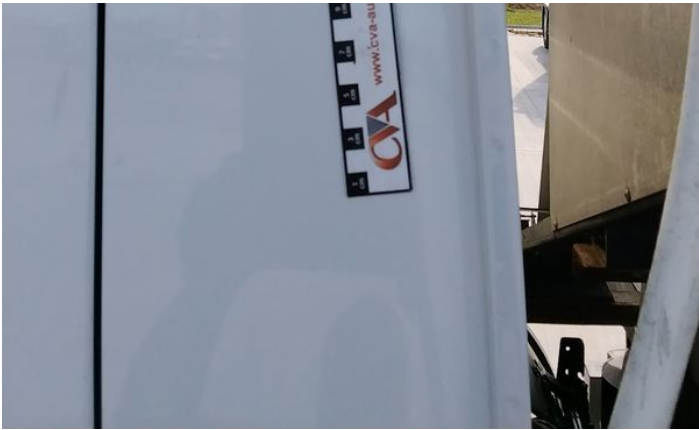
9: Qtr Panel nsr  
Chipped  
Multiple Chips

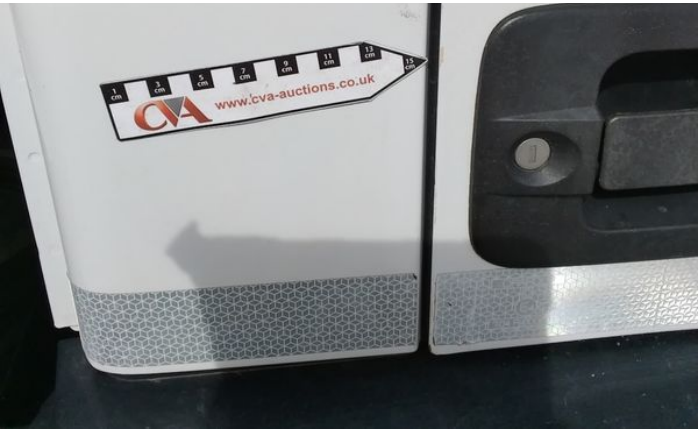
10: Door osf  
Chipped  
Multiple Chips
