VEHICLE INSPECTION REPORT

HX23YNB

Mercedes-Benz Atego 1223

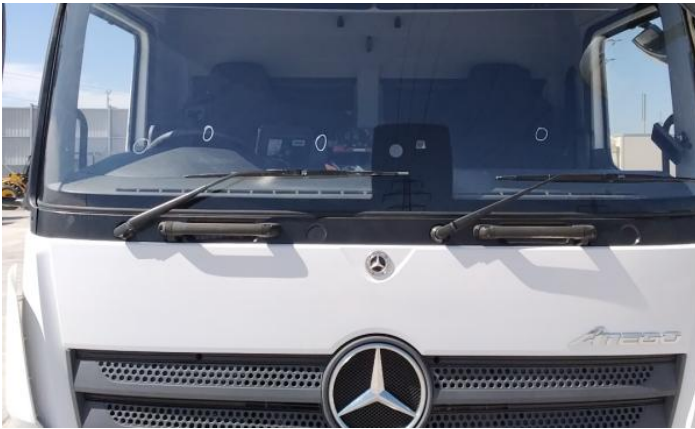
1: Screen Front
Chipped
Over 10mm

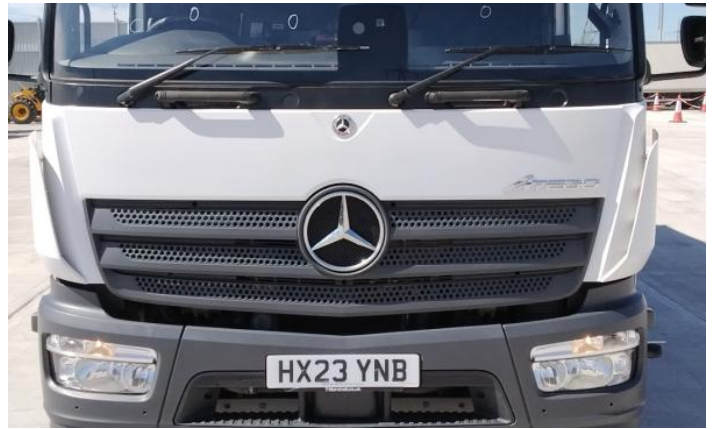
2: Bonnet
Chipped
Multiple Chips

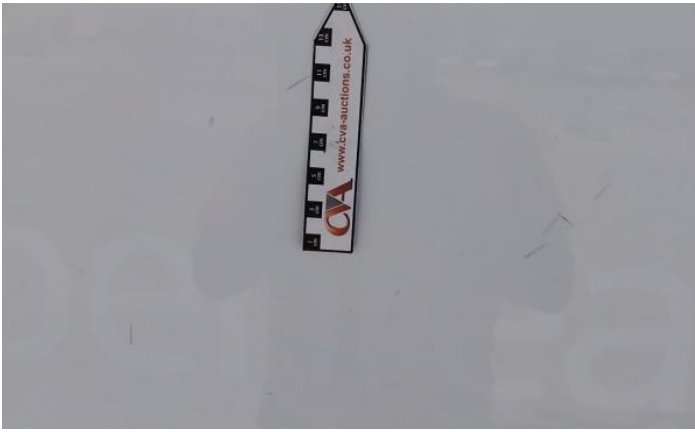
3: Door nsf
Scratched
Over 25mm Thru Paint

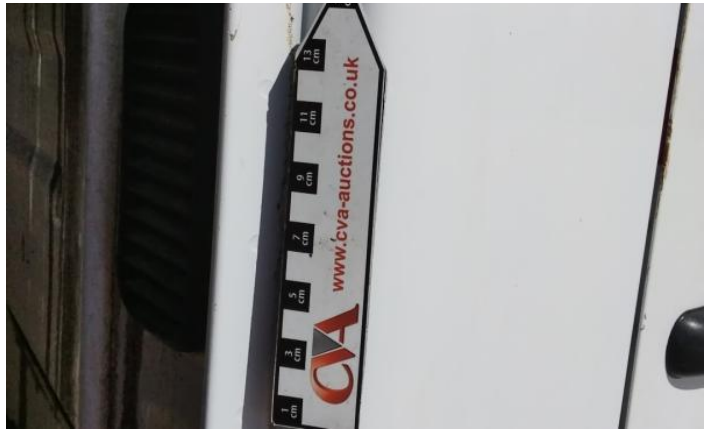
4: Qtr Panel osr
Scratched
Over 25mm Thru Paint

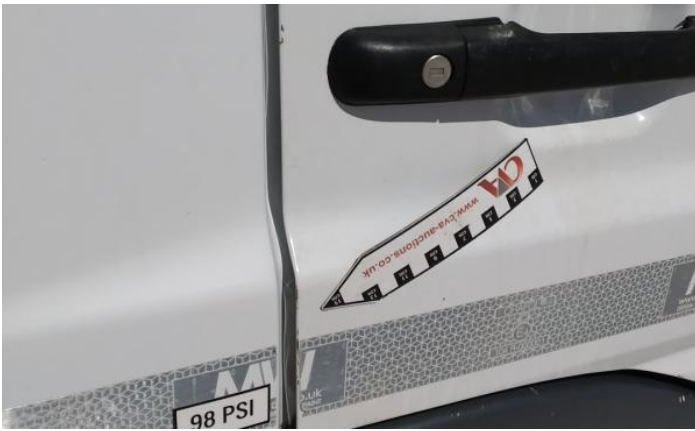
5: Door osf
Chipped
Multiple Chips

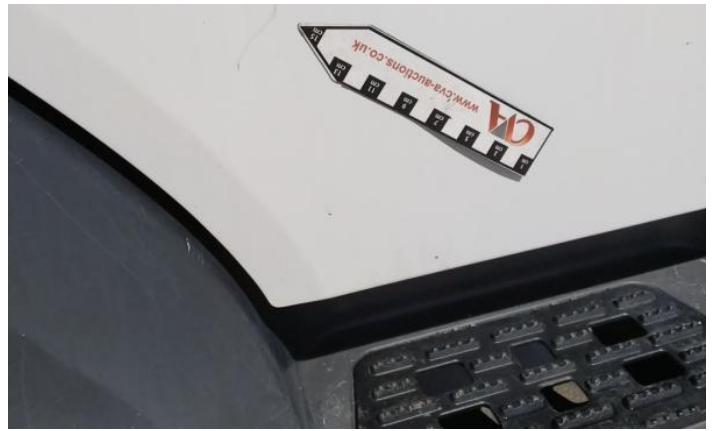
6: Door osf
Scratched
Over 25mm Thru Paint

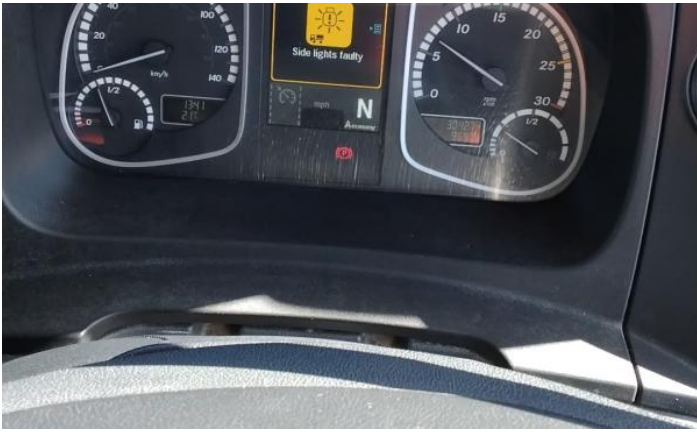
9: Dash Warning Lights
 Displayed
 No Action
