# VEHICLE INSPECTION REPORT

**PF20ACO**

## Mercedes-Benz Sprinter 314 CDI

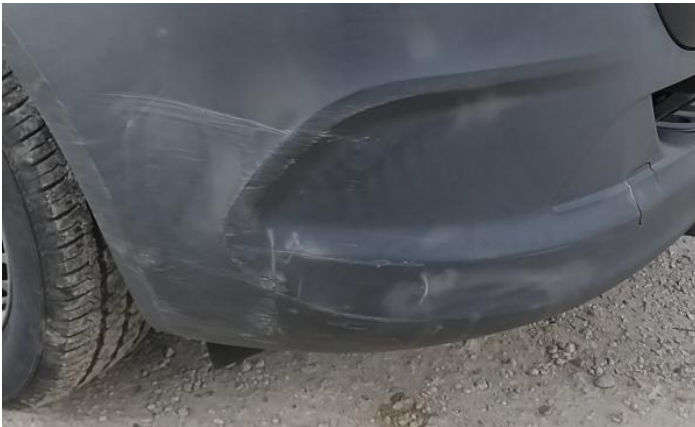
1: Bumper Front Moulding  
Scuffed (Unpainted)  
Over 100mm

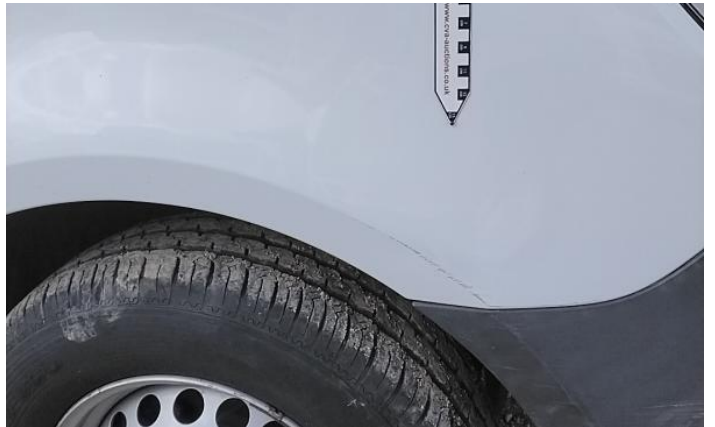
2: Wing of  
Scratched  
Over 25mm Thru Paint

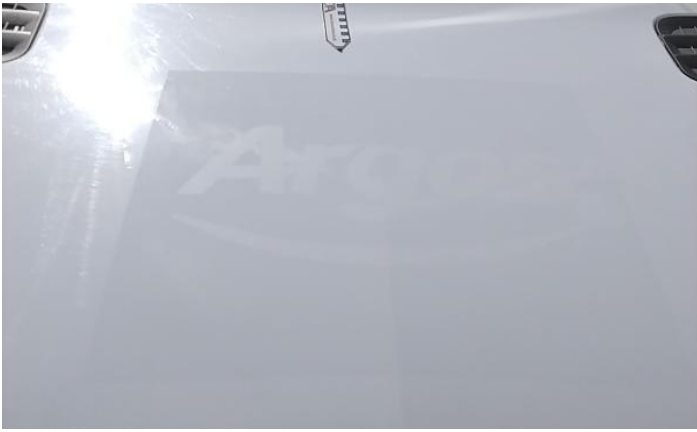
3: Bonnet  
Chipped  
Multiple Chips

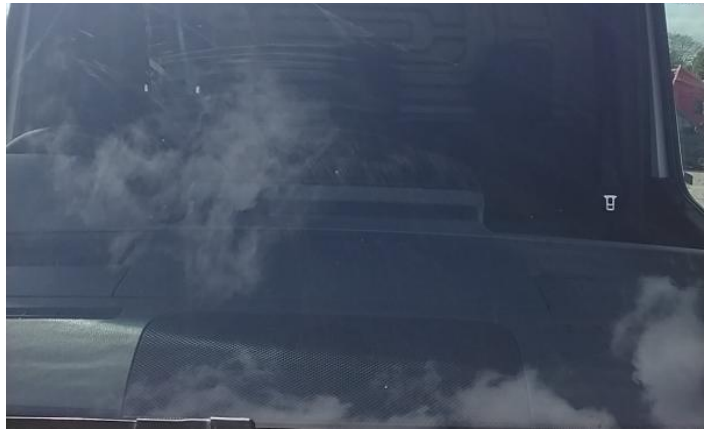
4: Screen Front  
Chipped  
UpTo 10mm

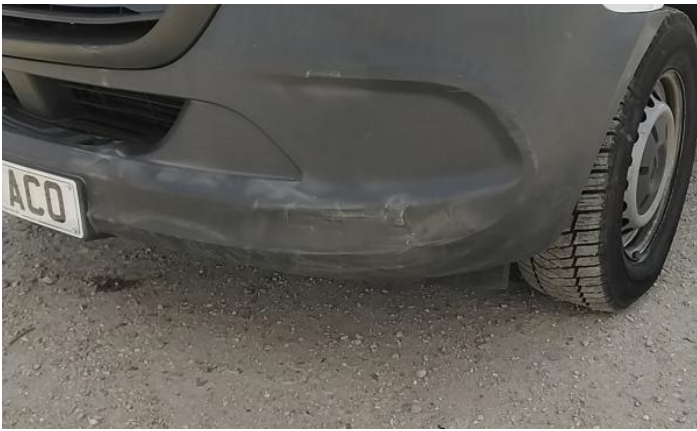
5: Bumper Front Moulding  
Scuffed (Unpainted)  
Over 100mm

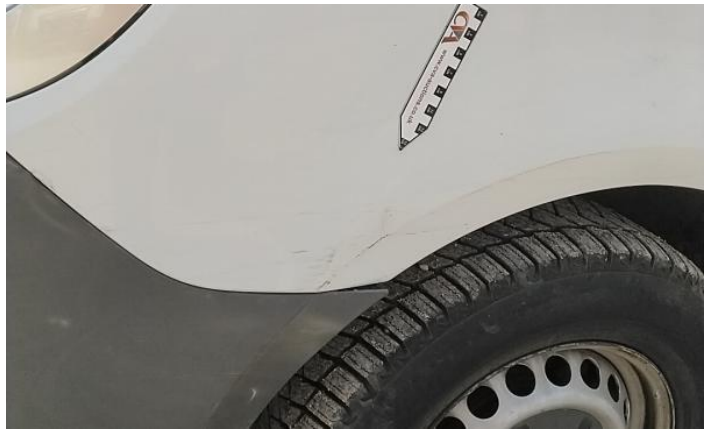
6: Wing nsf  
Dented  
With Paint Damage

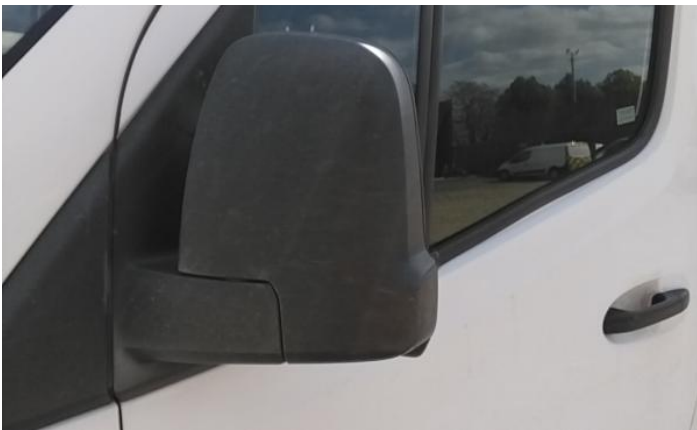
7: Door Mirror Assy nsf  
Scuffed (Unpainted)  
Over 100mm

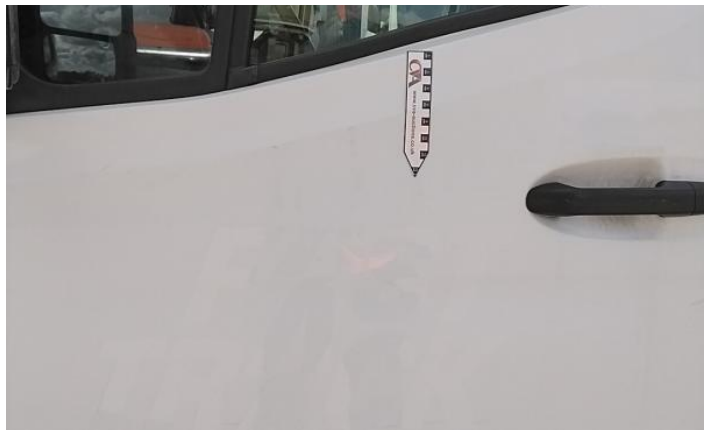
8: Door nsf  
Scratched  
Over 25mm Not Thru Paint

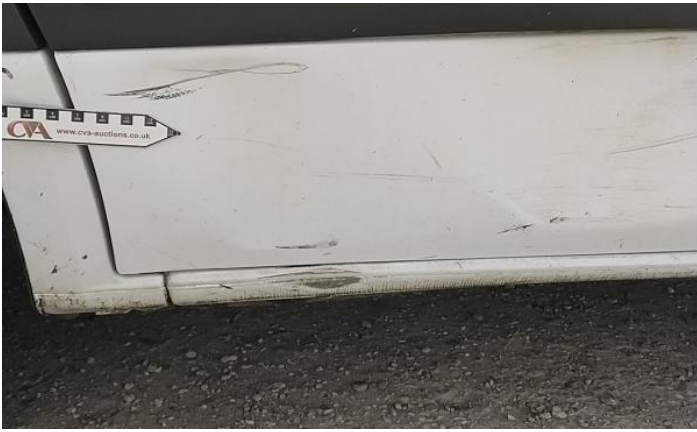
9: Door nsf  
Dented  
Over 30mm

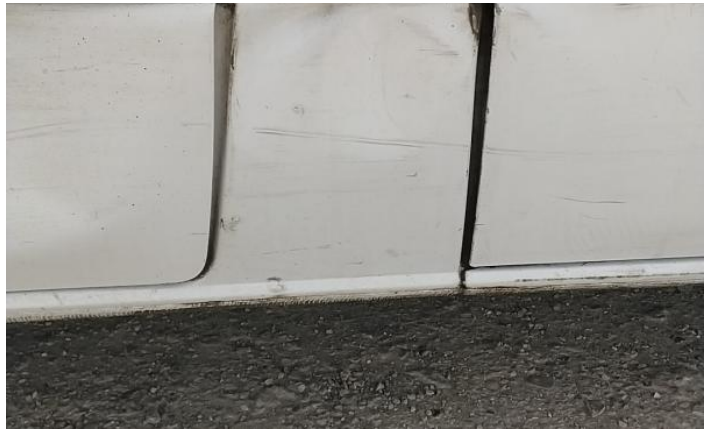
10: B Post ns  
Dented  
With Paint Damage

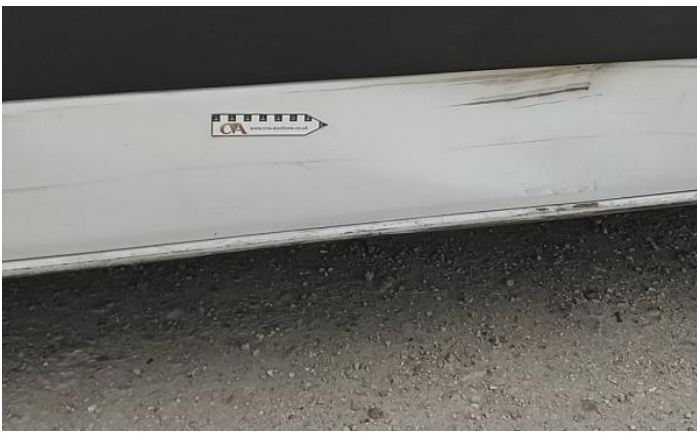
11: Door nsr  
Dented  
With Paint Damage

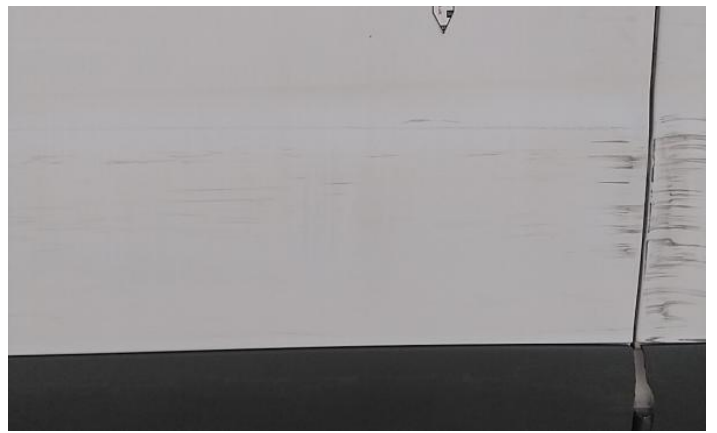
12: Door nsr  
Dented  
Over 30mm

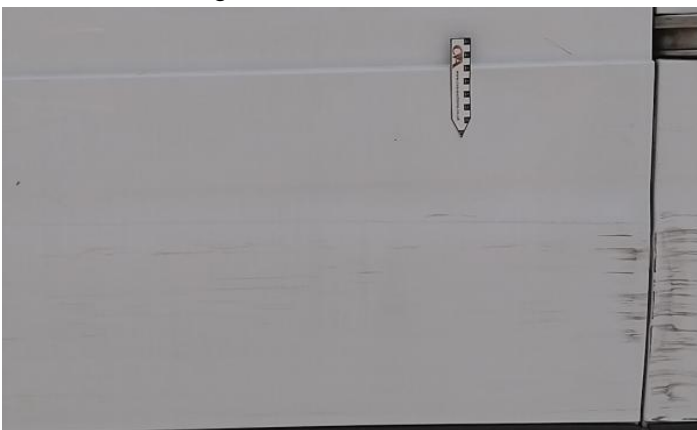
13: Door nsr  
Scratched  
Over 25mm Thru Paint

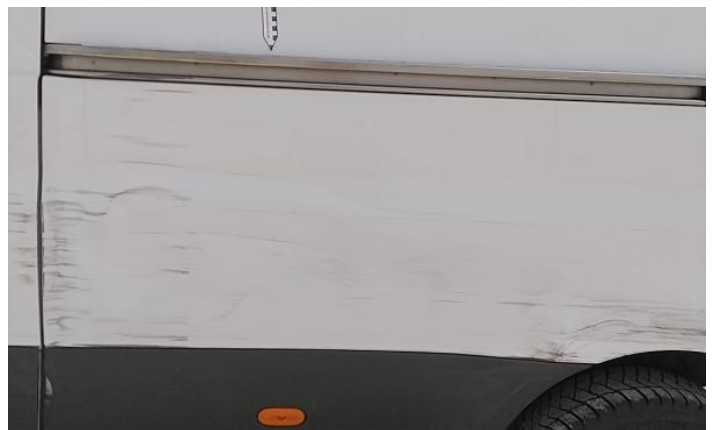
14: Qtr Panel nsr  
Dented  
With Paint Damage

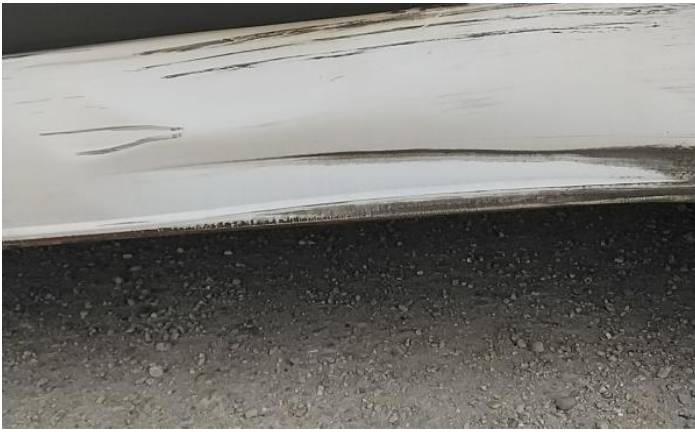
15: Sill ns  
Dented  
With Paint Damage

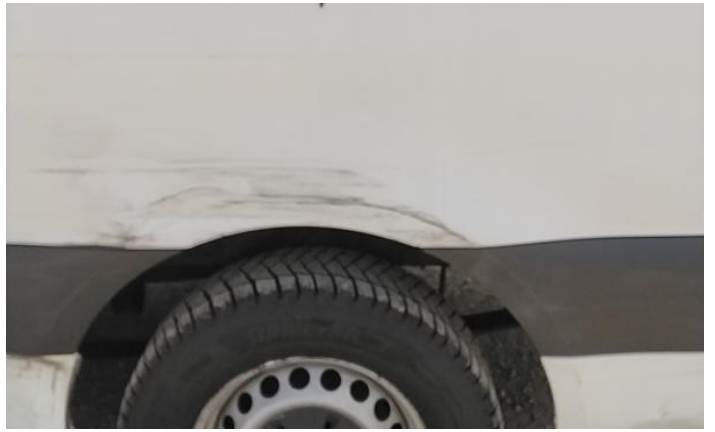
16: Qtr Panel nsr  
Dented  
With Paint Damage

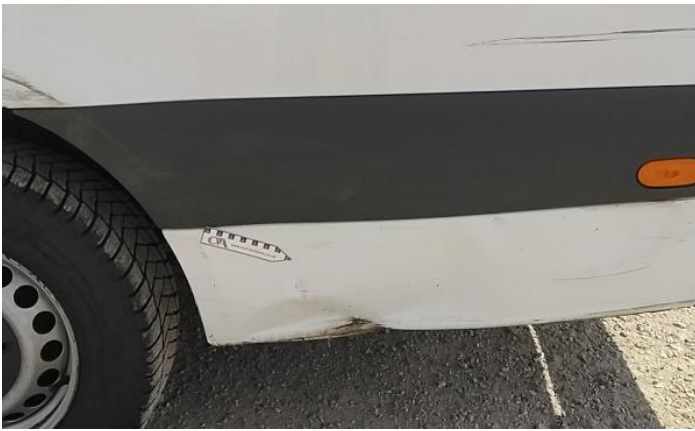
17: Sill ns  
Dented  
With Paint Damage

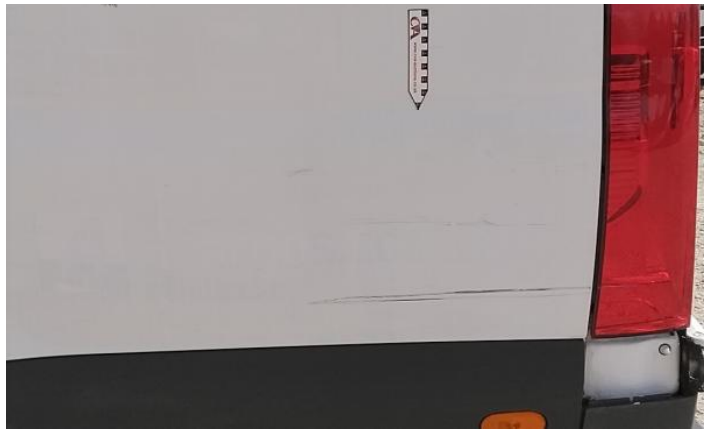
18: Qtr Panel nsr  
Scratched  
Over 25mm Not Thru Paint

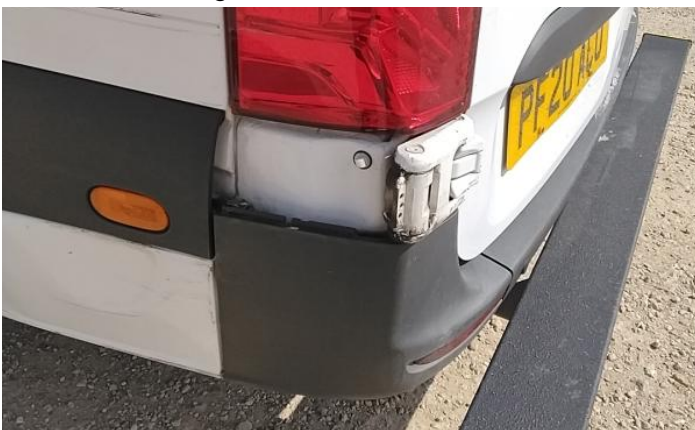
19: Bumper Rear Moulding  
Missing  
Replace

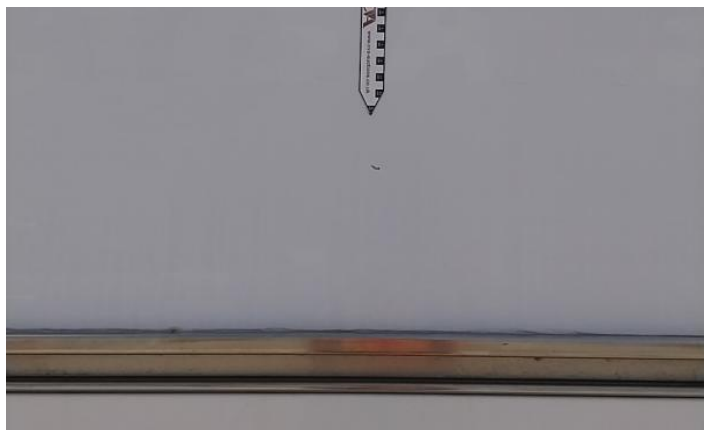
20: Qtr Panel nsr  
Dented  
With Paint Damage

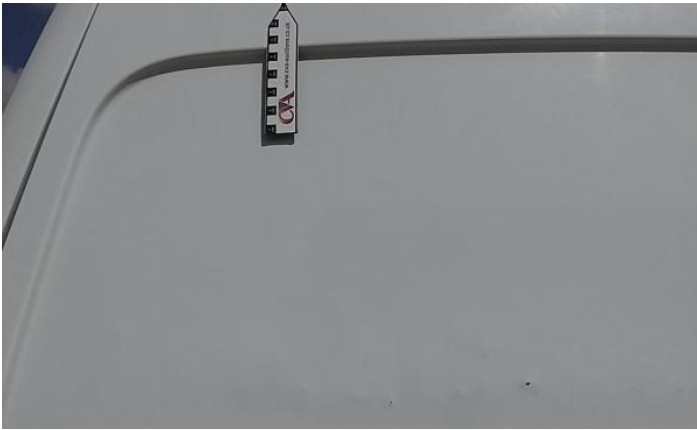
21: Door nsr  
Dented  
Over 30mm

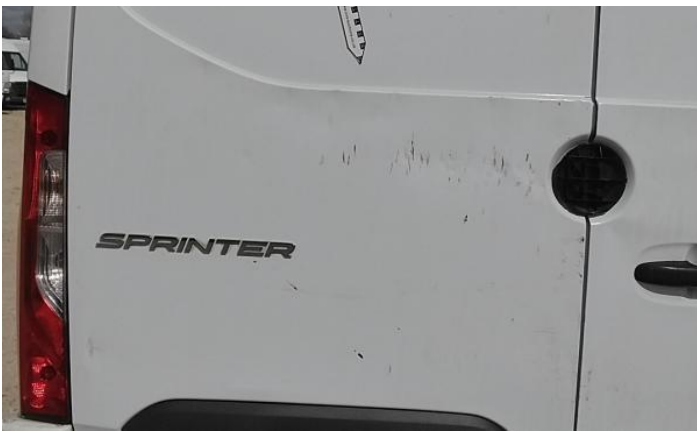
23: Door nsr  
Dented  
With Paint Damage

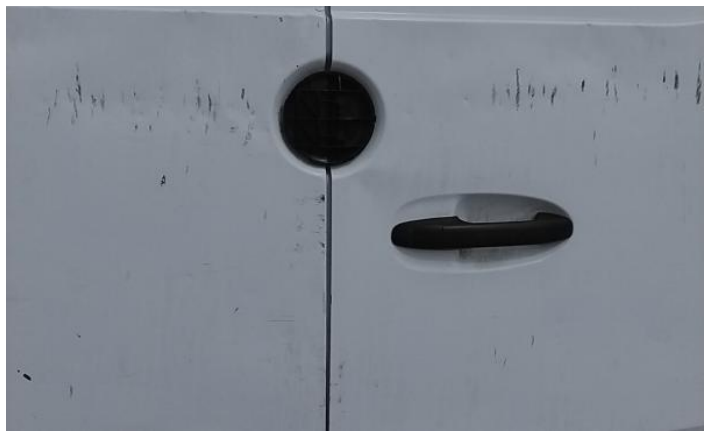
24: Badgedecal Rear  
Missing  
Replace

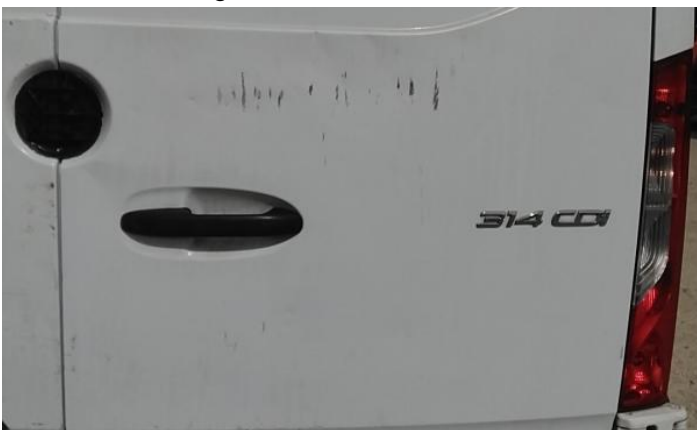
25: Door osr  
Dented  
With Paint Damage

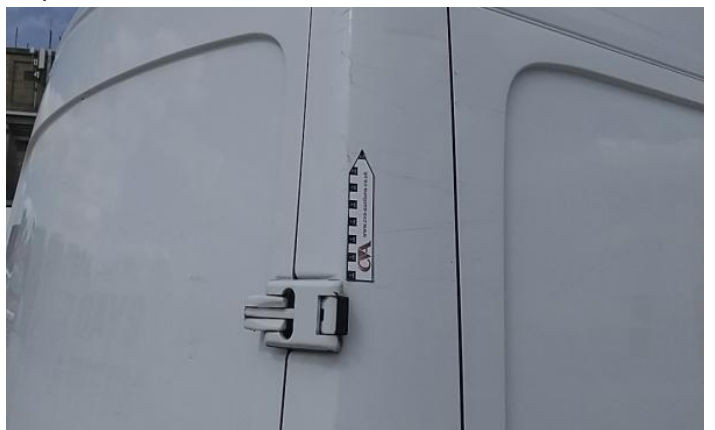
26: Qtr Panel osr  
Dented  
With Paint Damage

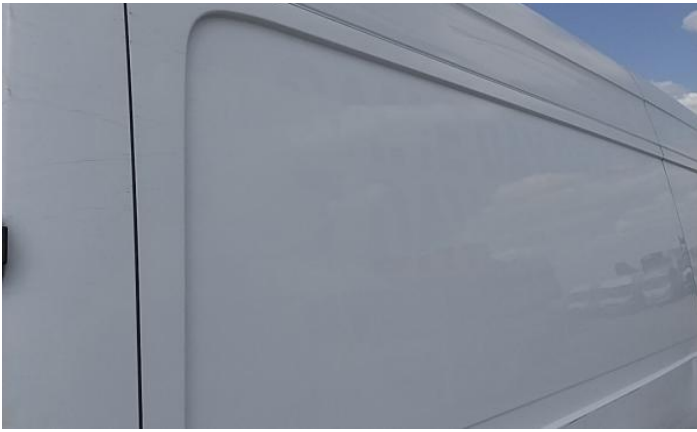
27: Qtr Panel osr  
Scratched  
Over 25mm Not Thru Paint

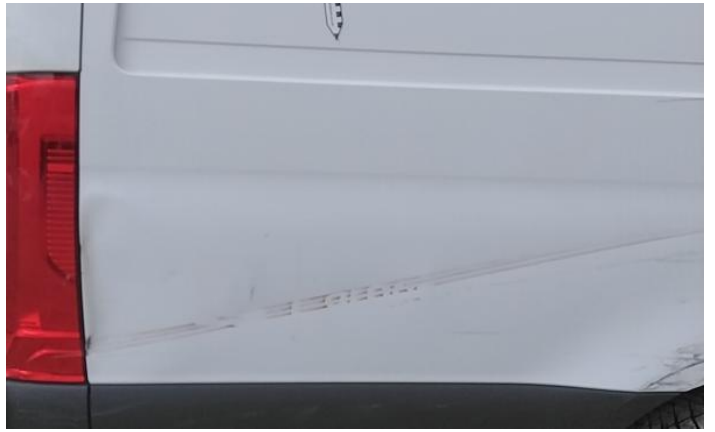
28: Qtr Panel osr  
Dented  
With Paint Damage

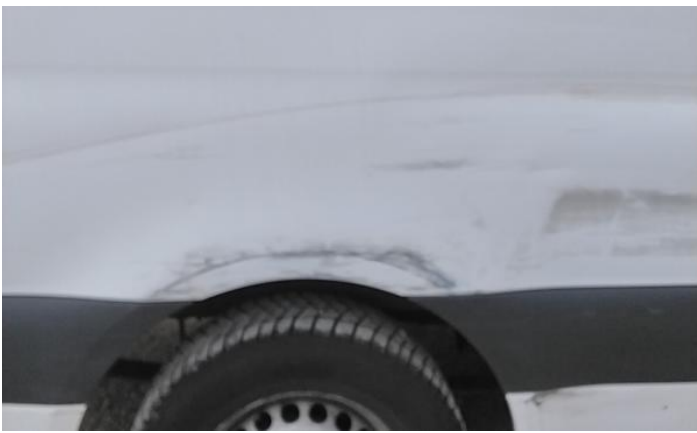
29: Qtr Panel osr  
Scratched  
Over 25mm Thru Paint

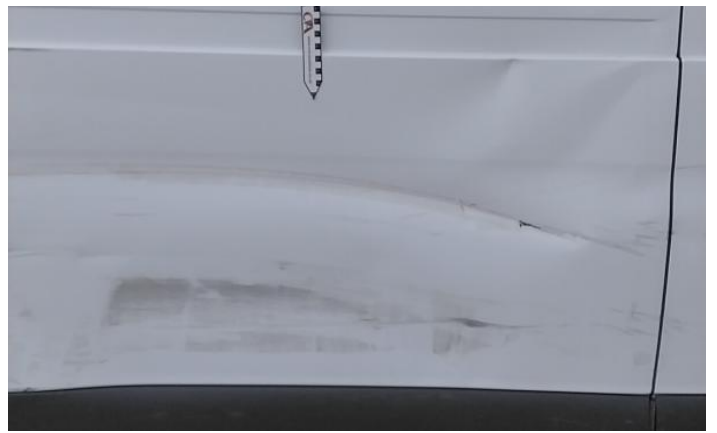
30: Qtr Panel osr  
Dented  
With Paint Damage

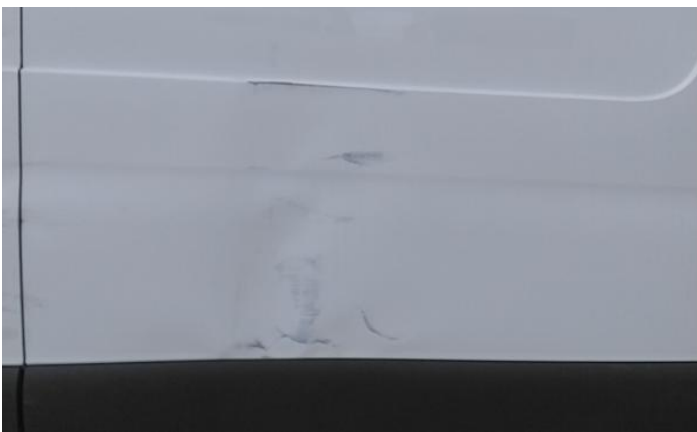
31: Qtr Panel osr  
Dented  
With Paint Damage

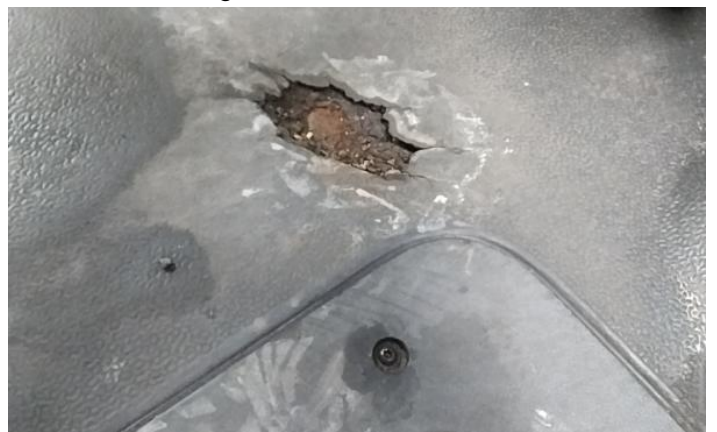
32: Carpets Front  
Holed  
Over 3mm

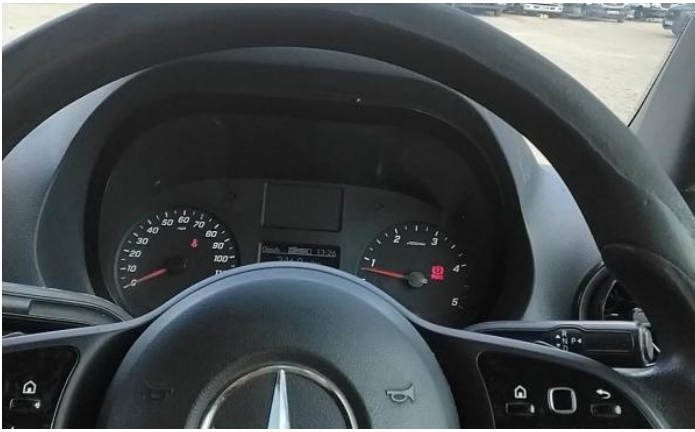
33: Steering Wheel  
 Damaged  
 Replace
