VEHICLE INSPECTION REPORT

PJ20NFG

Mercedes-Benz Sprinter 314 CDI

Inspection

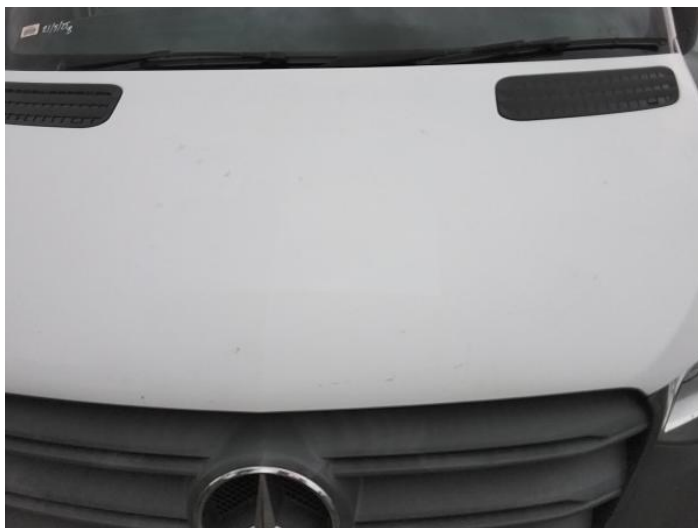
1: Bonnet
Chipped
Multiple Chips

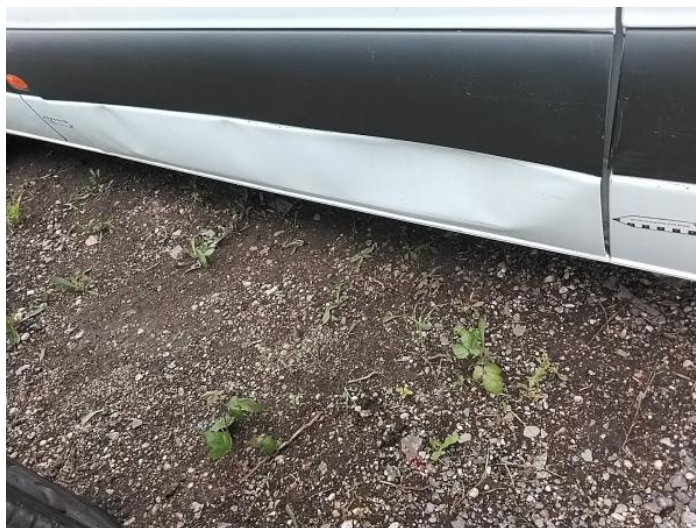
2: Qtr Panel nsr
Dented
Over 30mm

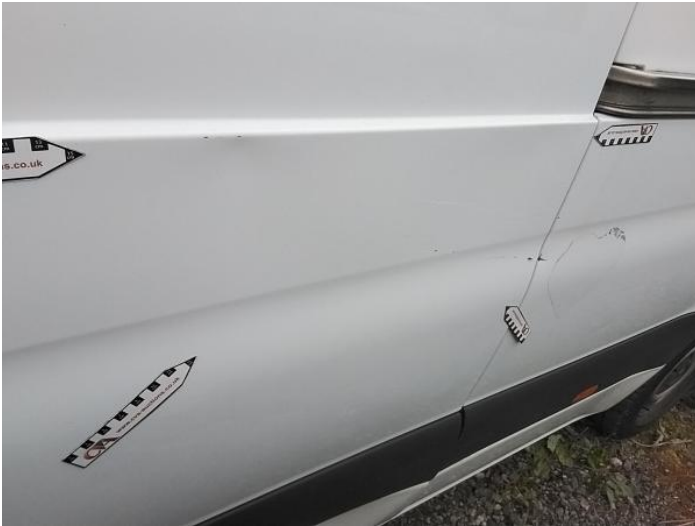
3: Qtr Panel nsr
Dented
Over 30mm

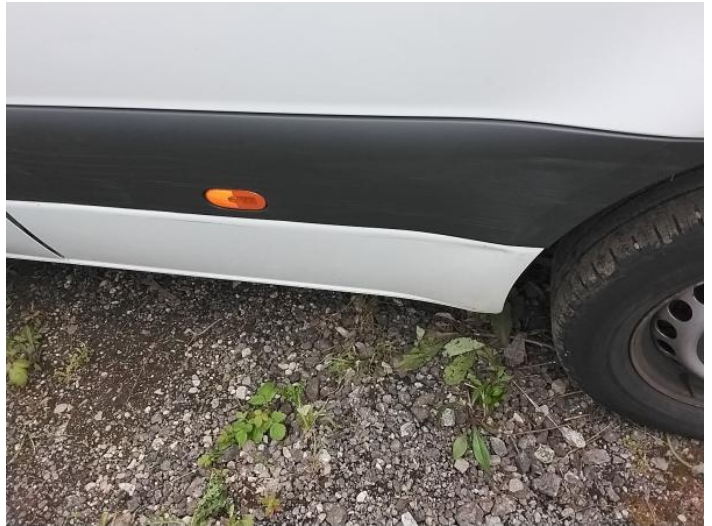
4: Qtr Panel Moulding ns
Scuffed (Unpainted)
Over 100mm

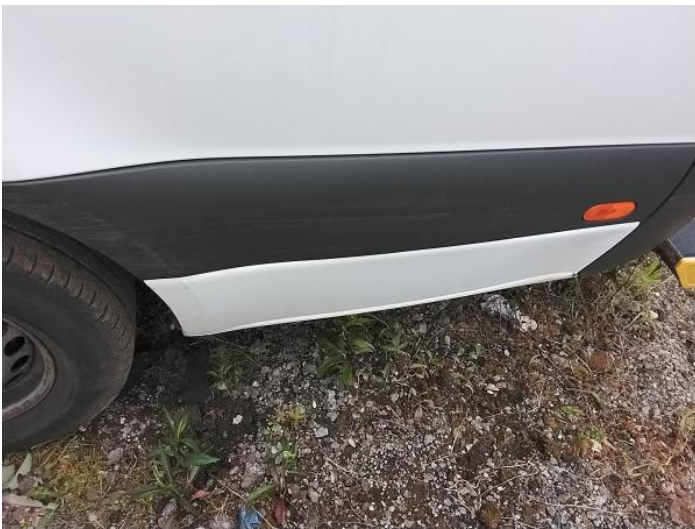
5: Qtr Panel Moulding ns
Scuffed (Unpainted)
Over 100mm

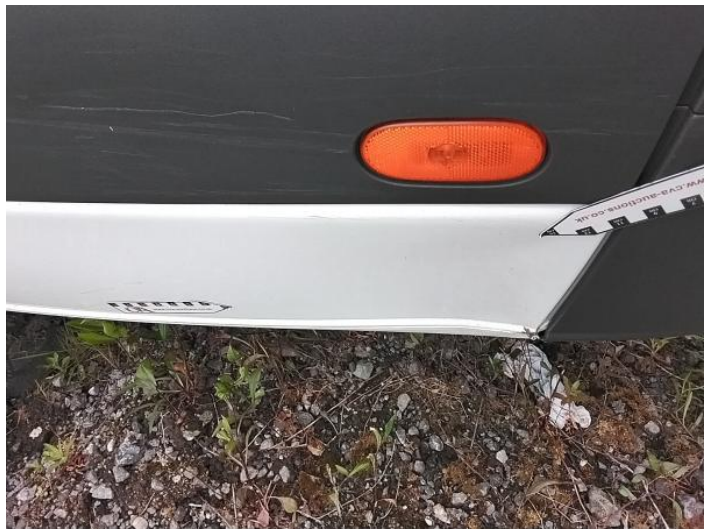
6: Qtr Panel nsr
Dented
Over 30mm

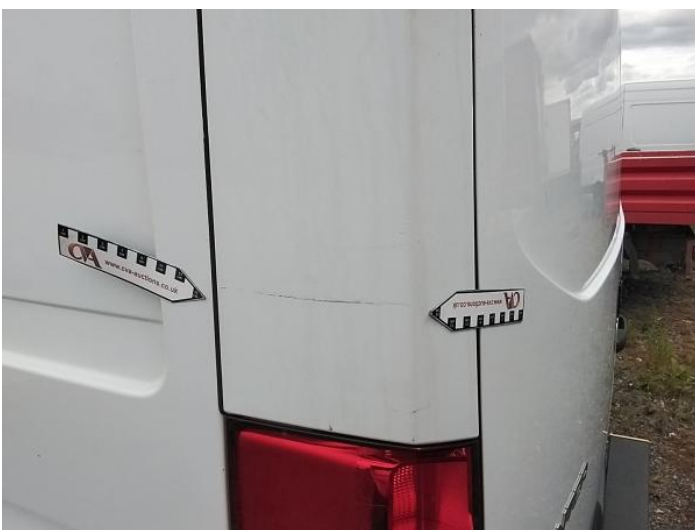
7: C Post ns
Scratched
Over 25mm Not Thru Paint

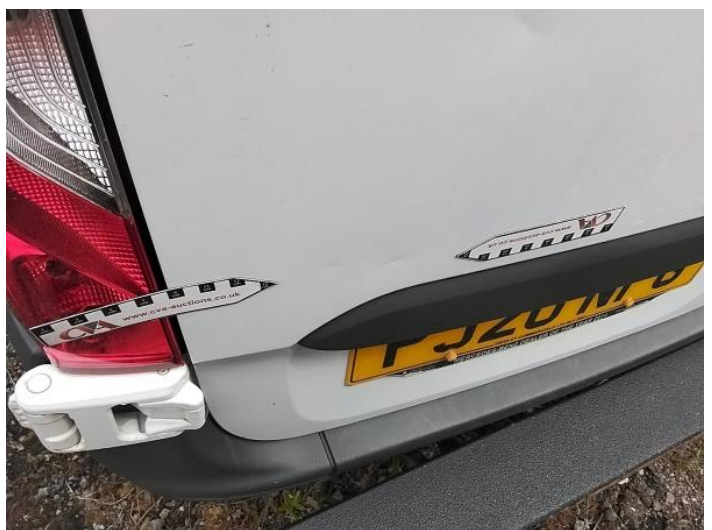
8: Door nsr
Dented
Over 30mm

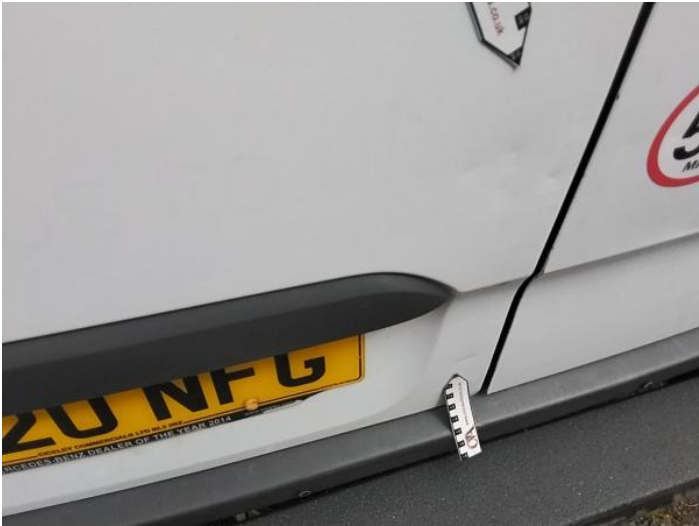
9: Door nsr
Dented
Over 30mm

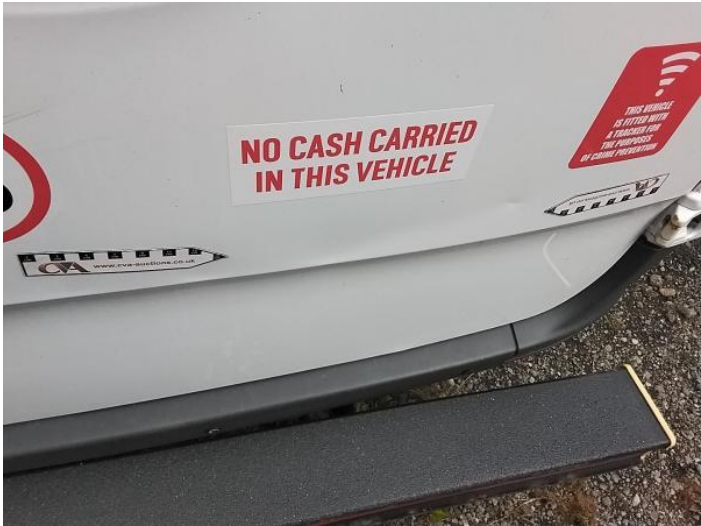
10: Door osr
Dented
Over 30mm

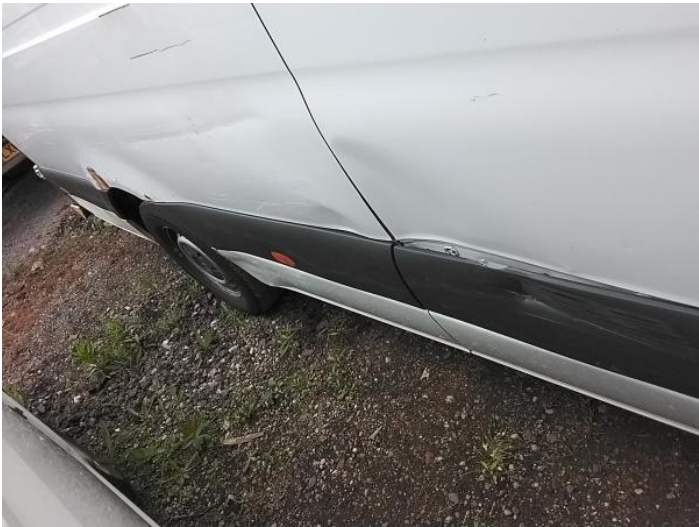
11: Unclassified
Substantial Accident Damage
Report Only

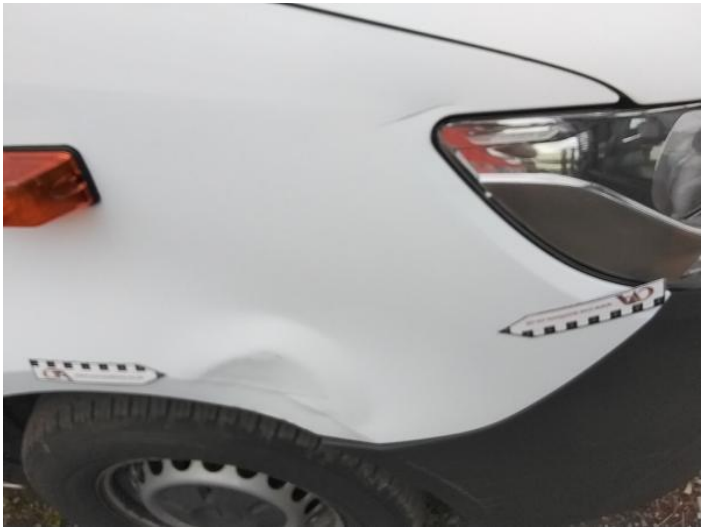
12: Wing osf
Dented
Over 30% Of Panel
