VEHICLE INSPECTION REPORT

PF20ABN

Mercedes-Benz Sprinter 314 CDI

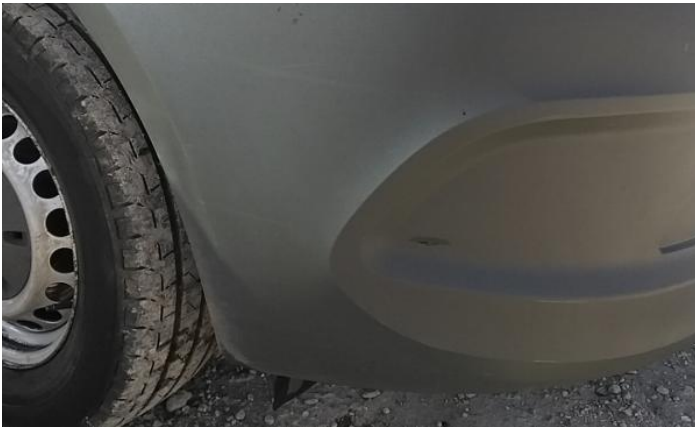
1: Bumper Front Moulding
Scuffed (Unpainted)
Over 100mm

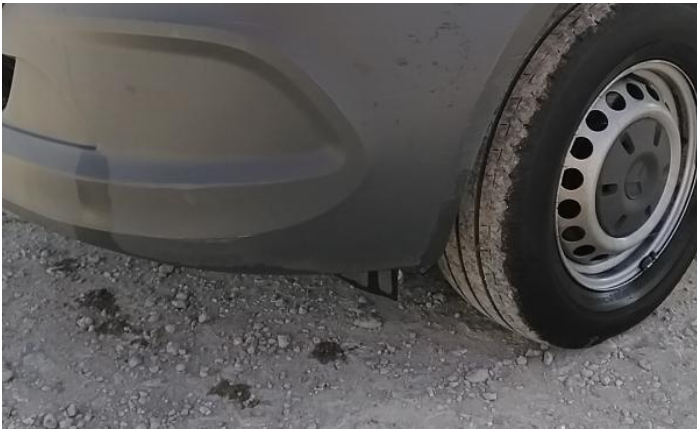
3: Bumper Front Moulding
Scuffed (Unpainted)
Over 100mm

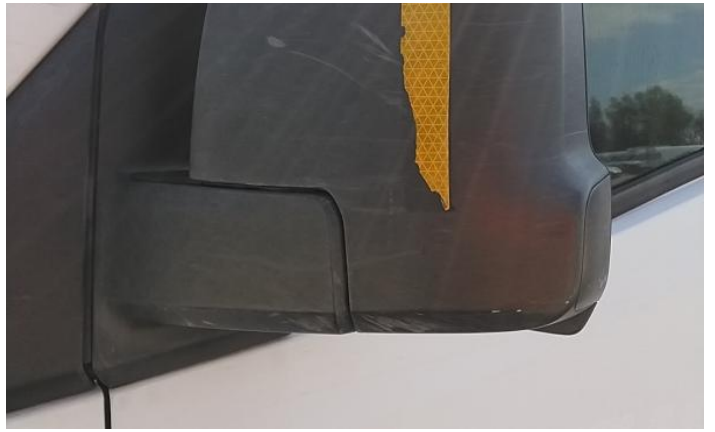
4: Door Mirror Assy nsf
Scuffed (Unpainted)
Over 100mm

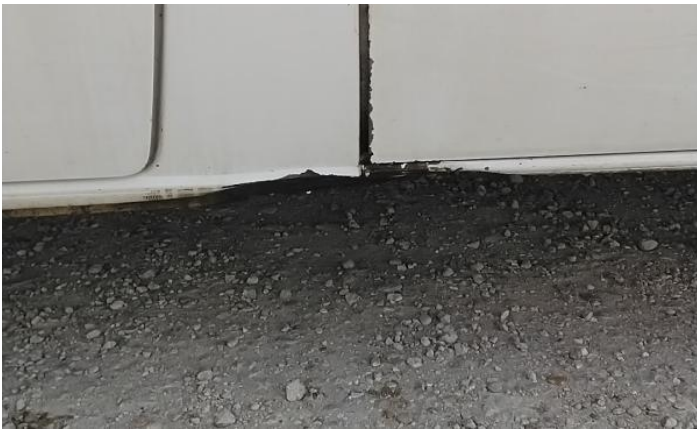
5: Sill ns
Dented
With Paint Damage

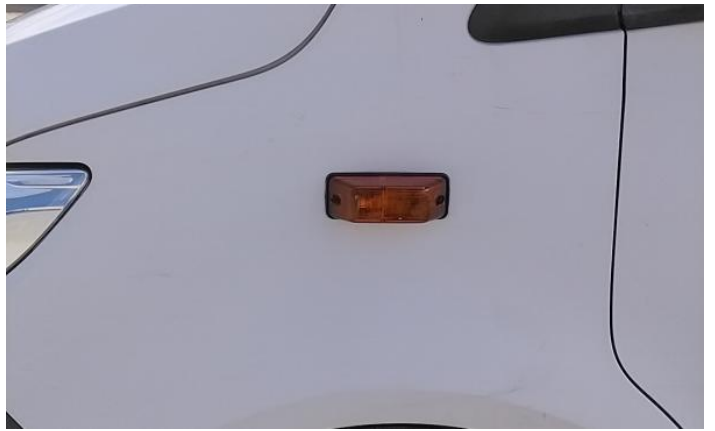
6: Wing nsf
Scratched
Over 25mm Not Thru Paint

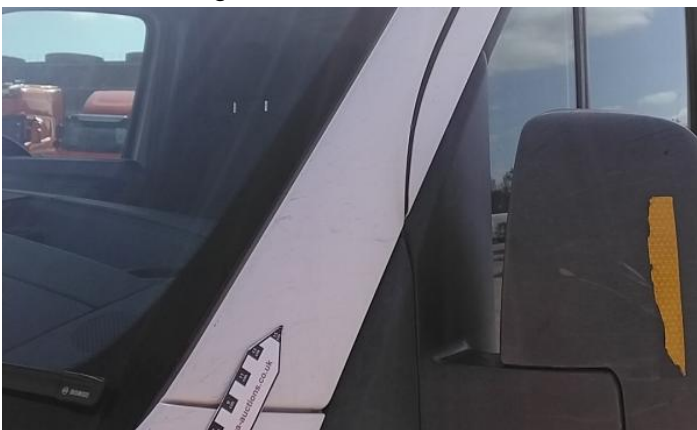
7: A Post ns
Scratched
Over 25mm Not Thru Paint

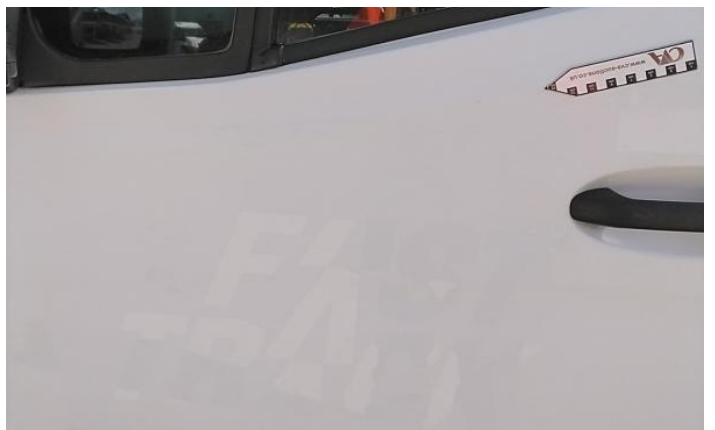
8: Door nsf
Scratched
Over 25mm Not Thru Paint

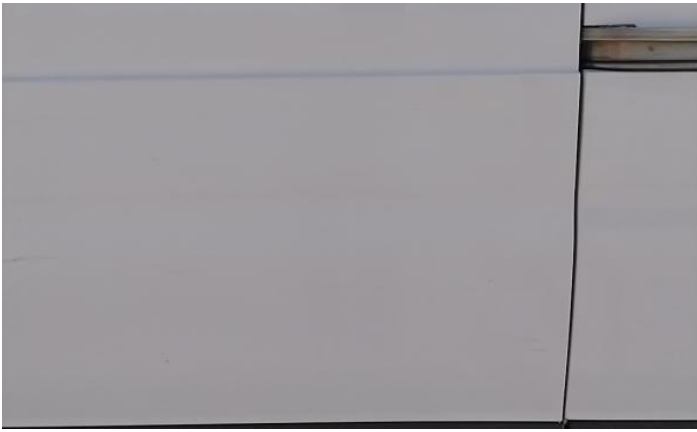
9: Door nsr
Dented
Over 30mm

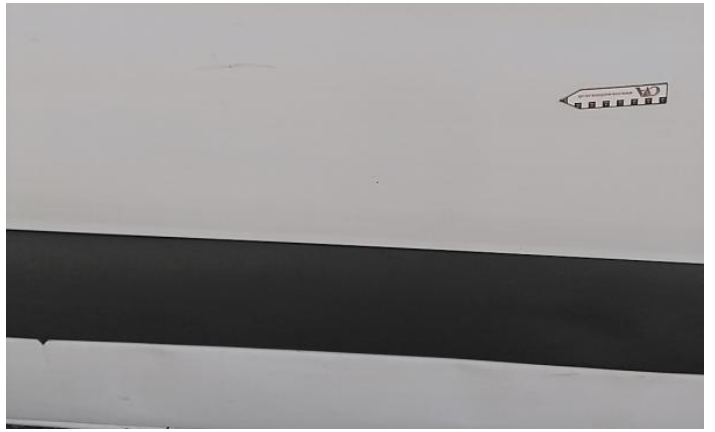
10: Door nsr
Scratched
Over 25mm Not Thru Paint

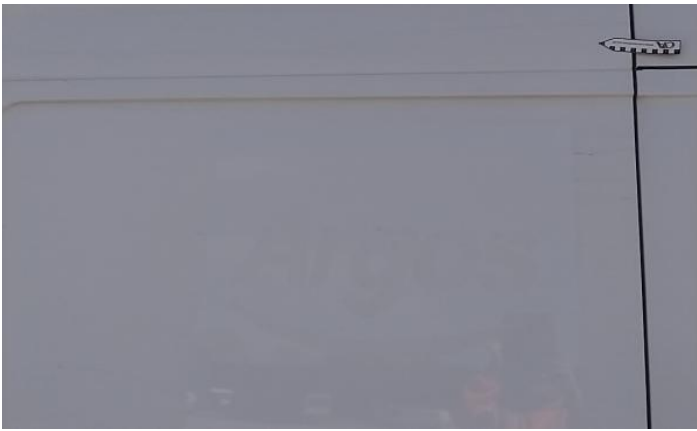
11: Roof
Scratched
Over 25mm Not Thru Paint

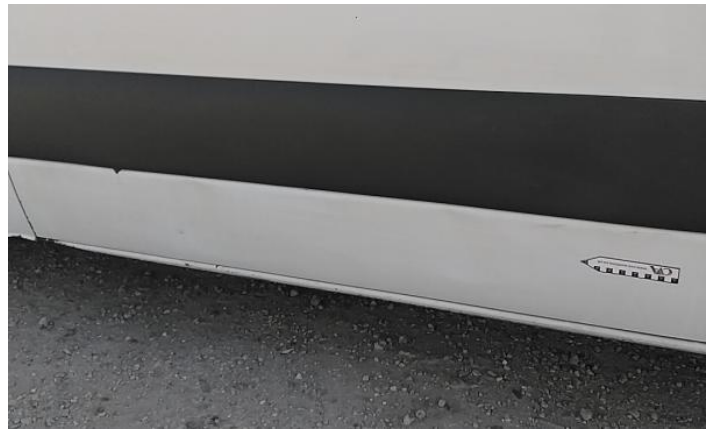
12: Door nsr
Dented
Over 30mm

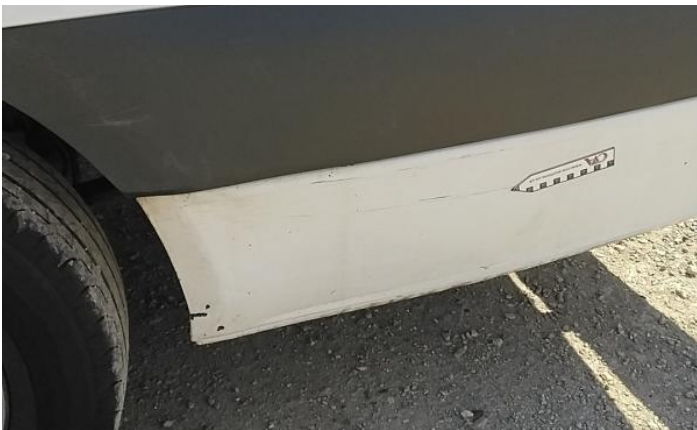
13: Qtr Panel nsr
Dented
With Paint Damage

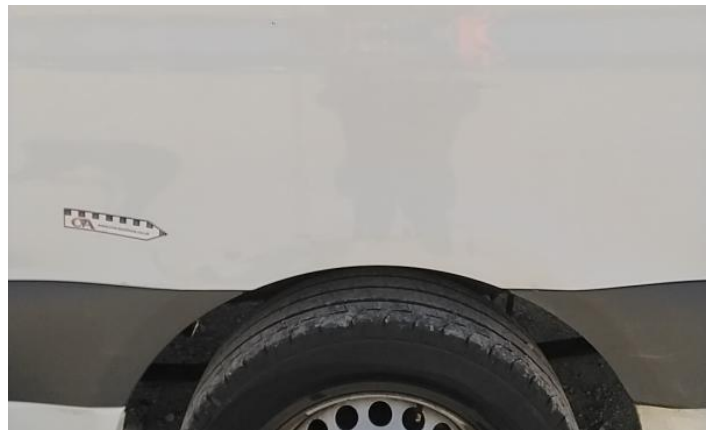
14: Qtr Panel nsr
Dented
Over 30mm

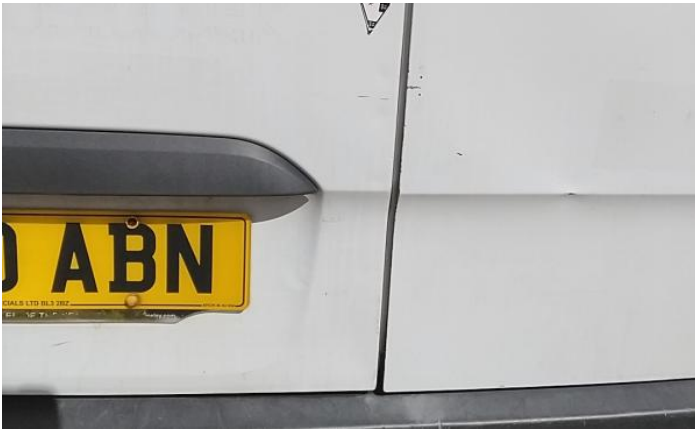
15: Door nsr
Dented
Between 10mm + 30mm

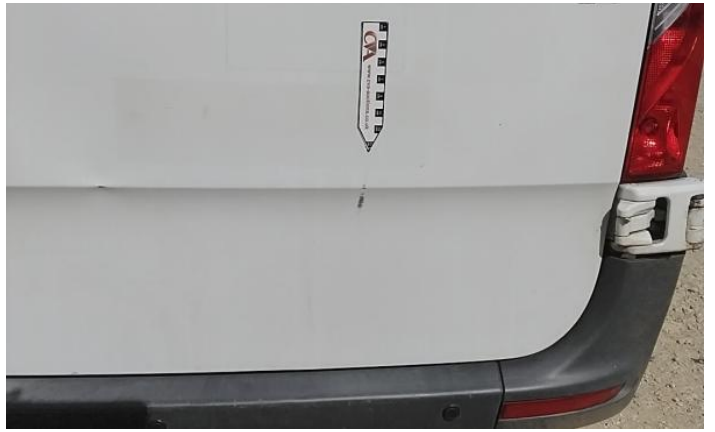
16: Door osr
Scratched
UpTo 25mm Thru Paint

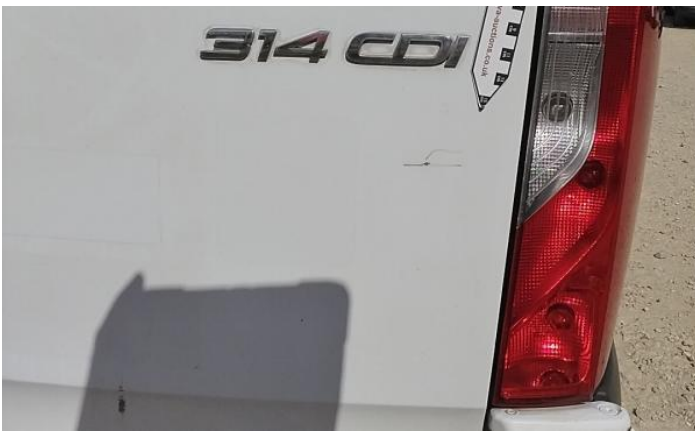
17: Door osr
Scratched
UpTo 25mm Thru Paint

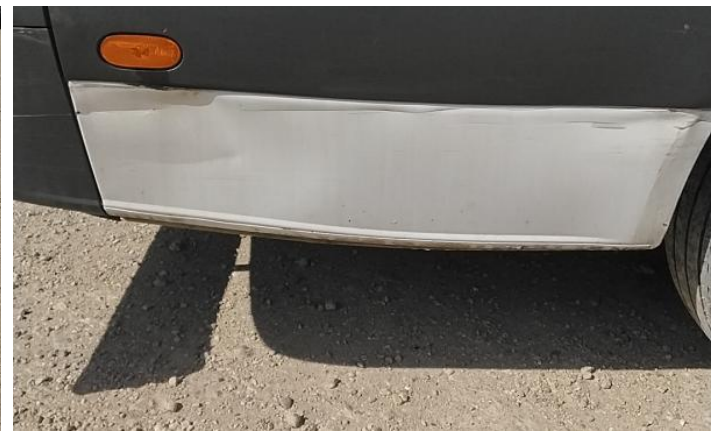
18: Qtr Panel osr
Dented
With Paint Damage

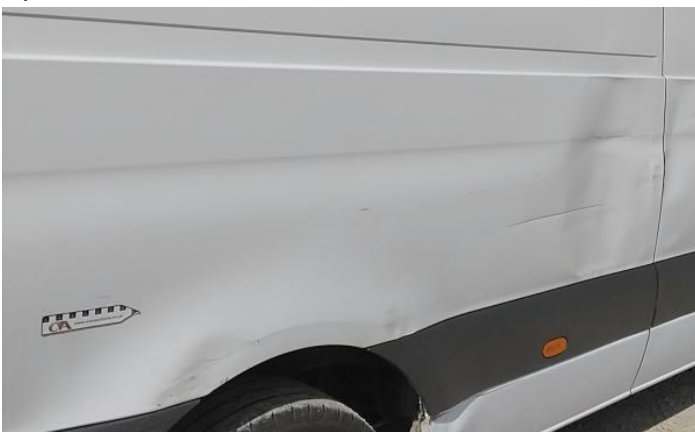
19: Qtr Panel osr
Dented
With Paint Damage

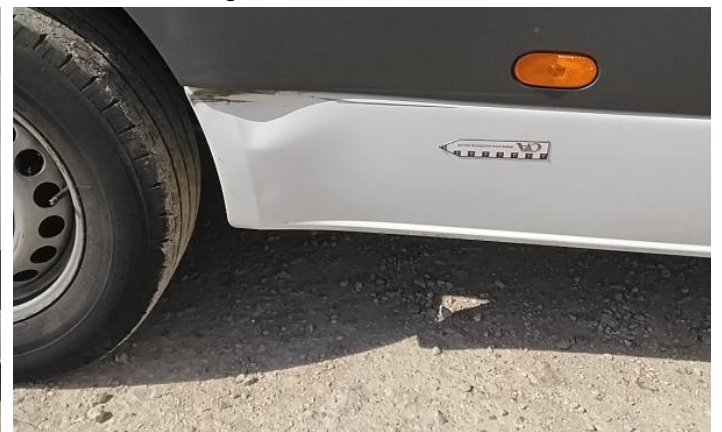
20: Qtr Panel osr
Dented
With Paint Damage

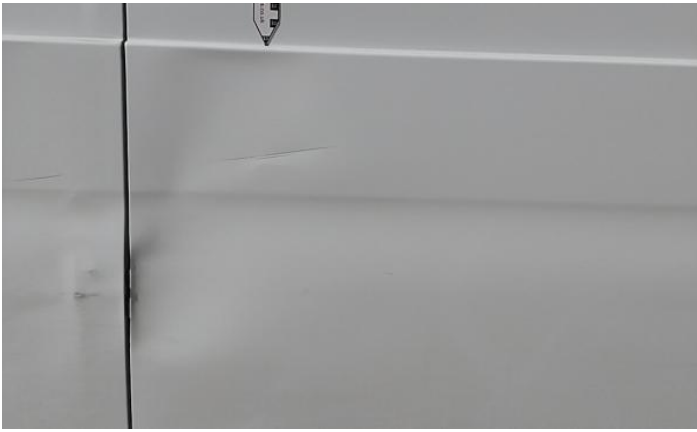
21: Qtr Panel osf
Dented
With Paint Damage

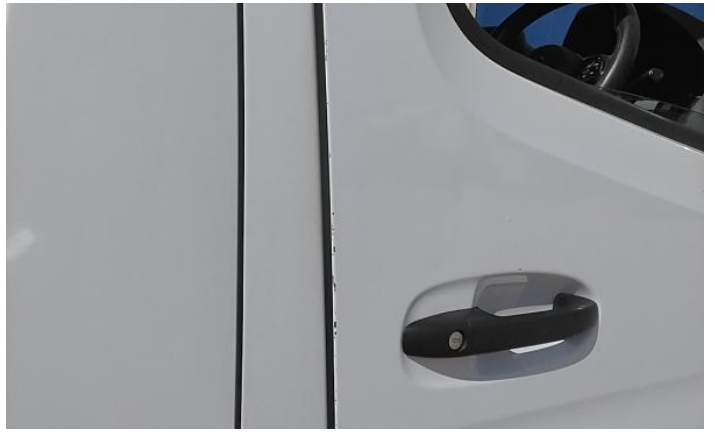
22: Door osf
Chipped
Edge Chip

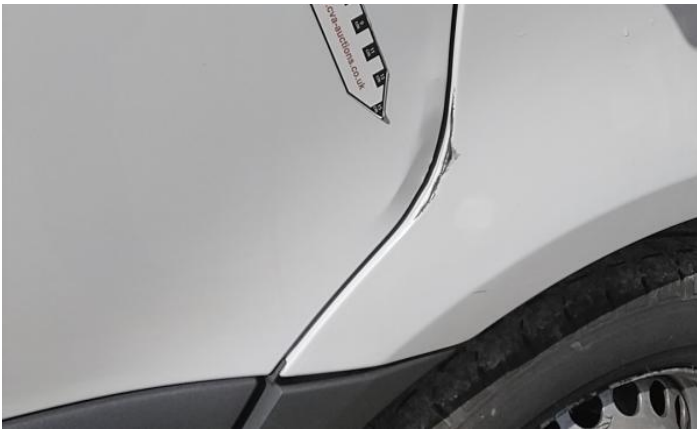
23: Door osf
Dented
With Paint Damage

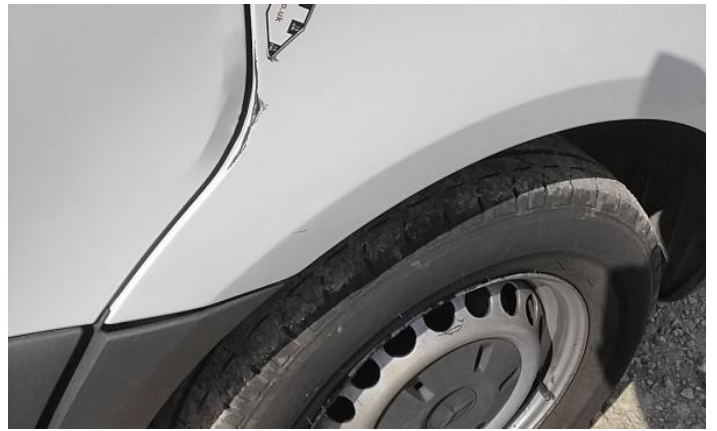
24: Wing osf
Scratched
Over 25mm Thru Paint

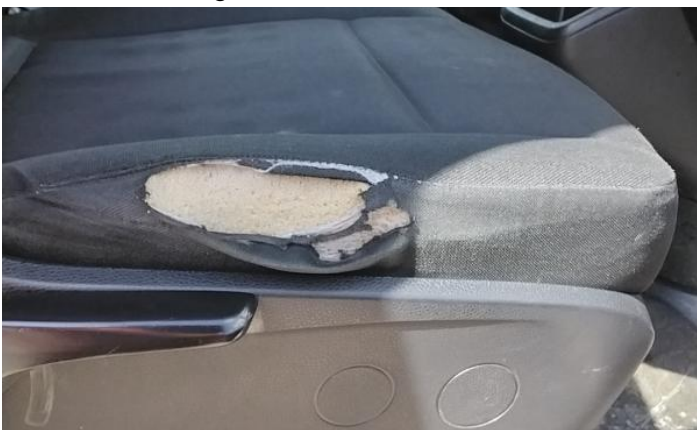
25: Seat Base Cover osf
Holed
Over 3mm
