# VEHICLE INSPECTION REPORT

**YT09BKA**

## Scania N 230

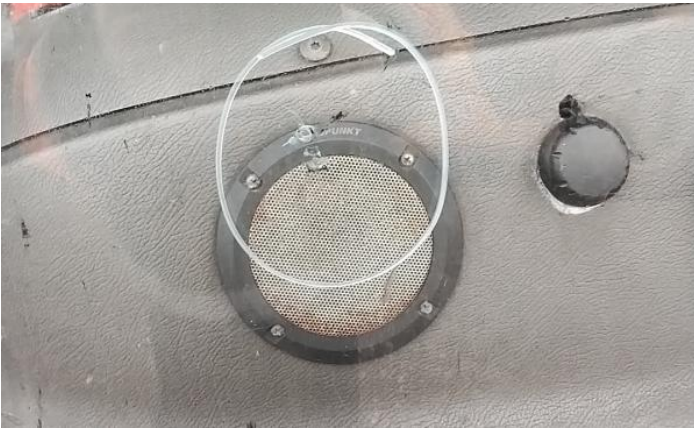
1: Screen Front  
Cracked  
Replace

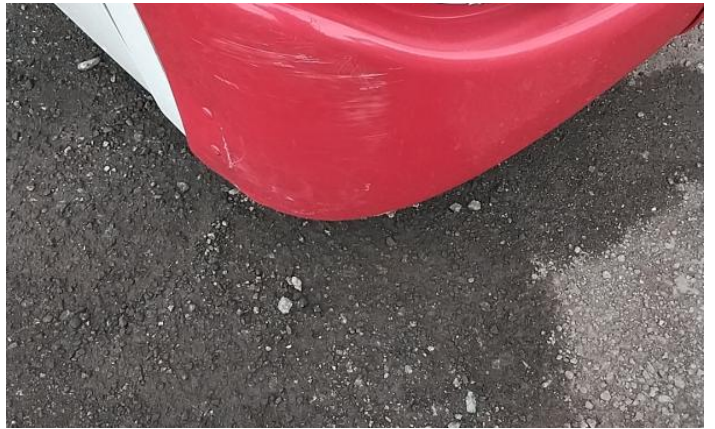
2: Bumper Front  
Scratched  
Over 100mm Thru Paint

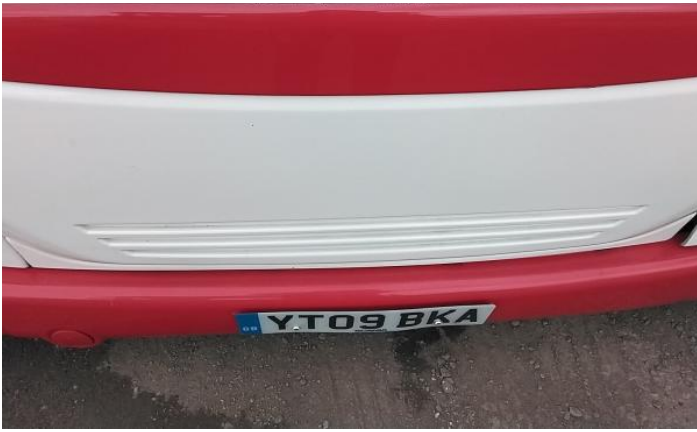
3: Bonnet  
Chipped  
Multiple Chips

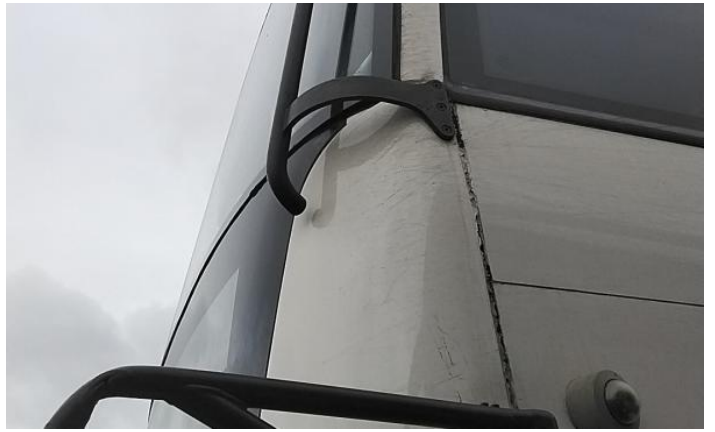
4: A Post ns  
Scratched  
Over 25mm Thru Paint

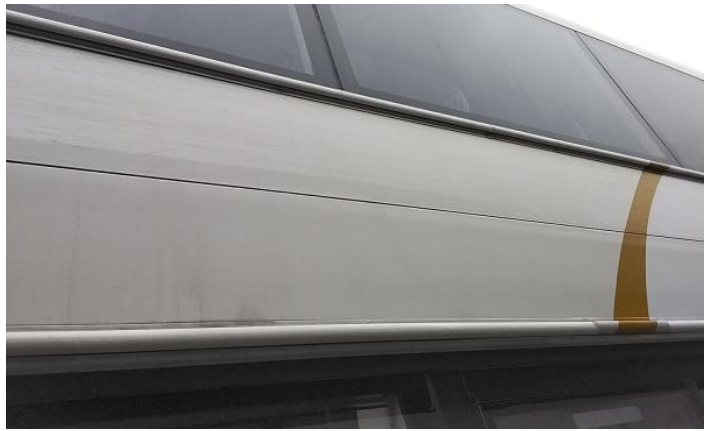
5: Qtr Panel nsr  
Scratched  
Over 25mm Thru Paint

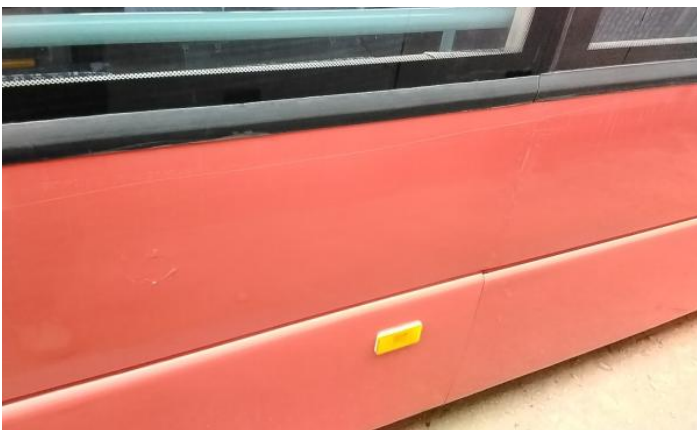
6: Qtr Panel nsr  
Scratched  
Over 25mm Thru Paint

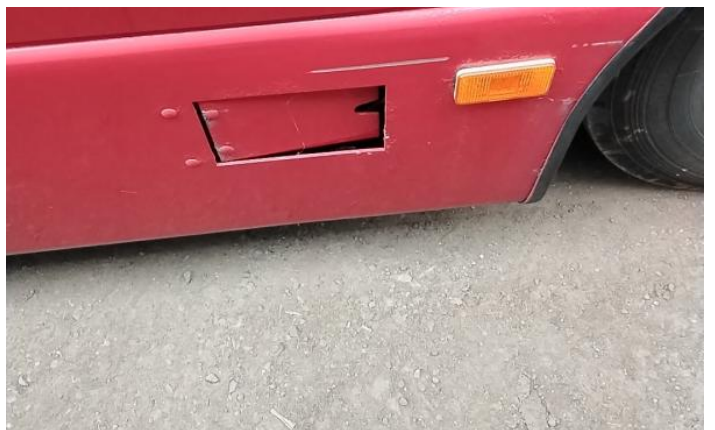
7: Qtr Panel nsr  
Scratched  
Over 25mm Thru Paint

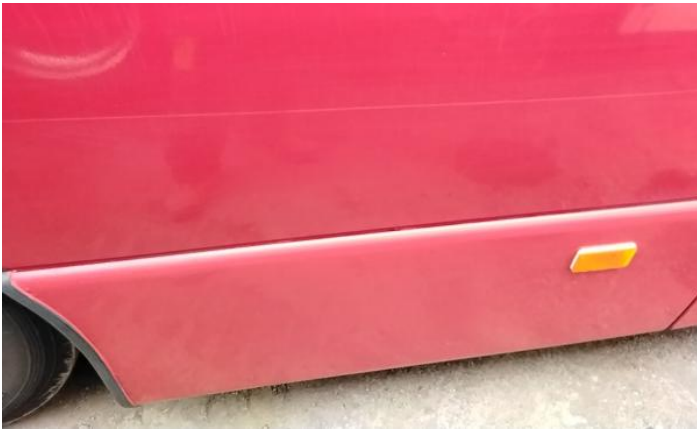
9: Qtr Panel nsr  
Scratched  
Over 25mm Thru Paint

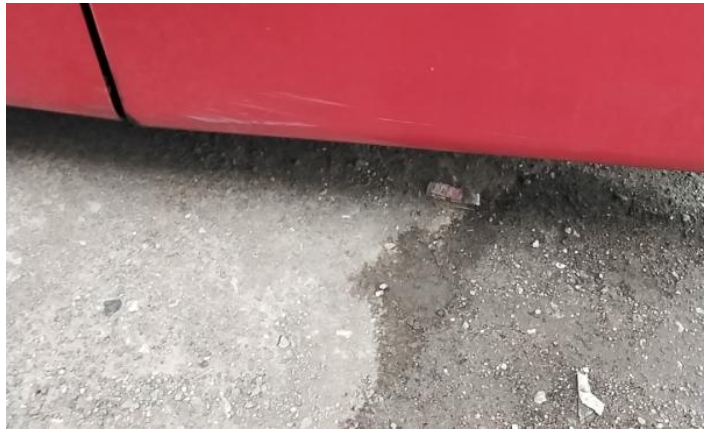
10: Qtr Panel Moulding ns  
Scratched (Painted)  
Over 25mm Thru Paint

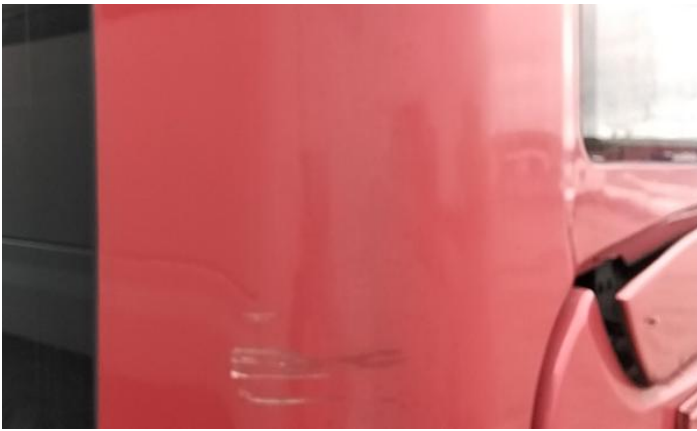
11: C Post ns  
Scratched  
Over 25mm Thru Paint

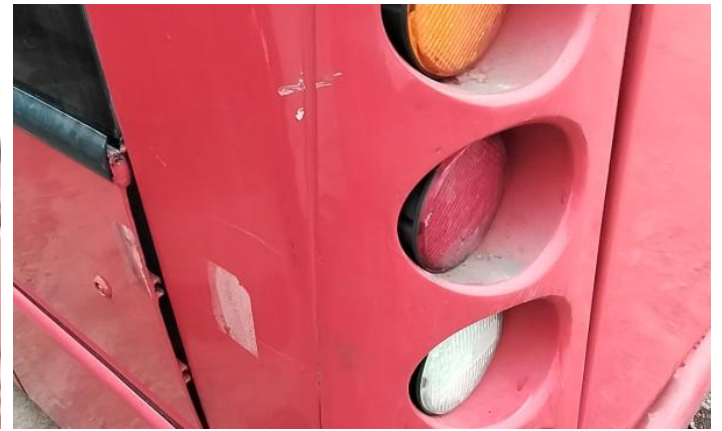
12: Panel Rear  
Scratched  
Over 25mm Thru Paint

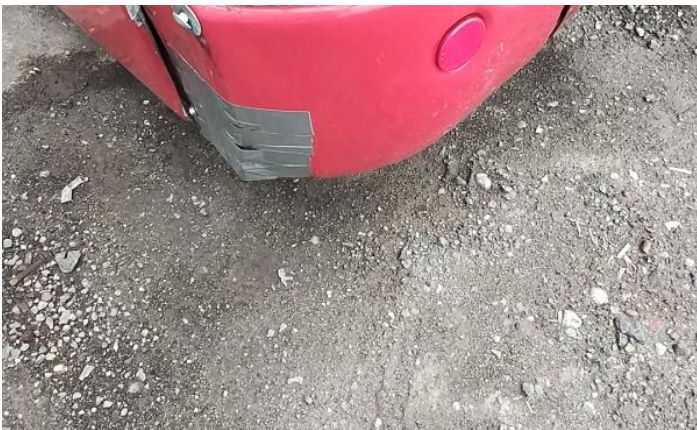
13: Bumper Rear Moulding  
Broken  
Replace

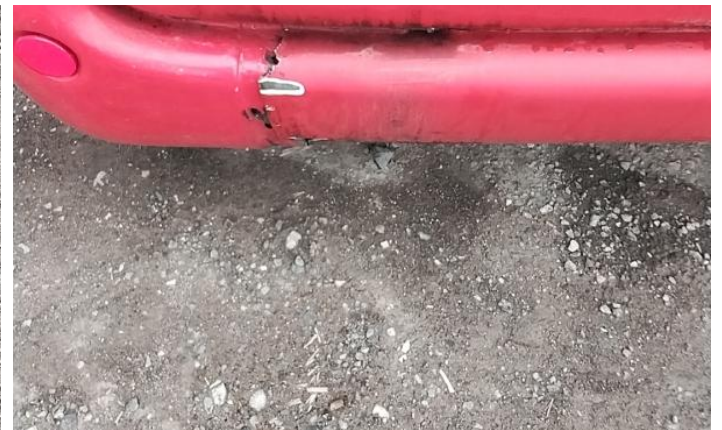
14: Bumper Rear  
Cracked  
Over 25mm

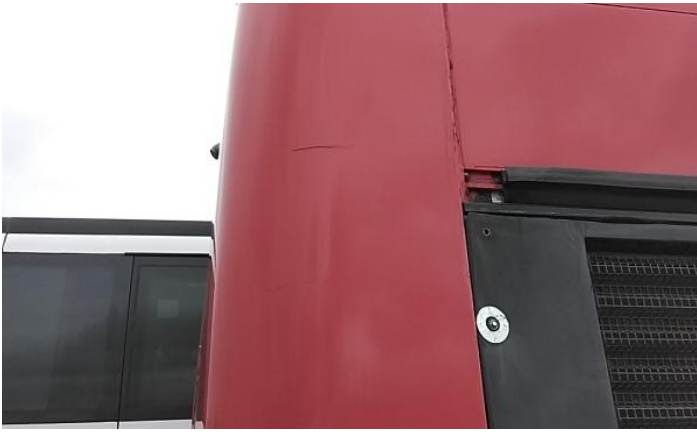
15: C Post os  
Scratched  
Over 25mm Thru Paint

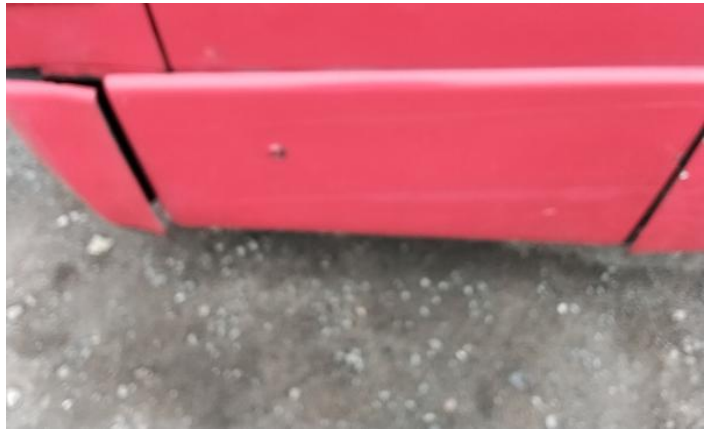
16: Qtr Panel Moulding os  
Scratched (Painted)  
Over 25mm Thru Paint

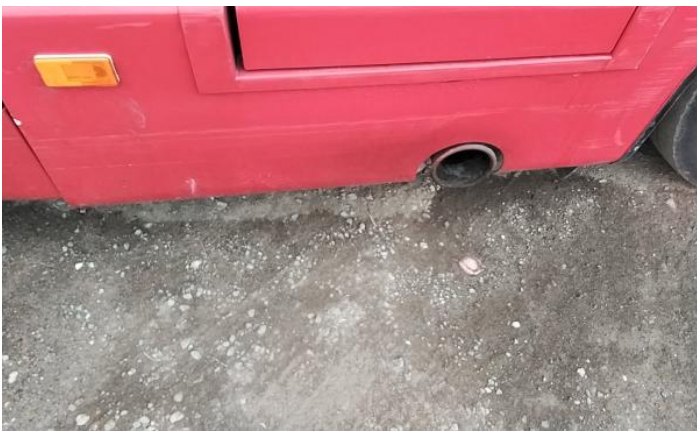
17: Qtr Panel Moulding os  
Scratched (Painted)  
Over 25mm Thru Paint

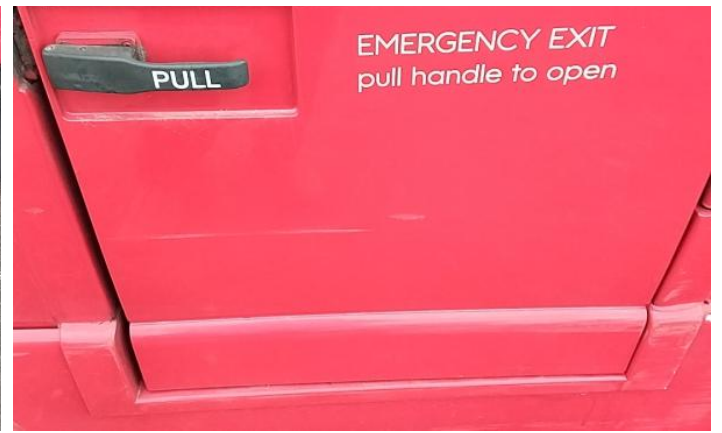
18: Door osr  
Scratched  
Over 25mm Thru Paint

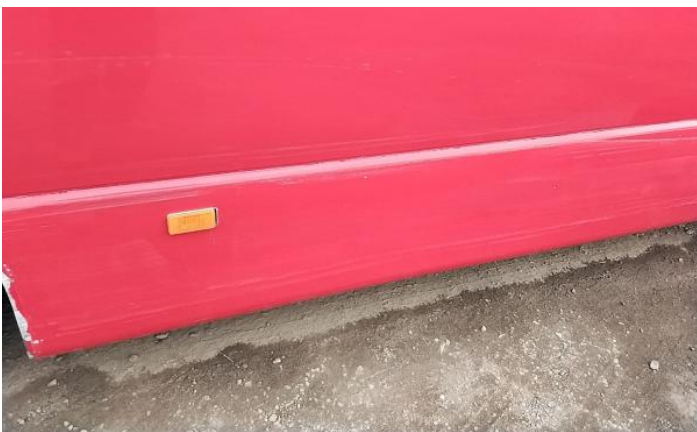
19: Qtr Panel Moulding os  
Scratched (Painted)  
Over 25mm Thru Paint

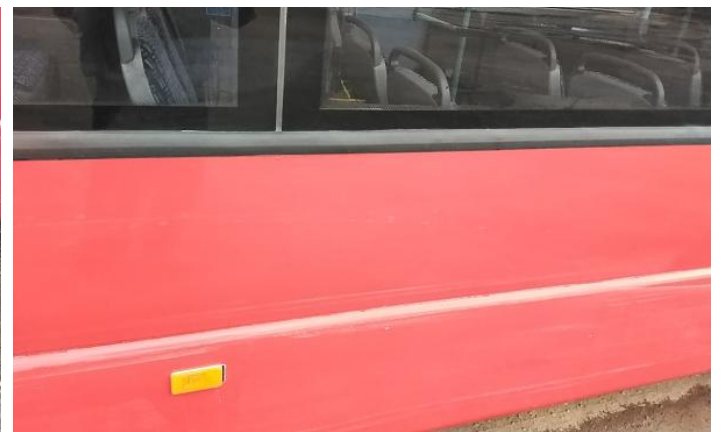
20: Qtr Panel osr  
Scratched  
Over 25mm Thru Paint

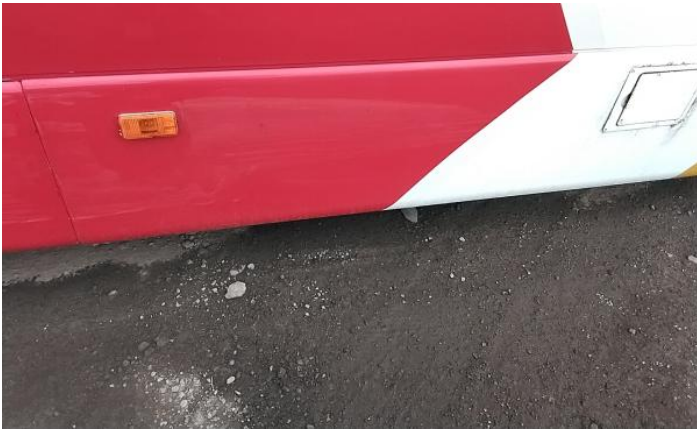
21: Qtr Panel Moulding os Scratched (Painted) Over 25mm Thru Paint

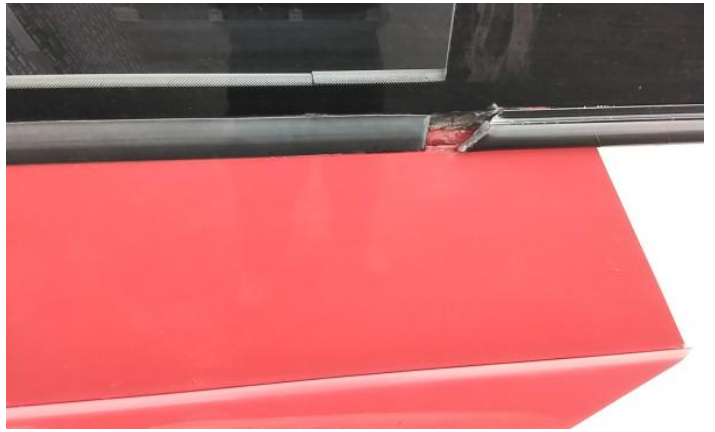
22: Aperture Seal osf Broken Replace

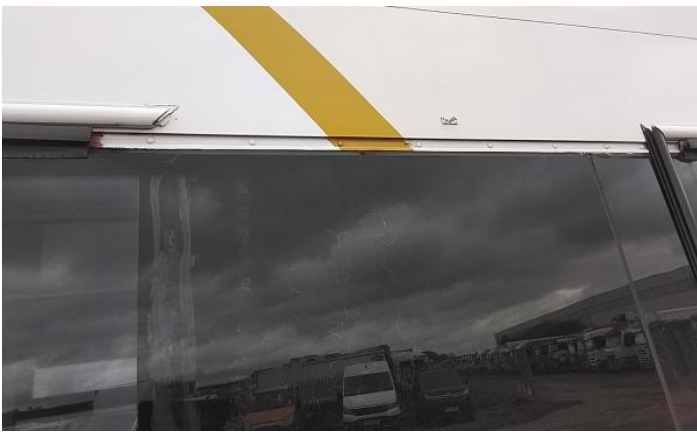
23: Aperture Seal osf Missing Replace

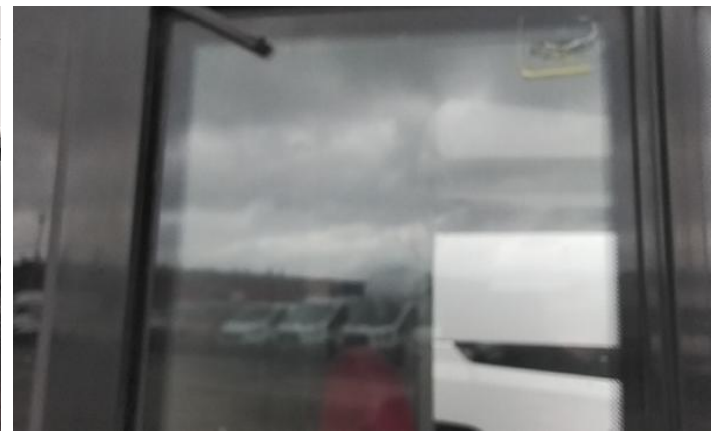
24: Aperture Seal osf Broken Replace

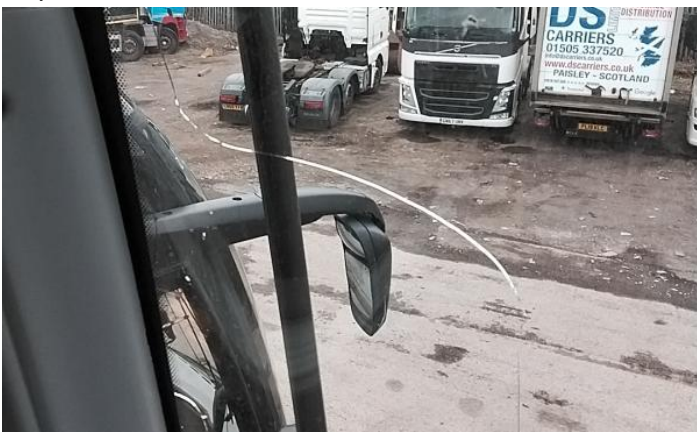
25: Screen Front Cracked Replace

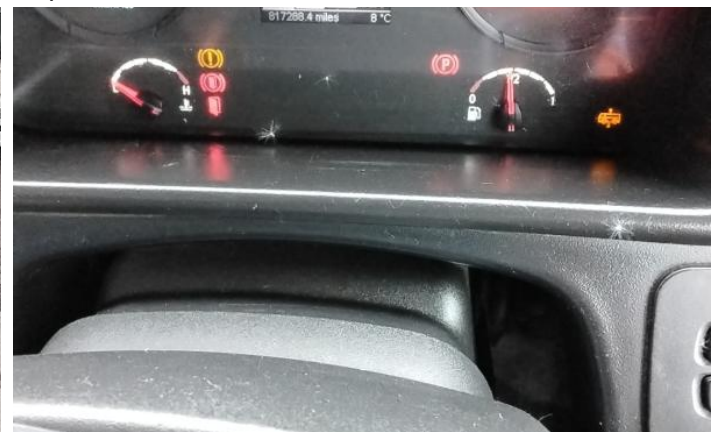
26: Dash Warning Lights Displayed No Action
