VEHICLE INSPECTION REPORT

PO13EJG

Daf LF 55.220

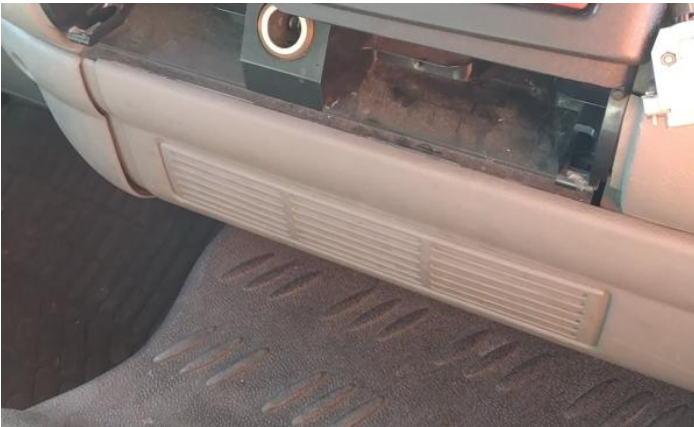
1: Centre Console Front
Missing
Replace

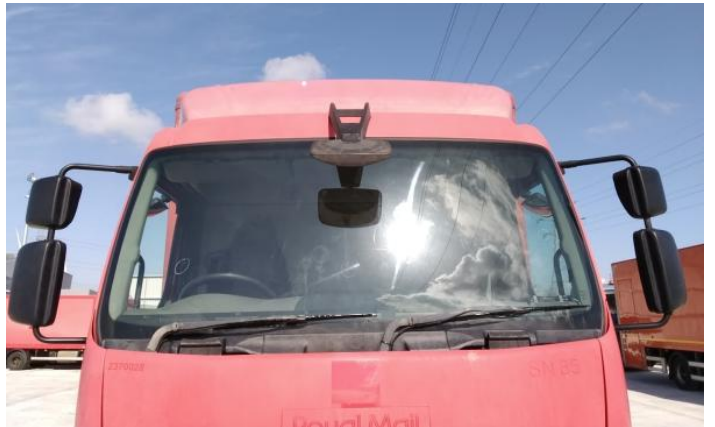
2: Screen Front
Chipped
Over 10mm

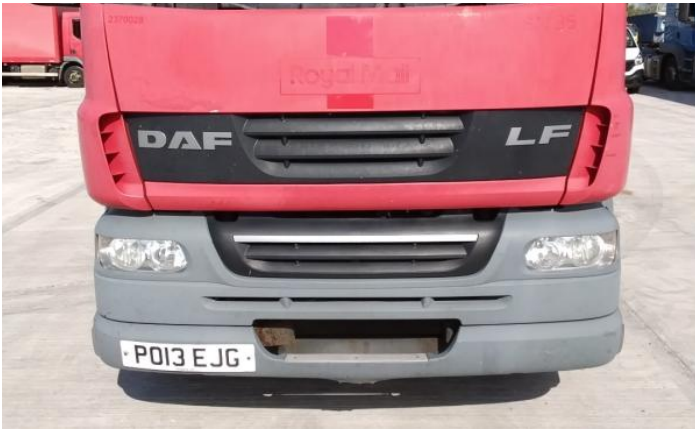
3: Bonnet
Chipped
Multiple Chips

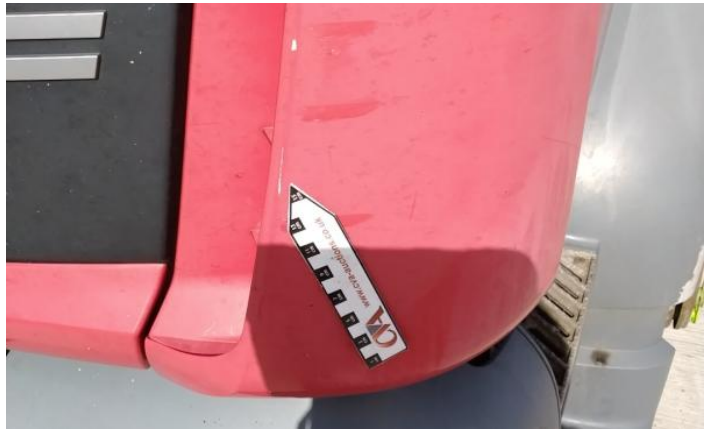
4: Moulding nsf Wing
Scratched (Painted)
Over 25mm Thru Paint

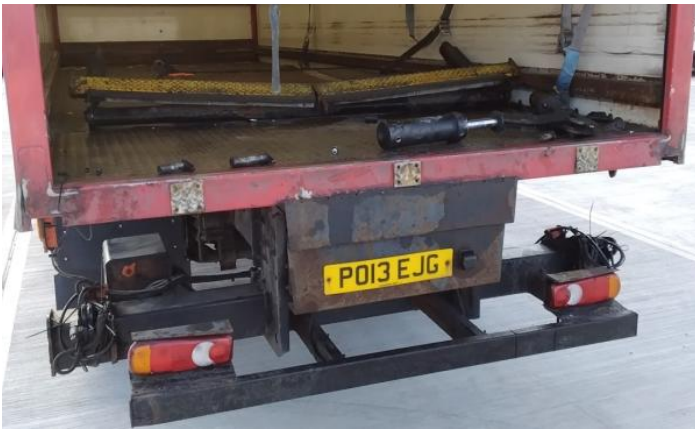
5: Unclassified
Major Parts Missing
Report Only

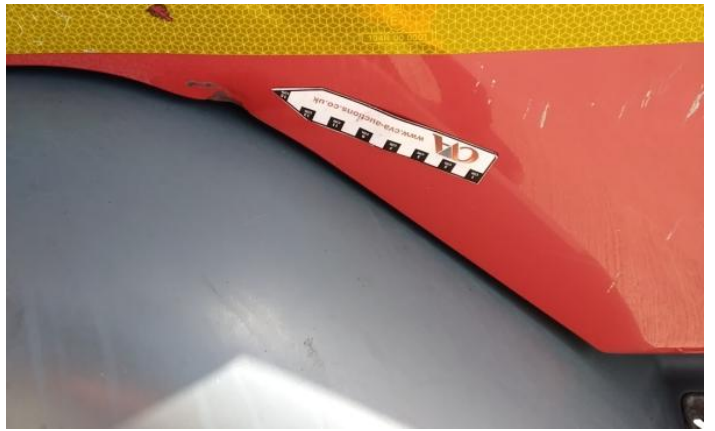
6: Door osf
Dented
With Paint Damage

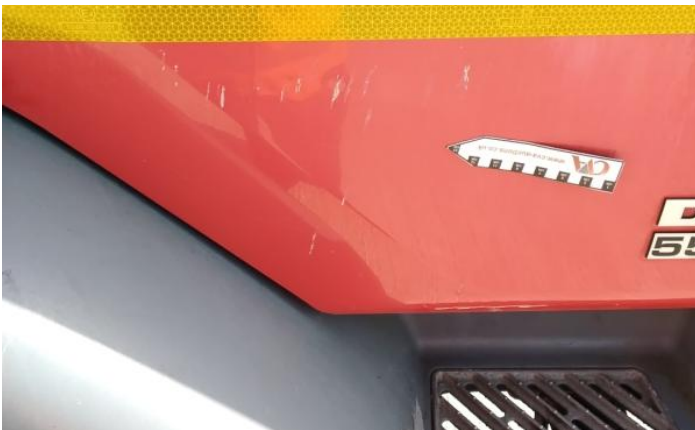
7: Door osf
Scratched
Over 25mm Thru Paint

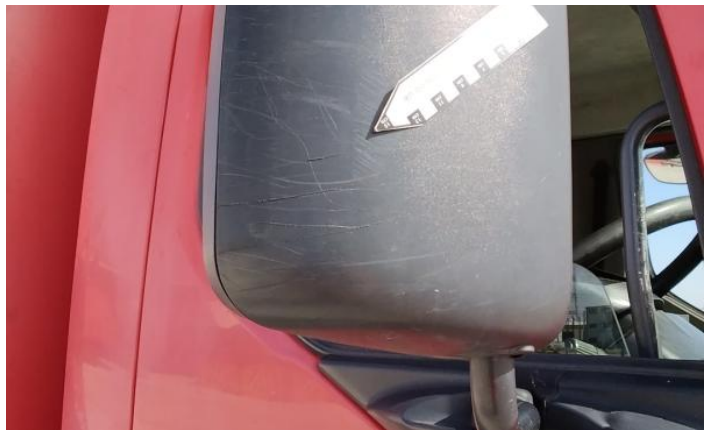
8: Door Mirror Assy osf
Scratched (Painted)
Over 25mm Thru Paint

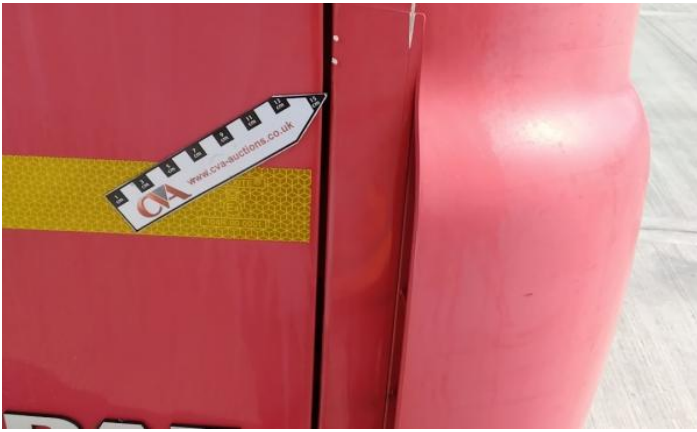
9: Moulding of Wing
 Scratched (Painted)
 Over 25mm Thru Paint

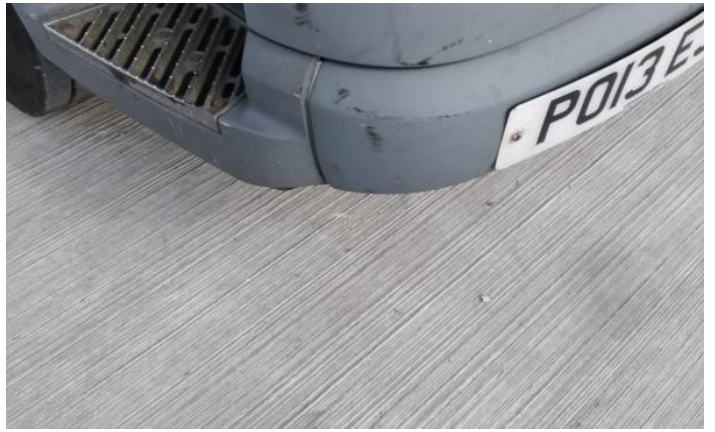
10: Bumper Front
 Scratched
 Over 25mm Not Thru Paint

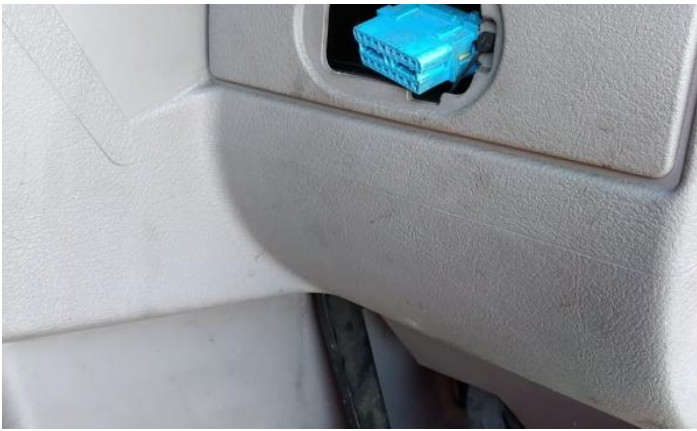
11: Centre Console Front
 Missing
 Replace
