VEHICLE INSPECTION REPORT

SL12CDU

Volkswagen Crafter CR35 2.0 TDI 109PS

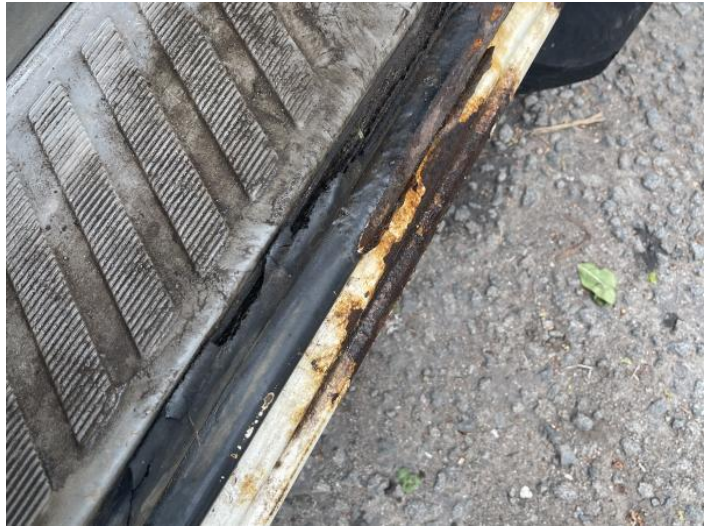
4: Sill os
Rusted
Over 5mm

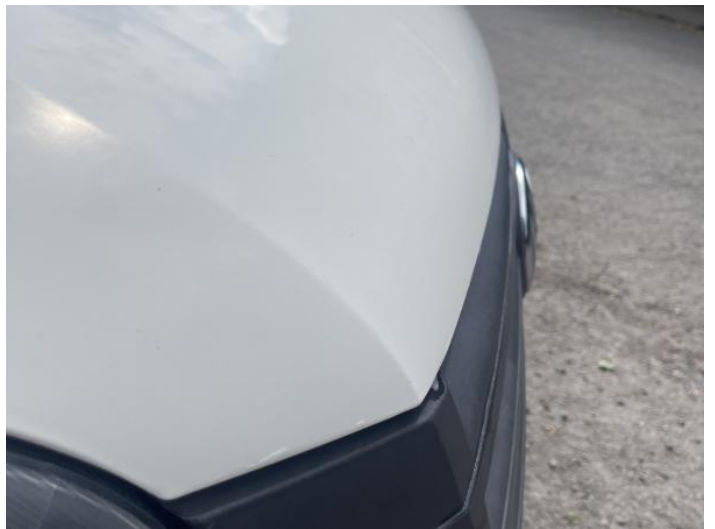
6: Bonnet
Dented
Over 30mm

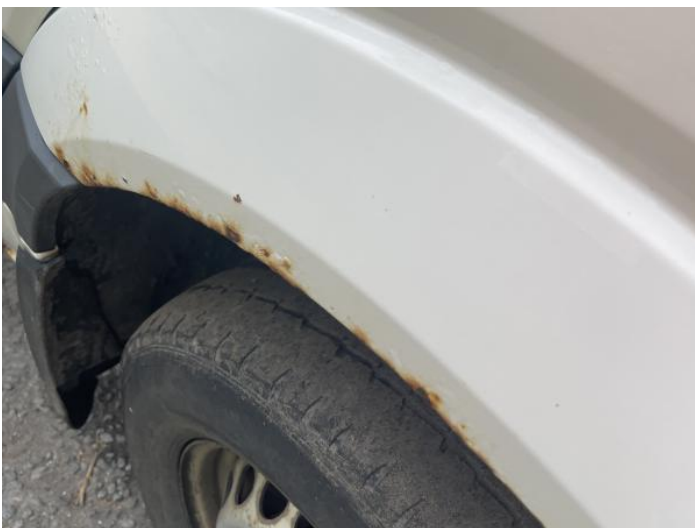
7: Wing osf
Rusted
Over 5mm

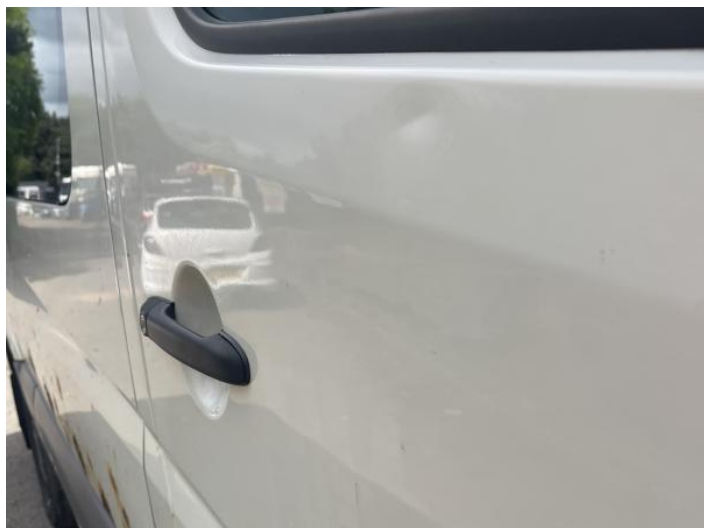
8: Door osf
Dented
Over 30mm

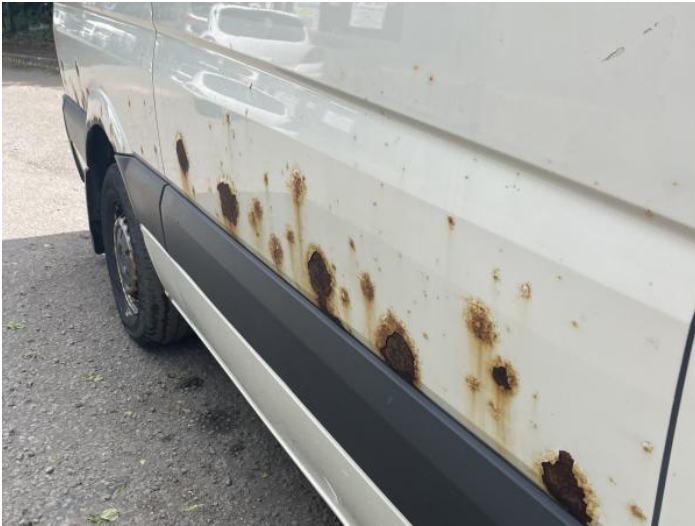
9: Qtr Panel osr
Rusted
Over 5mm

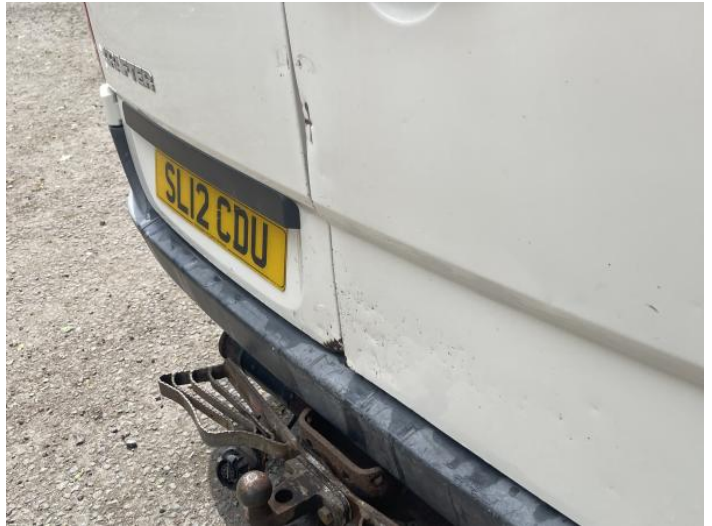
10: Tailgate
Dented
Over 30mm

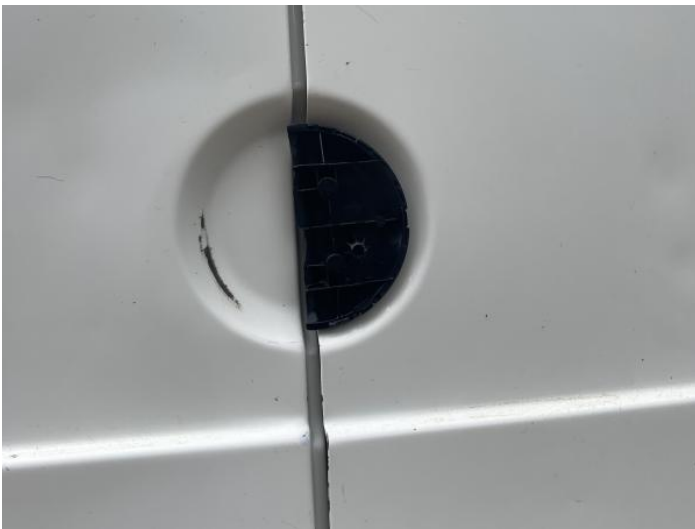
11: Badgedecal Rear
Missing
Replace

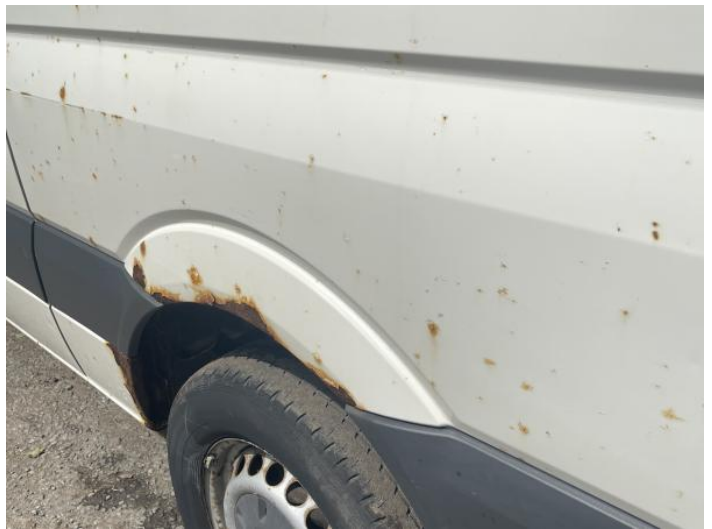
12: Qtr Panel nsr
Rusted
Over 5mm

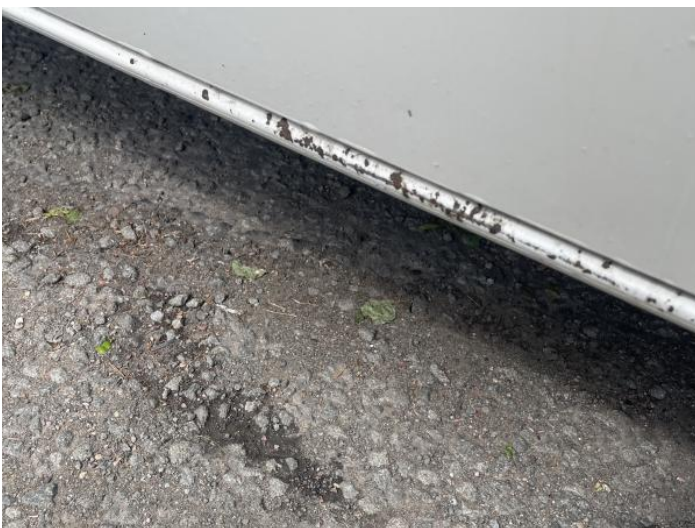
13: Sill ns
Rusted
Over 5mm

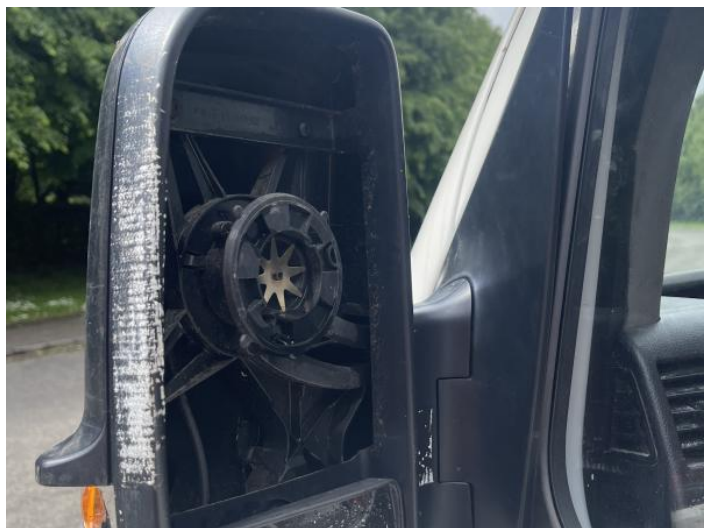
14: Door Mirror Glass ns
Missing
Replace

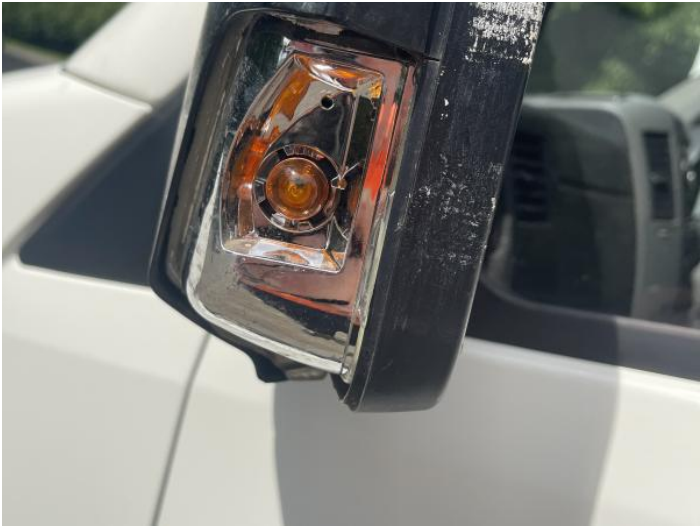
15: Door Mirror Glass ns
Missing
Replace
