# VEHICLE INSPECTION REPORT

**HX72YKW**

## Mercedes-Benz Atego 1223

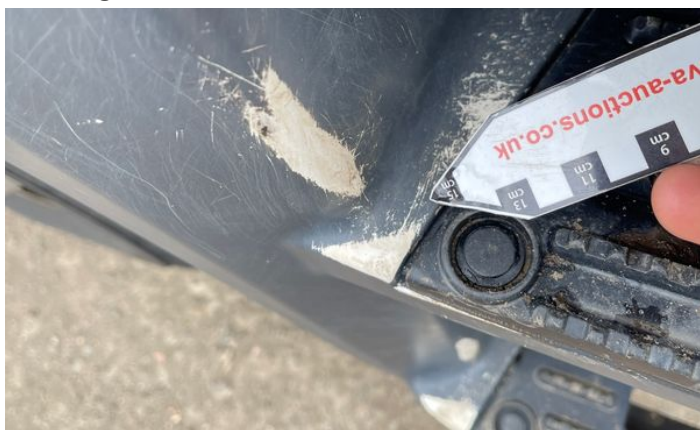
1: Door Moulding of  
Scuffed (Unpainted)  
Over 100mm

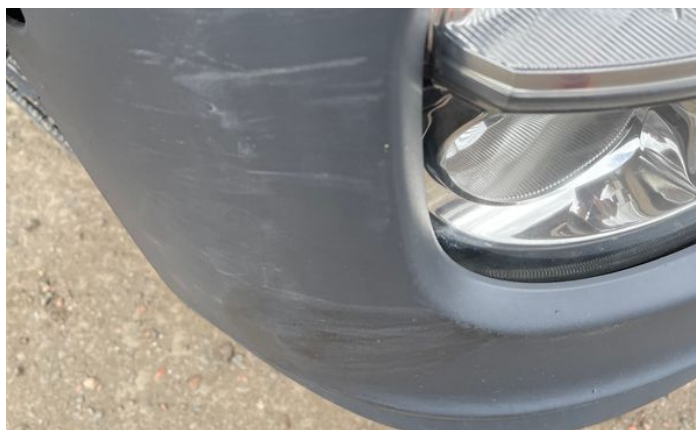
2: Bumper Front Moulding  
Scuffed (Unpainted)  
Over 100mm

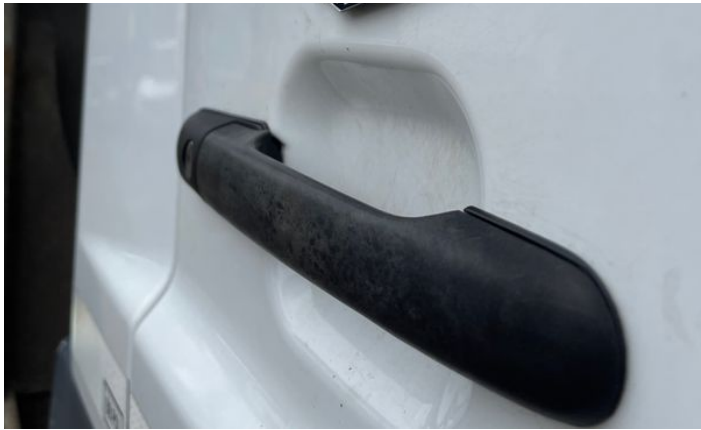
3: Door osf  
Dented  
Over 30mm

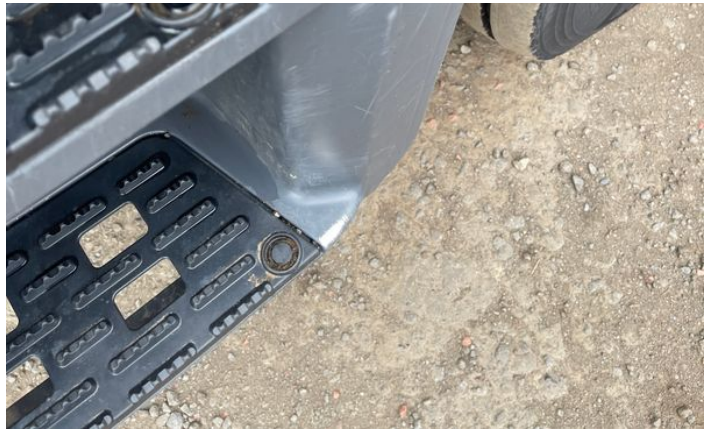
4: Door Moulding nsf  
Scuffed (Unpainted)  
Over 100mm
