VEHICLE INSPECTION REPORT

WP65FHA

Mercedes-Benz ACTROS 1824

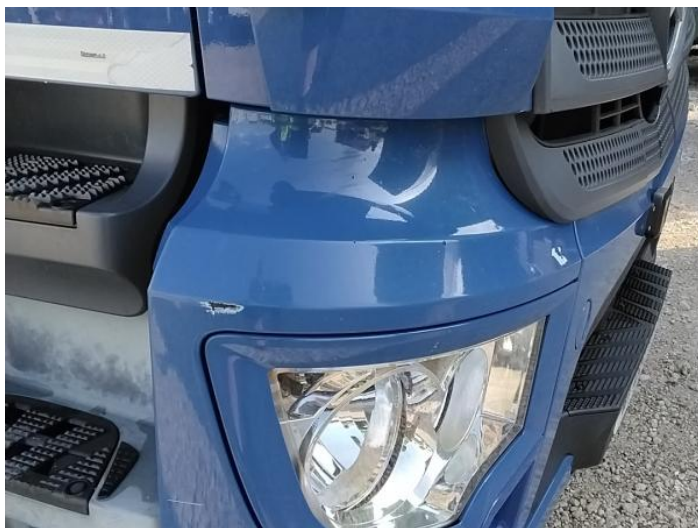
1: Moulding on Wing
Scratched (Painted)
Over 25mm Thru Paint

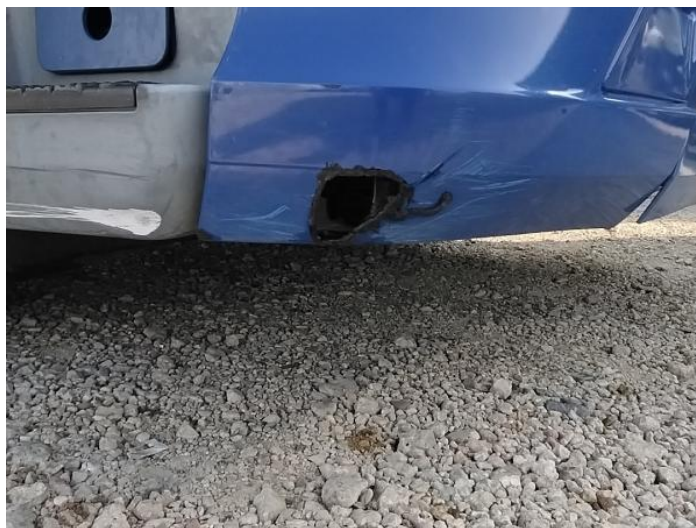
2: Bumper Front
Hole
Over 25mm

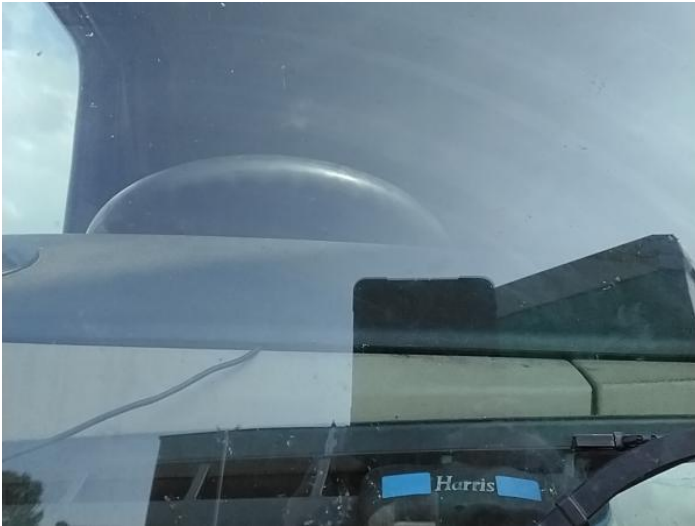
3: Screen Front
Chipped
Over 10mm

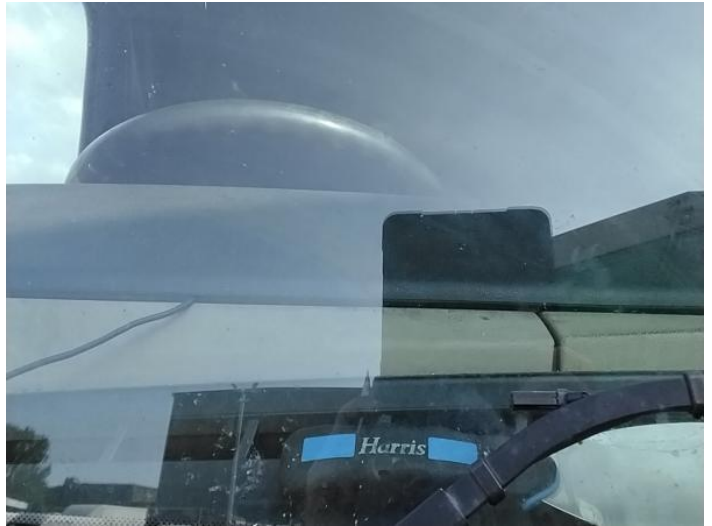
4: Screen Front
Chipped
Over 10mm

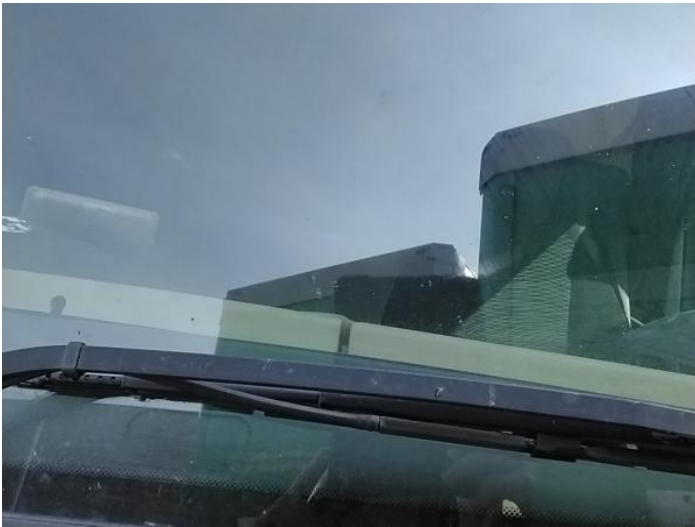
5: Screen Front
Chipped
Over 10mm

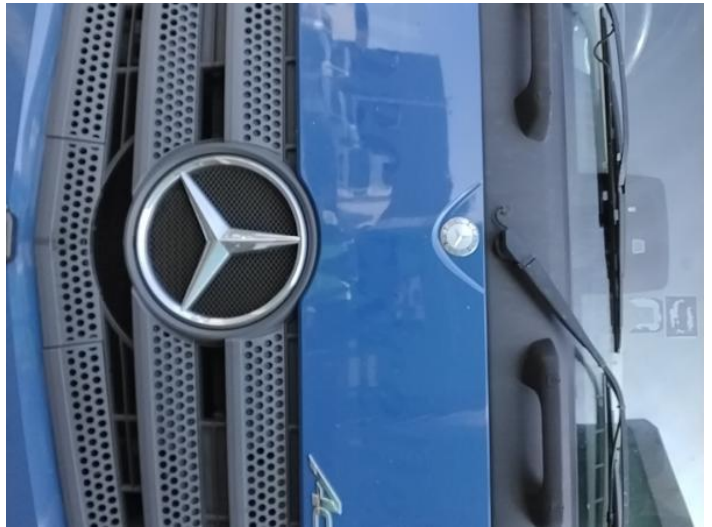
6: Bonnet
Chipped
Multiple Chips

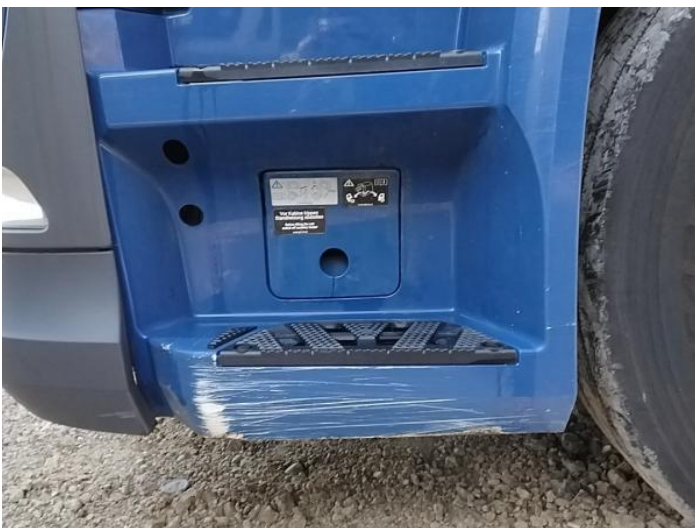
7: General Exterior
Soiled
Light

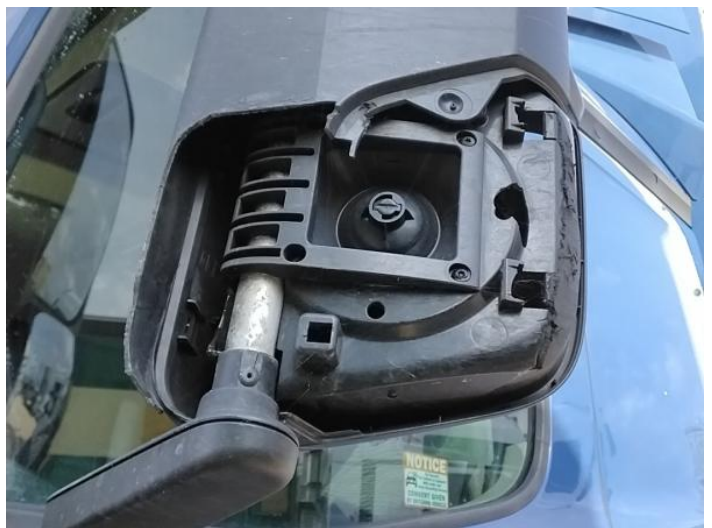
8: Door Mirror Assy nsf
Broken
Replace

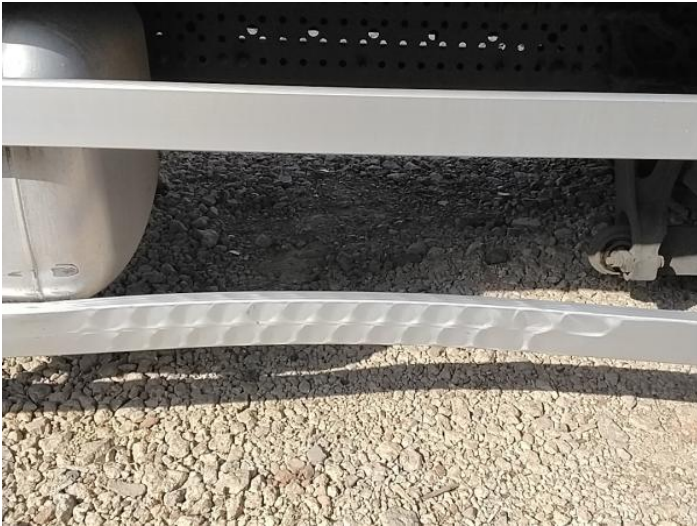
9: General Exterior
Soiled
Light

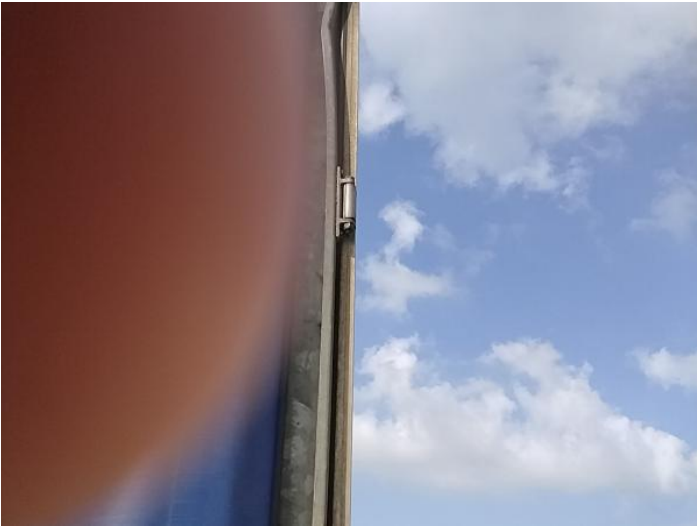
10: General Exterior
Soiled
Light

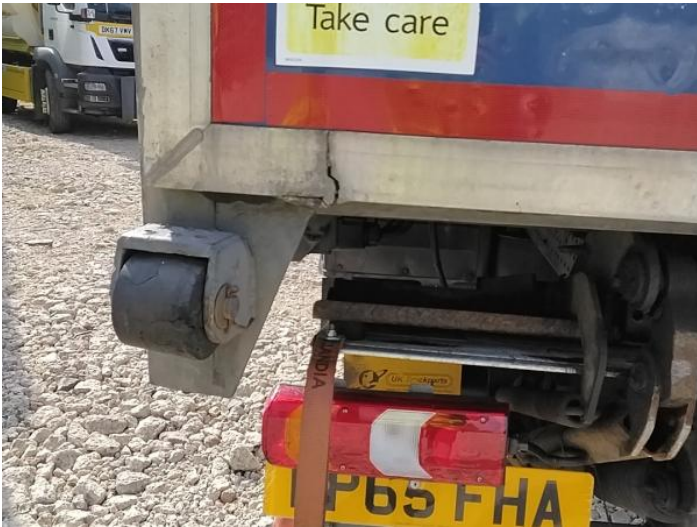
11: Door nsr
Cracked
Replace

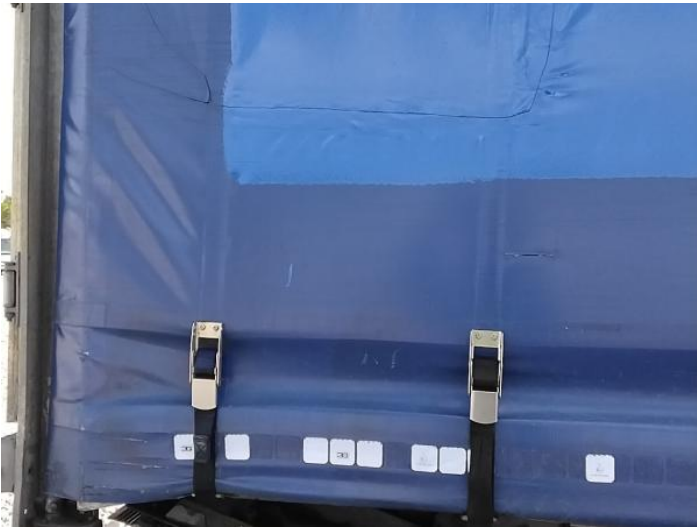
12: General Exterior
Soiled
Light

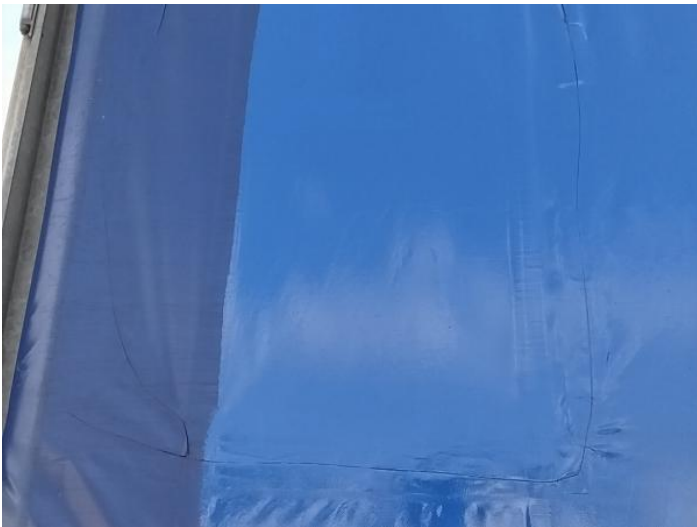
13: General Exterior
Soiled
Light

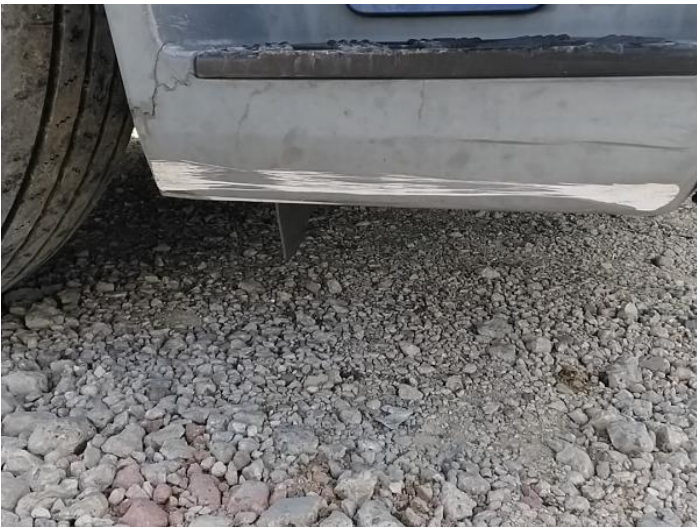
14: General Exterior
Soiled
Light

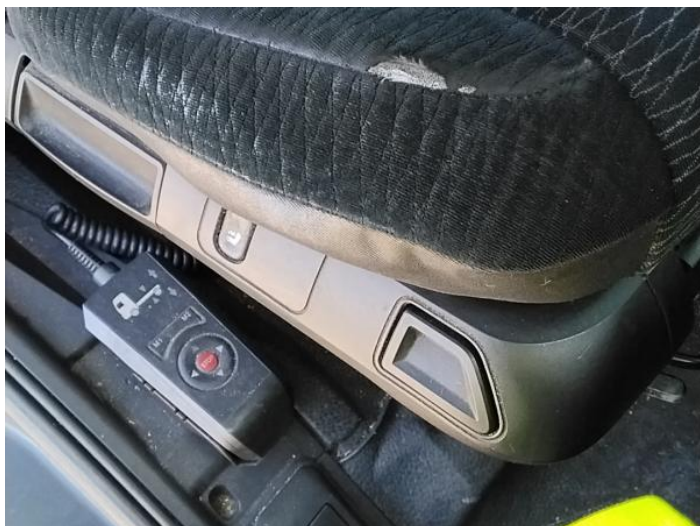
15: Seat Base Cover osf
Torn
Over 3mm
