VEHICLE INSPECTION REPORT

DK65XGD

Mercedes-Benz ANTOS 1824

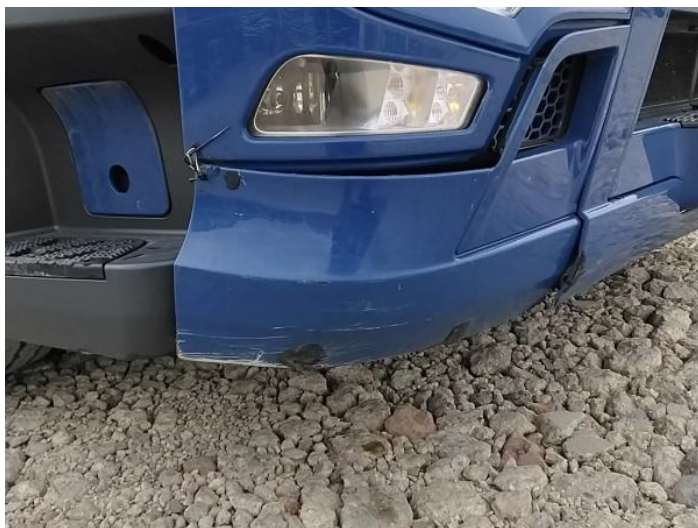
1: Bumper Front
Cracked
Over 25mm

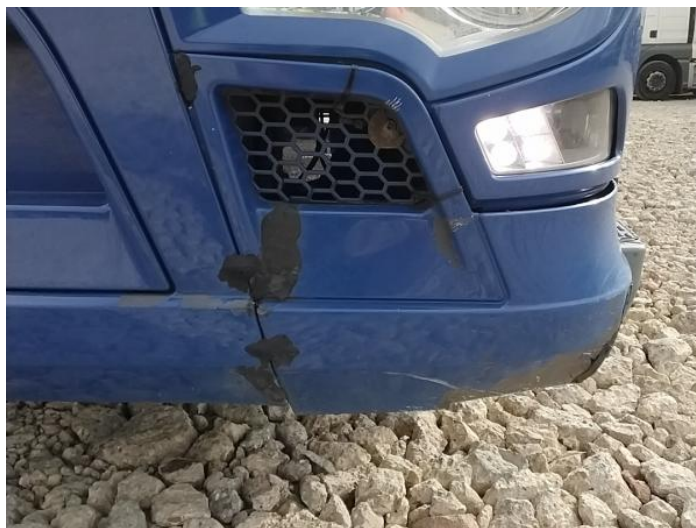
2: Bumper Front
Cracked
Over 25mm

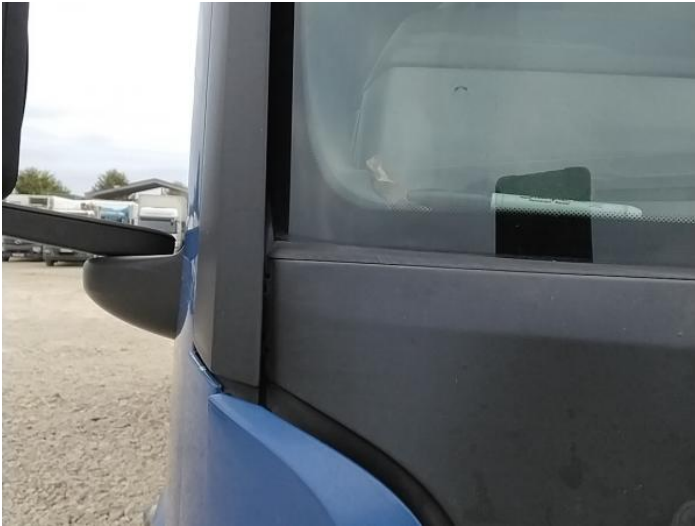
3: Screen Front
Chipped
Over 10mm

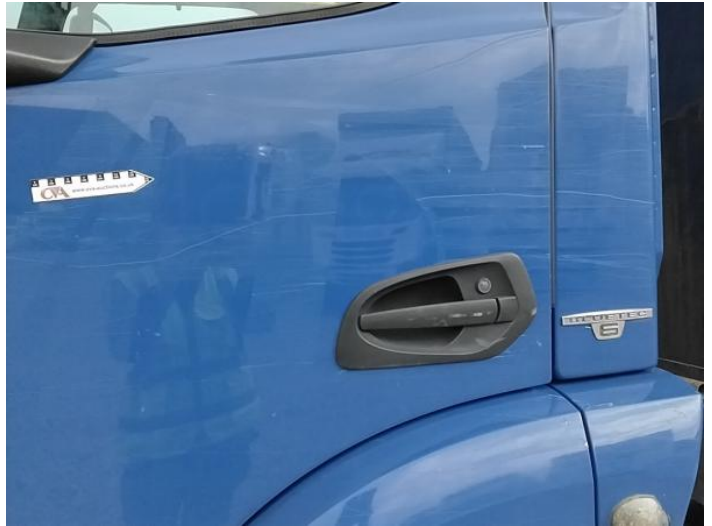
4: Door nsf
Scratched
Over 25mm Thru Paint

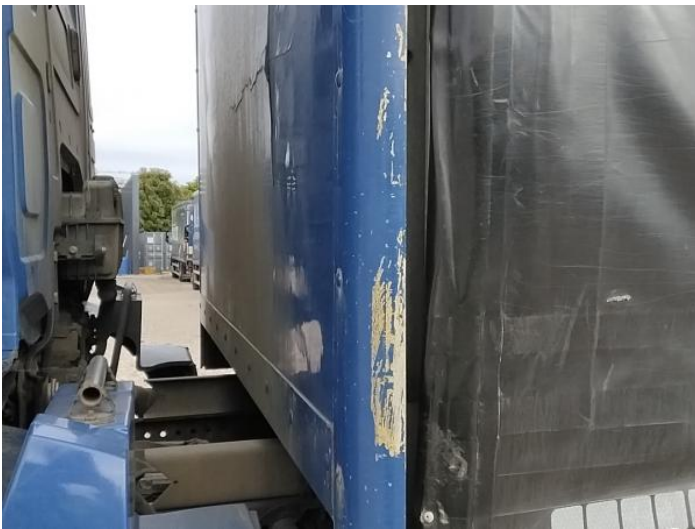
5: C Post ns
Scratched
Over 25mm Thru Paint

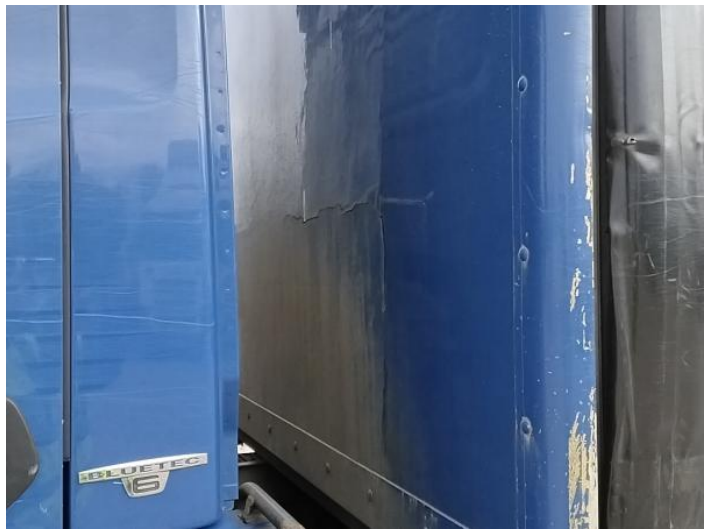
6: General Exterior
Soiled
Light

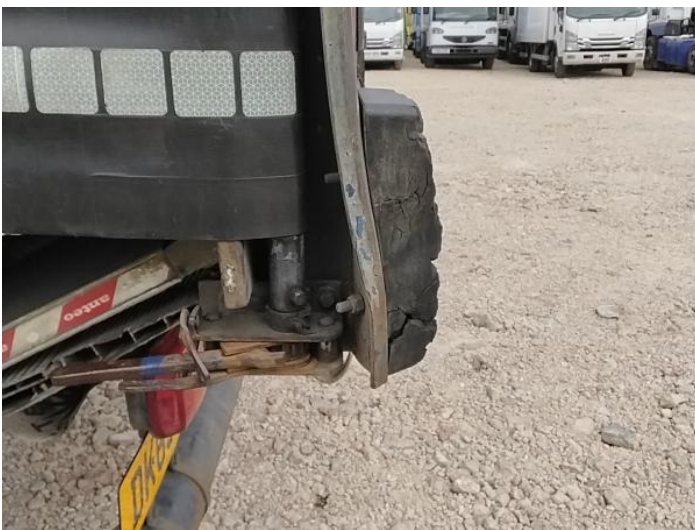
7: Door nsr
Rusted
Over 5mm

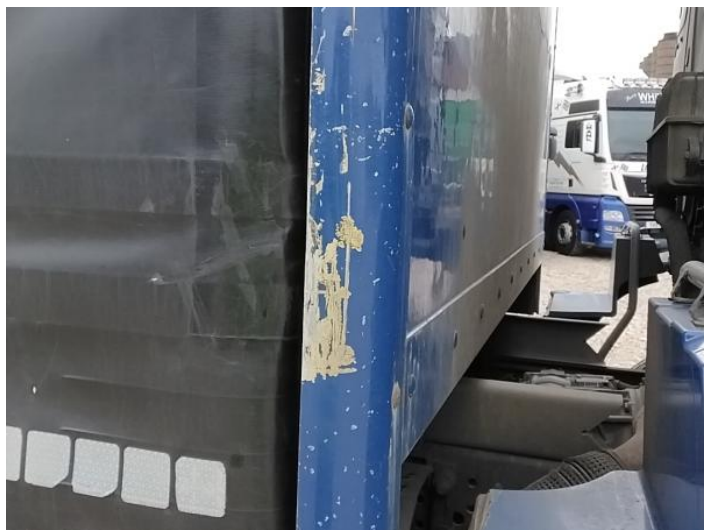
8: C Post os
Scratched
Over 25mm Thru Paint

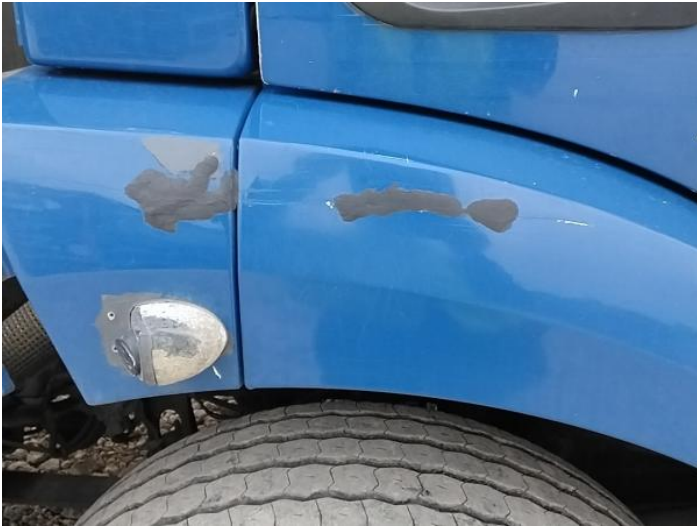
9: Wing osf
Poor Previous Repair
Poor Colour

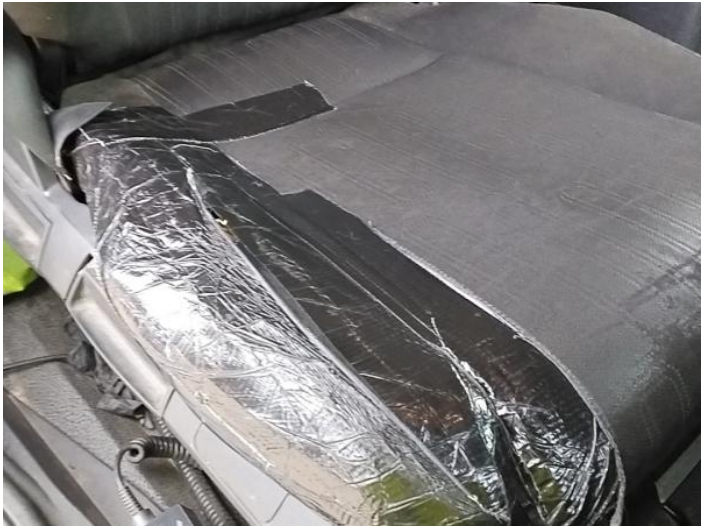
10: Seat Base Cover osf
Torn
Over 3mm
