# **VEHICLE INSPECTION REPORT**

LN19YPF

### **Mercedes-Benz ACTROS 1827**

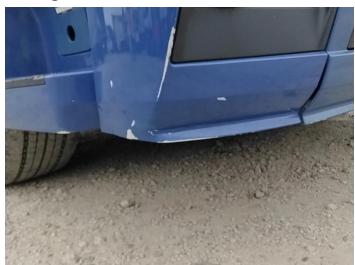
1: Bumper Front Scratched Over 100mm Thru Paint

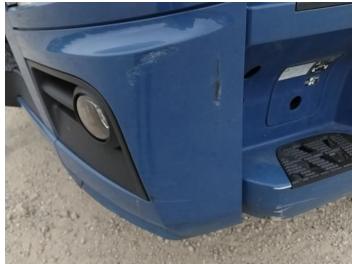
2: Bumper Front Scratched Over 100mm Thru Paint

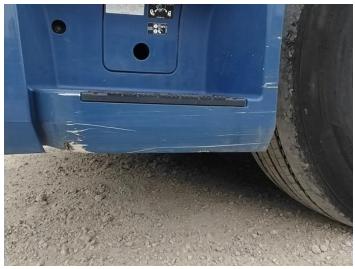
3: General Exterior Soiled Light

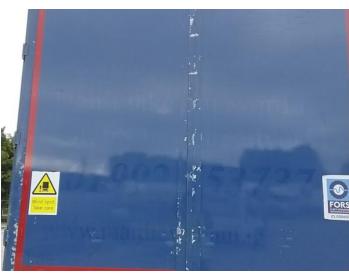
4: General Exterior Soiled Light

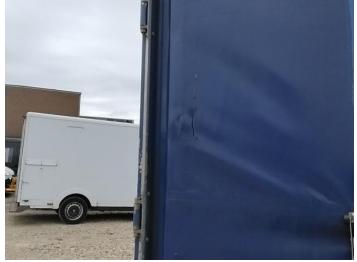
5: General Exterior Soiled Light
