VEHICLE INSPECTION REPORT

BK13NZU

Volvo B7R WRIGHTBUS ECLIPSE 2

Non Runner

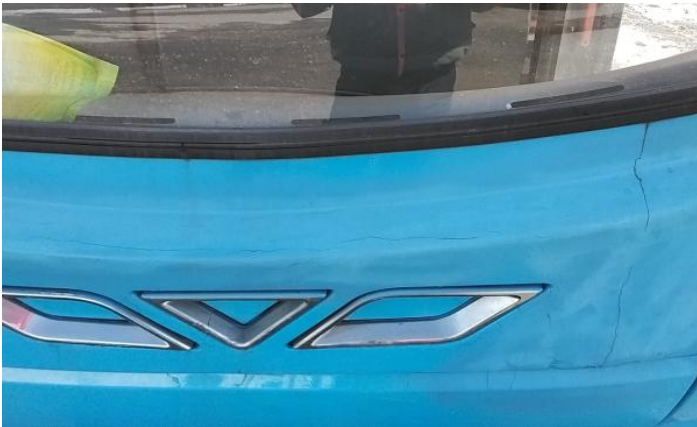
1: Bonnet
Cracked
Replace

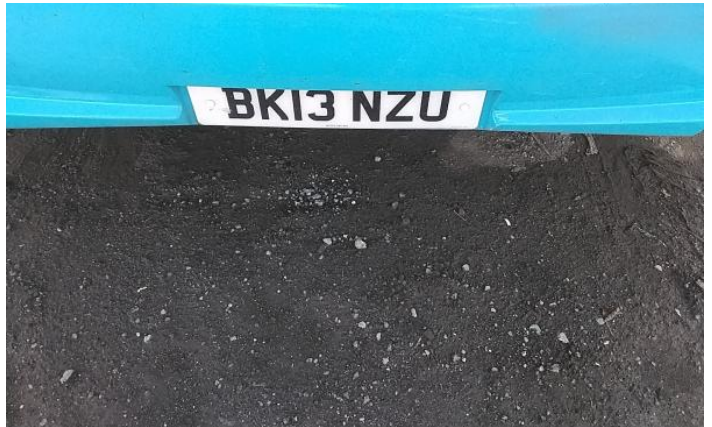
2: Bumper Front
Cracked
Over 25mm

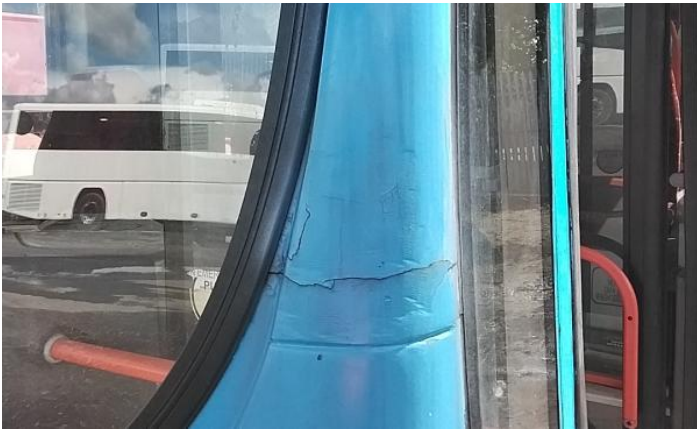
3: A Post ns
Cracked
Replace

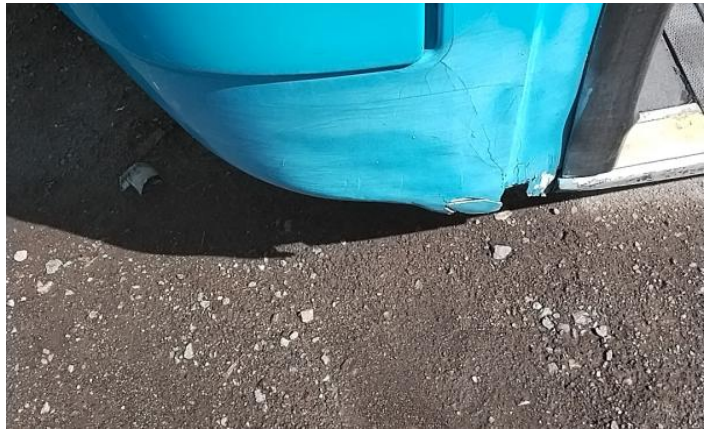
4: Bumper Front Moulding
Broken
Replace

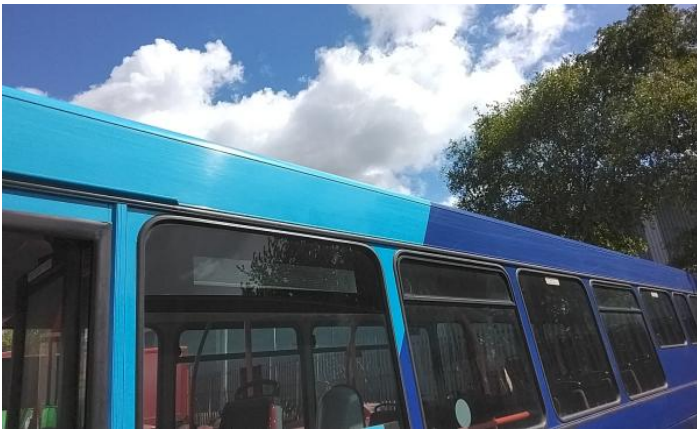
5: Qtr Panel nsr
Scratched
Over 25mm Thru Paint

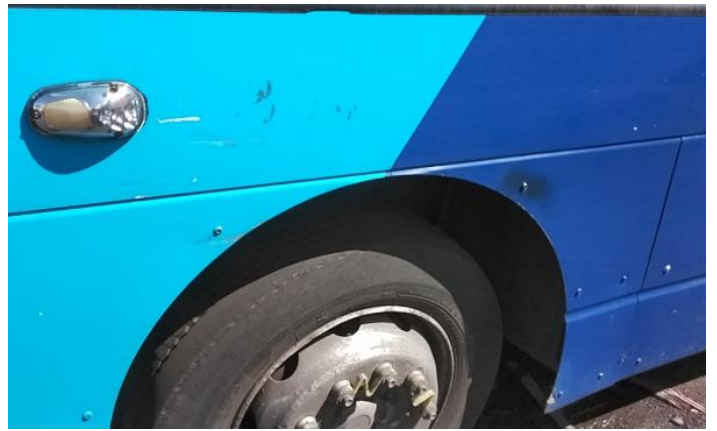
6: Qtr Panel nsr
Scratched
Over 25mm Thru Paint

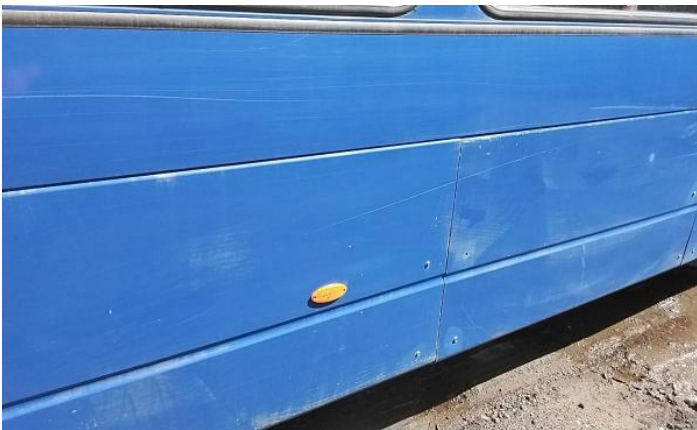
7: Qtr Panel nsr
Scratched
Over 25mm Thru Paint

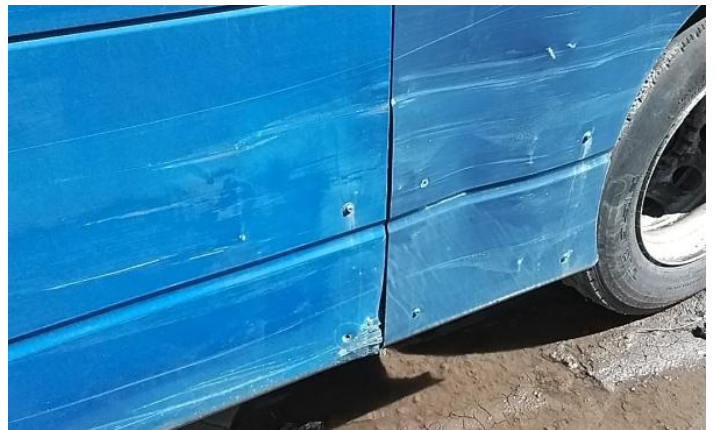
8: Qtr Panel nsr
Dented
With Paint Damage

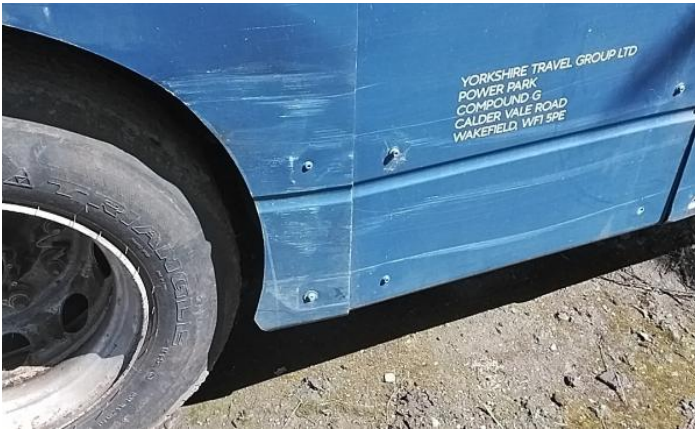
9: Qtr Panel nsr
Dented
With Paint Damage

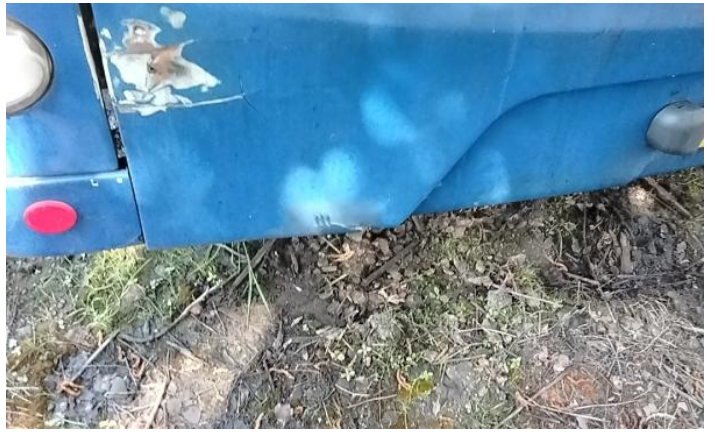
10: Bumper Rear
Cracked
Over 25mm

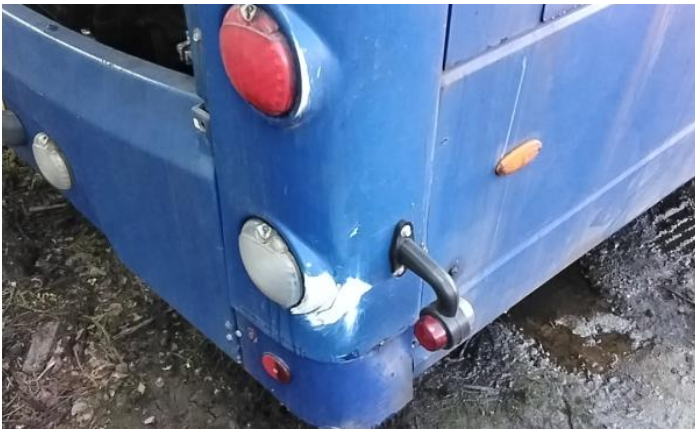
11: Panel Rear
Poor Previous Repair
Rippled Over 30%

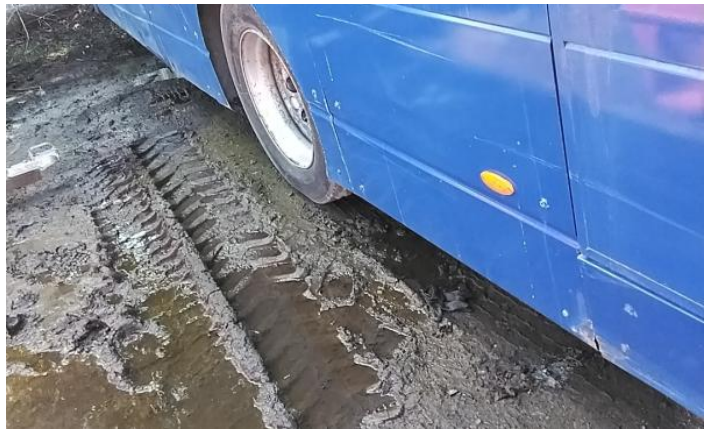
12: Qtr Panel osr
Scratched
Over 25mm Thru Paint

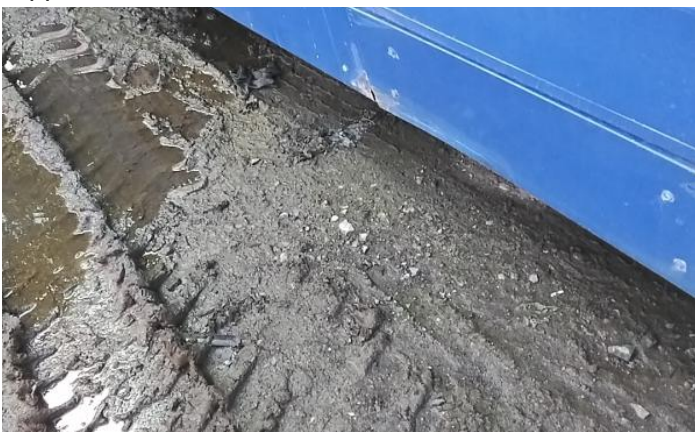
13: Qtr Panel osr
Dented
With Paint Damage
