VEHICLE INSPECTION REPORT

LD18BVX

Ford Transit Custom 320 2.0 TDCi 105ps

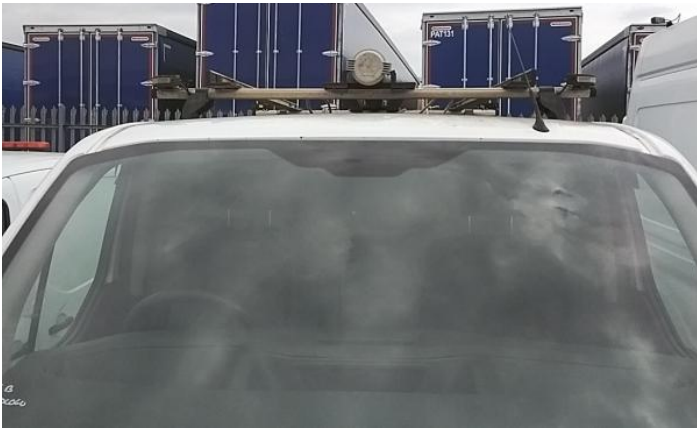
1: Roof
Chipped
Multiple Chips

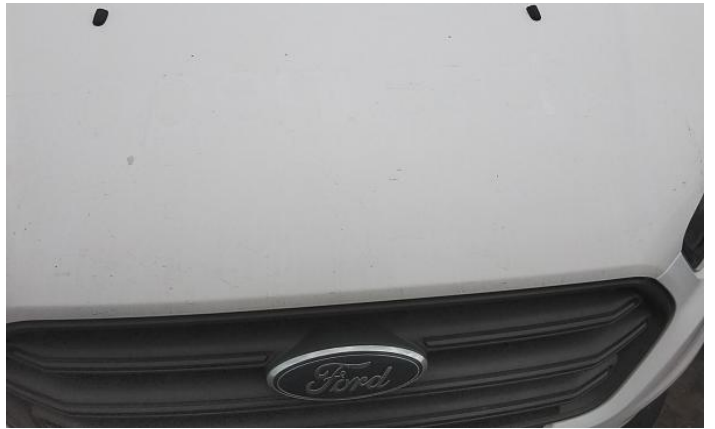
2: Bonnet
Chipped
Multiple Chips

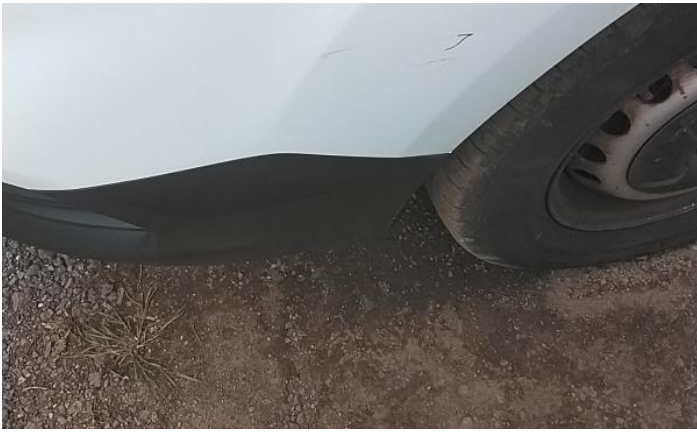
3: Bumper Front
Scratched
25 to 100mm Thru Paint

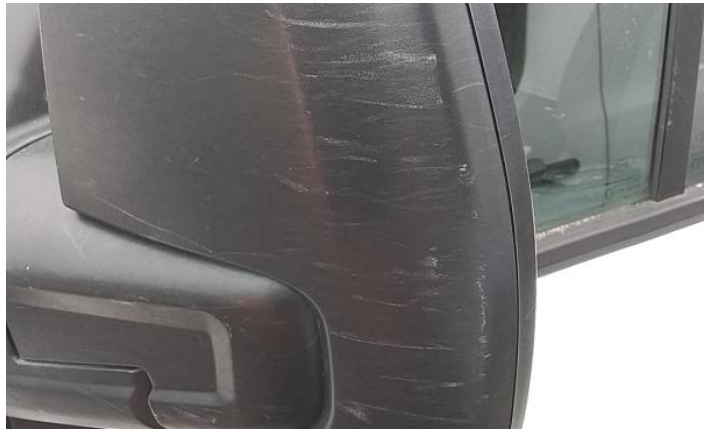
4: Door Mirror Assy nsf
Scuffed (Unpainted)
Over 100mm

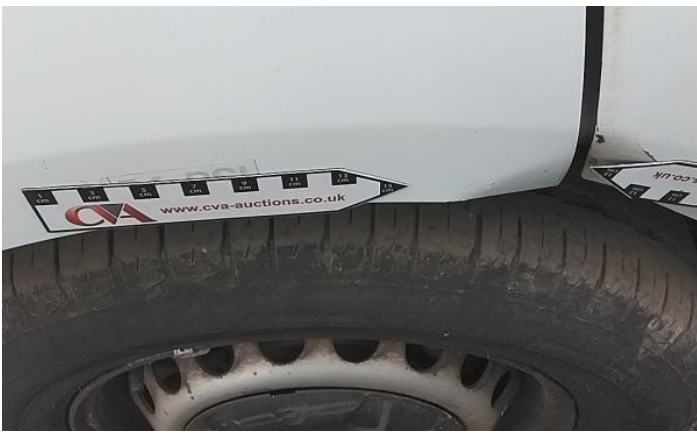
5: Wing nsf
Dented
Over 30mm

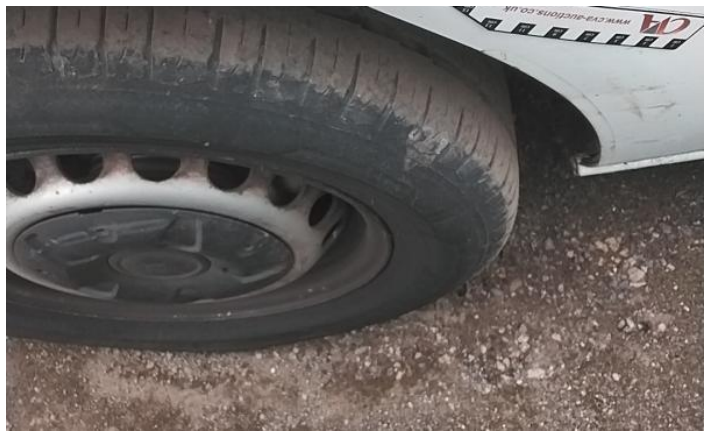
6: Door nsf
Dented
With Paint Damage

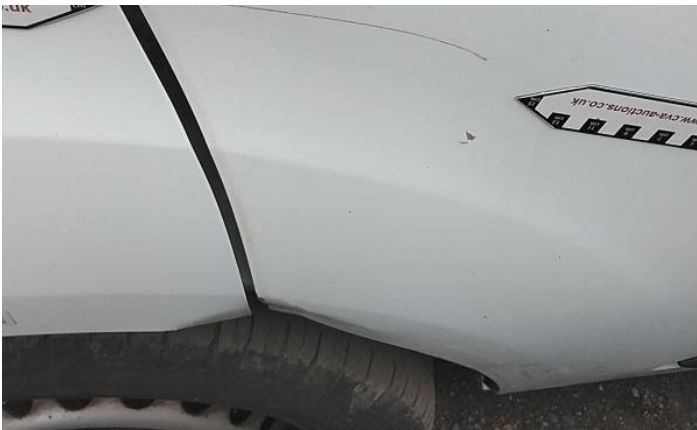
7: Door nsf
Scratched
Over 25mm Thru Paint

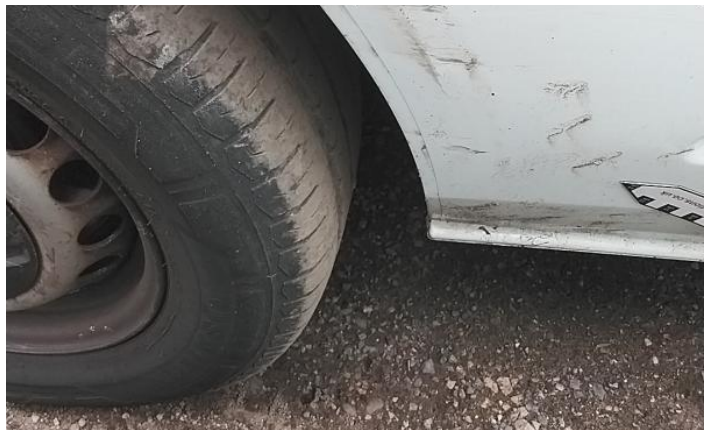
8: Door nsf
Dented
With Paint Damage

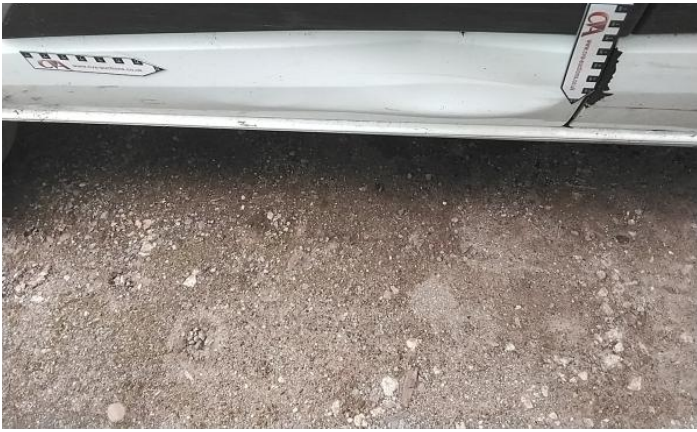
9: Door nsf
Dented
With Paint Damage

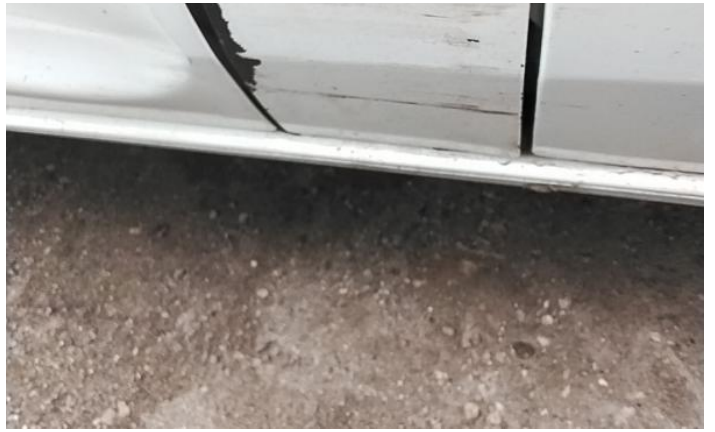
10: Qtr Panel Moulding ns
Scratched (Painted)
Over 25mm Thru Paint

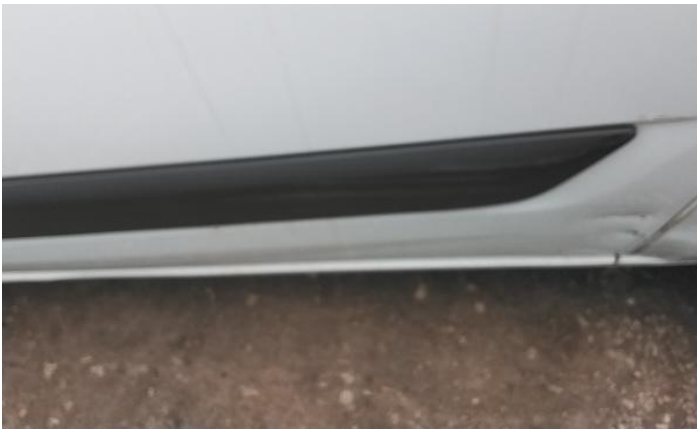
11: Qtr Panel Moulding ns
Scuffed (Unpainted)
Over 100mm

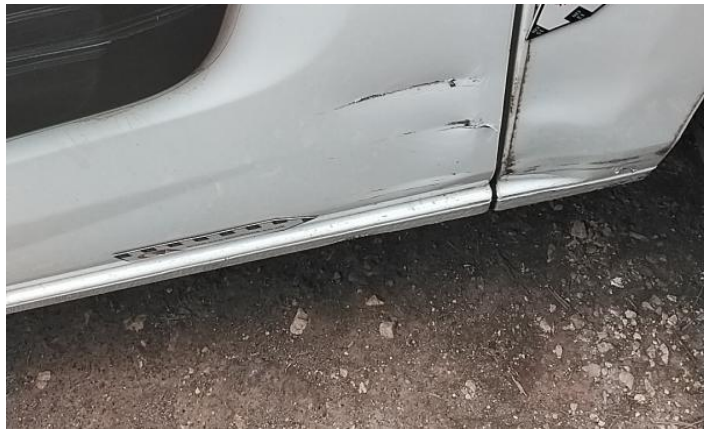
12: Qtr Panel nsr
Dented
With Paint Damage

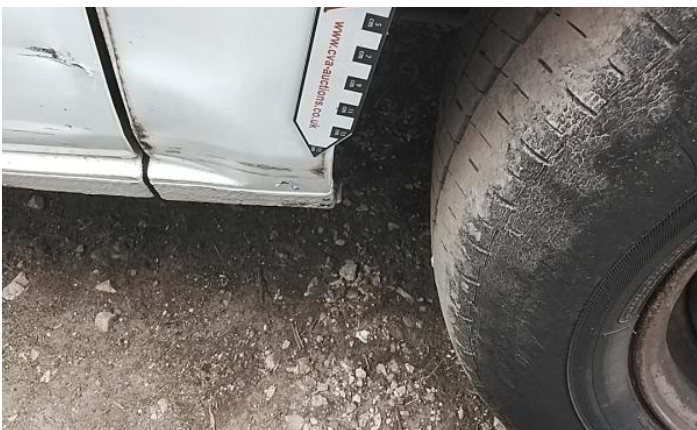
13: Qtr Panel nsr
Dented
With Paint Damage

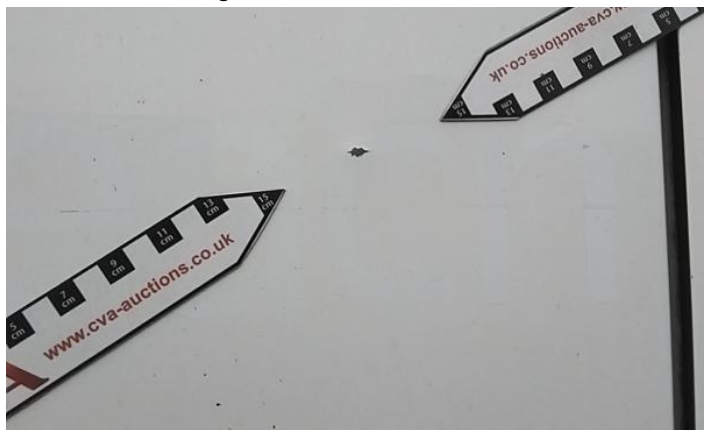
14: Door nsr
Dented
With Paint Damage

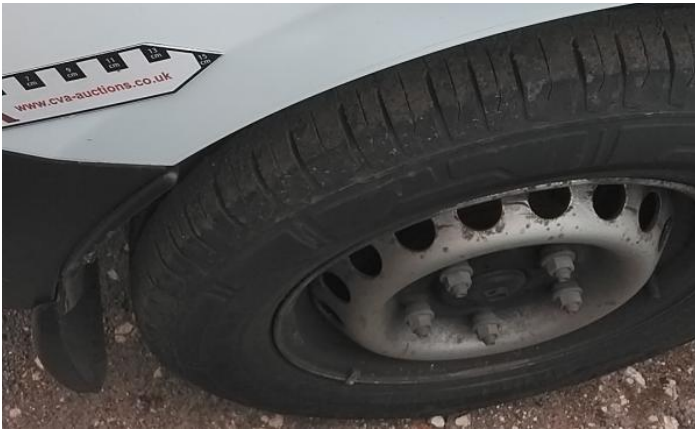
15: Qtr Panel osr
Dented
Over 30mm

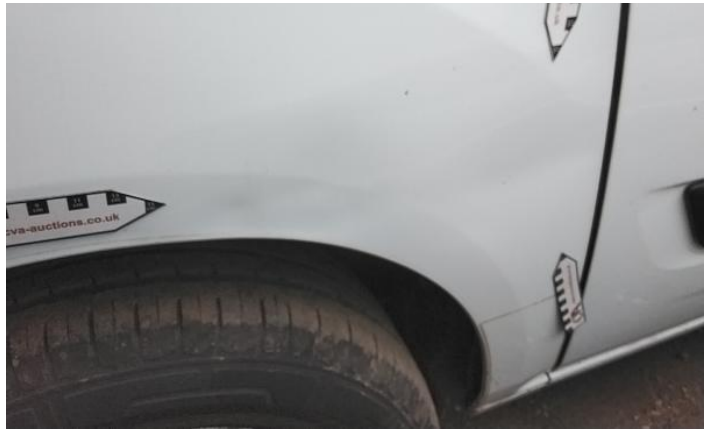
16: Qtr Panel osr
Dented
Over 30mm

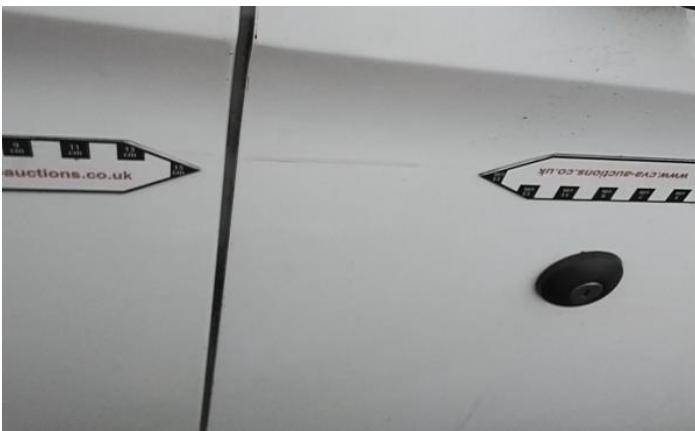
17: Door osf
Scratched
Over 25mm Not Thru Paint

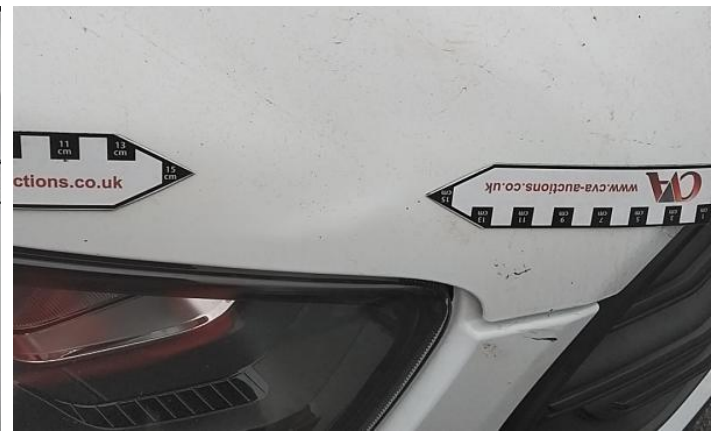
18: Bonnet
Dented
Over 30mm

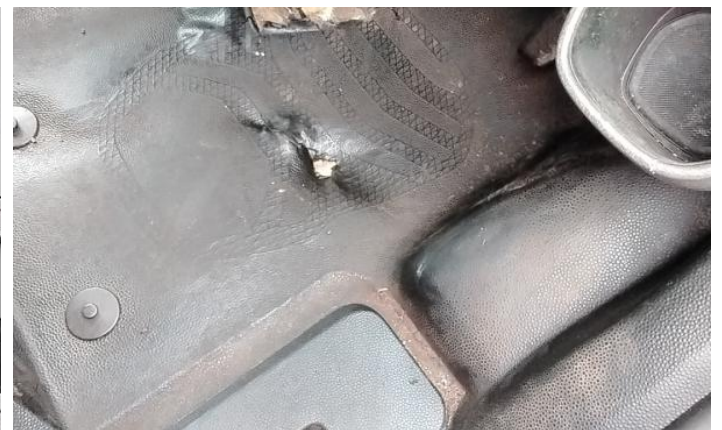
20: Carpets Front
Holed
Over 3mm

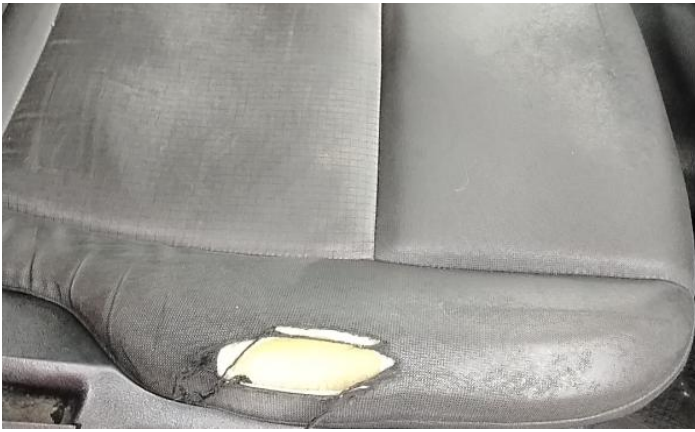
21: Seat Base Cover osf
Holed
Over 3mm

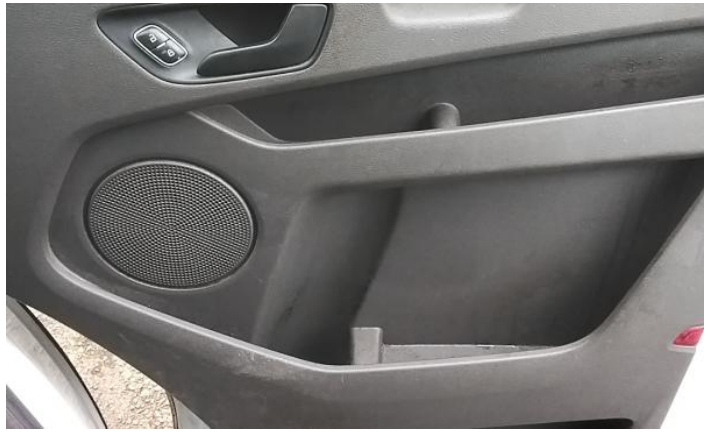
22: Door Pad osf
Scuffed
Over 25mm

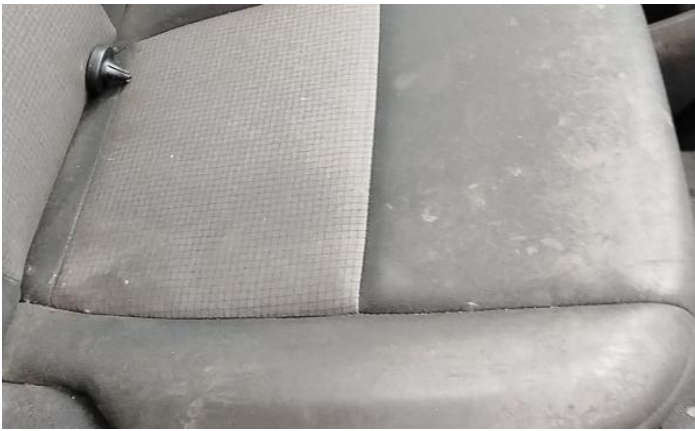
23: Seat Base Cover nsf
Soiled
Heavy

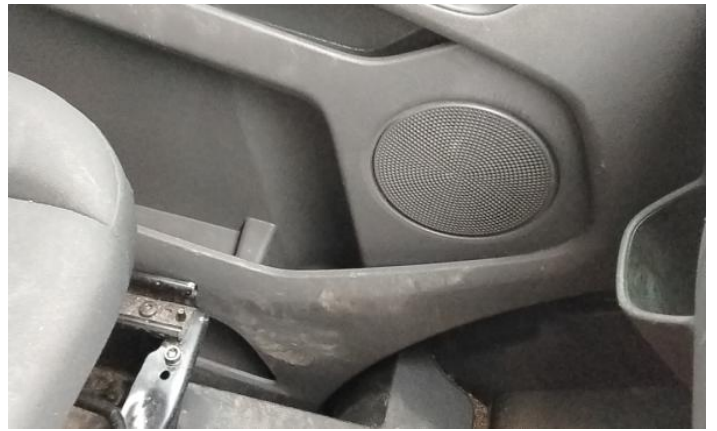
24: Door Pad nsf
Soiled
Heavy

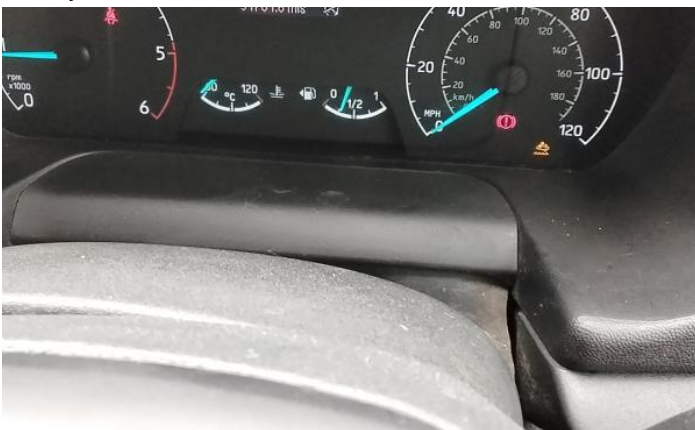
WARNING LIGHTS ON DASH TWIN SIDE LOAD DOOR, E/MIRRORS, AD-BLUE

25: Dash Warning Lights
Displayed
No Action
