VEHICLE INSPECTION REPORT

RV70DCO

Iveco Eurocargo 75-160

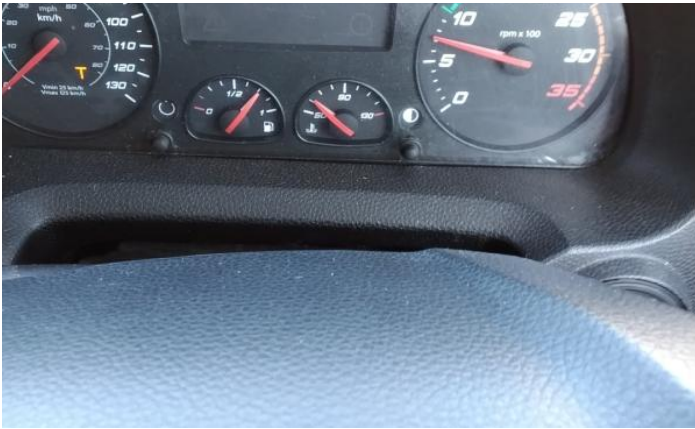
1: Dash Warning Lights
Displayed
No Action

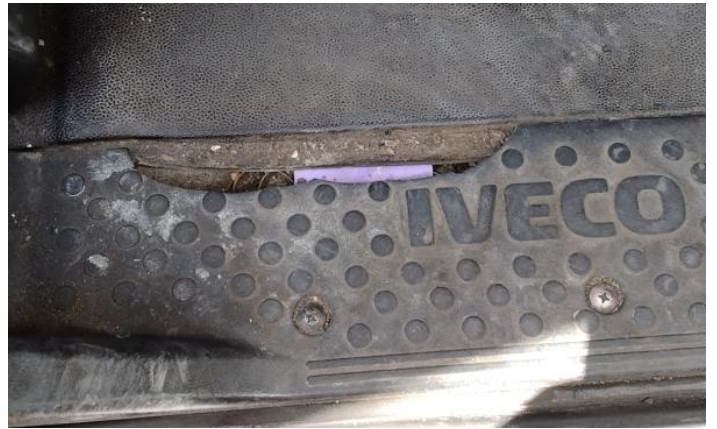
2: Carpets Front
Holed
Over 3mm

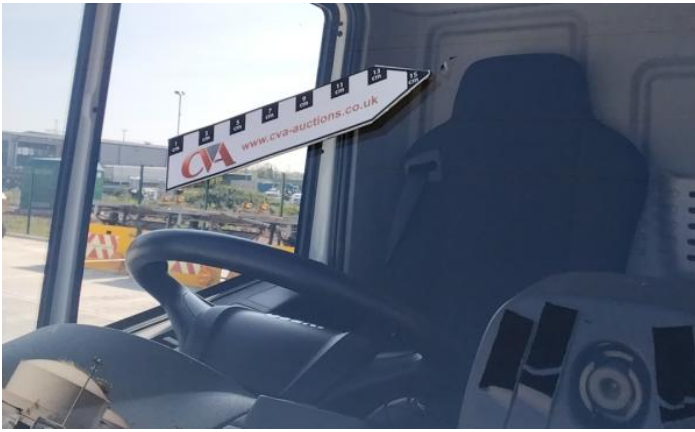
3: Screen Front
Chipped
Over 10mm

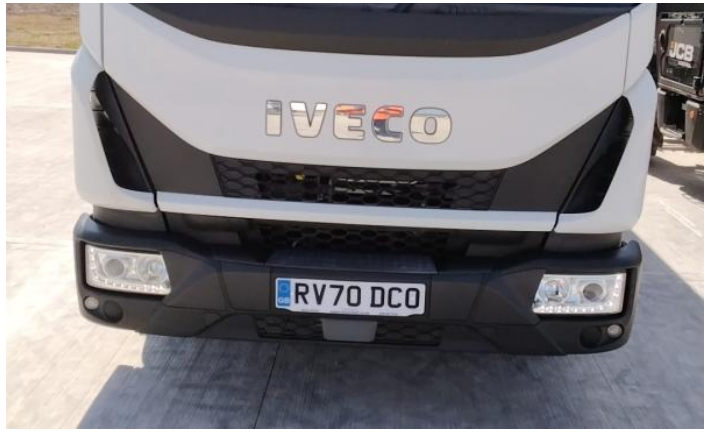
4: Bonnet
Chipped
Multiple Chips

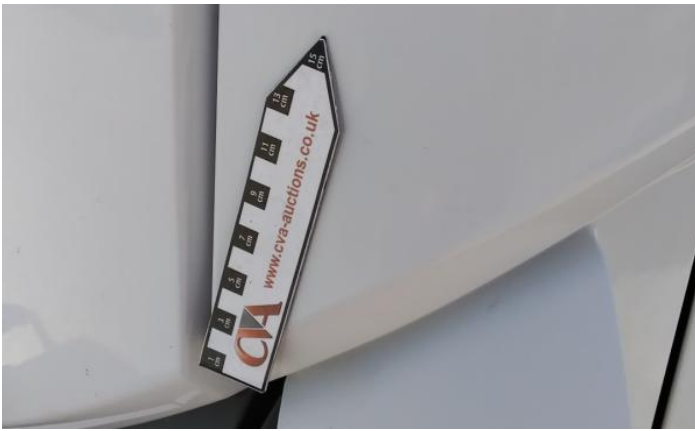
5: Moulding nsf Wing
Scratched (Painted)
UpTo 25mm Thru Paint

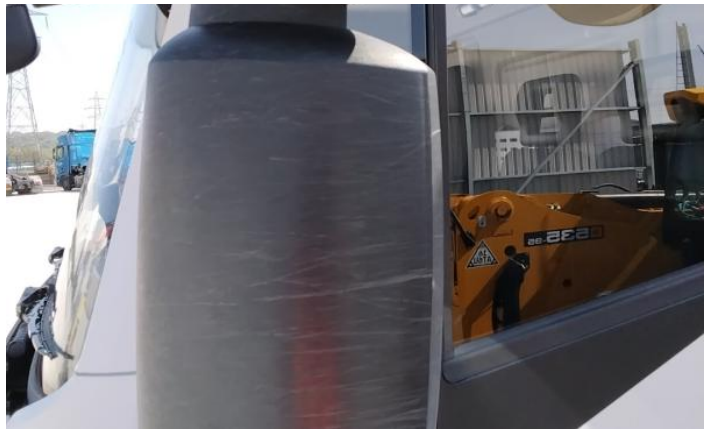
6: Door Mirror Assy nsf
Scuffed (Unpainted)
Over 100mm

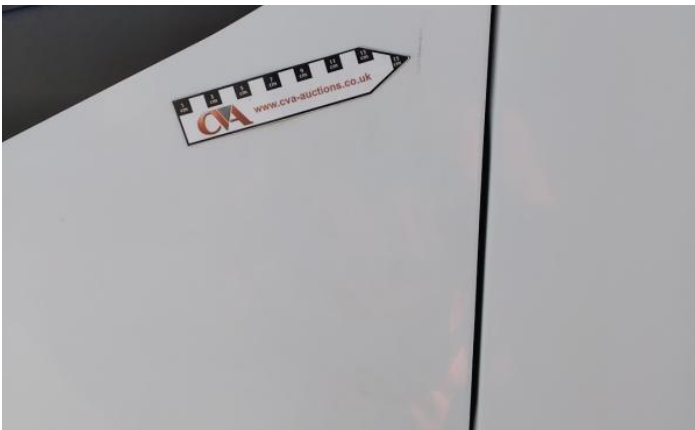
7: Door nsf
Scratched
Over 25mm Thru Paint

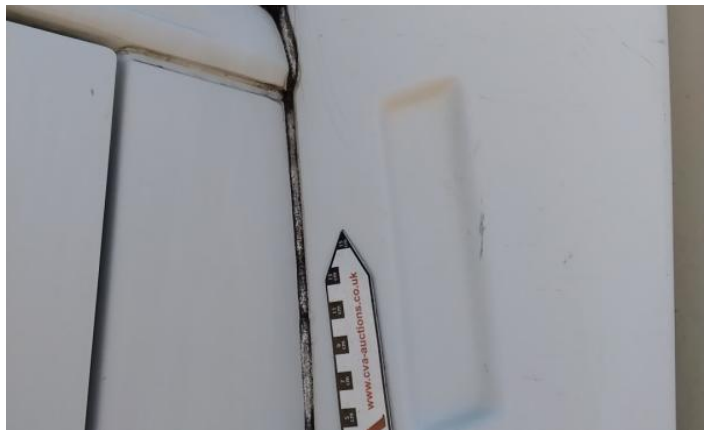
8: Qtr Panel nsr
Cracked
Replace

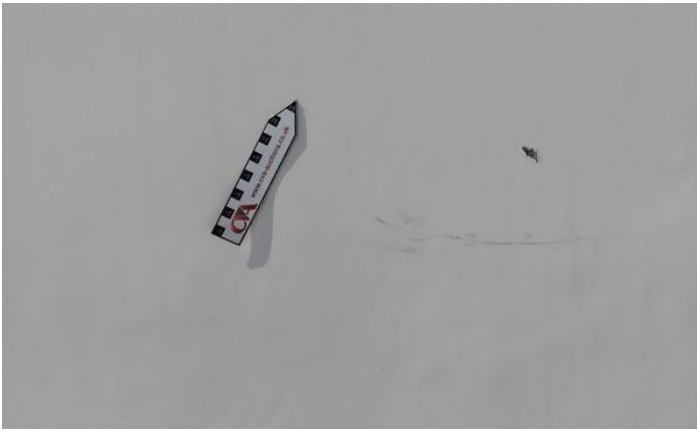
9: Qtr Panel osr
Cracked
Replace

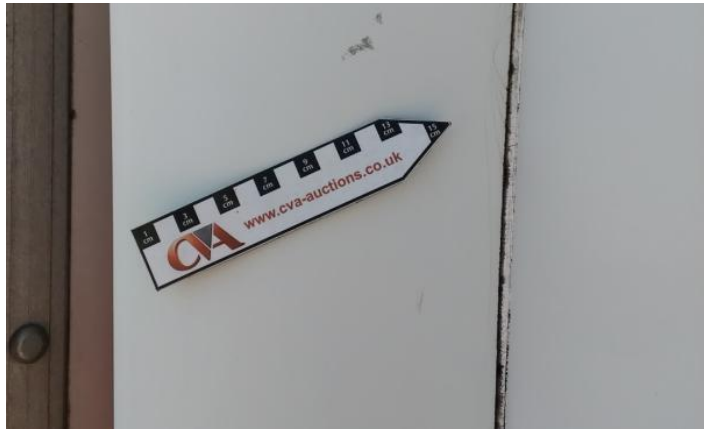
10: Qtr Panel osr
Cracked
Replace

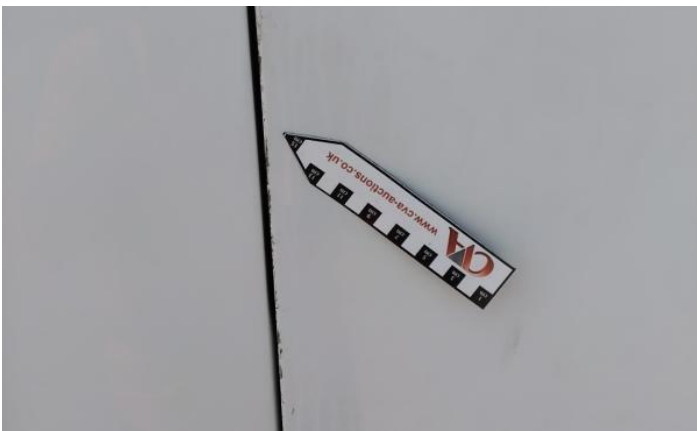
11: Door osf
Chipped
Multiple Chips

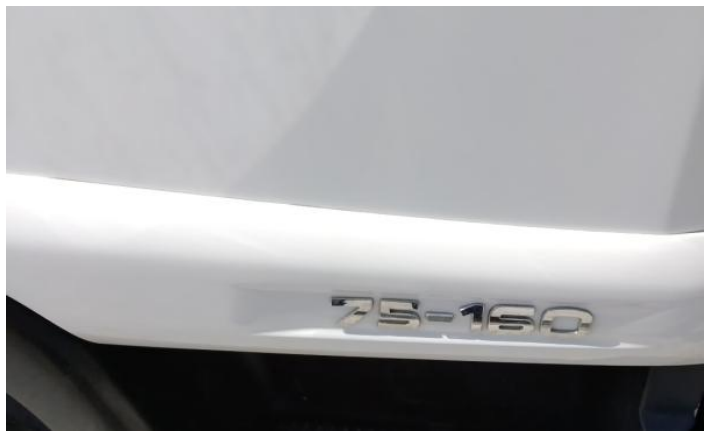
12: Door osf
Scratched
Over 25mm Thru Paint

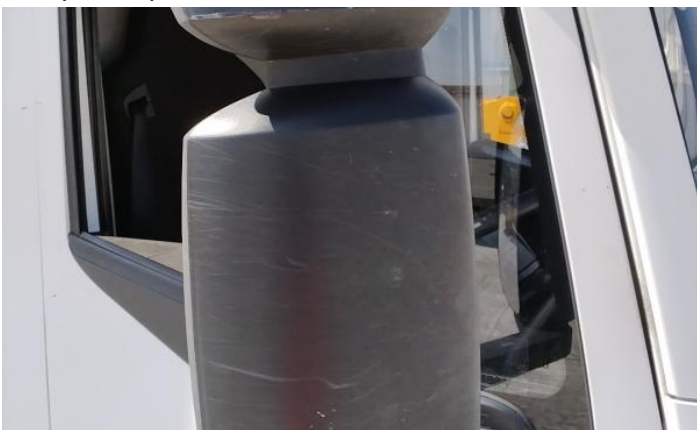
13: Door Mirror Assy osf
Scuffed (Unpainted)
Over 100mm

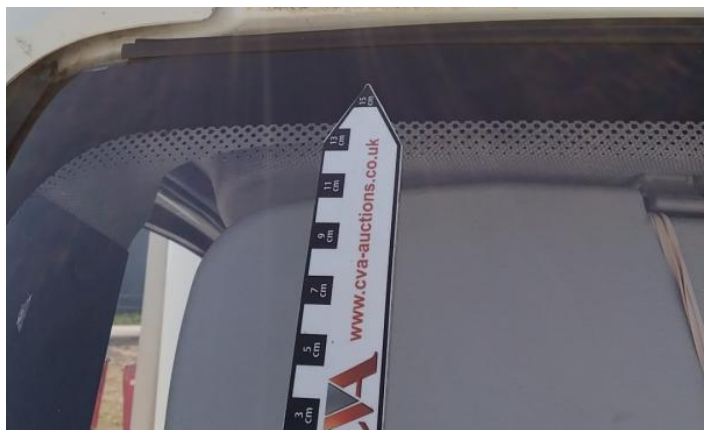
14: Roof
Scratched
Over 25mm Thru Paint

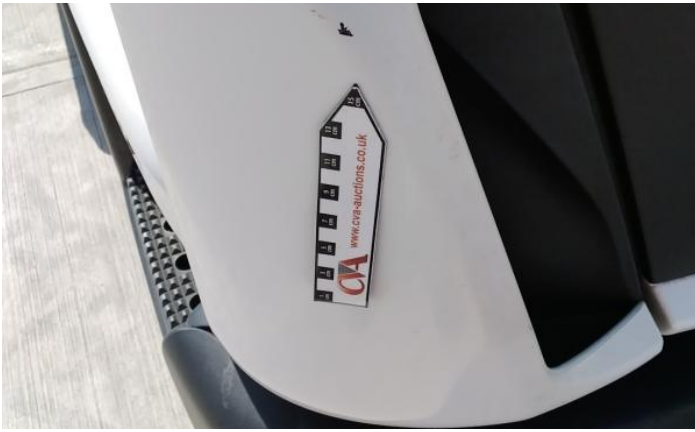
15: Moulding of Wing
 Scratched (Painted)
 Over 25mm Thru Paint

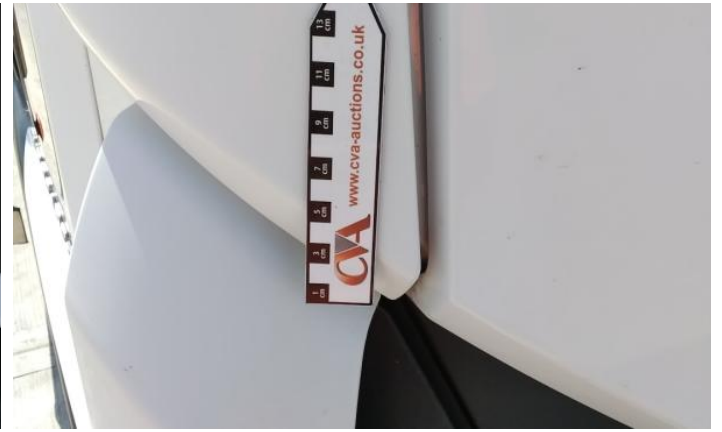
16: Moulding of Wing
 Scratched (Painted)
 Over 25mm Thru Paint
